Road 2021/03

REPORT ON MOTORCYCLE ACCIDENT AT GJØVIK DRIVER AND VEHICLE LICENSING OFFICE IN HUNNDALEN IN GJØVIK MUNICIPALITY, 10 JULY 2020

REPORT ON ROAD TRAFFIC ACCIDENT

Accident type: Run-off-the-road accident

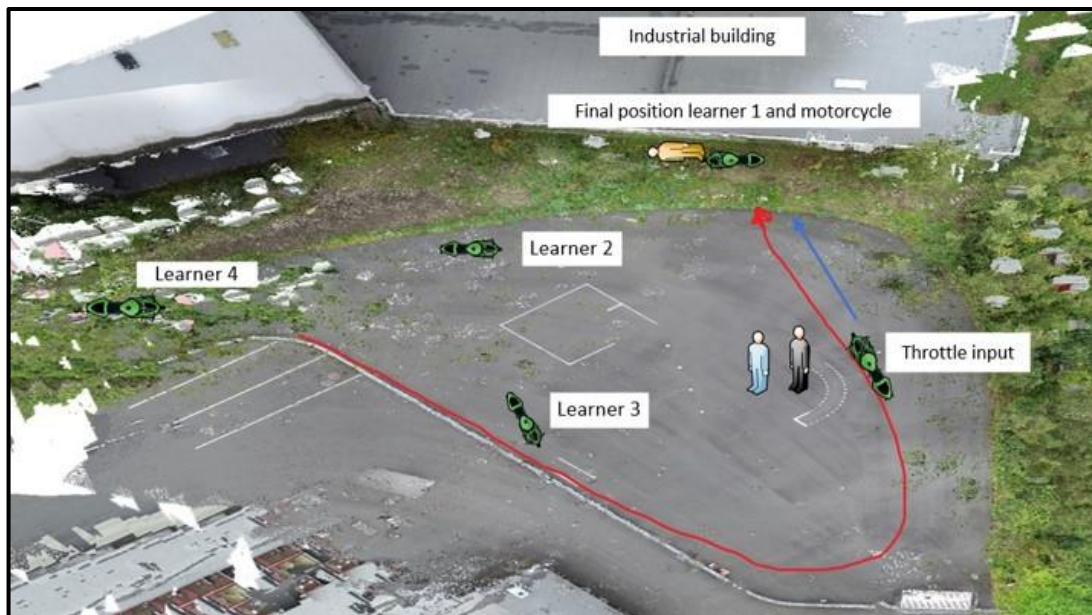
At the exit of a sharp bend, in the area where the two instructors were standing to observe the learners, an accidental throttle input occurred on learner 1's motorcycle. According to witnesses, the learner was left hanging on the handlebars with rigid arms, and was unable to regain control of the motorcycle. The learner rode out of the training area, continued down the slope by the training area, and subsequently crashed into the wall of an industrial building (see Figure 2).

Figure 2: Illustration of the sequence of events in the accident. The yellow figure illustrates the final position of learner 1. The blue line illustrates the distance between the point at which the throttle input occurred and the edge of the tarmac in the training area. Illustration: NSIA

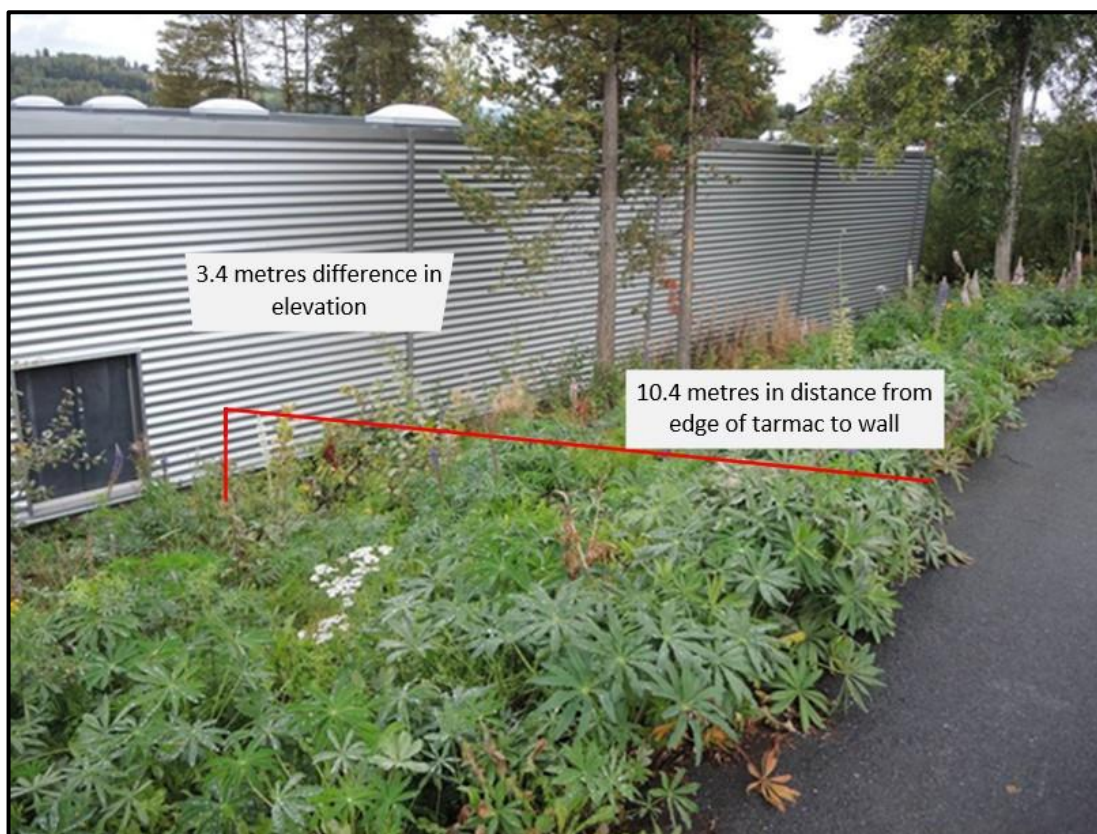
The difference in elevation between the edge of the tarmac in the training area and down to the industrial building was 3.4 metres. There were no railings or other barriers separating the training area from the surrounding terrain. Figure 3 shows the slope where the motorcycle drove into the terrain.

Figure 3: Distance from the industrial building to the edge of the tarmac in the training area where the motorcycle drove into the terrain. Photo: NSIA

The investigation of the motorcycle accident at Gjøvik Driver and Vehicle Licensing Office on 10 July 2020 has shown that the training area had no railings or other form of physical barrier that could have prevented or reduced the extent of the damage/injury in the event of a motorcycle driving into the terrain. There is no requirement for a risk assessment when establishing the Norwegian Public Roads Administration's training areas, over and above the general requirements described in the guidelines for administering driving tests.

The Norwegian Safety Investigation Authority recommends that the Norwegian Public Roads Administration establish safety requirements that include risk assessments in connection with designing and using both existing and new training areas for practical riding tests for motorcycles.

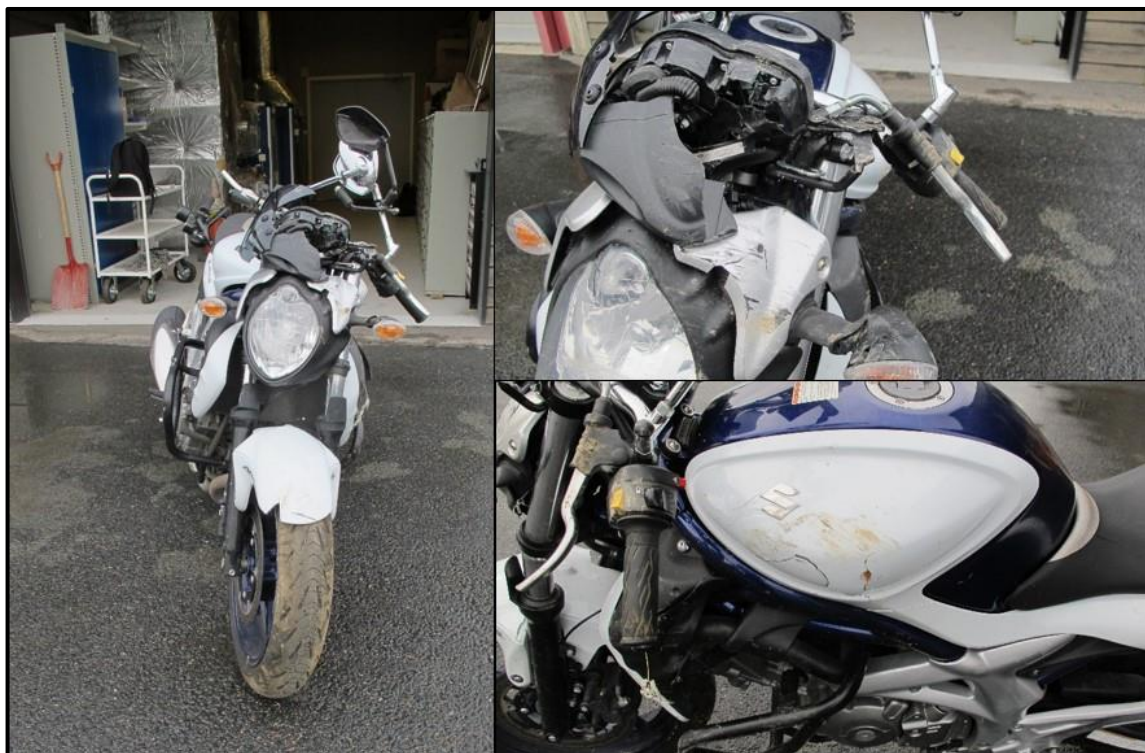
The motorcycle sustained major damage to its front as a result of crashing into the industrial building (see Figure 4). The motorcycle also sustained major damage on its left side, including a bent front fork and handlebars, as a result of the crash.

Figure 4: Damage to the motorcycle. Photo: NSIA

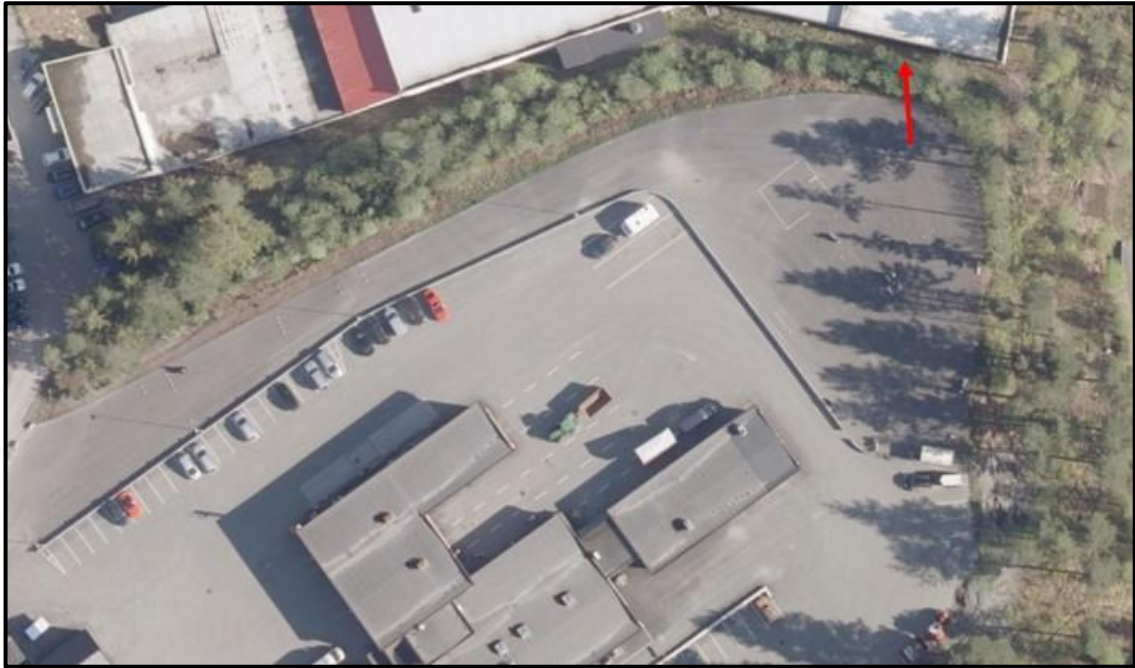
The accident happened in the training area at Gjøvik Driver and Vehicle Licensing Office in Hunndalen, situated about three kilometres west of Gjøvik town centre. The training area is situated on the northern side of the Driver and Vehicle Licensing Office (see Figure 5).

Figure 5: Overview of the training area at Gjøvik Driver and Vehicle Licensing Office. The red arrow indicates where the learner most likely went over the edge of the tarmac in the training area and down the slope towards the industrial building. Photo: Gule Sider

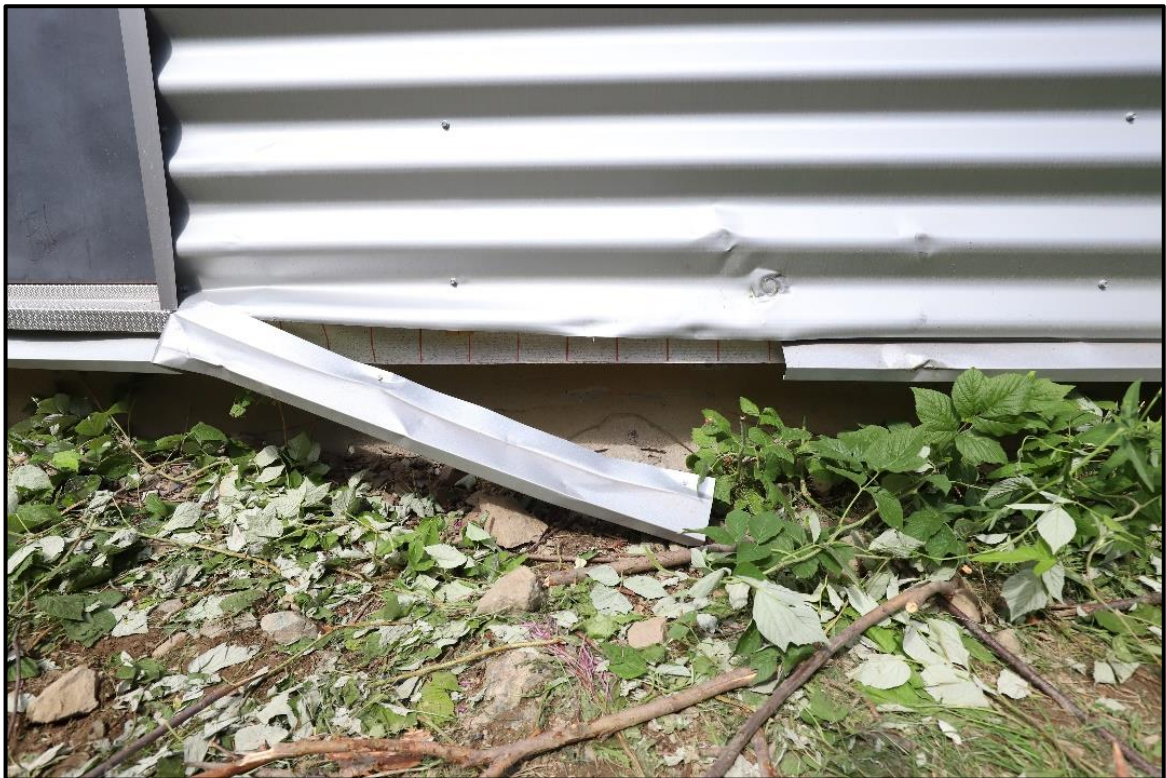
The wall of the industrial building sustained minor damage as a result of the crash (see Figure 6).

Marks from the motorcycle were found on the exterior wall of the industrial building. The building sustained damage to the wall consistent with the front of the motorcycle or the right handlebar (see Figure 6).

Figure 6: An aluminium strip on the wall of the industrial building was torn off in the crash. Photo: The police

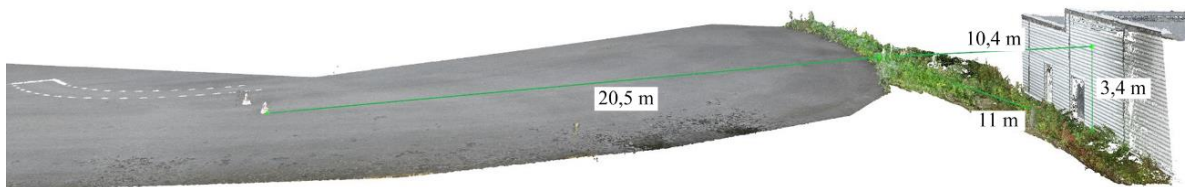
The distance from the point in the training area where the accidental throttle input occurred to the edge of the tarmac at the end of the training area was registered as approximately 20.5 metres. The distance between the edge of the tarmac and the exterior wall of the industrial building was registered as approximately 10.4 metres. The slope between the tarmac edge of the training area and the wall of the industrial building was measured to a length of approximately 11 metres, with a difference in elevation of approximately 3.4 metres. This means a gradient of approximately 30 degrees (see Figure 7 and Figure 8).

Figure 7: Survey of the accident site, seen from the east. Illustration: NSIA

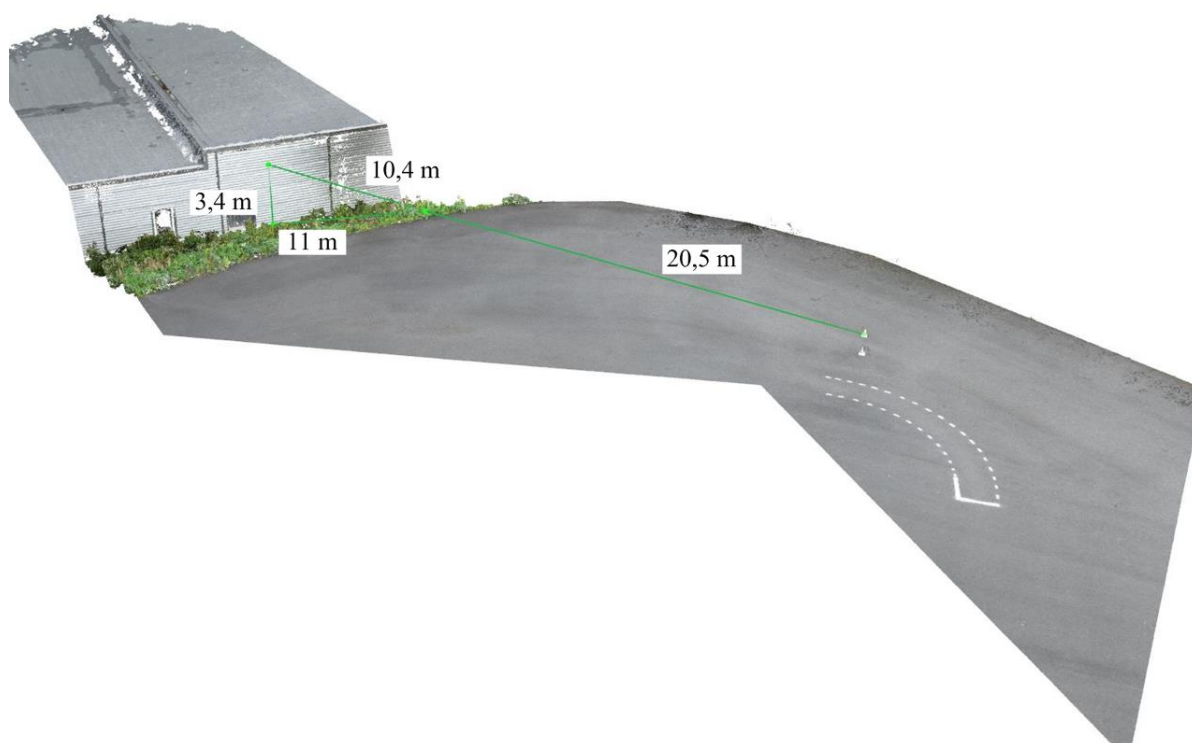
Figure 8: Survey of the accident site, seen from above. Illustration: NSIA

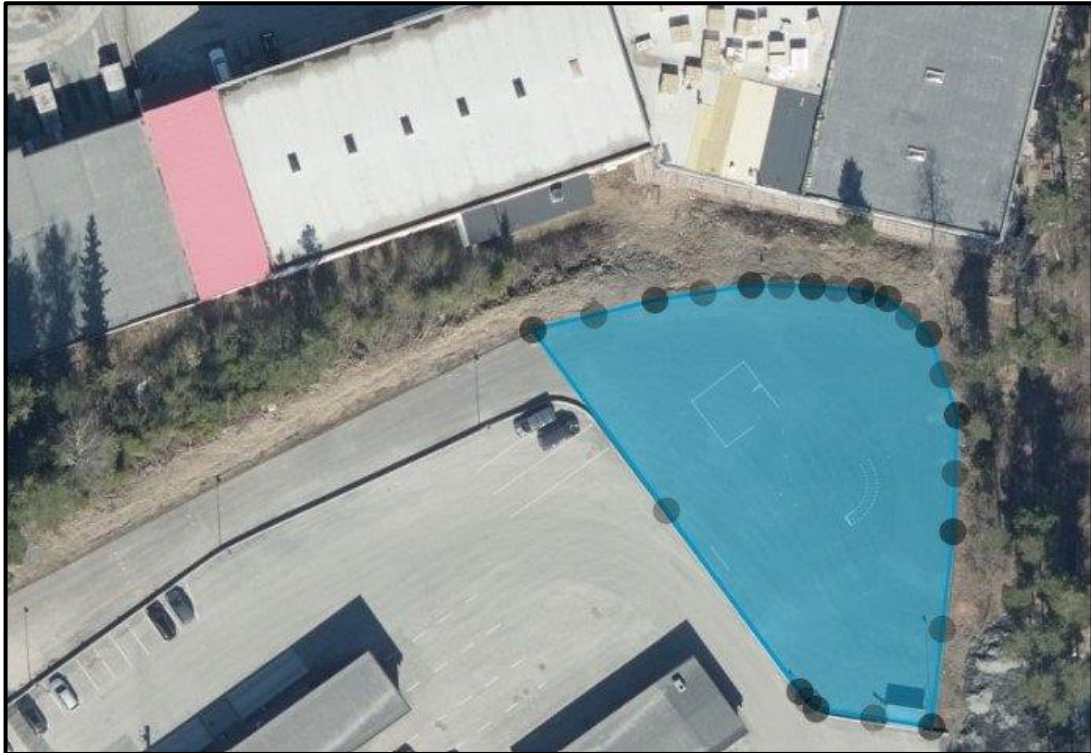
The accident occurred in a training area used by the NPRA for driving tests at Gjøvik Driver and Vehicle Licensing Office. It is situated in separate tarmacked area on the northern side of the Driver and Vehicle Licensing Office. The total size of the training area is 2,800 square metres, and the area in which the learner underwent driving practice is 1,725 square metres (see Figure 10).

The design of the training area is based on the guidelines for administering driving tests, and the last risk assessment of the area was carried out in 2009 (see section 1.12.3). In autumn 2019, excavation work took place on the slope for the purpose of installing district heating for the Driver and Vehicle Licensing Office. This meant that some vegetation was removed and the slope was covered in sharp gravel, which is partly covered by vegetation.

Figure 10: Overview of training area. The area where the learner was practising is marked in blue. Photo: © Norwegian Mapping Authority. Illustration: NSIA

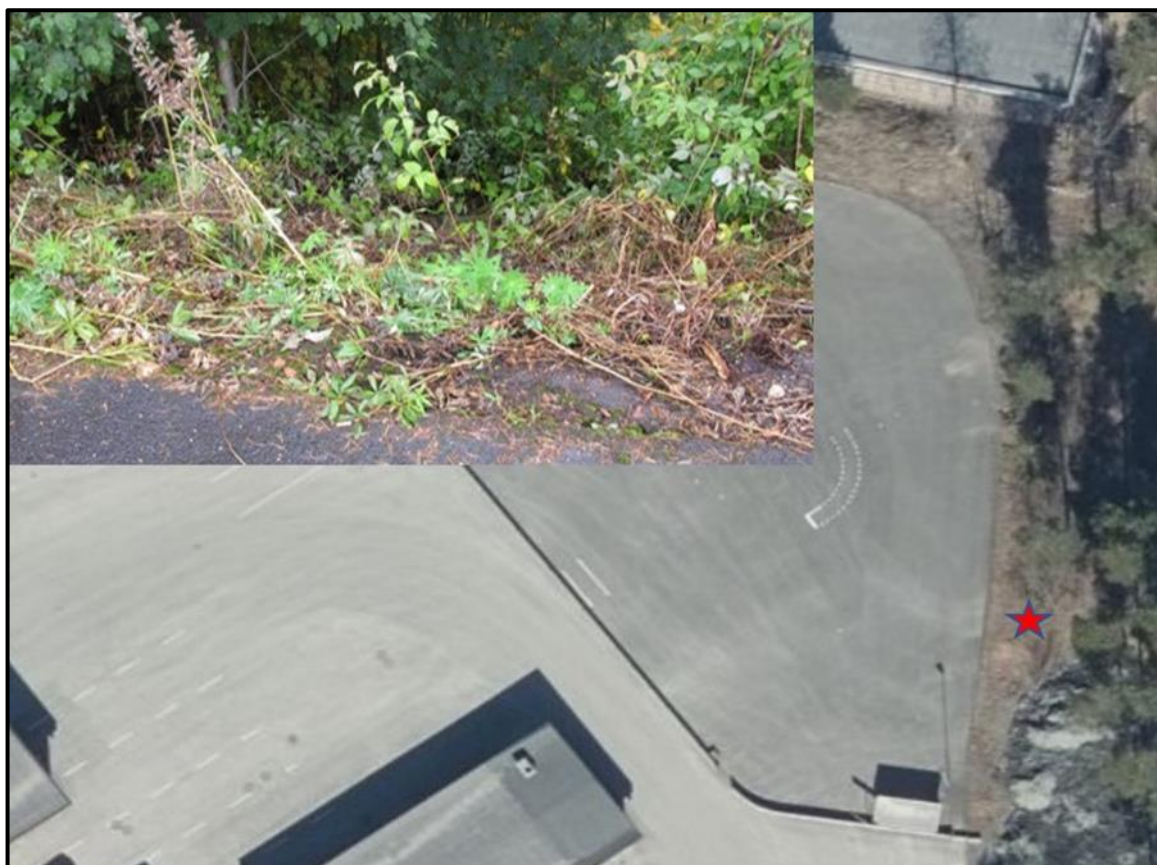
On Wednesday 19 August 2020, another accident occurred in the training area at Gjøvik Driver and Vehicle Licensing Office. This incident also concerned a learner who went over the edge of the training area and drove down a slope on the eastern side of the area, which was not secured either (see Figure 12). The learner sustained no injuries in the incident.

Figure 12: Overview of the training area and the slope (marked in red) where the motorcycle drove over the edge. Illustration: NSIA

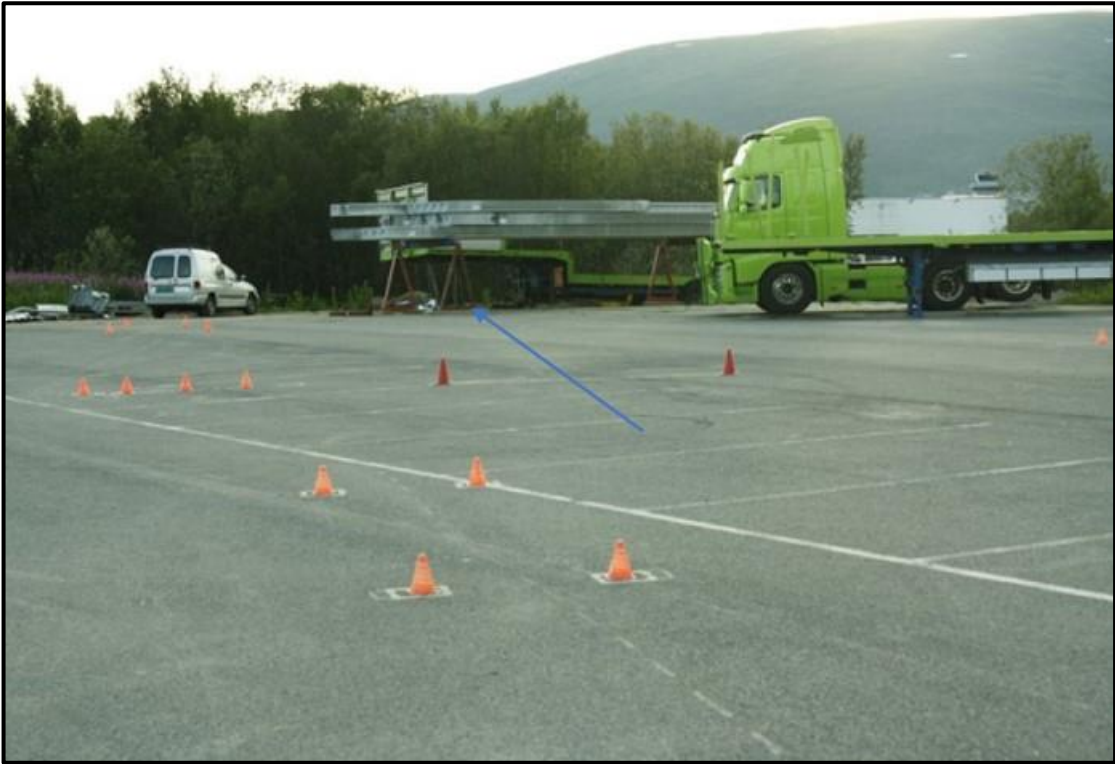
The learner was taking his twelfth lesson at the time of the accident. At the time the accident occurred, there were a number of concrete elements, trailers and equipment for excavators in the area that was used for training (see Figure 13).

Figure 13: The learner drove between the two red cones and collided with the green trailer.
Photo: The police
