ROAD 2022/04

Head-on collision between two heavy goods vehicles on the RV 4 road just north of the Hagan tunnel near Slattum in Nittedal municipality on 27 May 2021

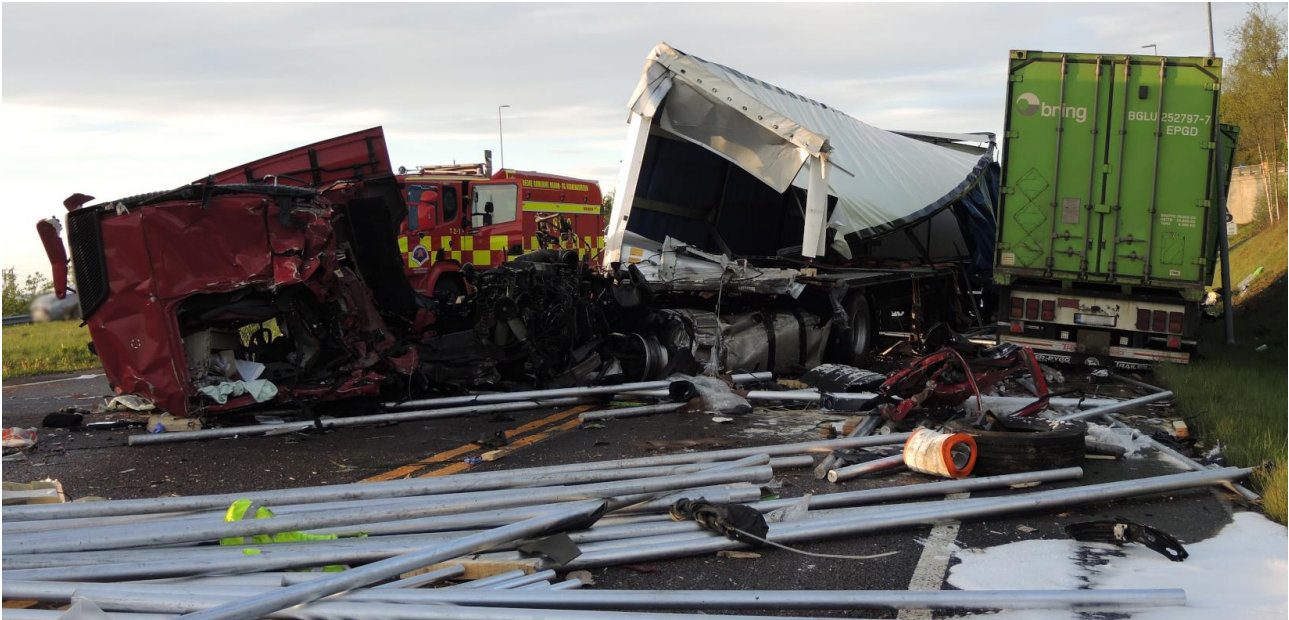
The buckles on the drivers' seat belts were stuck in the locked position after the accident. Furthermore, both seatbelts were cut when the vehicles were examined at the scene of the accident after the rescue effort. The NPRA's (2021) examinations of the seat belts after the accident indicated that they had been worn. There was survival space² in both driver's cabs after the accident (see Figure 3 and Figure 4).

Vehicle A was extensively damaged on the left side of the cab front and the left side of the trailer front, as a consequence of the collision. Figure 3 also shows how the cab of Vehicle A tipped forward after the collision.

Figure 3: Vehicle A with the red driver's cab to the left in the photo, as it appeared approximately 1.5 hours after the accident. Photo: NSIA

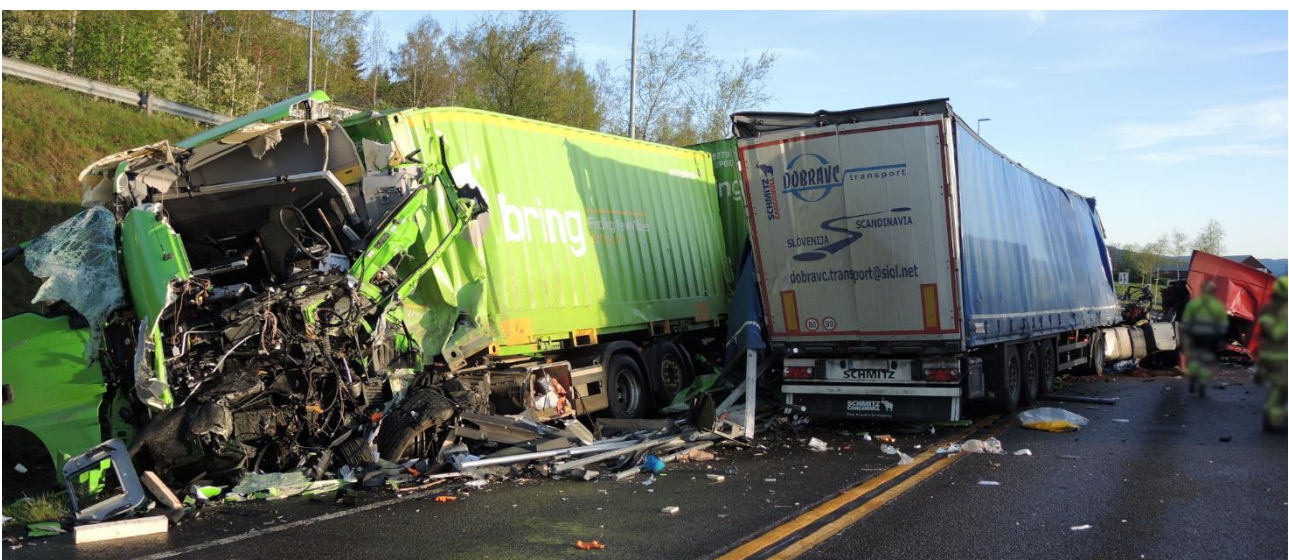
Vehicle B sustained extensive damage to the front and left side of the cab, as a consequence of the collision (see Figure 4). In addition, the foremost cargo container was buckled inwards both at the front and at the back.

Figure 4: Vehicle B to the left in the photo, as it appeared approximately 1.5 hours after the collision. The photo was taken after the rescue work. Photo: NSIA

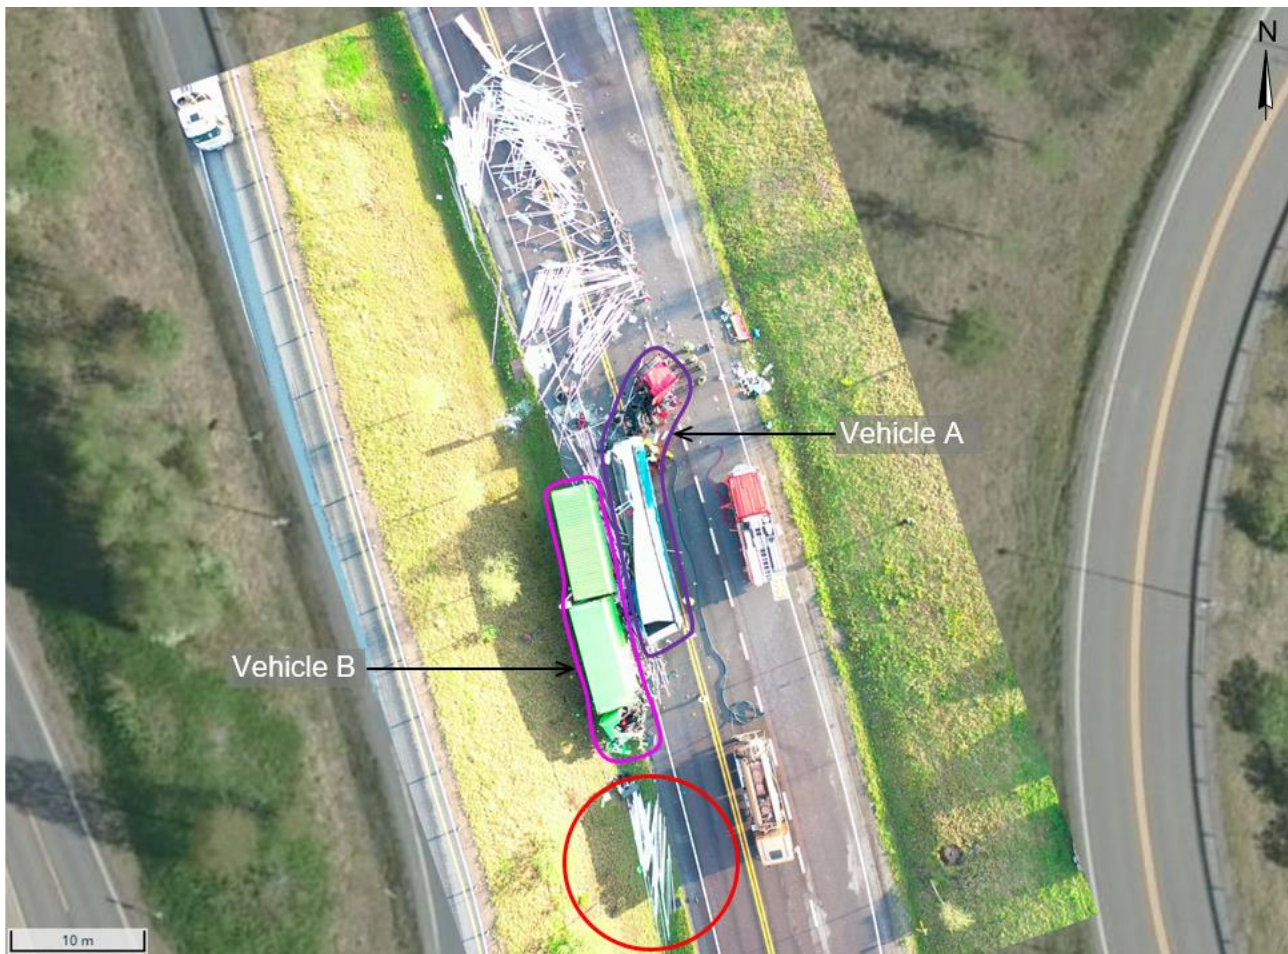
Figure 5 shows how Vehicle A's cargo was hurled out of the semi-trailer, both to the left and forward of the cab in the direction it was travelling. Vehicle A's cab tipped forward in the collision and tilted to the right in relation to the run of the roadway, ending up with the front window resting on the ground (see Figure 3).

Figure 5: Drone photo giving a general view of the scene, taken just under three hours after the collision. At that point in time, the aluminium sections marked with a red circle had been removed from the driver's side and the front of Vehicle B to facilitate rescue. Photo: © Norwegian Mapping Authority. Drone photo and illustration: NSIA

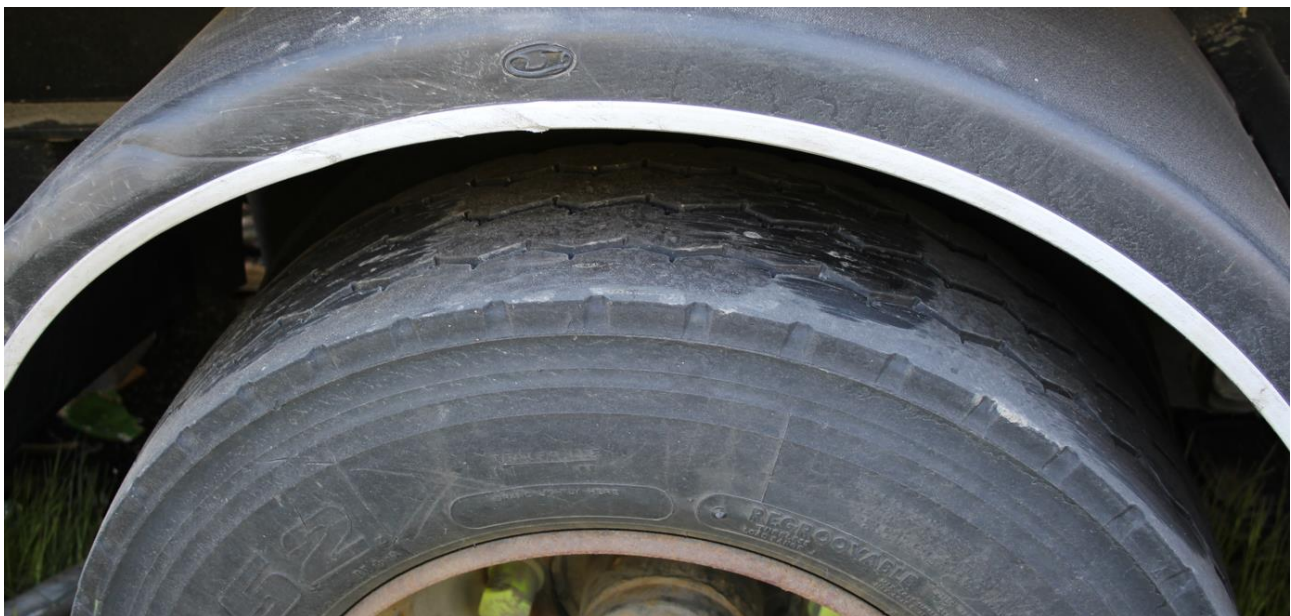
Vehicle B showed traces of braking action in the form of dark patches on the tyres of the truck's rearmost axle and the second-last axle on the drawbar trailer (see Figure 6).

Figure 6: Traces of braking action in the form of dark patches on one of the tyres of the second-last axle on Vehicle B's drawbar trailer. Photo: NPRA.

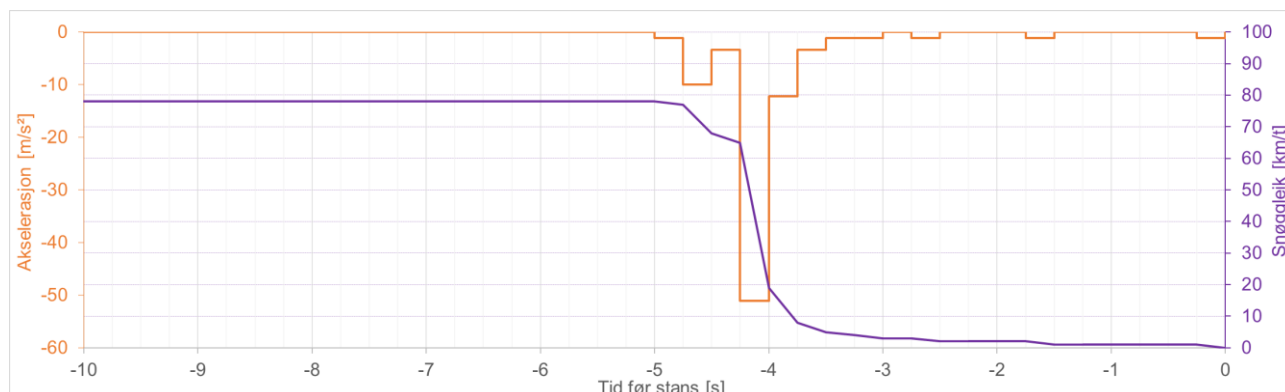
Downloaded tachograph data from Vehicle A show that it held an even speed of 78 km/h during the final seconds before the collision, and that the speed dropped from 78 km/h to 19 km/h in the course of one second (see Figure 7). Another four seconds then passed before it came to a complete standstill after the collision.

Figure 7: Vehicle A's speed and acceleration during the seconds immediately before and after the collision. The data are presented as retrieved from the tachograph in the tractor unit, with a resolution of four log entries per second. Tachograph data from the tachograph in Vehicle A's tractor unit. Illustration: NSIA

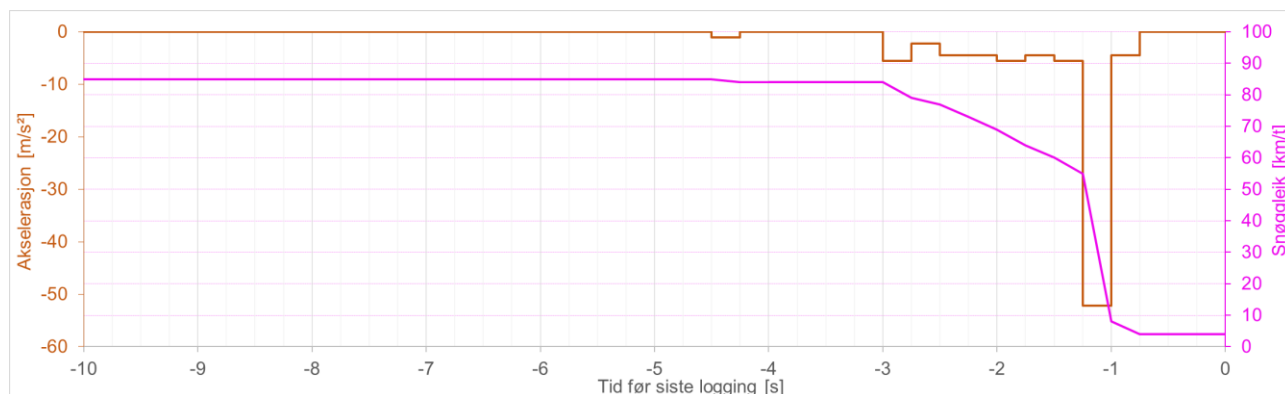
Downloaded tachograph data from Vehicle B show that it held an even speed of approximately 85 km/h during the final seconds before the collision (see Figure 8). The data also show that the speed dropped to 55 km/h in the course of 1.75 seconds, and then to 8 km/h in the course of 0.25 second. One more second passed before the tachograph lost its power supply. The final speed logged before the power failed was 4 km/h.

Figure 8: Vehicle B's speed and acceleration during the final seconds before the collision up until the power supply failed. The data are presented as retrieved from the tachograph in the truck, with a resolution of four log entries per second. Tachograph data from the tachograph in Vehicle B's tractor unit. Illustration: NSIA

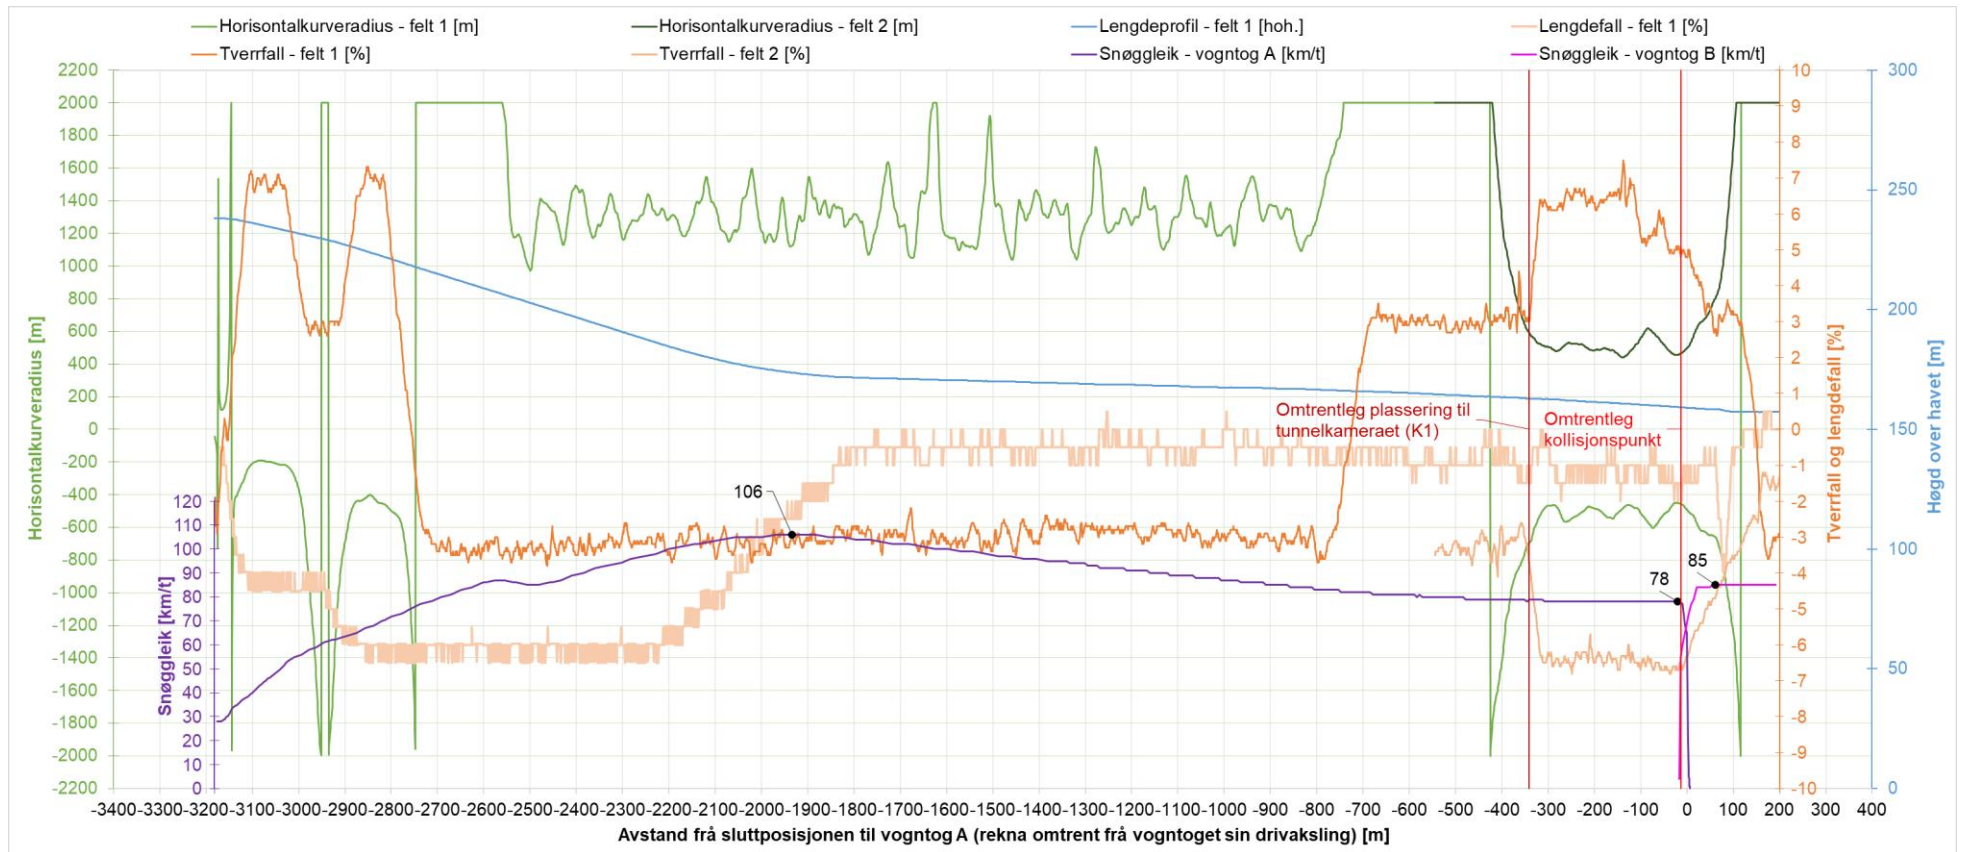
On 1 July 2021 the NPRA registered¹³ the condition of the paving on the stretch of road where the accident occurred, after the road north of the Hagan tunnel had been given new asphalt paving in 2020 (the road going south to the roundabout at Gjelleråsen was given new asphalt paving in 2013). Measurement data from that work show that the cross slope of the last 500 metres of Vehicle A's lane through the curve leading up to the point of collision was generally in accordance with the standards for operation and maintenance of national roads described in *Håndbok R610 Standard for drift og vedlikehold av riksveger*¹⁴ (see Figure 9).

Figure 9: Horizontal curve radius, cross slope, longitudinal slope and longitudinal profile of Vehicle A's lane (Lane 1) and driving direction from approximately 3,200 metres south to approximately 200 metres north of the point of collision (marked with a vertical red line), and horizontal curve radius and cross slope in the southbound lane (Lane 2) from approximately 550 metres south to approximately 200 metres north of the point of collision, collated with the speed development of Vehicle A and Vehicle B, respectively, until they reached their final position. Negative radius values indicate curving to the left and positive cross-slope values indicate sloping to the left, viewed from the driving direction in each lane. Data about the road: NPRA Tachograph data from the tachographs of Vehicle A and Vehicle B, respectively. Illustration: NSIA

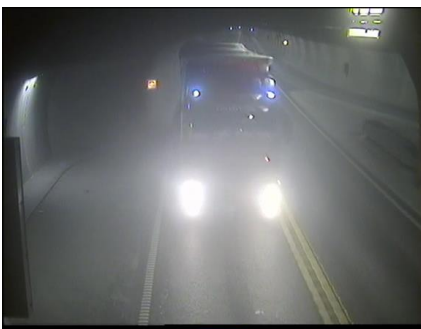
Figure 10: Screenshot from the K1 recording, showing the position of Vehicle A approximately 1.5 seconds before it disappeared from the camera's view. Source: NPRA

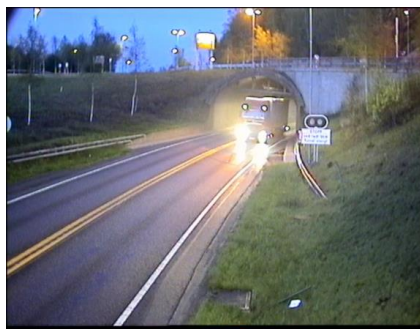
Another CCTV camera (K2) located approximately 30 metres north of the tunnel portal and approximately 90 metres south of the point of collision¹⁷, shows that Vehicle A was almost entirely in the southbound lane when it left the tunnel (see Figure 11). This was approximately nine seconds after Vehicle A had disappeared from the view of the camera inside the tunnel.

Figure 11: Screenshot from the K2 recording, showing Vehicle A passing through the tunnel portal in the opposite lane. Source: NPRA

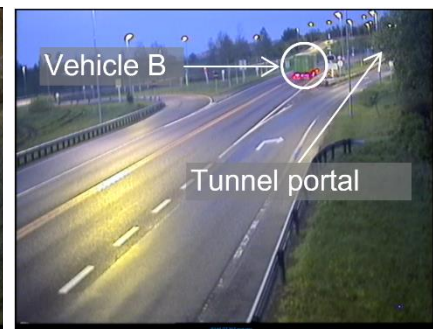
The recording from the third CCTV camera (K3), located approximately 250 metres north of the point of collision, shows Vehicle B travelling in its own (southbound) lane (see Figure 12).

Figure 12: Screenshot from the K3 recording, showing the position of Vehicle B when Vehicle A passed through the tunnel portal. Source: NPRA

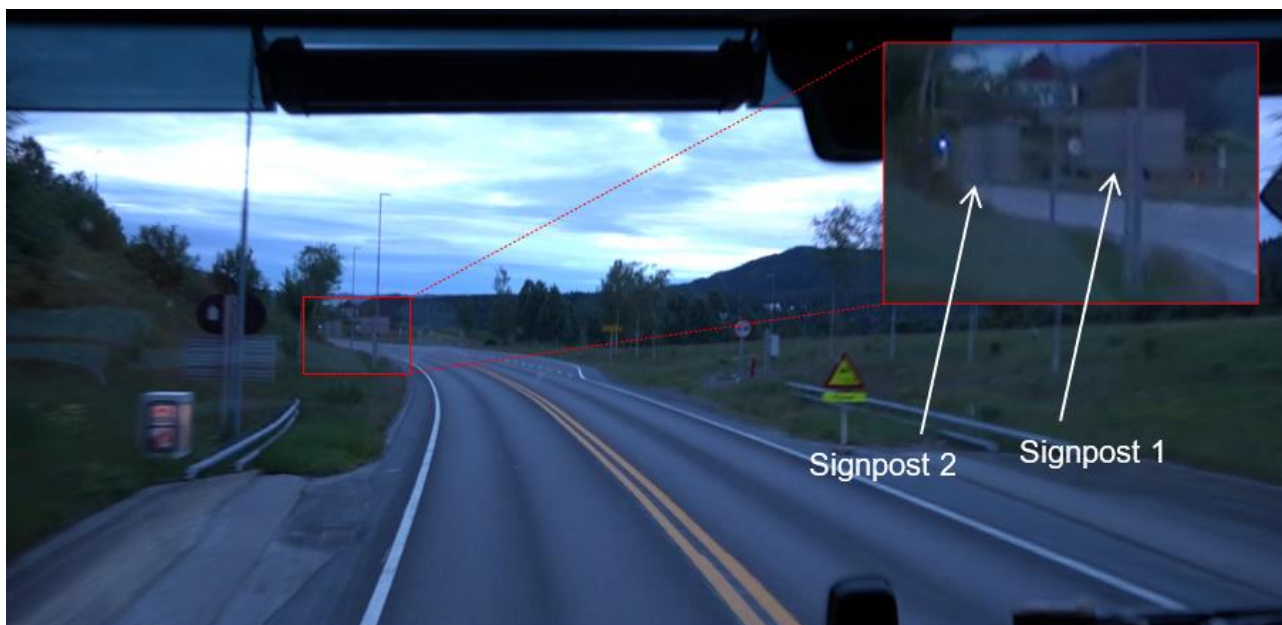
Figure 13 shows the view from a truck, corresponding to Vehicle A, approximately from where Vehicle A passed through the tunnel portal as shown in Figure 11. Figure 14 shows the view from a passenger car in the approximate position of Vehicle B as shown in Figure 12, when Vehicle A passed through the tunnel portal.

Figure 13: Screenshot from the police reconstruction of the accident, showing the view from a truck leaving the tunnel portal in the opposite lane. Signposts 1 and 2 are marked to enable comparison with Figure 14. Photo: The police. Illustration: NSIA

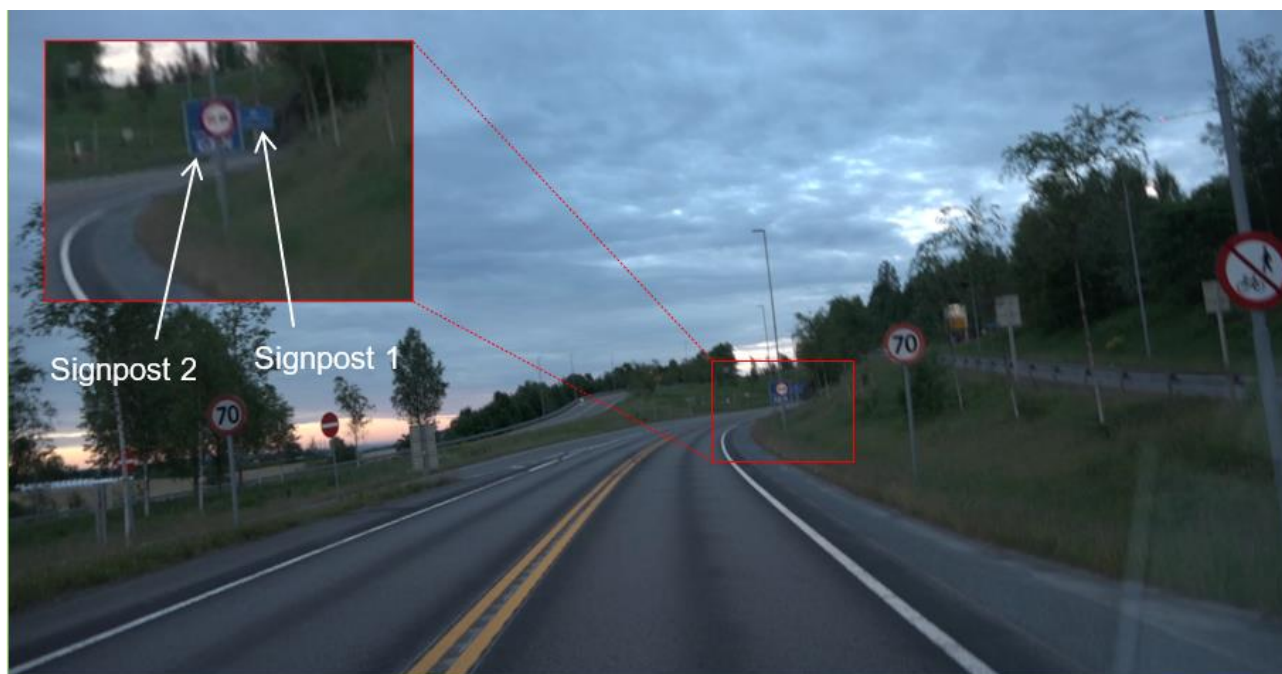
Figure 14: Screenshot from the police reconstruction of the accident, showing the view from a passenger car approaching the Hagan tunnel from the north. Signposts 1 and 2 are marked to enable comparison with Figure 13. Photo: The police. Illustration: NSIA

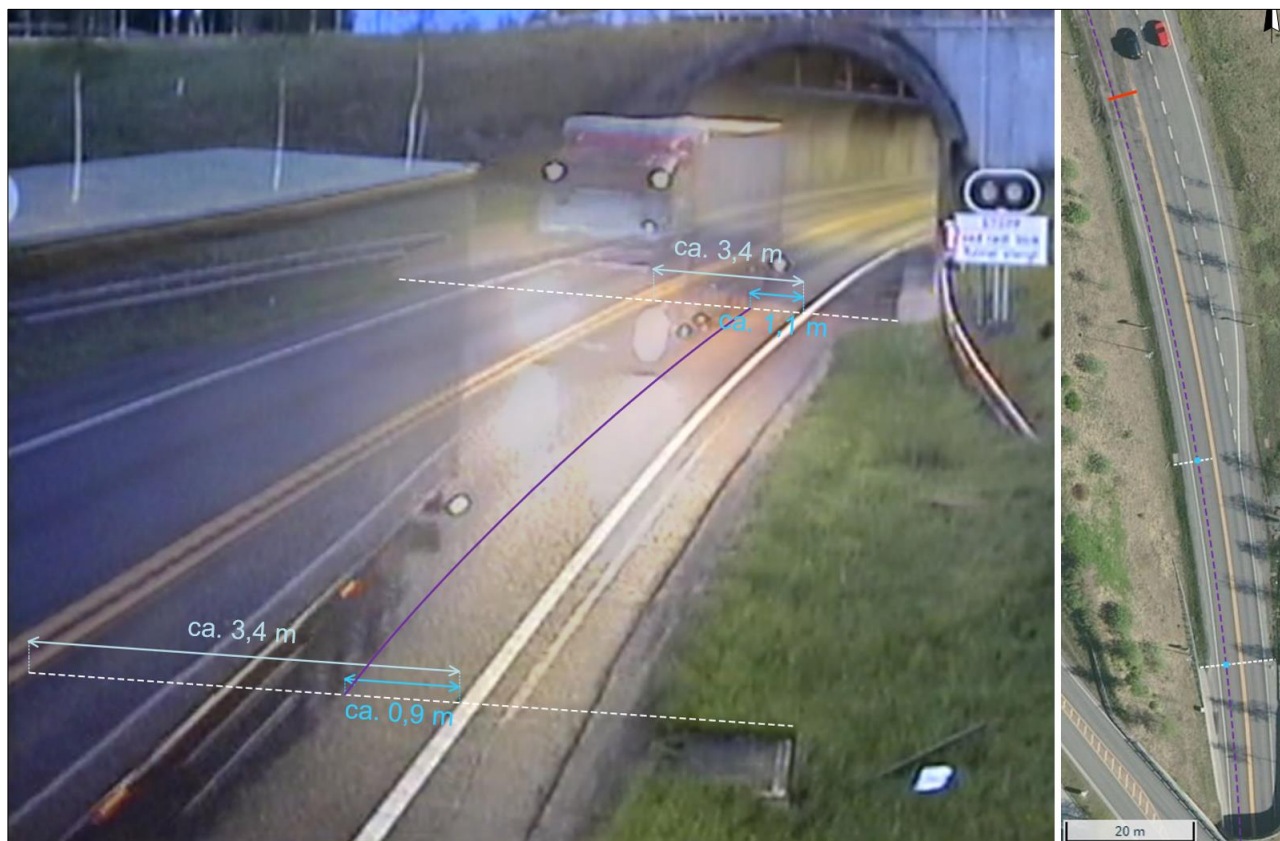
Figure 15: The illustration on the left is based on two screenshots (one on top of the other) recorded by K2 at different times. The purple line illustrates the curve along which Vehicle A travelled in the recording. The white broken lines are used as references to get the right perspective for measurements by the use of projective geometry.

The photo on the right gives an overview of where the accident occurred. The red line marks the approximate point of collision. The blue dots are placed at the same distance from the edge line as shown in the screenshots on the left. The broken purple line shows part of the circumference of a circle with a radius of approximately 500 m.

The broken purple line in the overview photo in Figure 15 is part of the circumference of a circle with a radius of approximately 500 metres, which intersects these two points. Using a plan drawing of the tunnel in the same scale as the overview photo, the NSIA has traced this line backwards, past the emergency lay-by where the CCTV camera in the tunnel (K1) was located. By drawing the purple line so that it ends on the right-hand side of the road's centreline at K1, the line will pass close to the edge line at the point of collision, indicated by the red line in Figure 15. The purple line will thus cross the centreline approximately 50 metres north of K1.

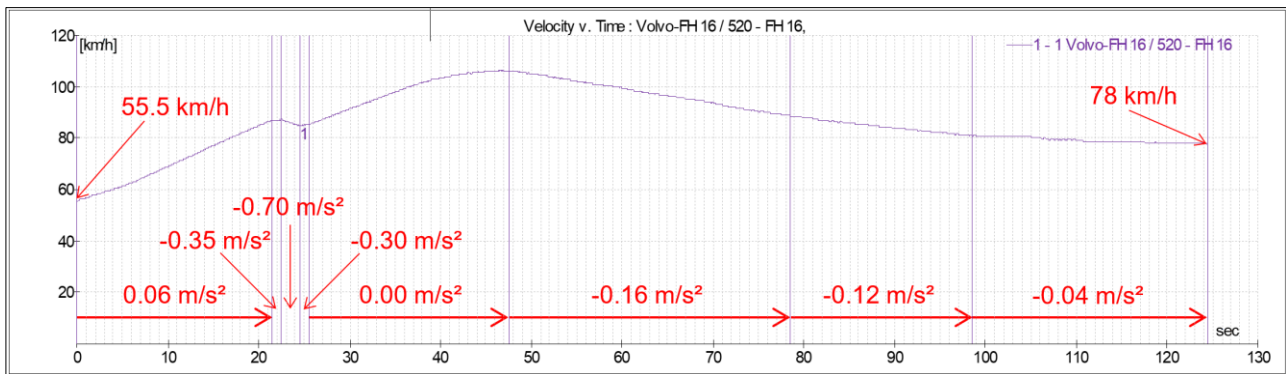
A heavy goods vehicle of approximately the same weight and dimensions as Vehicle A was used for the simulation. A 3-km-long road model was constructed, corresponding to the distance to the left of the point of collision in Figure 9, but without the curvature of the real road section. Data from the NPRA's registration of the condition of the paving in the northbound lane were used as a point of departure for the longitudinal profile used in the road model.²¹ The simulation resulted the curve shown in Figure 16. For purposes of comparison, the speed as a function of time, as logged by the tachometer in Vehicle A on the real road section, is shown in Figure 17.

Figure 16: Screenshot from PC-Crash showing the speed development of a heavy goods vehicle model (corresponding to Vehicle A) along a 3-km-long road model (corresponding to the northbound lane on the real road section). Illustration: NSIA

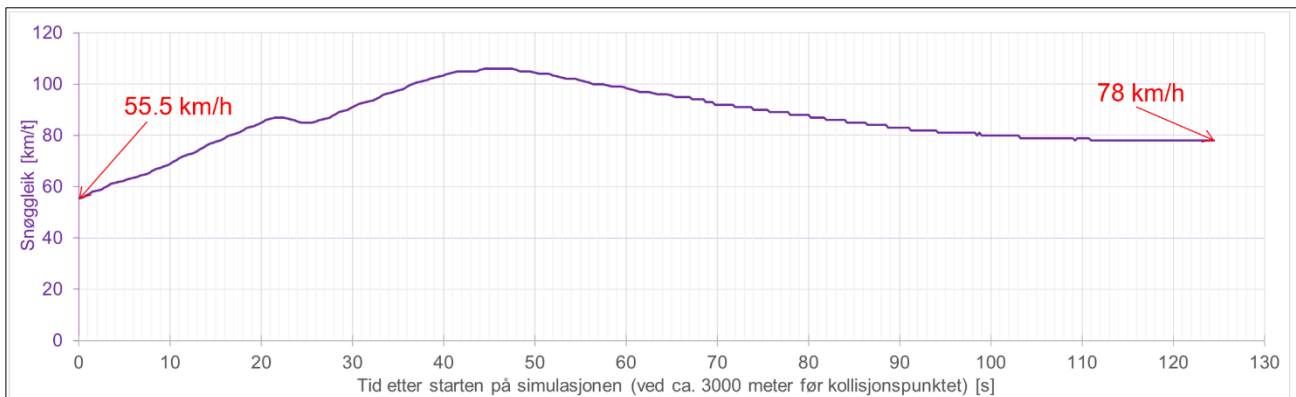
Figure 17: The speed of Vehicle A along the final 3,000 metres or so before the point of collision. The tachograph data are presented as retrieved from the tachograph in the tractor unit, with a resolution of four log entries per second. Tachograph data from the tachograph in Vehicle A's tractor unit. Illustration: NSIA
