# REPORT

ROAD 2022/06

*Accident involving a passenger car and  
an HGV driver on the E18 road near  
Arendal on 29 May 2020*

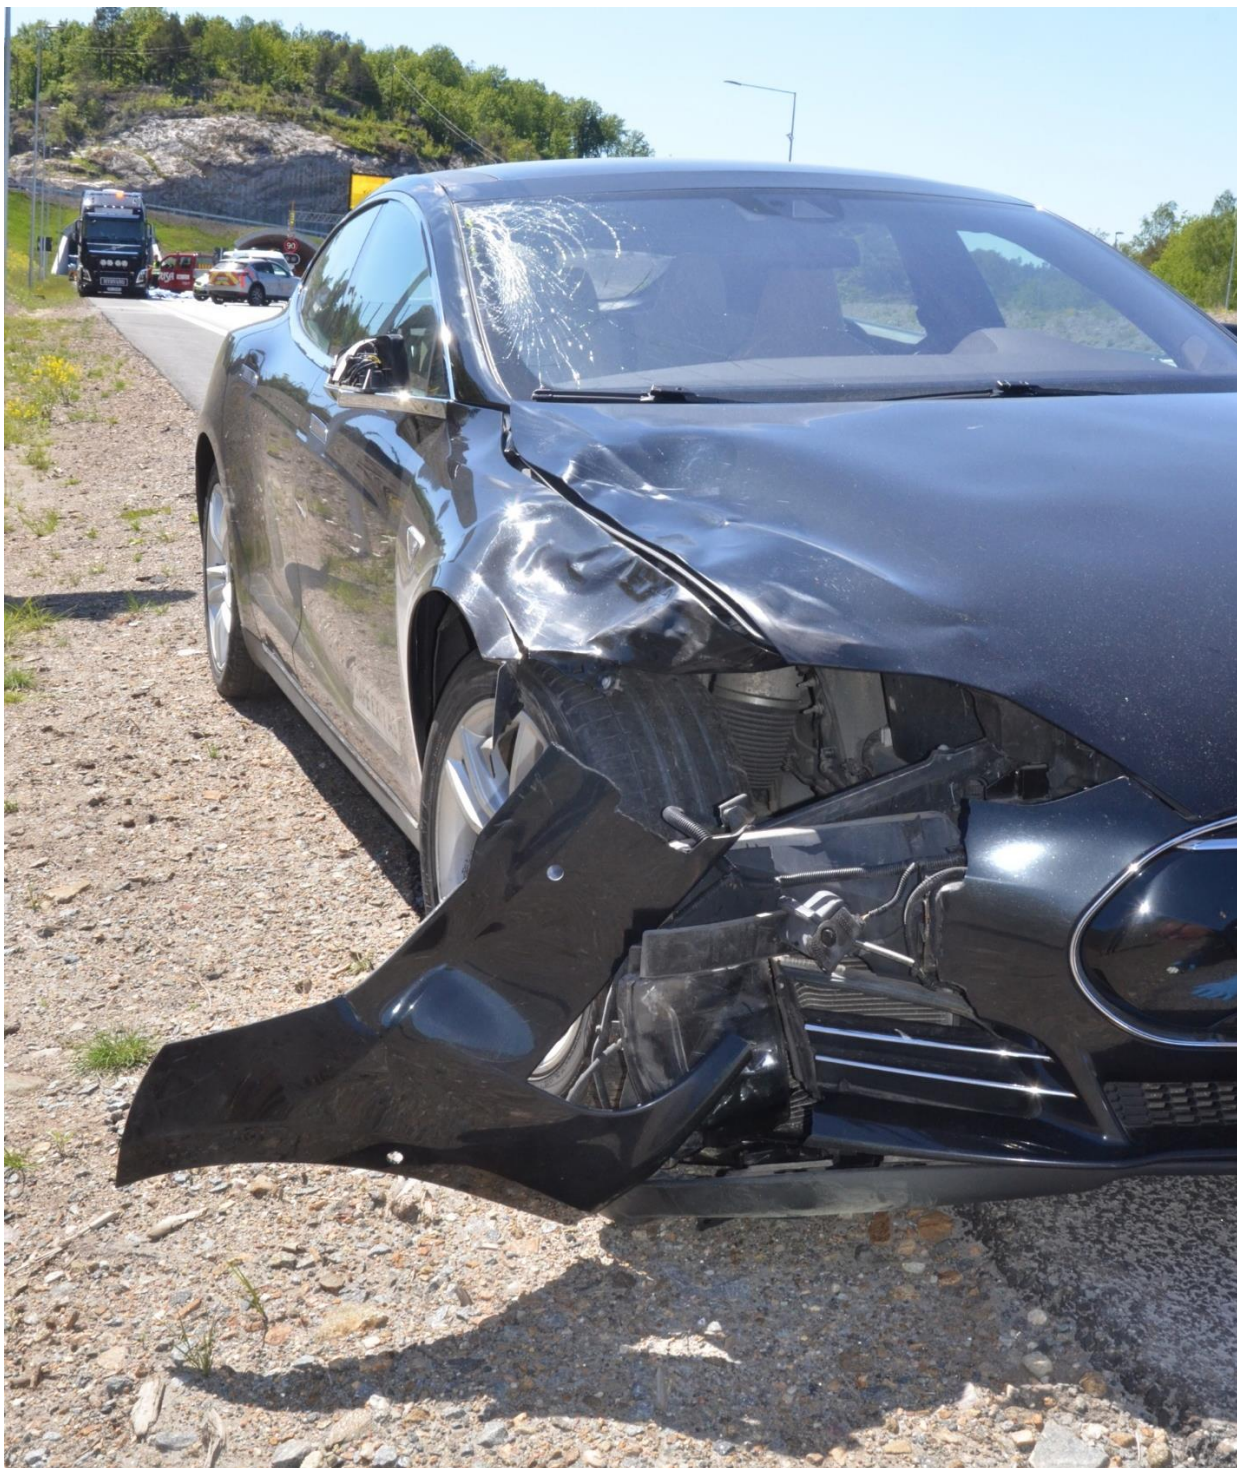
The passenger car sustained damage to the right side as a result of colliding with the HGV driver (see figure 4). The passenger car had damage to the front, windscreen, A pillar and roof. The wing mirror was also broken.

Figure 4: Damage to the right side of the passenger car. Photo: The police

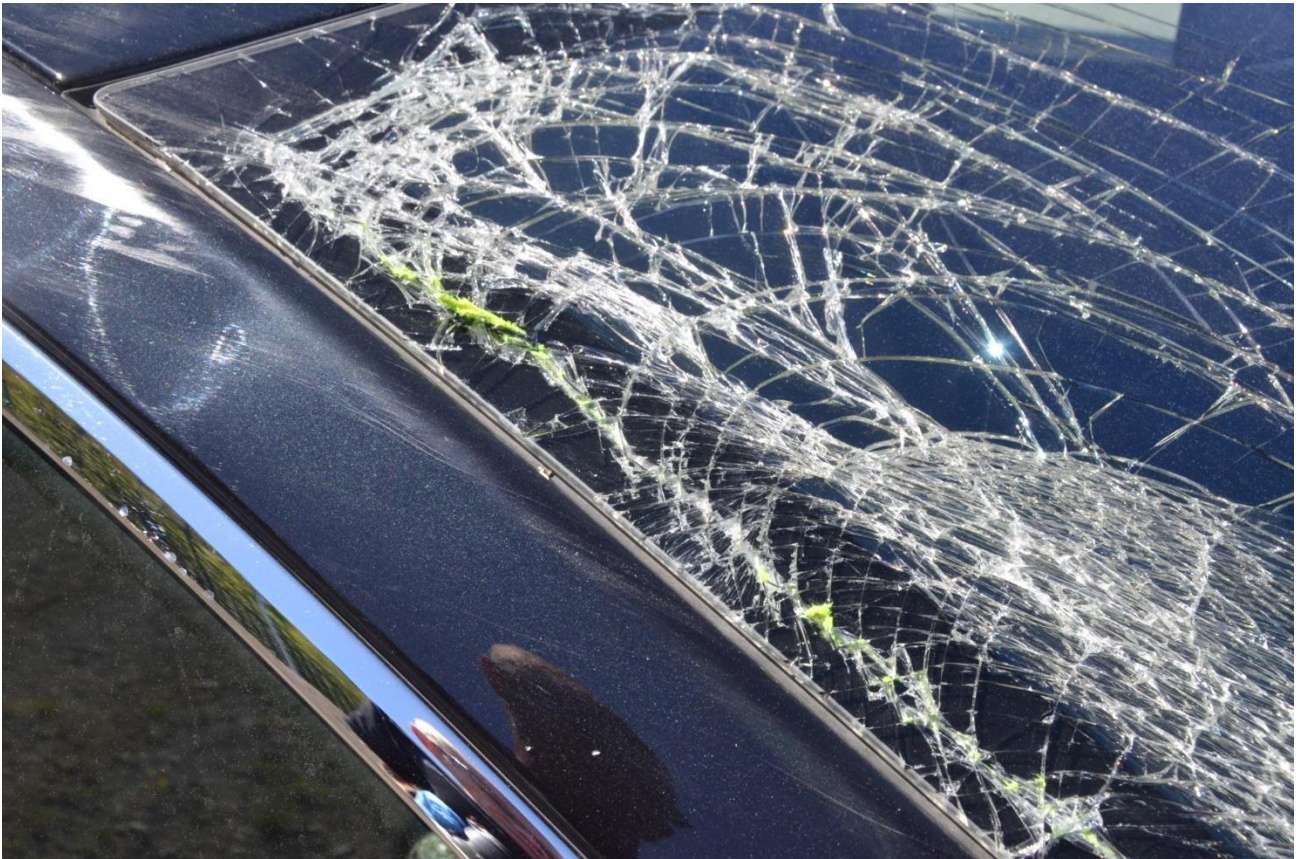
Technical examinations of the passenger car found bright yellow textile traces in the cracks in the windscreen (see figure 5) and on the bottom apron below the bumper (see figure 6).

Figure 5: Yellow textile traces in the windscreen. Photo: The police

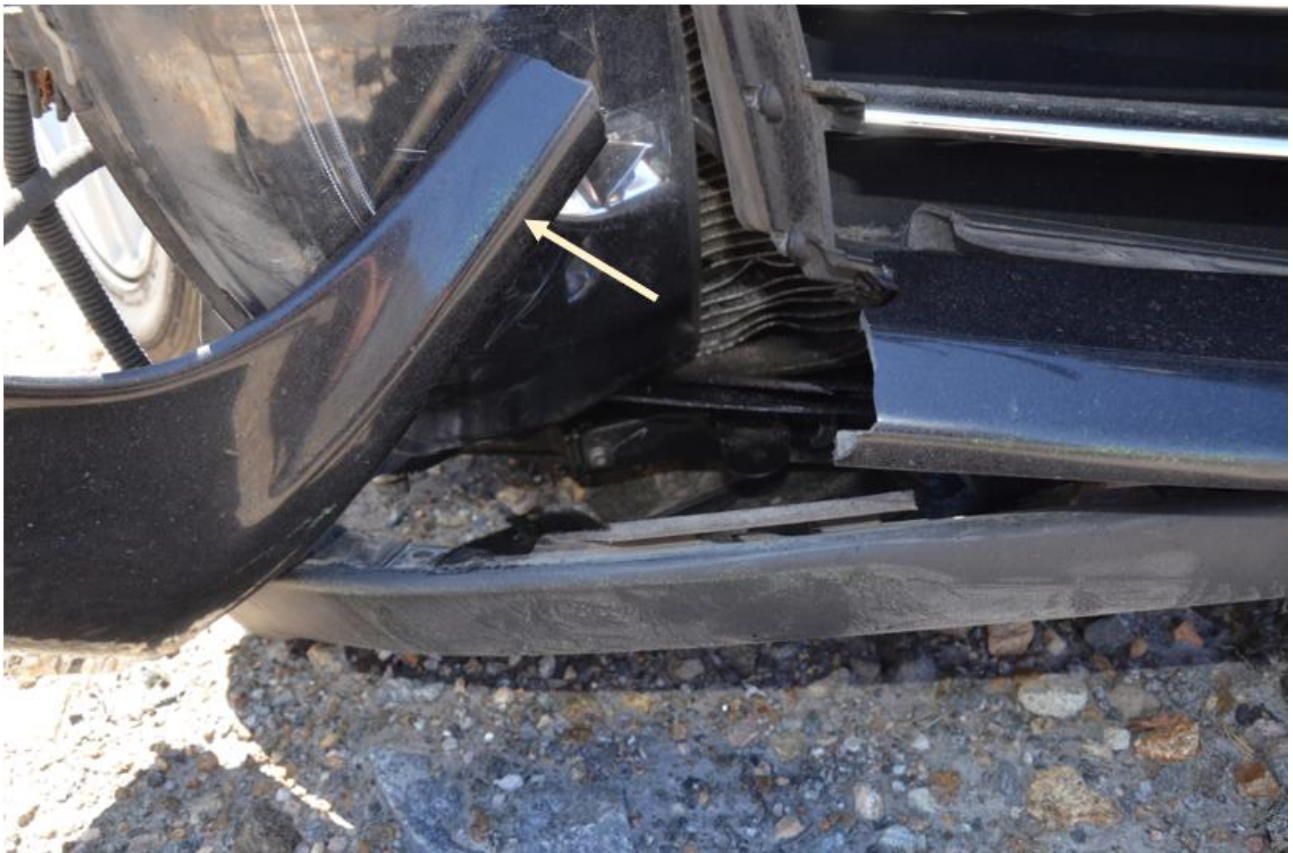
Figure 6: Lower part of the bumper and apron. The arrow indicates where traces of yellow textile were found. Photo: The police

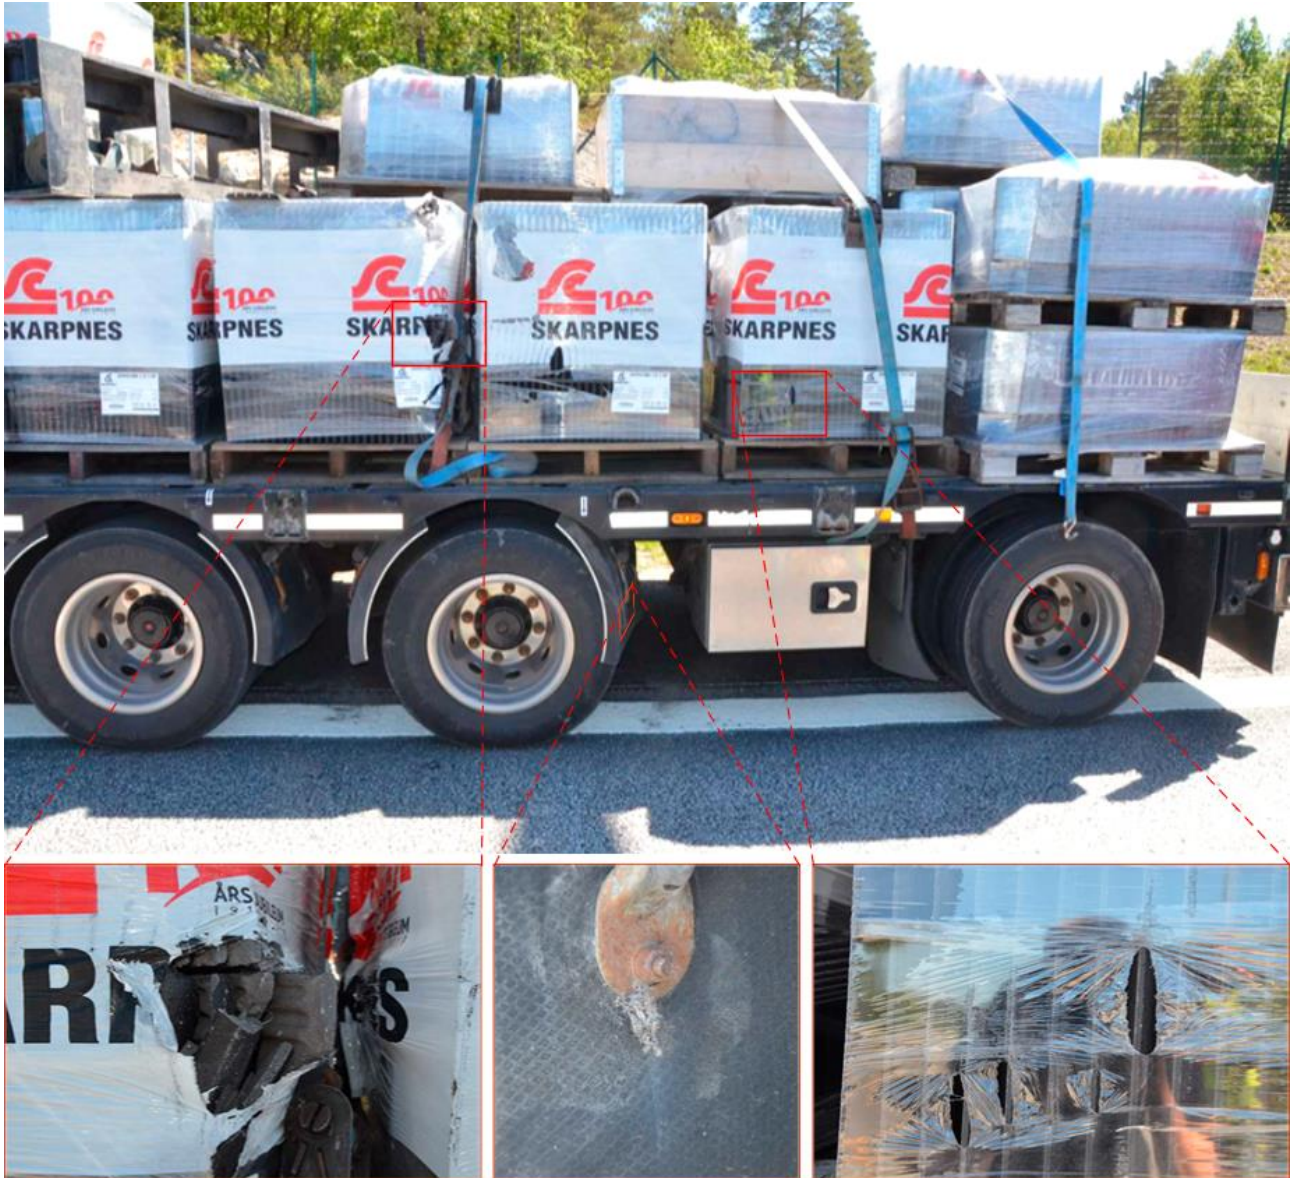
The semi-trailer was carrying pallets of roof tiles wrapped in plastic. The packaging on the second, third and fourth rearmost pallets on the left-hand side of the flatbed sustained some damage in the collision between the passenger car and the HGV driver (see figure 7). Several of the tiles in the fourth pallet from the rear were broken, and pieces of broken tiles were found in the roadway from the pallet and forward in the passenger car's direction of travel. A structure on top of the semi-trailer had also shifted forward.

Figure 7: Damage to the cargo and packaging, and textile fibres found on the fender behind the left wheel on the semi-trailer's middle axle. Photo: The police. Illustration: NSIA

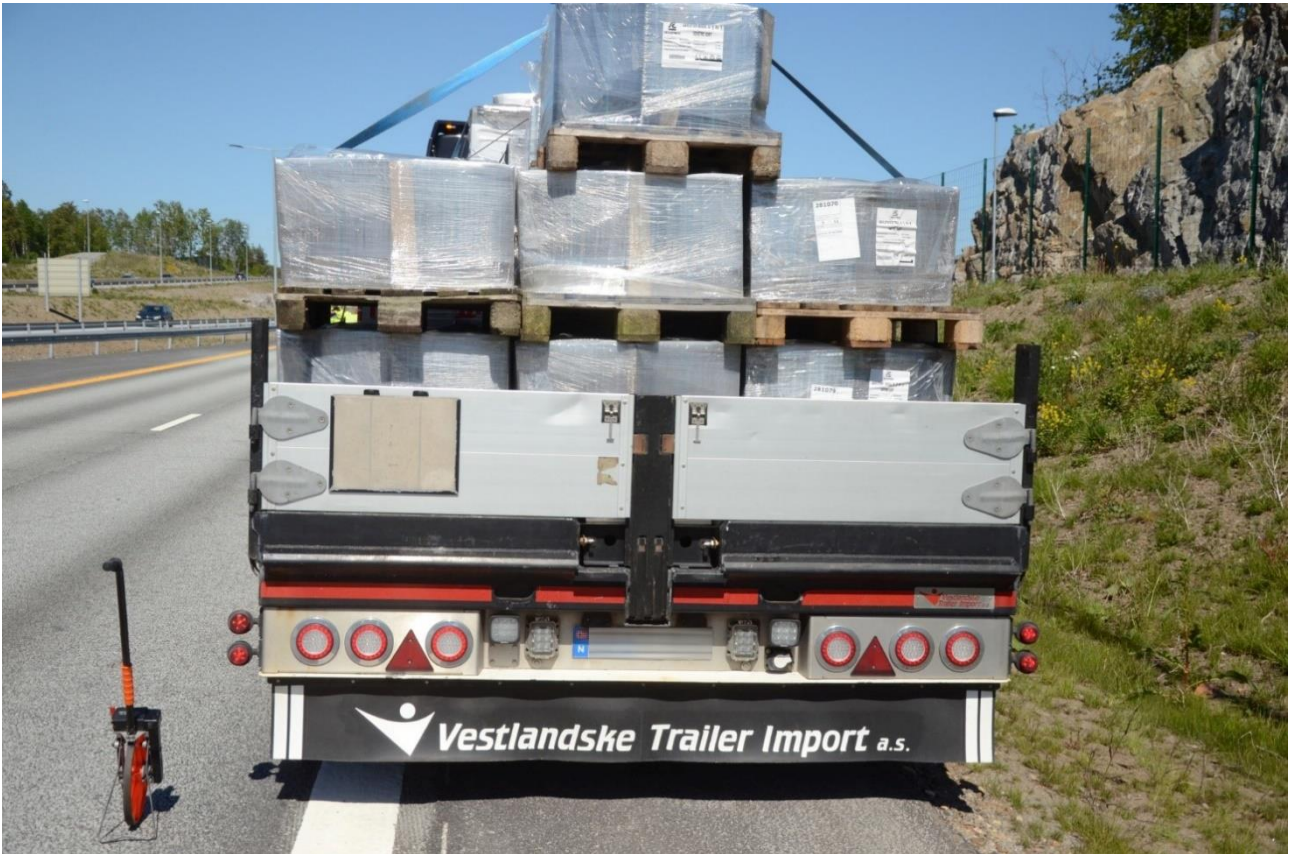
The HGV was parked on the hard shoulder of the right lane, more or less parallel with the road markings (see figure 9 and figure 10). The left-side tyres of the HGV were partly in the right lane of the road. The police measured the outer edges of the tyres to be approx. 15–16 cm into the right lane. The tractor unit's front and rear axles were measured to extend approx. 13 cm and 23 cm, respectively, into the right lane. The tyres on the right side of the HGV were partly outside the tarmacked surface of the hard shoulder.

Figure 9: The HGV's position on the roadway. Photo: The police

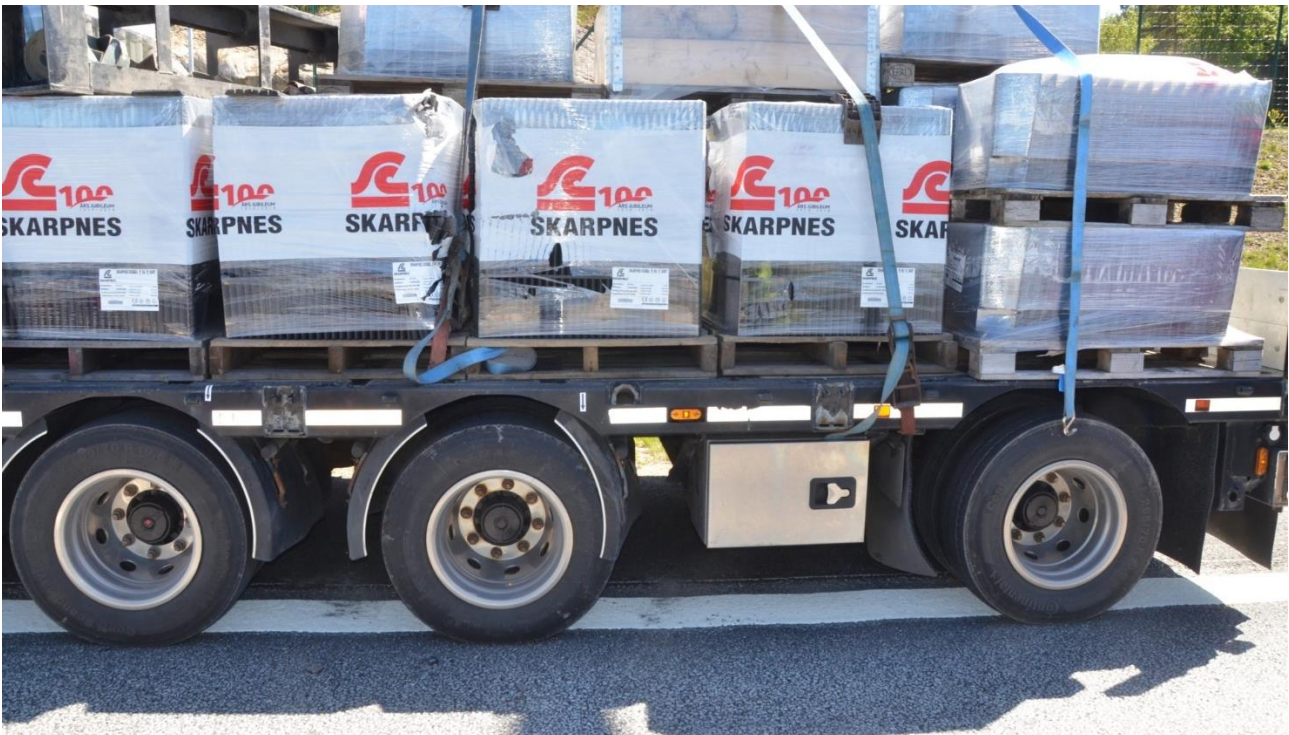
Figure 10: The HGV's position in relation to the white edge line. Photo: The police

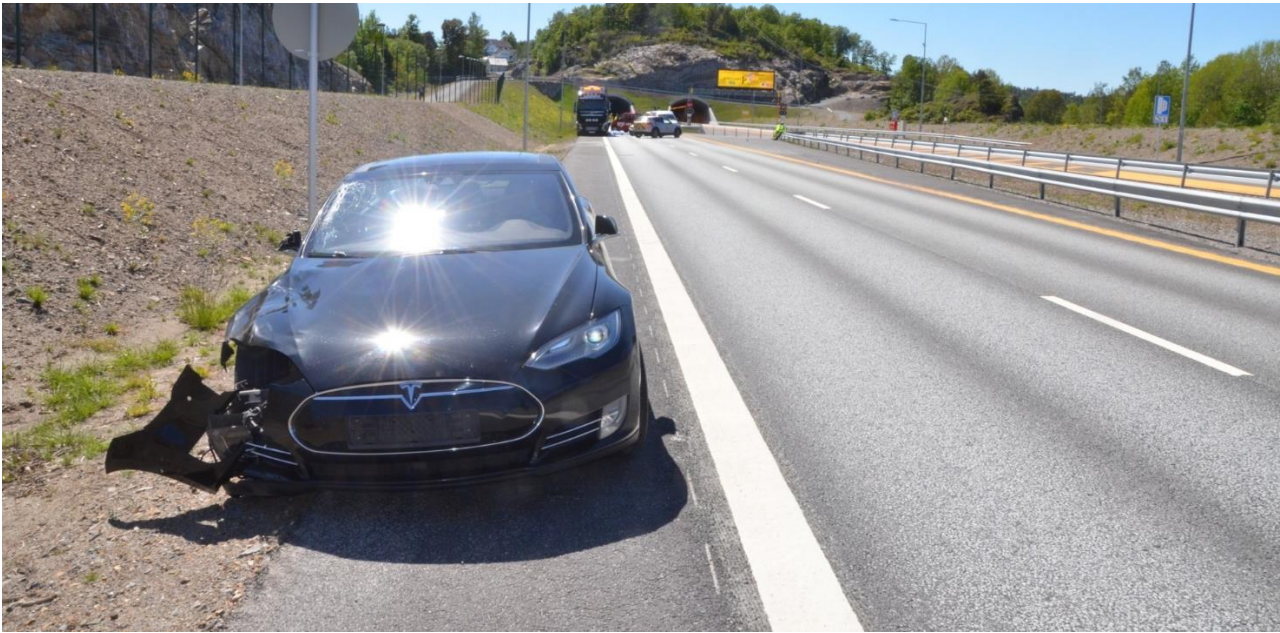
The passenger car was on the hard shoulder of the right lane, outside the road markings (see figure 11).

Figure 11: The passenger car's position in the roadway. Photo: The police

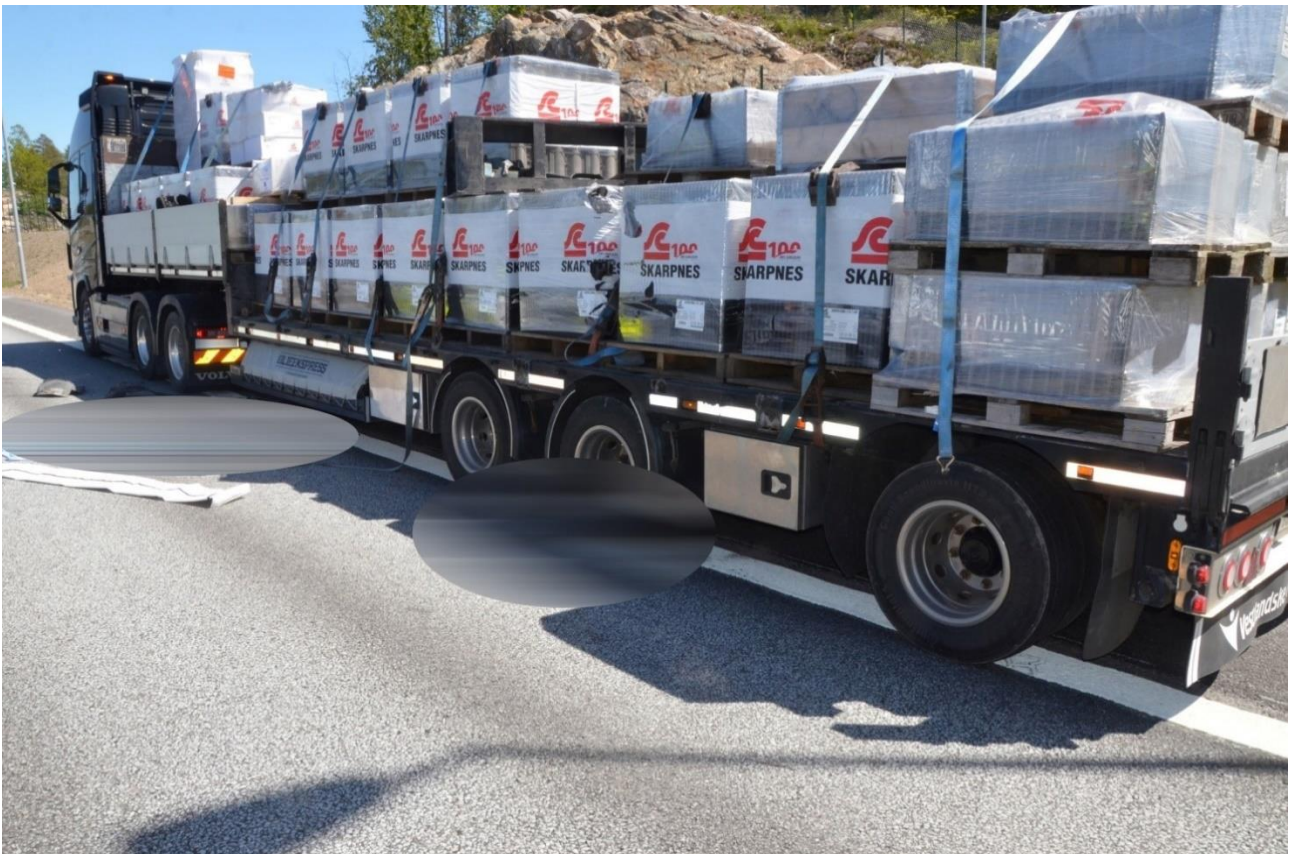
The semi-trailer was mostly carrying pallets of roof tiles wrapped in plastic (see figure 14). The pallets were stacked in two rows next to each other with a central third row on top. The rearmost row of pallets consisted of seven pallets of plastic-wrapped cargo stacked three wide and two high. The final pallet was placed on top of two other pallets at the centre of the flatbed.

Figure 14: The HGV consisted of a tractor unit and a semi-trailer. The rearmost ratchet strap is hanging loose, and the HGV driver was in the process of securing it when the accident happened. Photo: The police

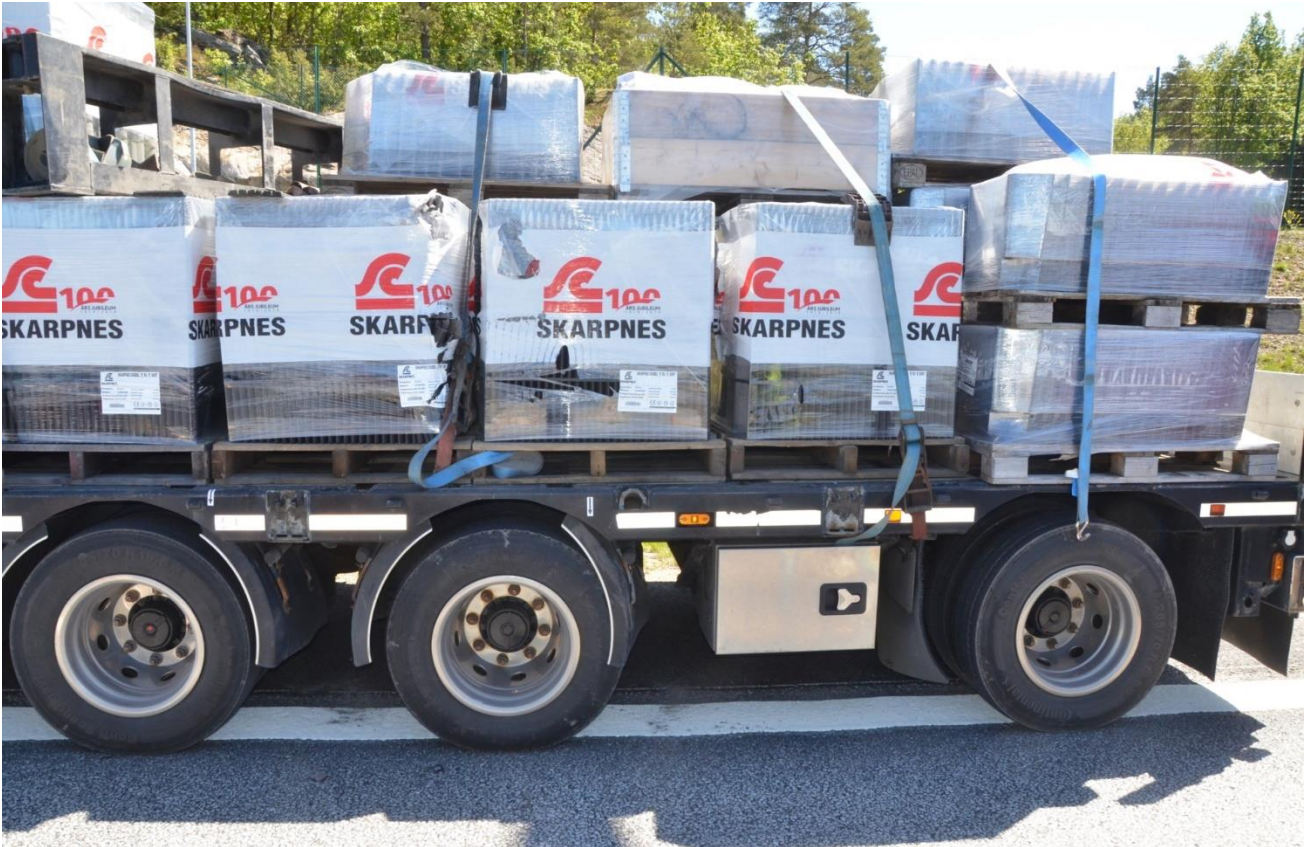
The pallets were secured by transverse ratchet straps in top-over lashing using web lashings (see figure 15). The ratchet strap ends were secured by being placed either inside the pallets or in compartments under the flatbed. The ratchet straps were all tightened from the left side of the HGV, with the exception of the rearmost one that was hanging loose, which the HGV driver was

securing when the accident happened. That ratchet strap was tightened from the right side of the semi-trailer.

Figure 15: Location and securing of pallets on the semi-trailer. Photo: The police

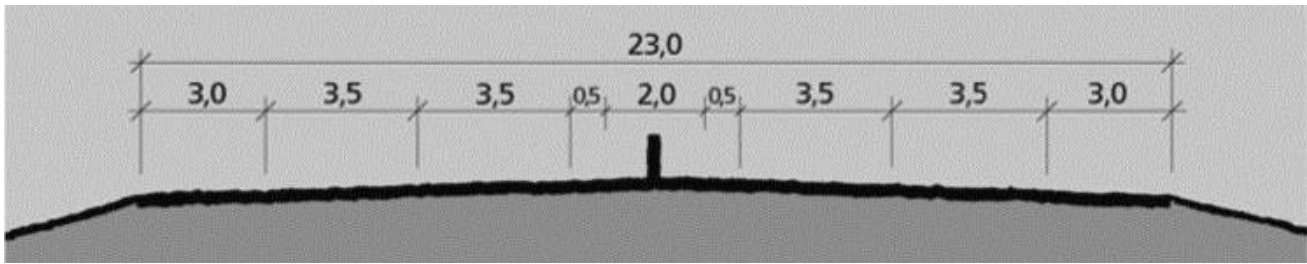
Figure 26: Cross section for AADT > 20,000 vehicles/day with a speed limit of 110 km/h. Source: NA circular 2015/2, Norwegian Public Roads Administration

The AADT estimated for the section of road where the accident occurred was just over 20,000 vehicles/day, and the road should have been dimensioned in accordance with the requirements illustrated in figure 26, which indicate a hard shoulder width of 3.0 metres.
