Issued December 2023

REPORT ROAD 2023/05

***Head-on collision between two buses on
the Rv 110 road in Fredrikstad on
28 December 2022***

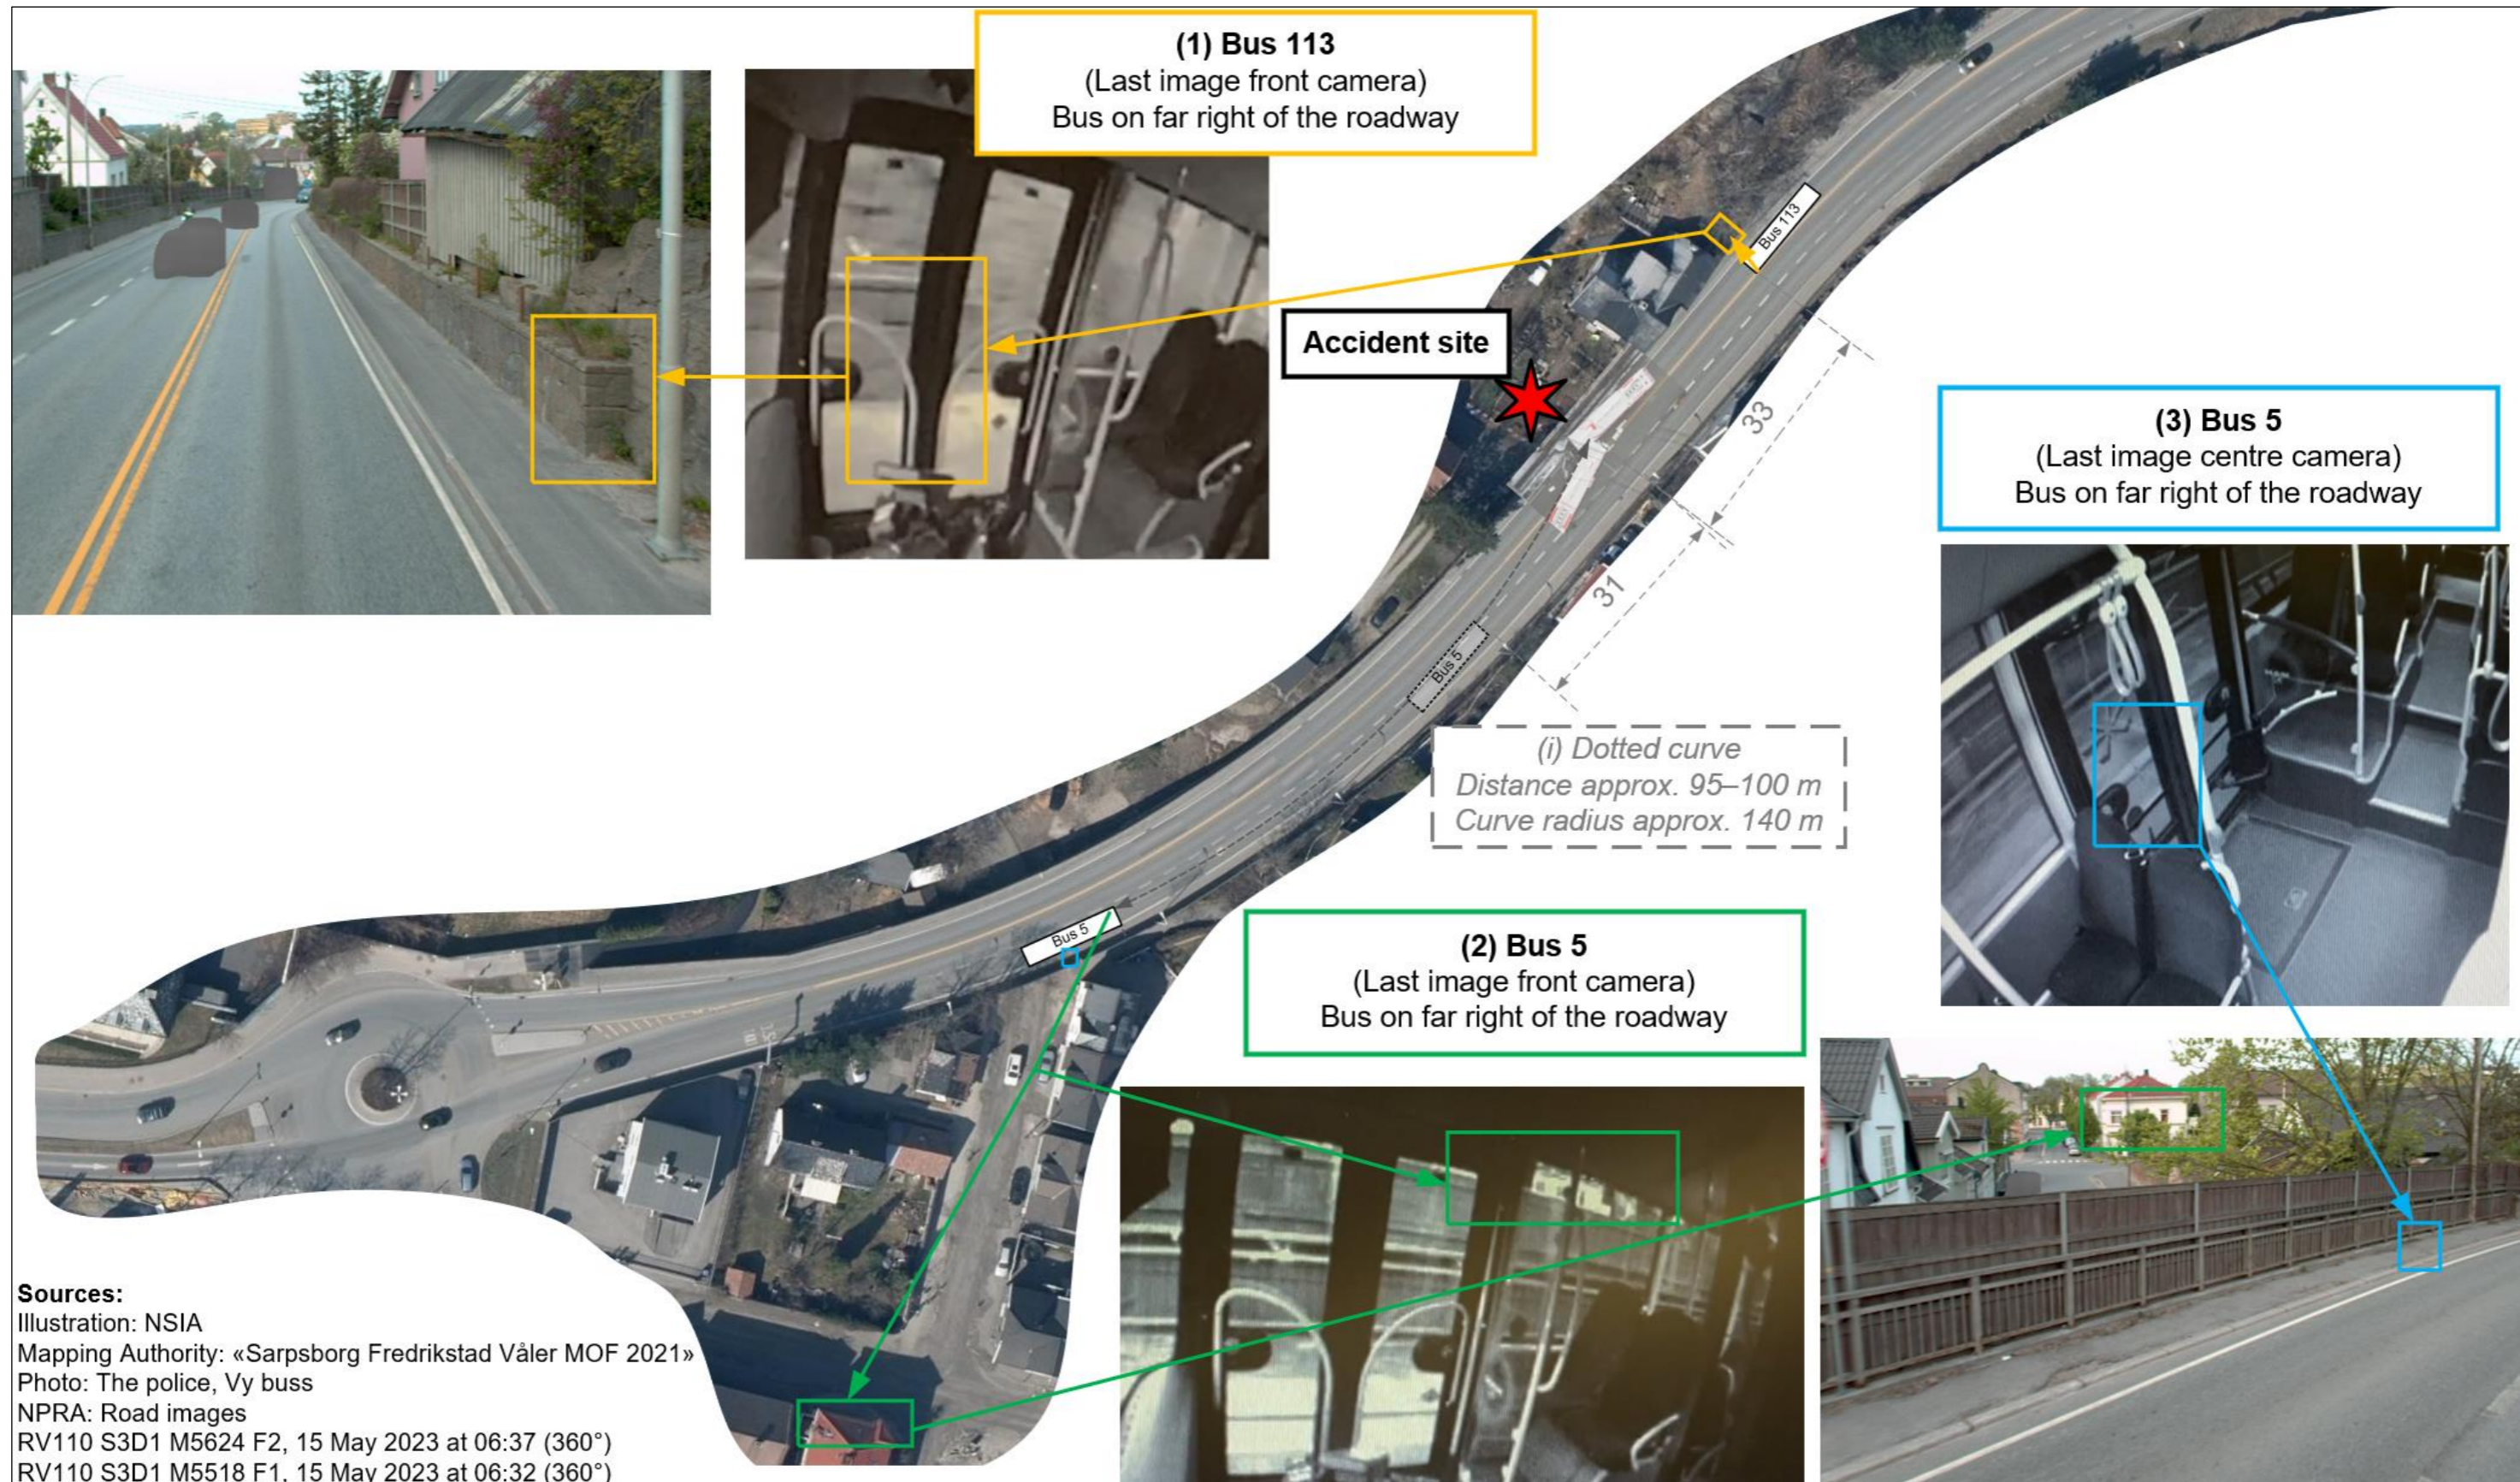
Just before the collision, Bus 5 crossed over into the left-hand lane and continued over towards Bus 113 in the oncoming lane. The buses collided head on with a small overlap in the southbound lane. At the moment of impact, Bus 5's speed was approx. 32 km/h, while Bus 113's speed was approx. 35 km/h; see section 1.7.

Figure 2: Sequence of events based on the last images from the video cameras on the two buses. Bus 113's last front camera image before the collision is shown together with the roadside terrain (1). Bus 5's last front camera and centre camera images are shown together with the roadside terrain in order to estimate its last documented longitudinal position (2) and its last position in relation to the breadth of the roadway (3) before the collision. The dotted curve (i) shows the possible trajectory of Bus 5. Illustration: NSIA

Findings from the investigation indicate that, just before the collision, the driver of Bus 5 turned the steering wheel but failed to straighten it up again as the roadway straightened out. A possible trajectory, marked (i), for Bus 5 is illustrated in Figure 2. If the bus has followed this trajectory, Bus 5 would not have crossed over into the middle lane before the buses were approx. 60 metres apart, and it would have been difficult for oncoming drivers to detect anything abnormal before that. In the NSIA's assessment, the speed reduction in the last second before the collision is related to the driver probably having passively slackened the pressure on the accelerator, and that it was not the result of active braking. This is because the investigation found no evidence in the roadway to indicate braking or attempts at avoidance manoeuvres before the accident.

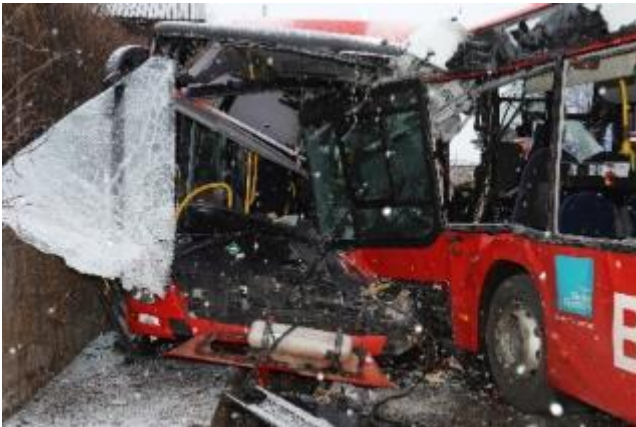
There was no survival space in the driver's cab in Bus 113 because of the penetration of the oncoming bus's side panel into the driver's cab (see Figure 3 and Figure 4). The driver of Bus 113 died as a result of the injuries suffered. The passengers in Bus 113 sustained minor injuries.

Figure 3: Bus 113 seen from the front. Photo: The police

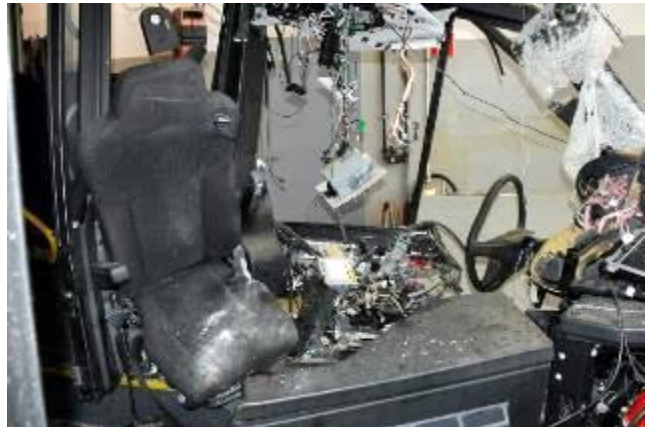
Figure 4: Driver's cab Bus 113. The driver's seat has been pushed backwards. Photo: NSIA

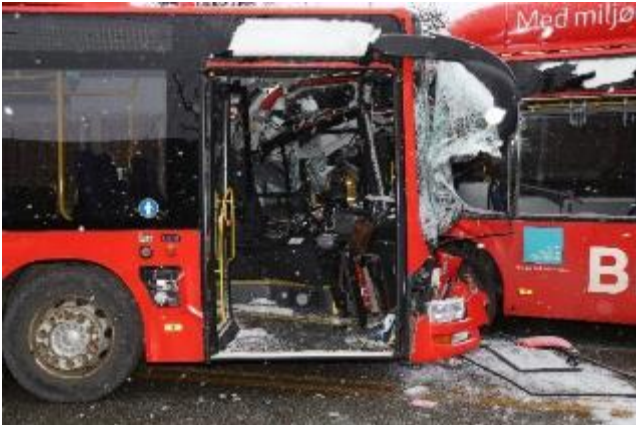
The driver of Bus 5 was conscious after the collision and was trapped in a seated position with critical injuries. The side panel of the oncoming bus penetrated alongside the driver's cab, while other parts of the bus were pressed inwards at seat height (see Figure 5 and Figure 6). There was survival space in the upper part of the driver's cab in Bus 5, but the area below seat height was crushed. The driver was put in a medically induced coma after the accident.

Figure 5: Bus 5 seen from the side. Photo: The police

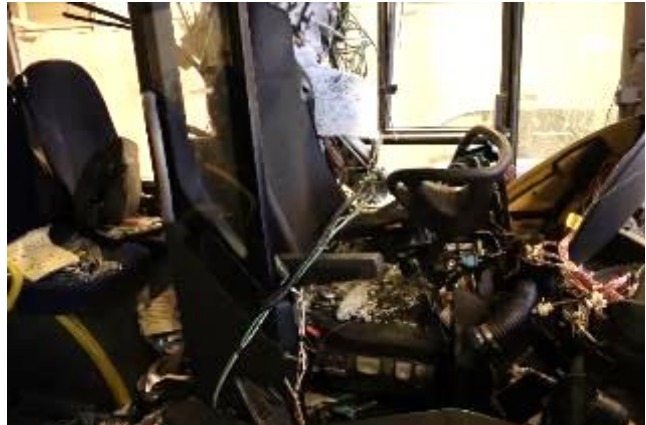
Figure 6: Driver's cab in Bus 5. Driver's seat intact. Photo: NSIA

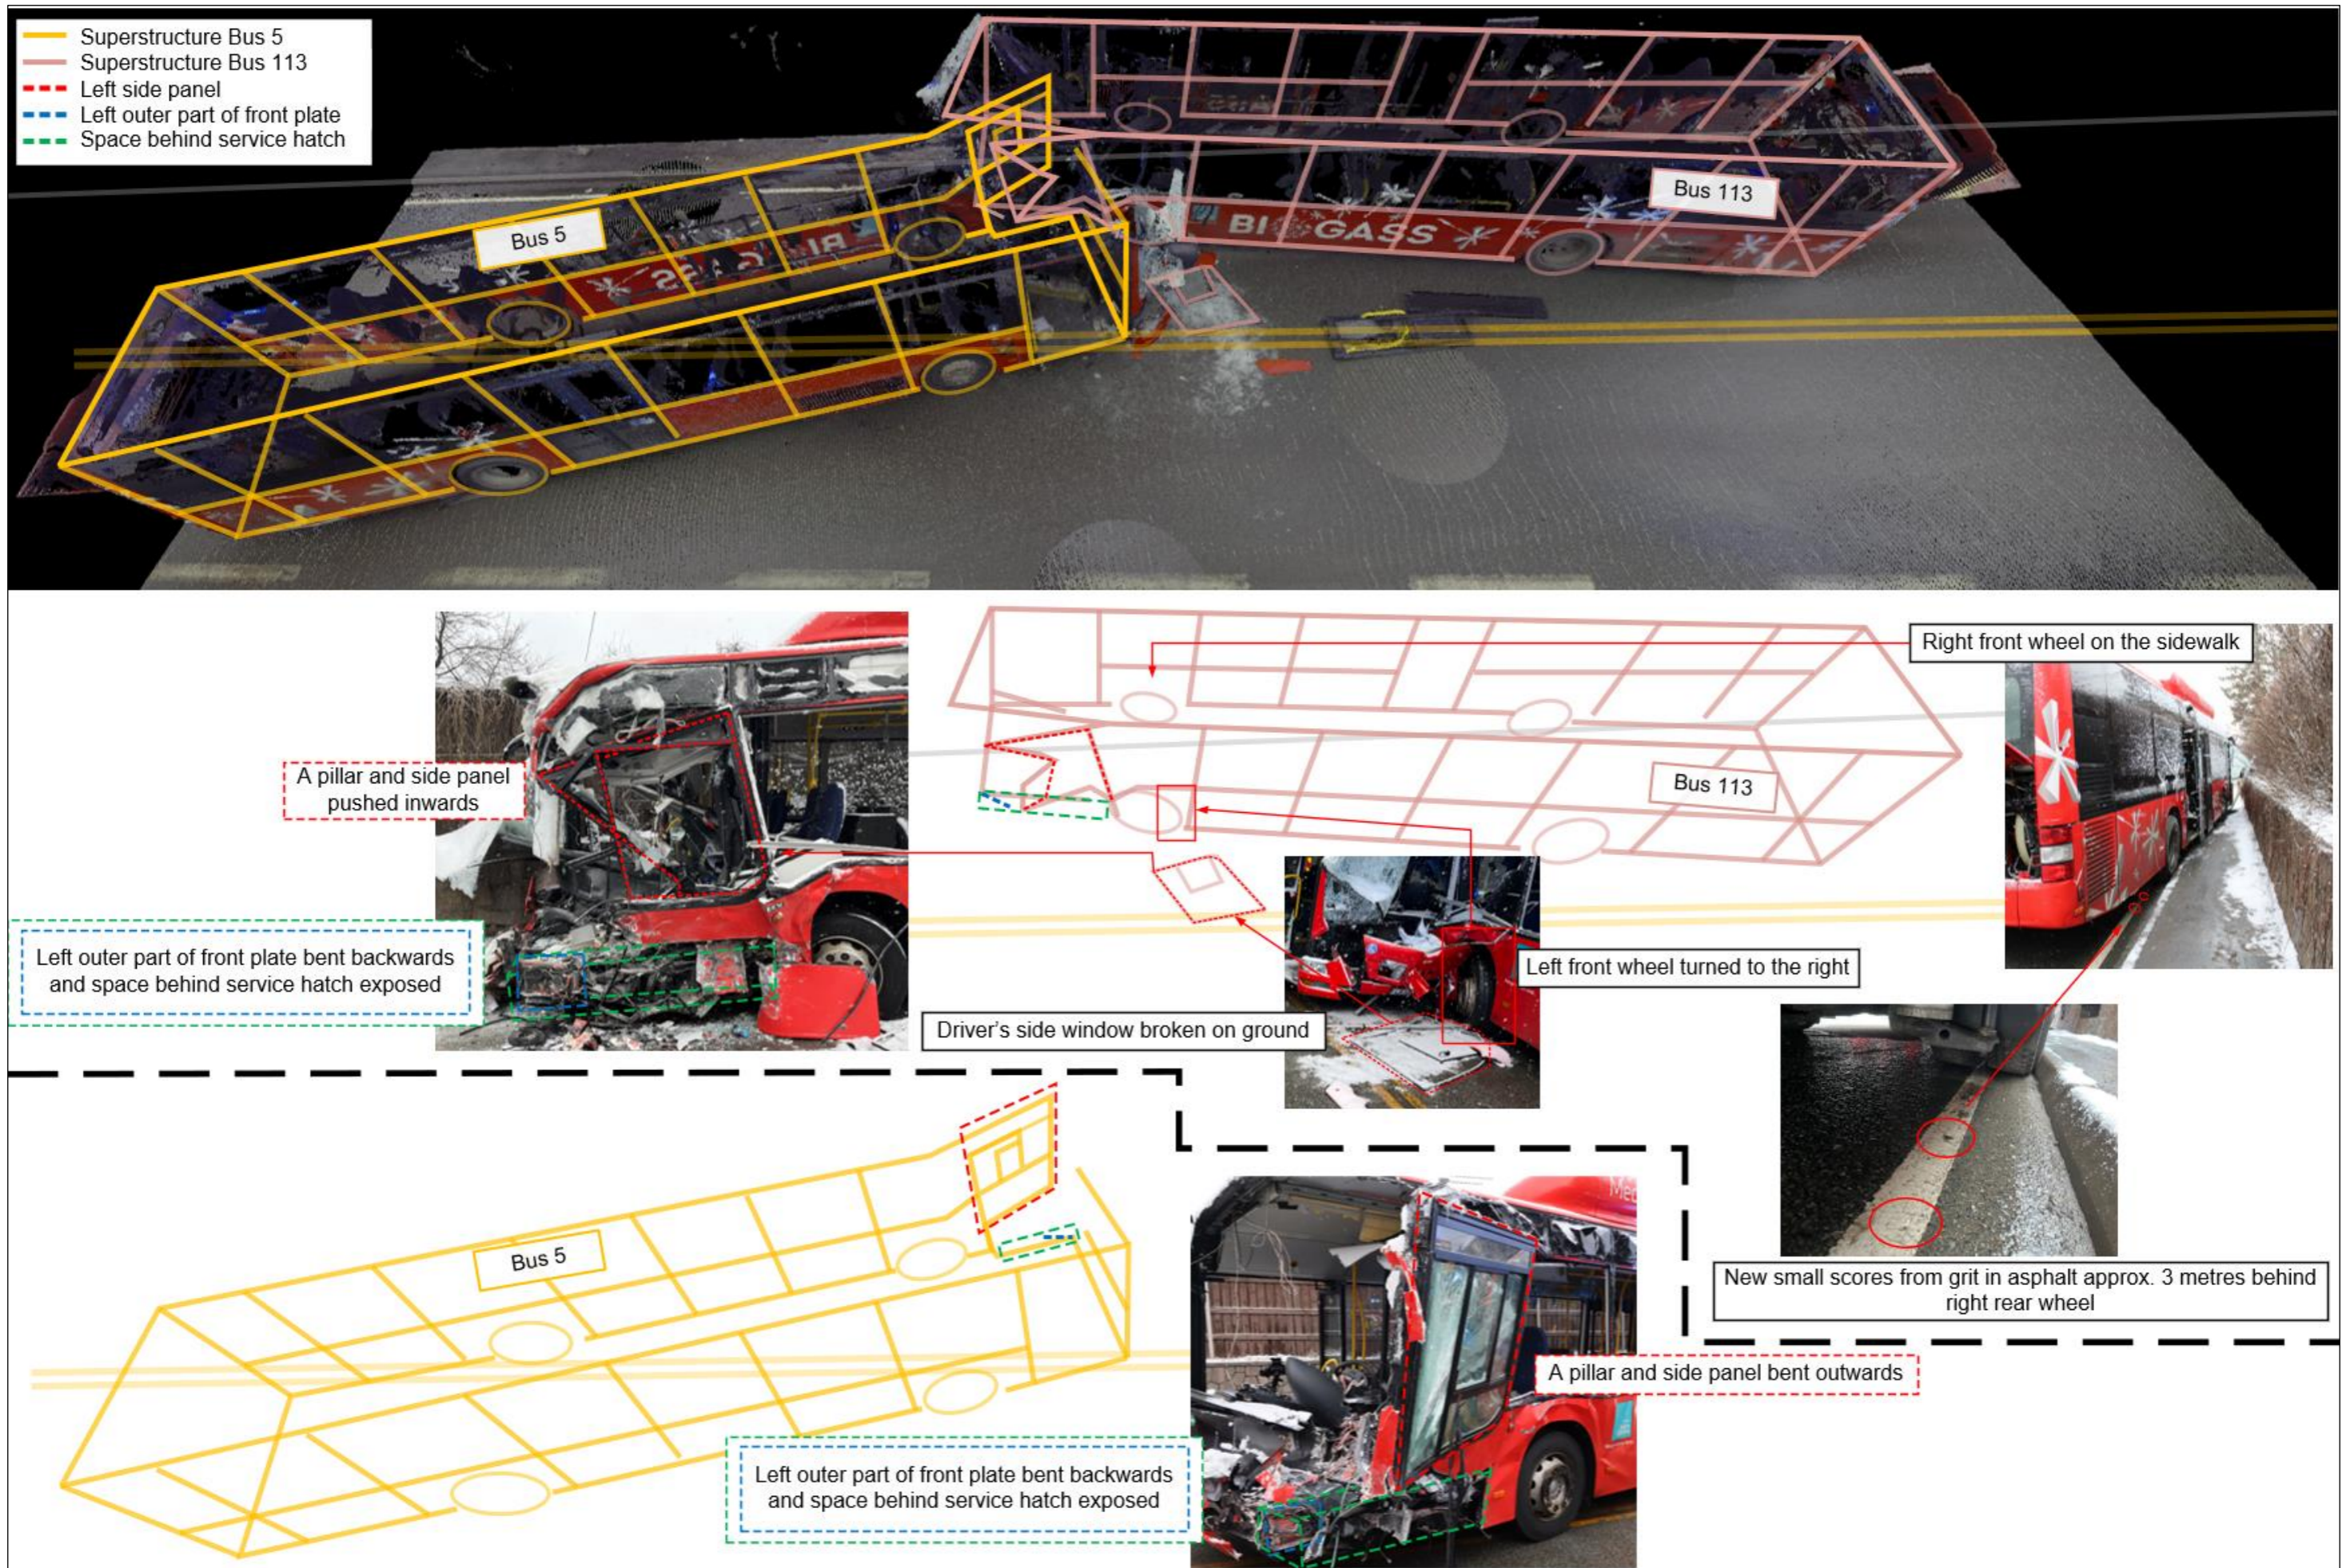
In the final position, the buses were interlocked at an angle of approx. 23°. The damage was primarily on the front-left side and the front of both buses; see Figure 7. Both buses were examined by the Norwegian Public Roads Administration (NPRA) at the accident site.

The examinations carried out by the NPRA showed that the steering wheel axle on both buses had been knocked loose and that there was no connection between the steering wheel and the wheels. The angle of the steering wheel in Bus 5 indicated a slight turn to the left, while the angle of the steering wheel in Bus 113 indicated a turn to the right in the final position. The NPRA's assessment was that both buses were in the prescribed condition before the accident.

Figure 7: Collation of evidence and findings at the accident site. The deformation of the side panels (dotted red line), the outer parts of the front plates (dotted blue line), the service space (dotted green line) and the final position of the buses has been mapped. Photo/3D scan: NPRA, NSIA. Illustration: NSIA

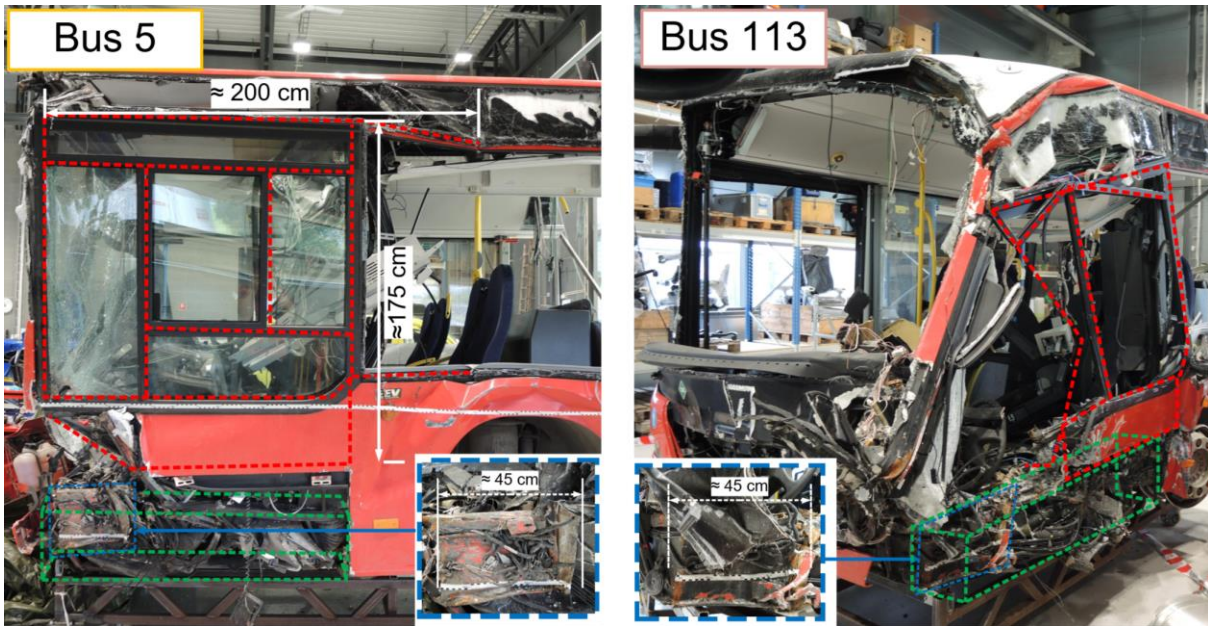
The buses were moved to the NSIA's premises at Lillestrøm and examined by the NSIA. The NSIA's technical examinations have focused on three elements of the design of the front left part of the buses, as shown in Figure 7 and Figure 9:

- Left side panel (dotted red line)
 - This design consists of a vertical A pillar that is connected to the 'superstructure' of the buses.
- Left outer part of the front plate (dotted blue line)
 - The outermost part of a continuous horizontal front plate from corner to corner at the front of the buses. The part is attached to the left part of the vehicle's frame in the driver's cab towards the left-hand corner and the A pillar, and it is approx. 45 cm wide.
- The space inside the service hatch (dotted green line)
 - This space is behind the outer left-hand part of the front plate, and it extends from the left-hand corner back to the left-hand front wheel arch. On these buses, this space is designed as a 'service space', while on other buses it can be designed to house the battery/fuses.

Figure 9: Examination of Bus 5 (to the left) and Bus 113 (to the right)¹ on the NSIA's premises. Photo: NSIA

¹ Both buses have sustained damage as a result of the salvage work, during which, among other things, the A pillar on Bus 113 was pulled forwards.

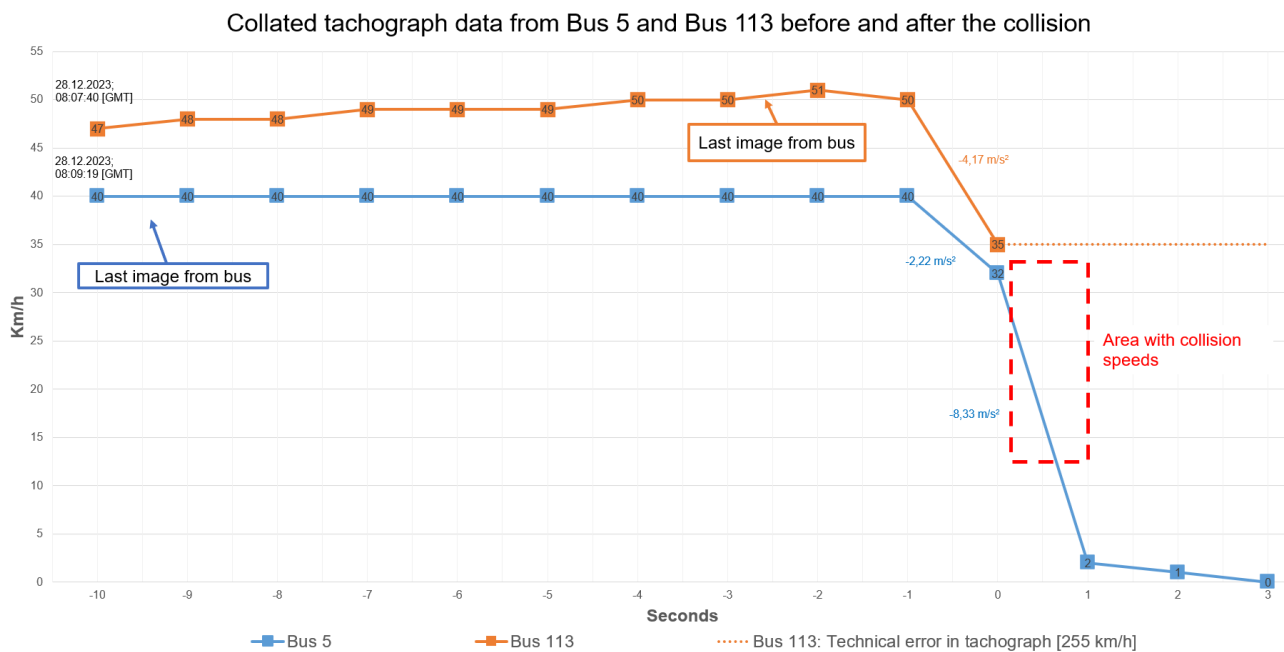
The tachographs from both buses were secured, and speeds at one-second resolution were downloaded. During the collision, both the tachographs experienced an error in a file that registers 1/4-second speeds, and the results of attempts to reconstruct it have not become available during the investigation period. The tachographs had unsynchronised clocks, so that the speed curves were synchronised by setting the assumed collision time as the point zero.²

Figure 10: Collation of the buses' tachographs, and the time of the last camera image from the buses. The assumed collision time is set as point zero. Source: NSIA

On this basis, the collision speed of Bus 5 was approx. 32 km/h, while the collision speed of Bus 113 was approx. 35 km/h.³

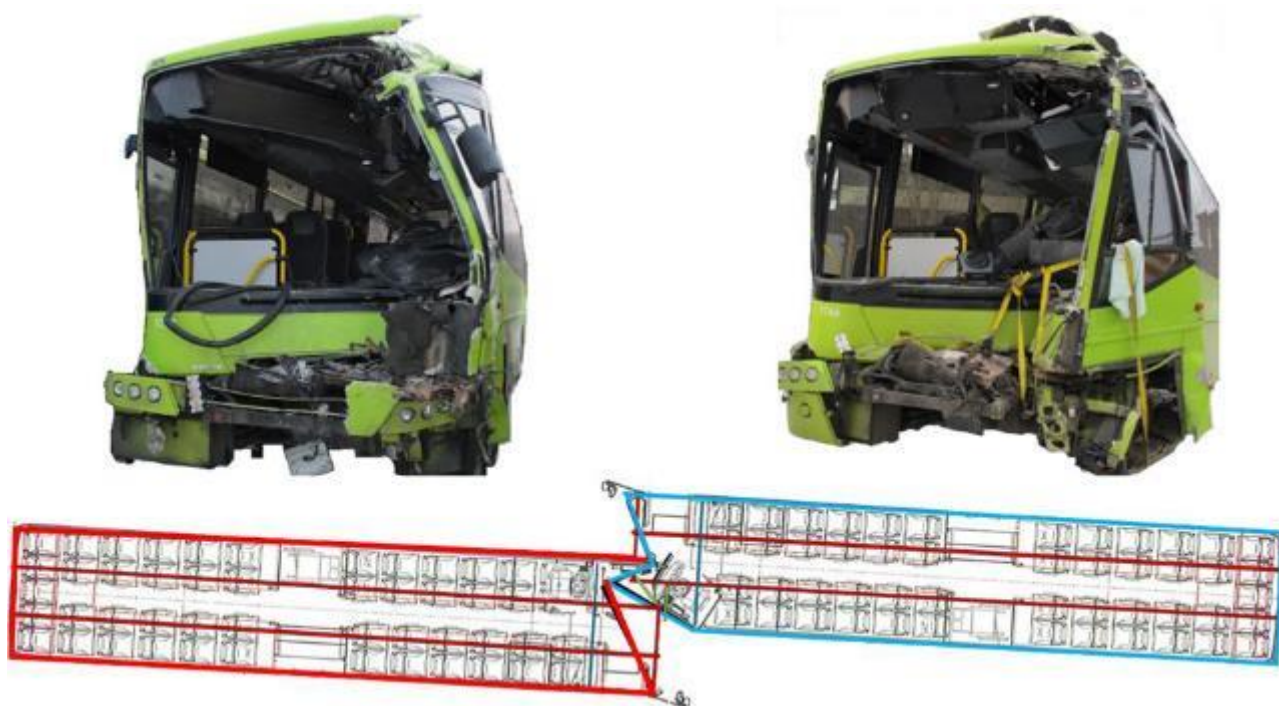
Figure 11: Photo and illustration of the vehicles after a head-on collision on the Fv 4500 road at Nafstad in Ullensaker on 17 November 2017. Source: Road traffic report 2019/04, SHK⁴

In both these head-on collisions, the buses that collided were of two identical models. In both accidents, one of the buses crossed partly over into the oncoming lane, and they collided with each other at a narrow angle and with little overlap on the left-hand side. Two drivers died in the two head-on collisions and one driver was critically injured.

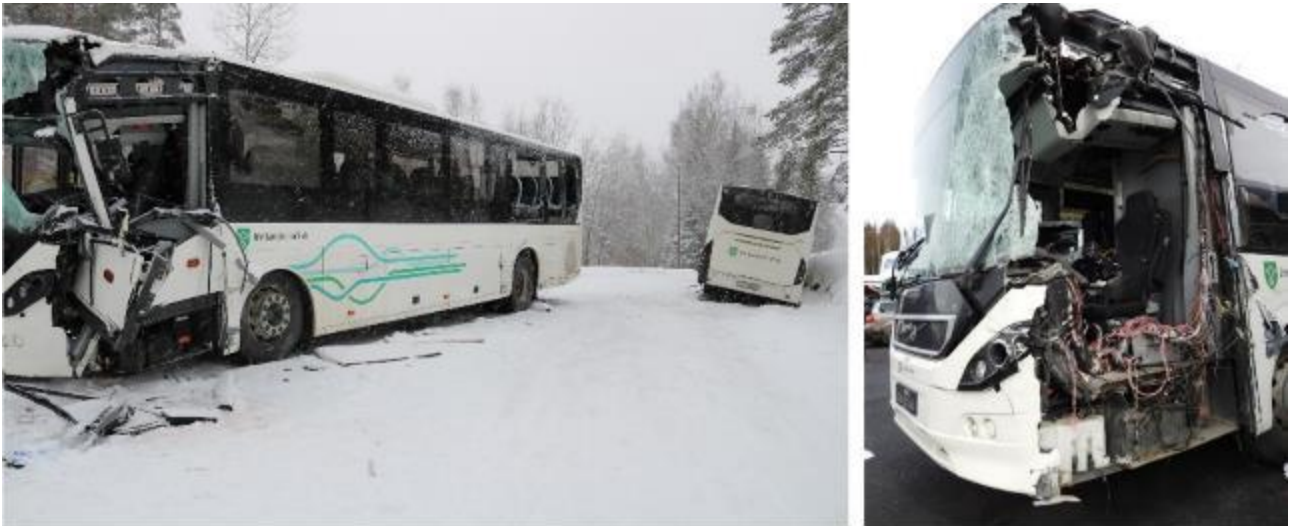
Figure 12: Photo of the vehicles after the head-on collision on the FV 222 road near Tangen in Stange on 11 March 2021. Source: Road traffic report 2022/02, SHK⁵

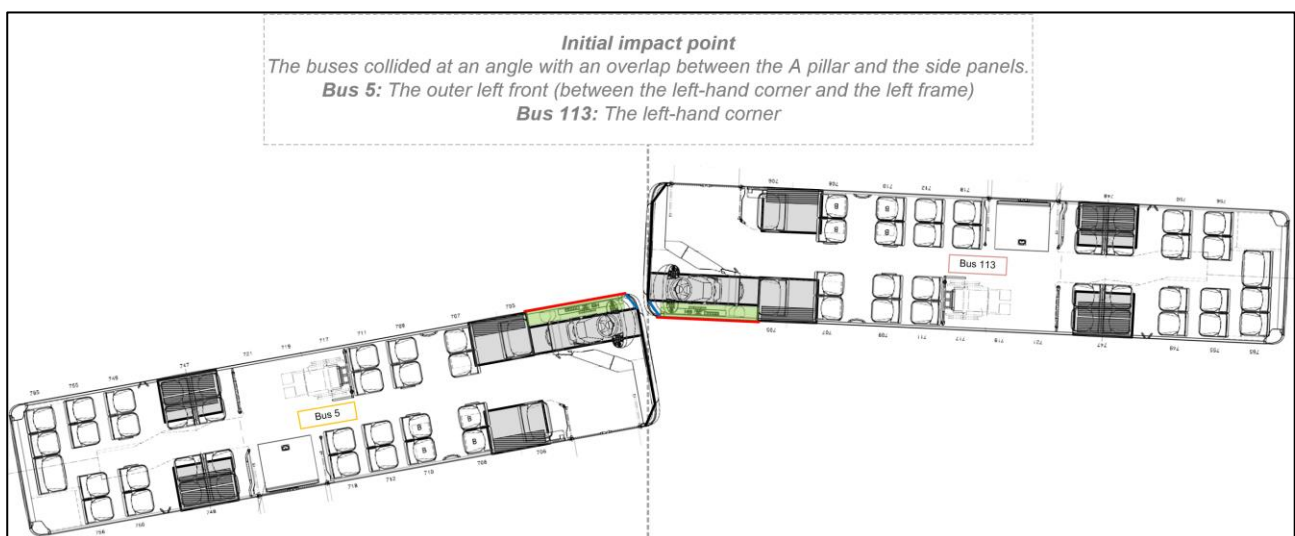
Based on the evidence, the impact point on Bus 113 was the left-hand corner. Bus 5's first impact point was between the left-hand corner and the left-hand frame on the front of the bus, on the outer part of the front plate (up to approx. 45 cm); see Figure 15. At the first impact point, there was an overlap between the buses' A pillars. This meant that the left-hand outer part of the buses' front plates was bent backwards and cut off the lower part of the A pillar, so that the side panels of both buses broke loose.

Figure 15: The buses' initial impact point. Illustration: NSIA

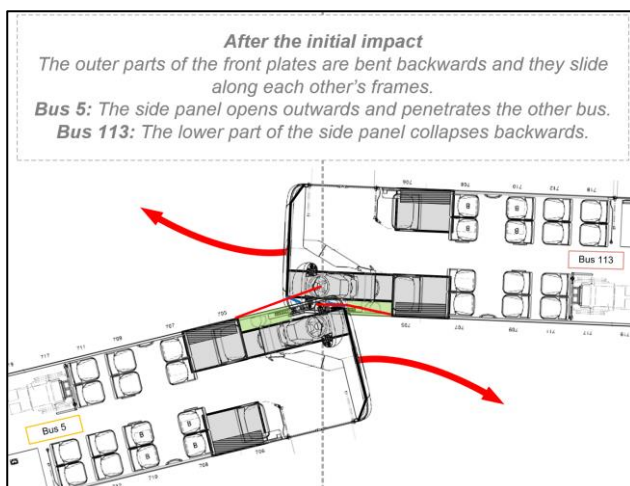
The side panel of Bus 5 was bent outwards, forming something that can be described as a 3.5 sq m panel hinged on the left front wheel, about 2 metres behind the front. The side panel on Bus 113 collapsed backwards and its strength was reduced as a result of one of the side windows breaking loose. The buses hit each other's left-hand frame, beneath the driver's seat, and then slid along this frame; see Figure 16. The buses stopped when Bus 5's front frame hit the other bus's left forward axle. During this period, Bus 5's side panel penetrated the other bus and swept over the driver's cab; see Figure 17. As a result, there was no survival space for the driver of Bus 113.

Figure 16: The buses' penetration after the initial impact. Illustration: NSIA

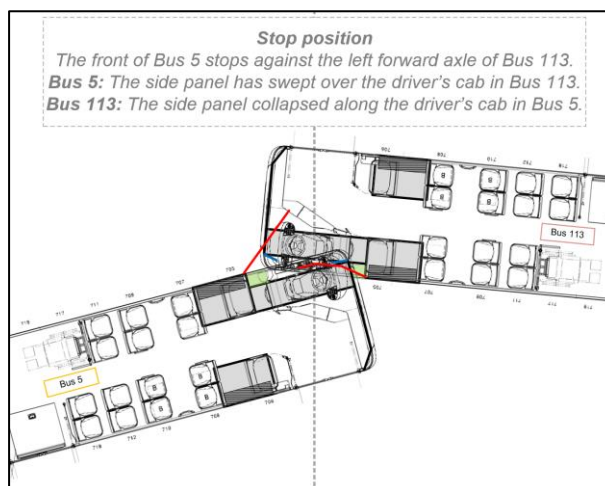
Figure 17: The buses' stop position in relation to each other. Illustration: NSIA

The collision highlights what the NSIA regards as a combination of unfortunate elements of the design of the buses' left-hand corners. The side panel with an A pillar and wall frame are of a robust design. This is a result of the bus's superstructure, which meets minimum requirements for rollover and impact tests to prevent collapse (described in UN Regulation No 66¹⁵). The left-hand frame of the buses was approx. 45 cm inside and under the left side panel. In this space (the service space) there was no shock absorbent or shock resistant structure except the outer part of the front plate, which collapsed on both buses.

As a result of the lack of a shock-absorbent or shock-resistant structure, the collision between the buses led to a collapse furthest down in the left-hand corner, and to the whole left side panel bending outwards. The NSIA believes that this played a decisive role in the side panel penetrating Bus 113, leading to the death of the driver.
