## INFORMATION DOCUMENT NO 1: PRELIMINARY INVESTIGATION OF THE BRIDGE COLLAPSE AT TRETTEEN ON 15 AUGUST 2022

Date and time:	15 August 2022 at 07:33
Place:	Tretten bridge, Fv 254, Øyer municipality, Innlandet county
Type of accident:	Bridge collapse
Vehicles involved:	Heavy goods vehicle (lorry with trailer) and passenger car
Road users involved:	HGV driver and passenger car driver

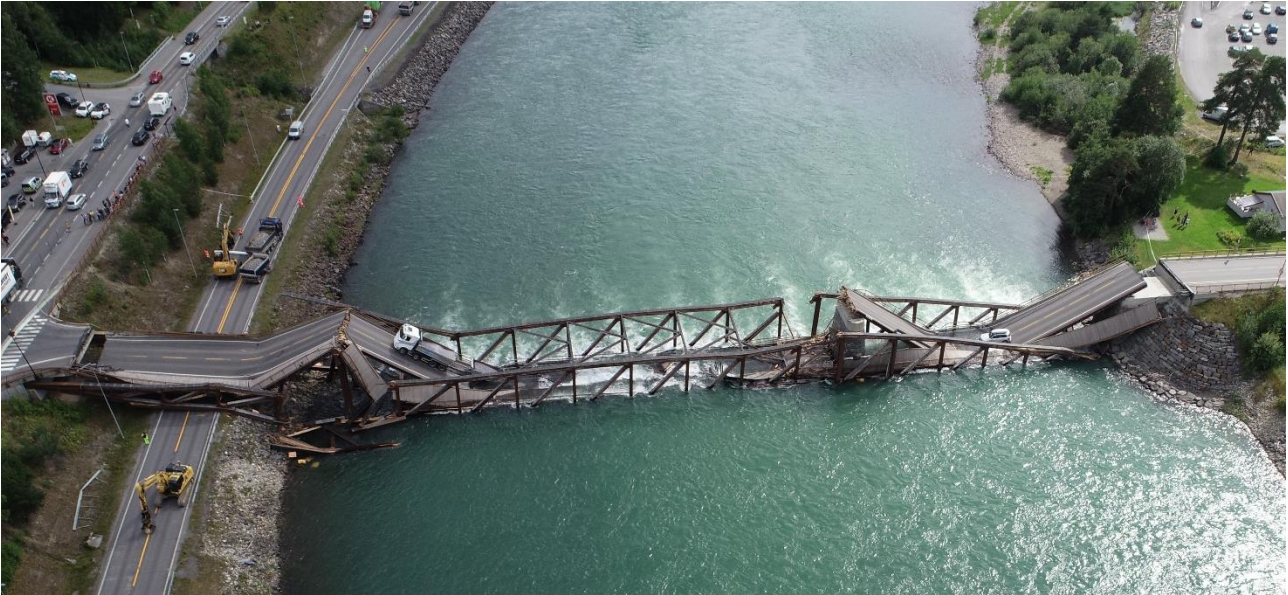
*Figure 1: Tretten bridge at 14:45 on 15 August. Photo: NSIA*

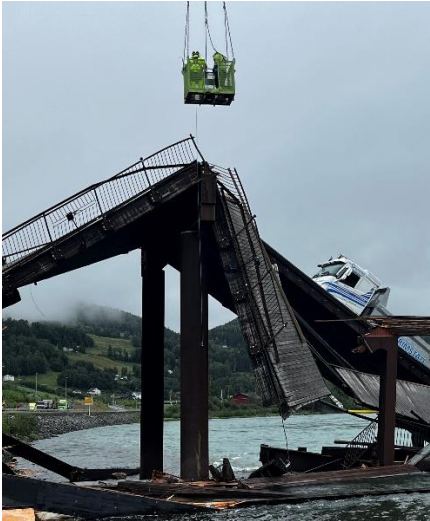
Figure 2: Search for bolts around axis 3 using a magnet. Photo: NSIA transport.
