INFORMATION DOCUMENT NO 2: PRELIMINARY INVESTIGATION OF THE BRIDGE COLLAPSE AT TRETTEEN ON 15 AUGUST 2022

Date and time:	15 August 2022 at 07:33
Place:	Tretten bridge, Fv 254, Øyer municipality, Innlandet county
Type of accident:	Bridge collapse
Vehicles involved:	Heavy goods vehicle (lorry with trailer) and passenger car
Road users involved:	HGV driver and passenger car driver

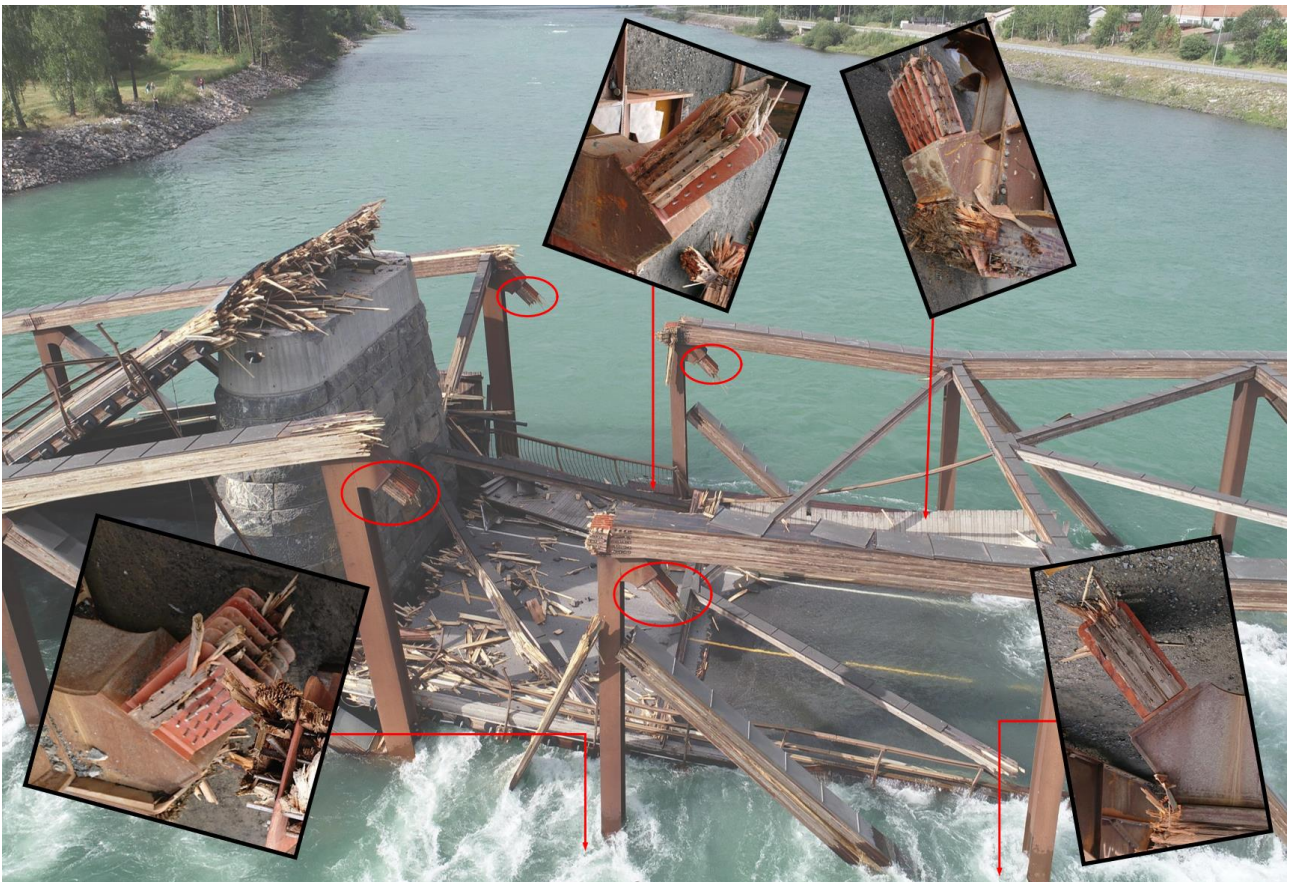
The technical investigations substantiate that the initial cause of damage to the collapse of the Tretten bridge was a break in one of the diagonals in the main span towards the western river foundation (axis 2).

Figure 1: Red rings around the upper connections, and images of the connections that was under water, and attached to the diagonals in the main span towards the western river foundation (axis 2). Illustration: NSIA

The fracture form is identified as block shear failure between the wooden part and steel/dowels at the junction. This is a momentary form of failure that can cause overloading of other elements in the truss upon subsequent loading, and then with the collapse of the bridge as a result. The fracture form is supported both by technical examinations of fracture parts, photographic material and witness observations, as well as carried out structural analysis and calculations.

The cause of the fracture form has so far been assessed to be a significant overload in relation to the bridge's load impact and bearing capacity, with regard to block shear failure in the connections to the said diagonals. Checked according to the recommended calculation methods in today's current regulations for the design of wooden structures, the degree of utilization in the connections on the relevant diagonals was around 200%². That is to say, the capacity of these connections was half of what they should have been
