SAFETY NOTE AFTER THE THEMATIC INVESTIGATION OF SEVERAL INCIDENTS IN WHICH SEMI-TRAILERS DETACHED FROM THE TRACKING VEHICLE DURING TRANSPORT

Road 2024/SN1

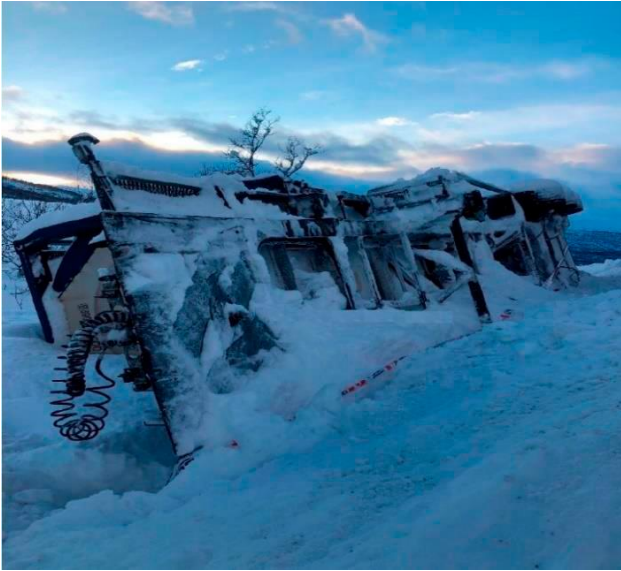
Figure 2: Gratangen – the semi-trailer on its side in the ditch. Photo: NPRA

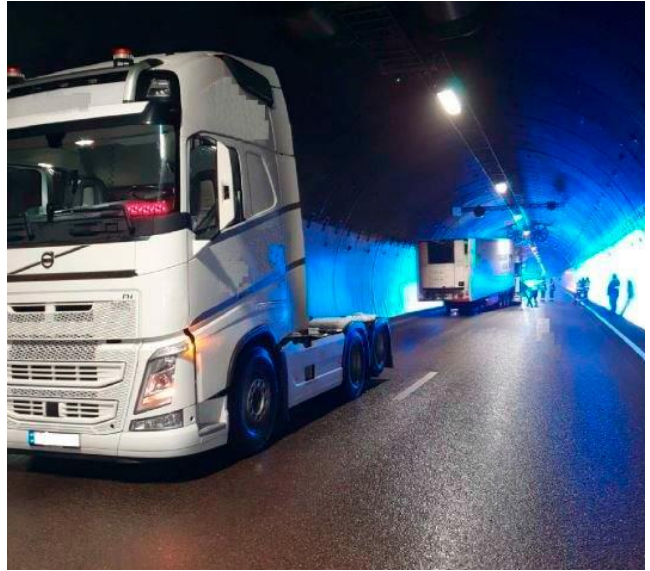
Figure 3: Rælingen – tractor unit and semi-trailer seen from the front. Photo: The police

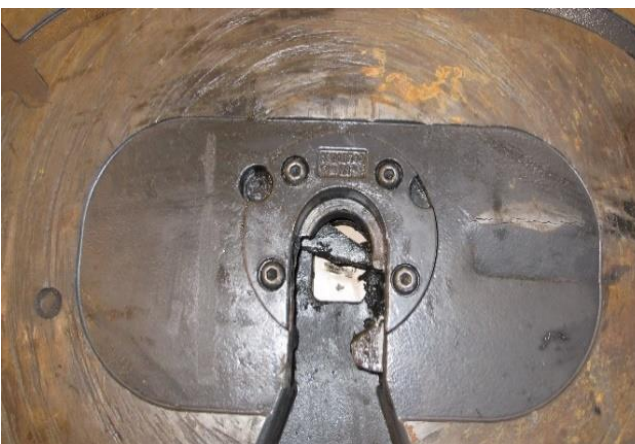
- Fifth wheels of the type Fontaine 3000 that the NSIA has investigated appear to be susceptible to technical damage in the locking mechanism (see Figure 4 and Figure 5), which probably occurs in connection with the coupling of the vehicle combination throughout its lifecycle, in that the locking mechanism not being set in fully open position when coupling the vehicle combination. The nature of the damage means that it does not necessarily have an immediate effect but may develop and worsen over time. The damage will eventually prevent the fifth wheel from being locked in the safe position.

Figure 4: Crack formation and dent on the fifth wheel top plate, to the right of the locking mechanism. Photo: NSIA

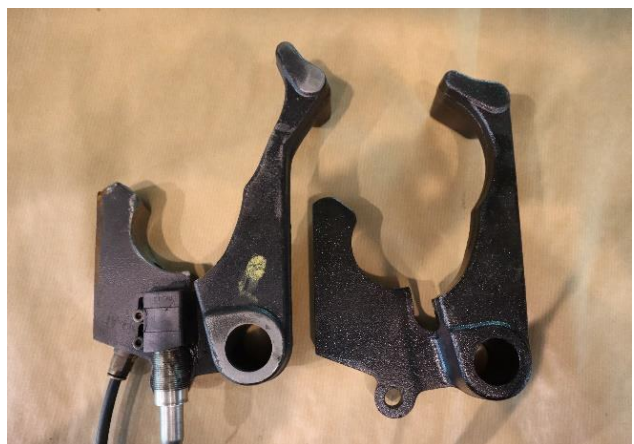
Figure 5: Lock jaw, damaged example on the left, new on the right. Photo: NSIA

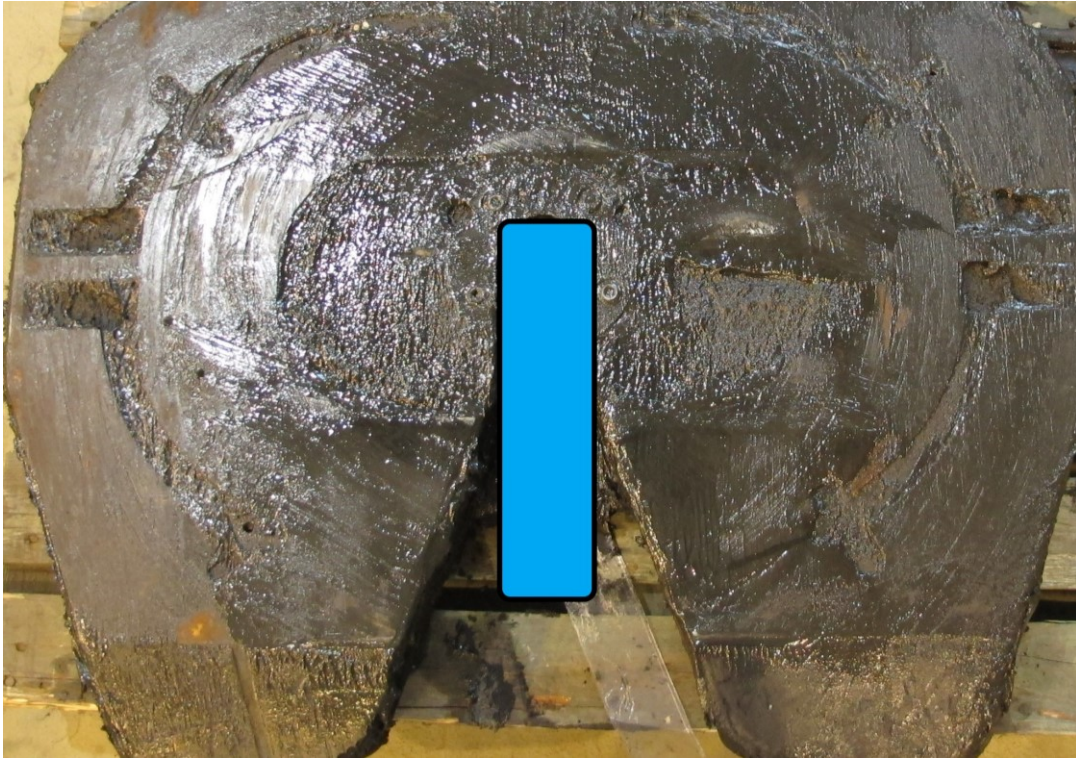
The Raelingen tunnel 3 January 2022

- Volvo FH, 2020 mod, approx. 260,000 km
- Trailer falls off after approx. 2 km drive
- Visible damage to the fifth wheel/locking mechanism:
 - Bent and twisted release handle.
 - Wear under handle.
- The image contains a visible critical damage, this is identified on the next page.

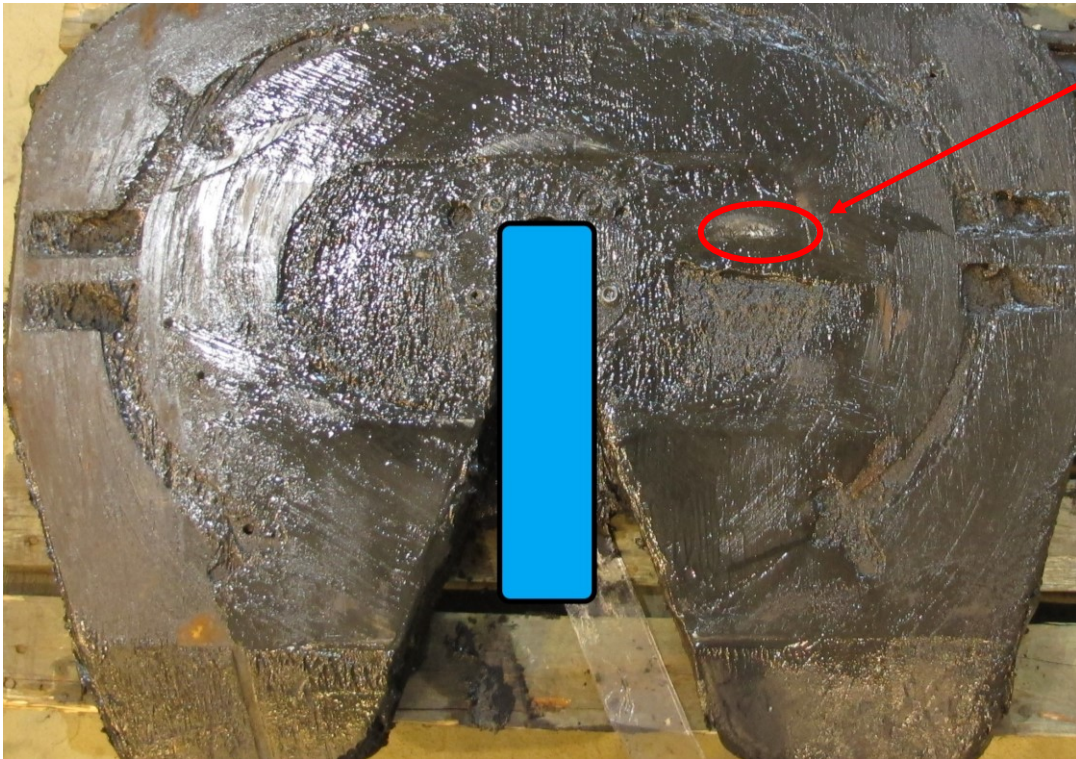
The Raelingen tunnel 3 January 2022

- The damage is barely visible on the top of the disc, but this is usually hidden by the grease on the fifth wheel.
- This is due to a critical but almost invisible damage to the underside.
- The sidewalls for the locking wedge are bent out (extended). This allows the King pin to move inside the fifth wheel lock.
- This means that the damage will continue to develop under load, during normal transport.
- The damage will eventually destroy the fifth wheel lock and could give a “false” lock, in that the driver believing that the train is securely connected without being so.

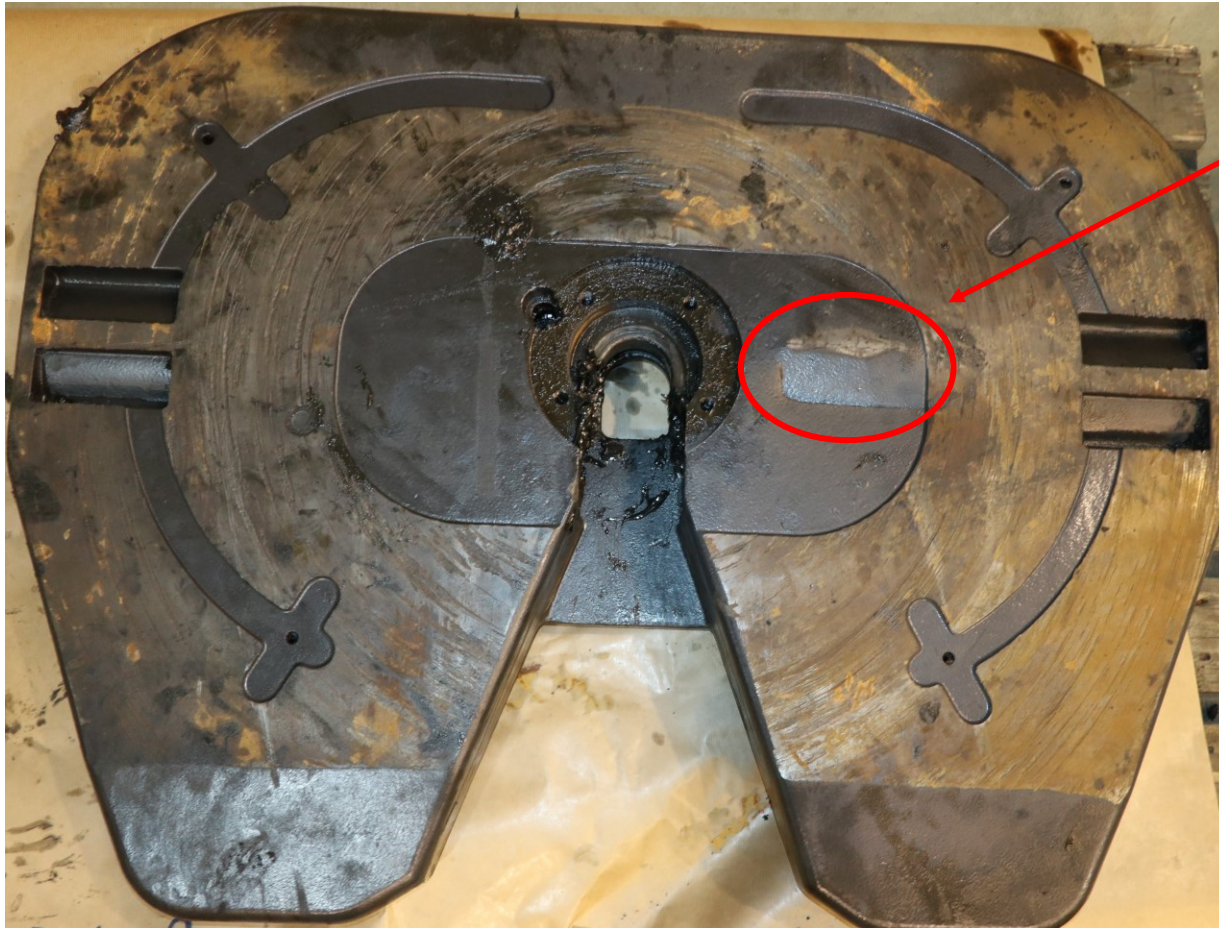
The Raelingen tunnel 3 January 2022

- Cleaned fifth wheel, now the damage is more visible.
- Clear crack formation in the submerged area in the middle of the fifth wheel, this area is normally filled with fifth wheel grease.

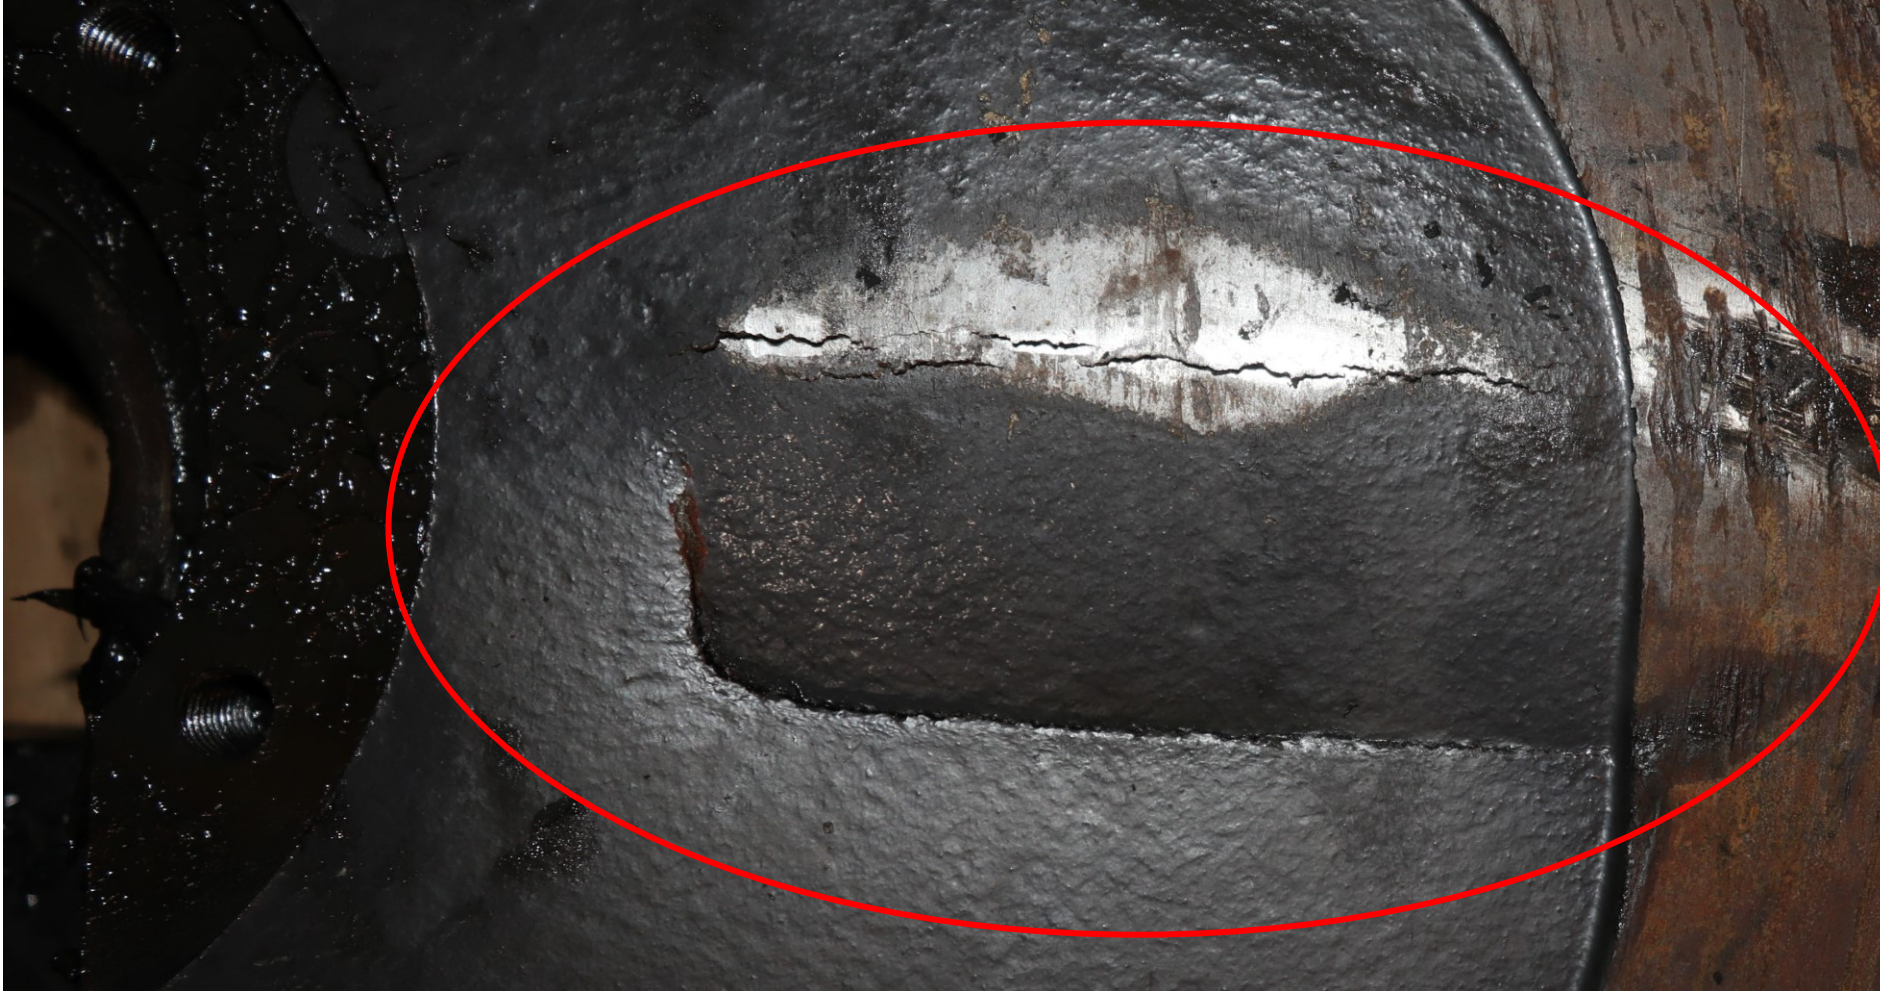
The Raelingen tunnel 3 January 2022

- Visible crack formation.

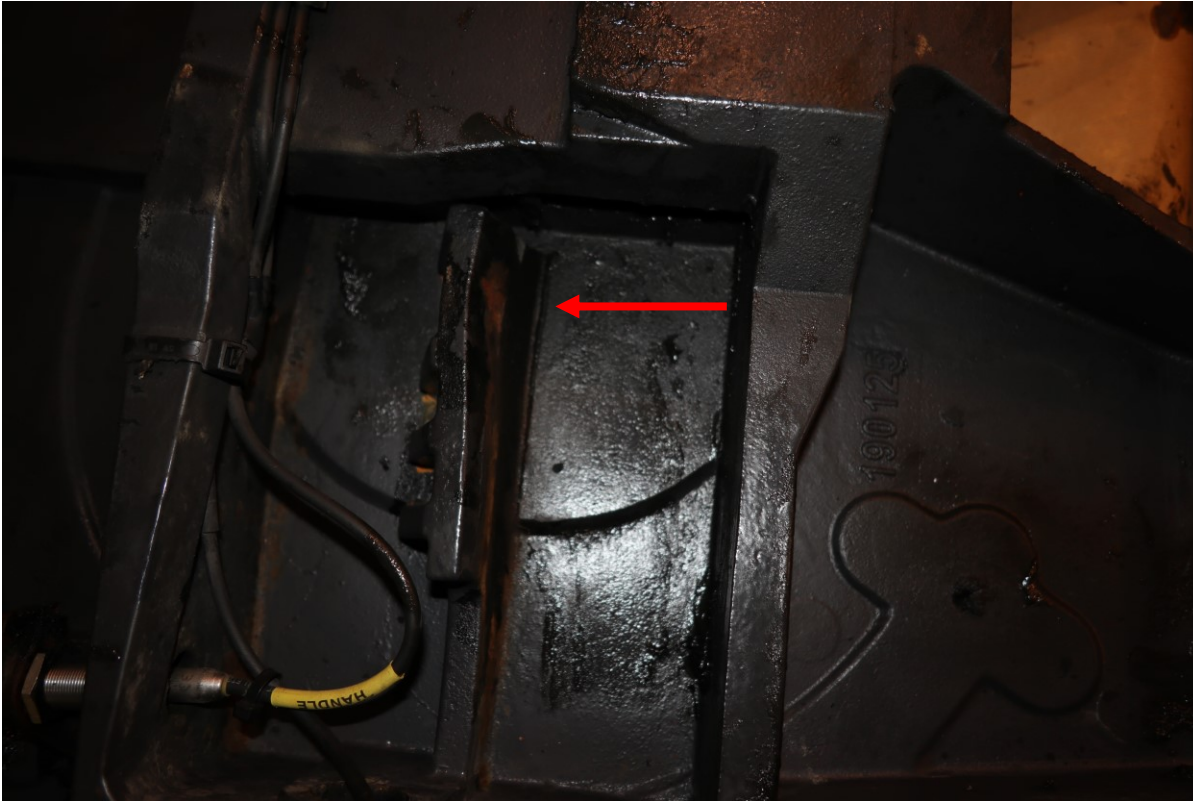
The Raelingen tunnel 3 January 2022

- The sidewalls for the locking wedge are clearly bent/extended.
- The investigation has so far shown that it is not possible to get the fifth wheel to securely lock. The locking handle enters, but not in the secured position.
- If the driver does not carry out a thorough check, it may look as if it has been locked.

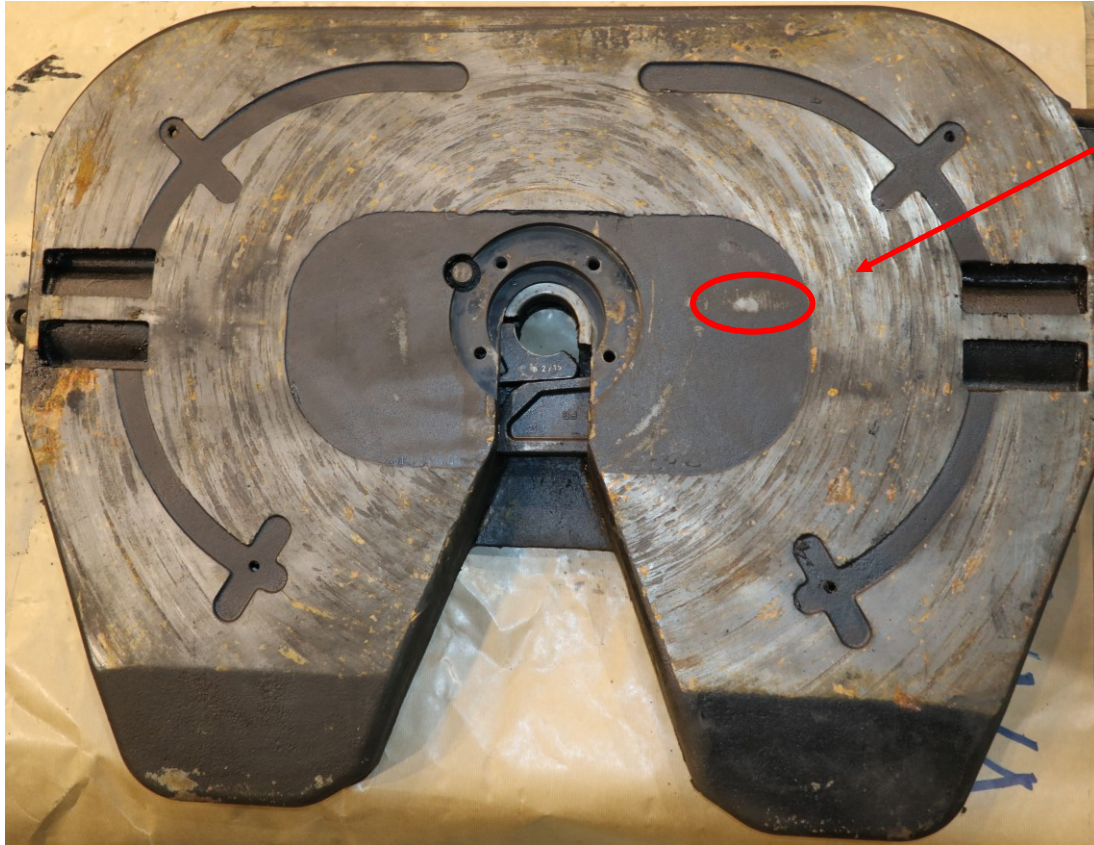
Odda, construction area, 1 March 2021

- Mercedes Actros, ca. 400,000 km
- Lost trailer (dump trailer) inside a construction site.
- Cleaned fifth wheel has a little visible wear/dent in the marked area.
- This wear/dent looks insignificant but indicates a critical damage to the locking wedge slide.

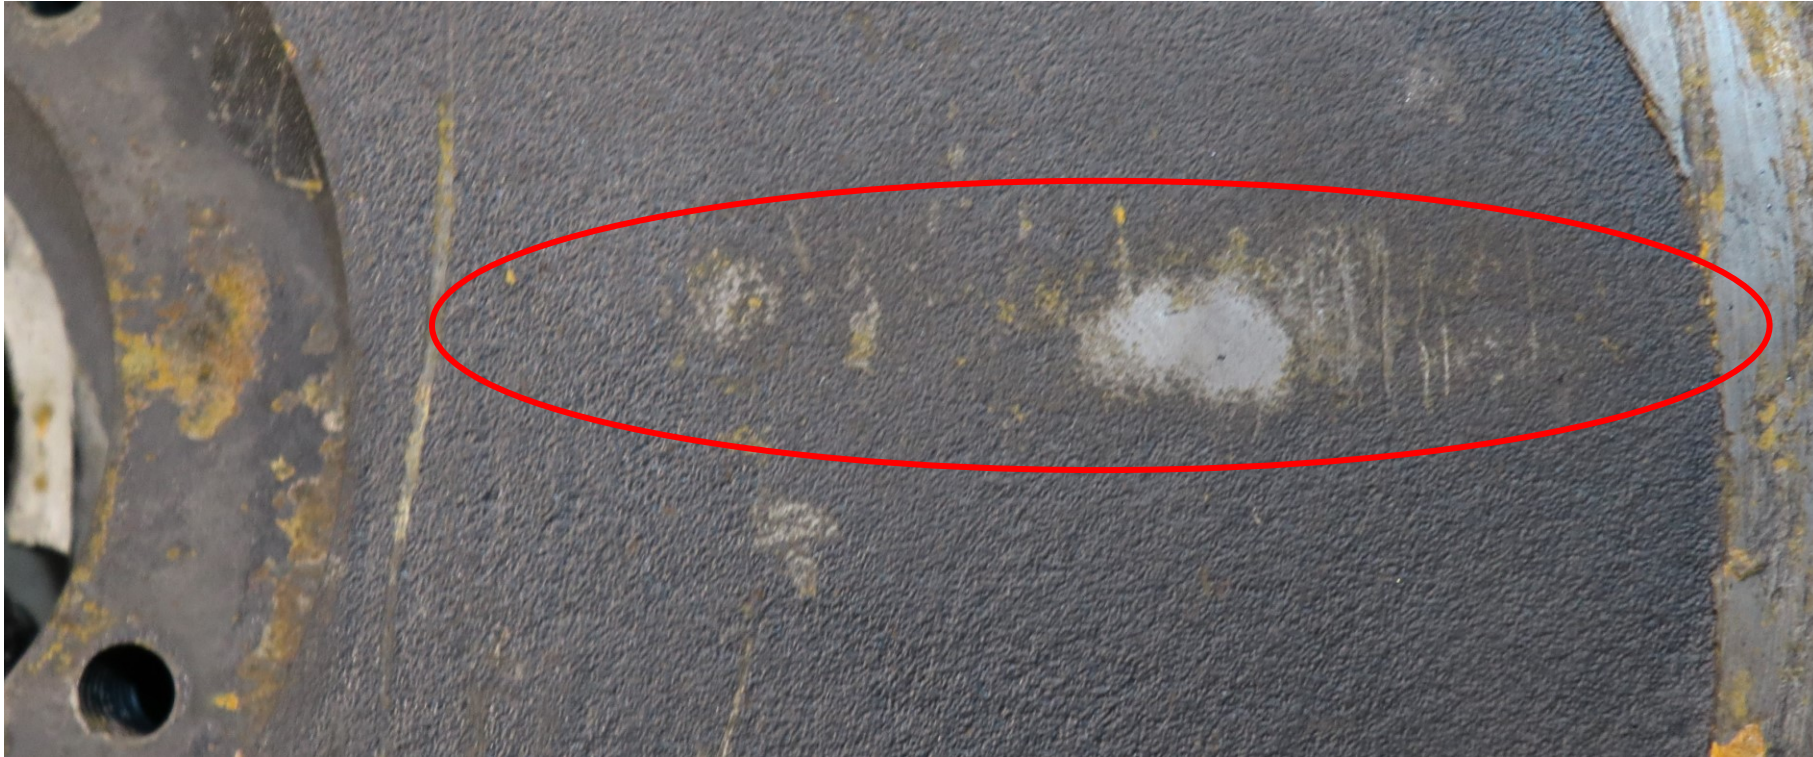
Odda, construction area, 1 March 2021

- Upon closer inspection, it appears that the fifth wheel has a smaller dent from the underside.

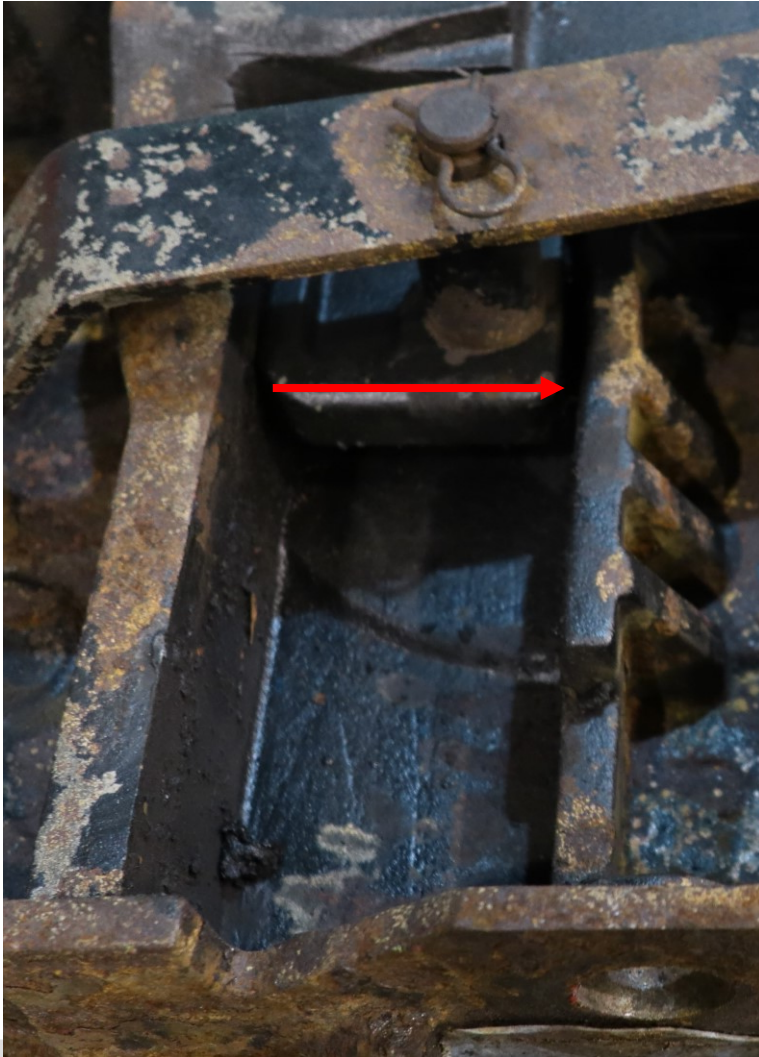
Odda, construction area, 1 March 2021

- The sidewalls for the locking wedge have been extended, by the red arrow.
- This extension allows the King pin to travel inside the fifth wheel lock.
- This damage will develop over time.

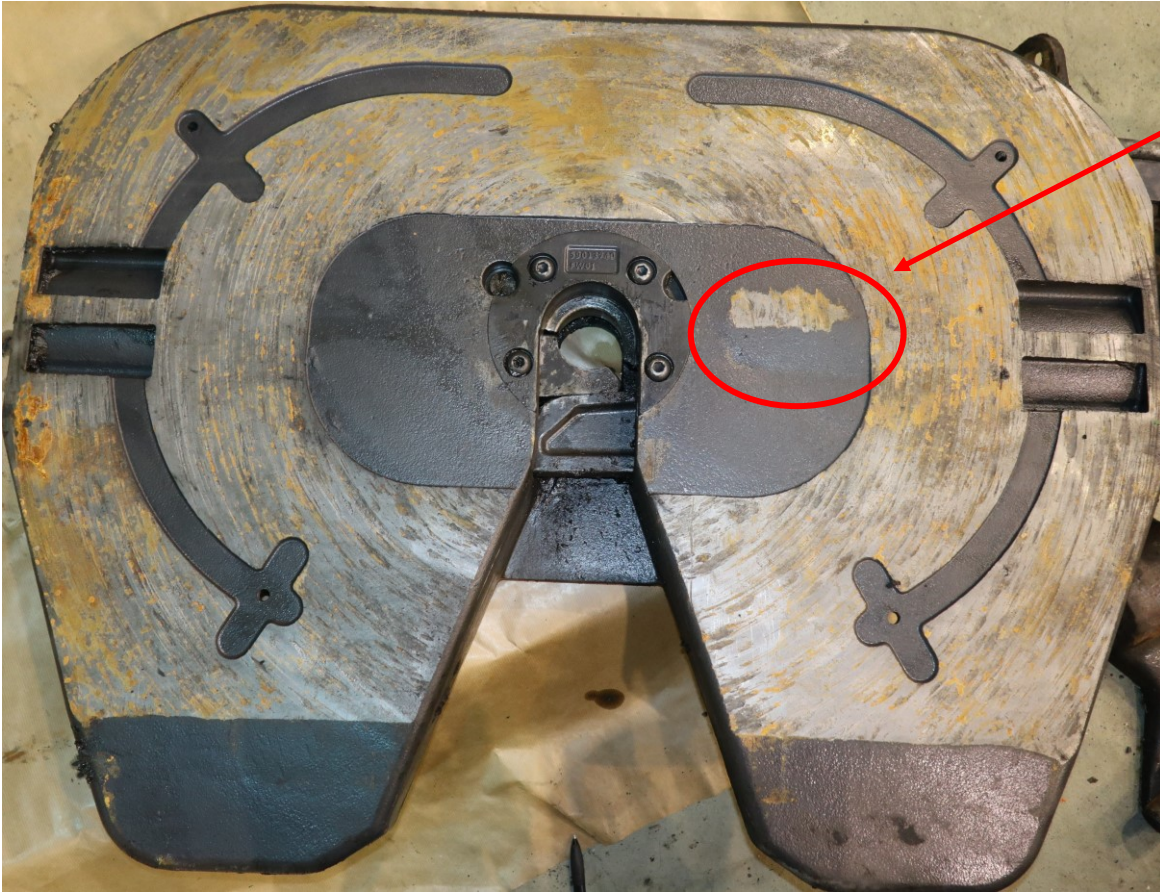
Gratangen 10 February 2021, bulk transport

- Volvo FH, ca. 260,000 km, Swedish registered.
- E10 in Gratangen, overturns in the ditch.
- 25 tons of formic acid in reservoir.
- Cleaned fifth wheel has a slightly more visible wear/dent in the submerged area, which is normally filled with fifth wheel grease.
- This wear/dent looks insignificant, but indicates a critical damage to the locking wedge slide.

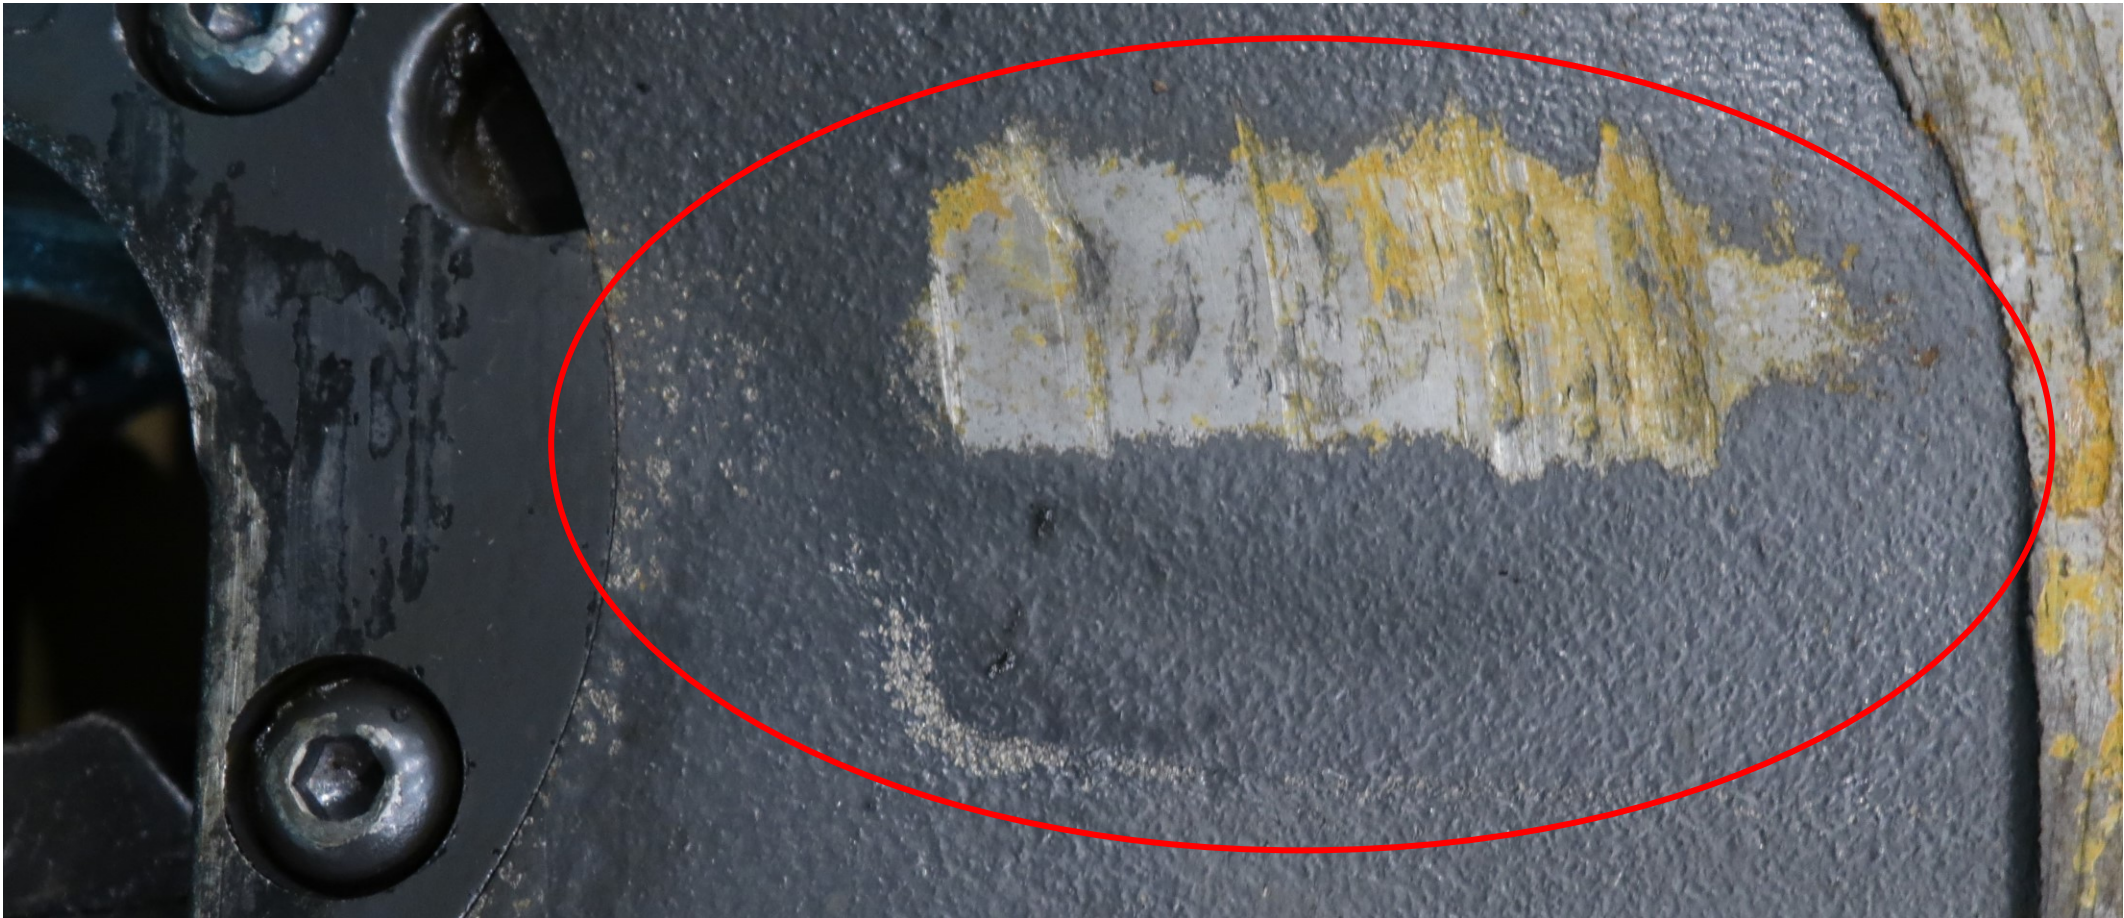
Gratangen 10 February 2021, bulk transport

- The fifth wheel has a visible larger damaged area, also normally hidden by fifth wheel grease.

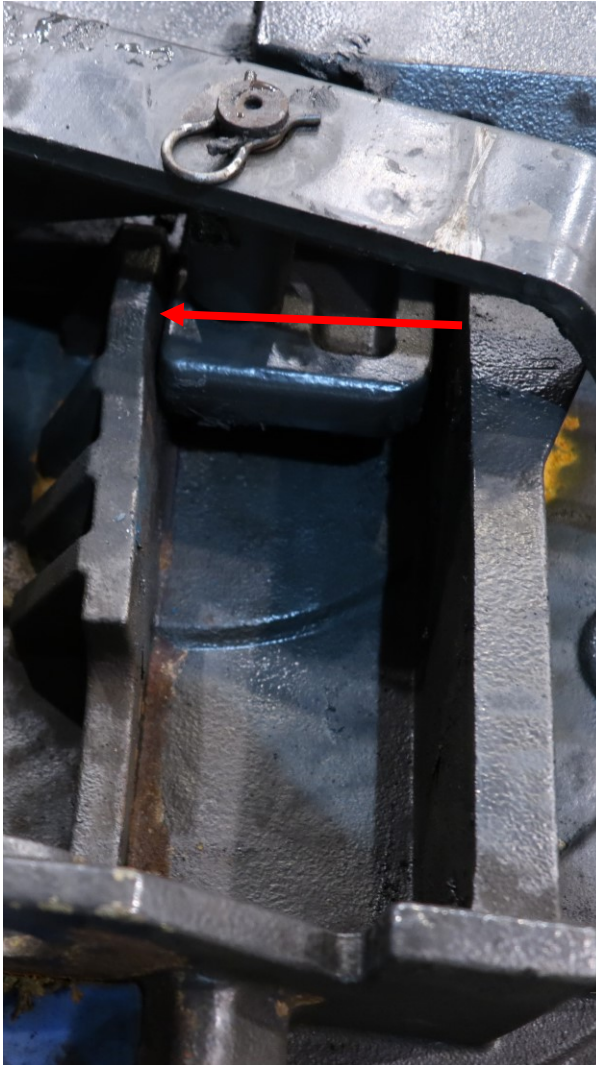
Gratangen 10 February 2021, tank transport

- The sidewalls for the locking wedge are clearly extended by the red arrow.
- After examination at an approved workshop, the fifth wheel was rejected and replaced.
