# REPORT

ROAD 2025/02

***Head-on collision between a passenger car and a heavy goods vehicle on the Rv 7 road in Flå on 21 May 2024***

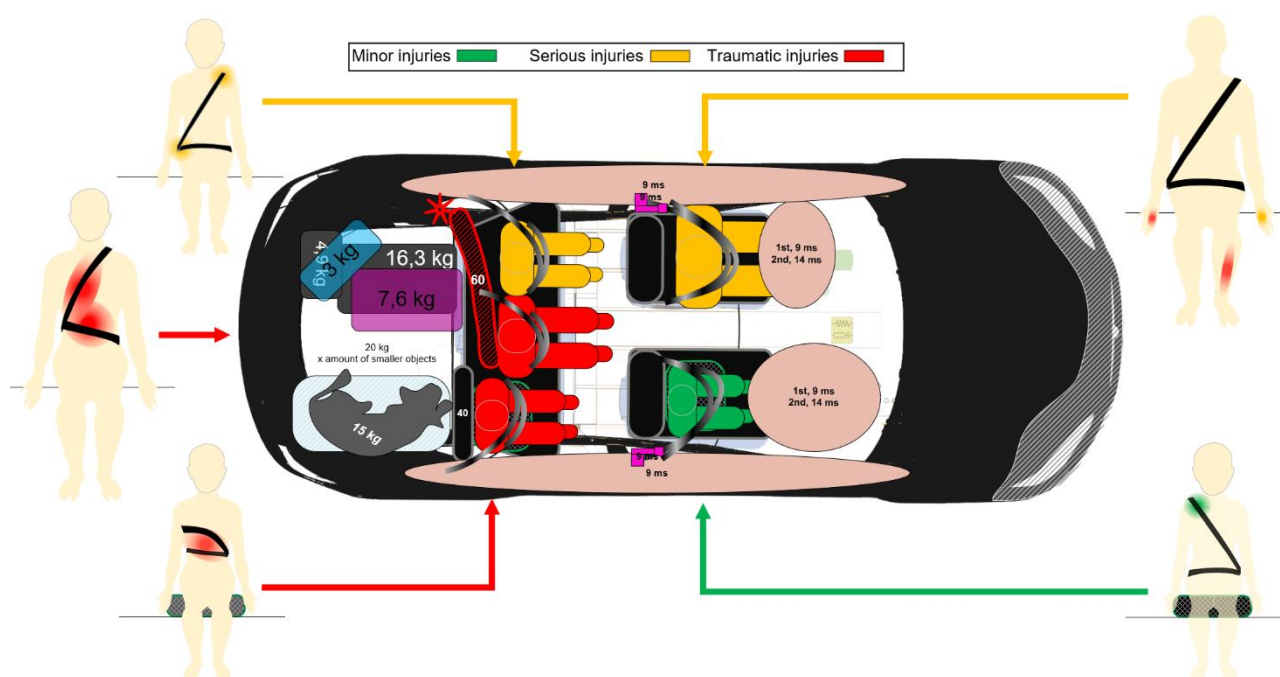
The striker of the 60-part of the rear seat-back was torn off, but no luggage from the boot moved into the vehicle body. Figure 4 illustrates the location of the various elements in the car, which safety equipment was activated and the severity of the injuries sustained by the different occupants of the car after the collision.

Figure 4: Deployed safety equipment, torn-off rear seat-back, luggage and seat belt positions in the collision are shown. Illustration by the NSIA

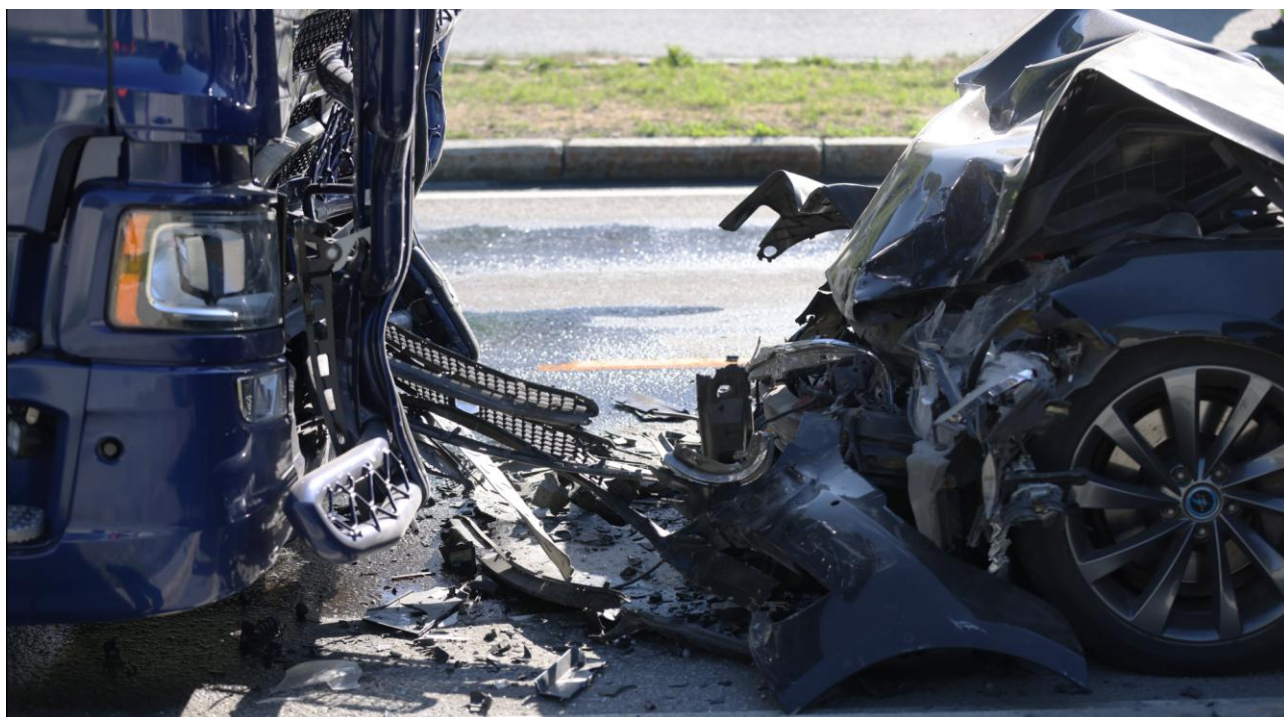
unit, which was fitted with frontal protection. As a result of the collision, the chassis of the tractor unit was bent, and it sustained damage to the fifth wheel, among other things.

Figure 5: Deformation of the tractor unit and passenger car after the collision. Photo: Tangen foto

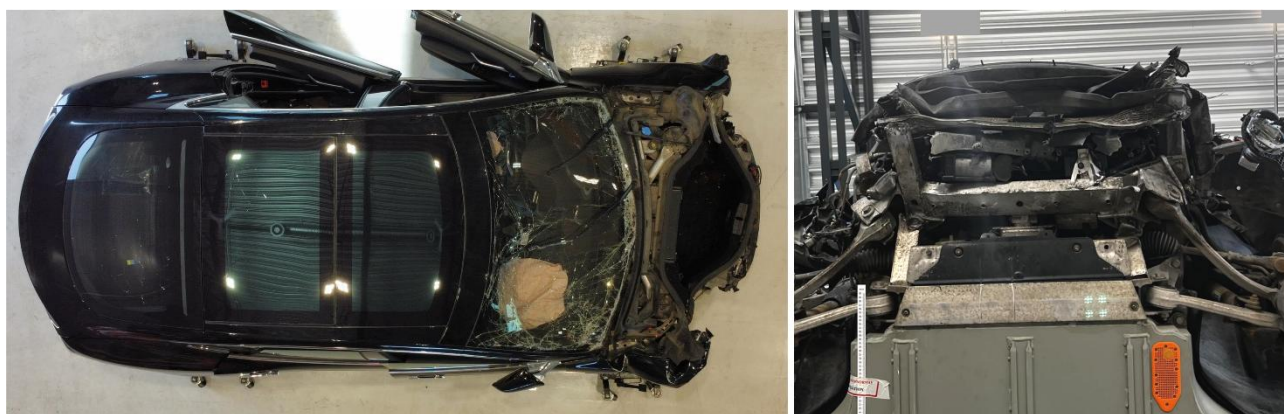
The damage to the passenger car was primarily in the front crumple zone. The car bumper was deformed rearwards and the outer edges on both sides folded back outside the chassis frame.

Figure 6: Passenger car after collision seen from above and crumple zone in front seen from below. Photo: NSIA

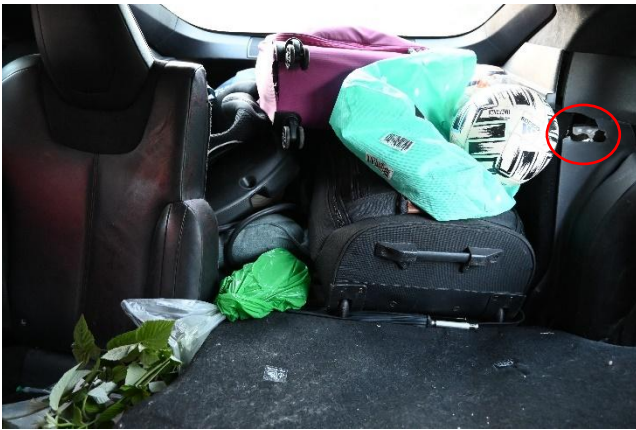
All the luggage in the boot of the car was still there after the collision. The striker of the 60-part of the rear seat-back was torn off and lodged in the rear seat-back latch, see red circles in Figure 7 and Figure 8.

Figure 7: Luggage in the boot after the collision behind the loose rear seat-back. Photo: Norwegian Public Roads Administration

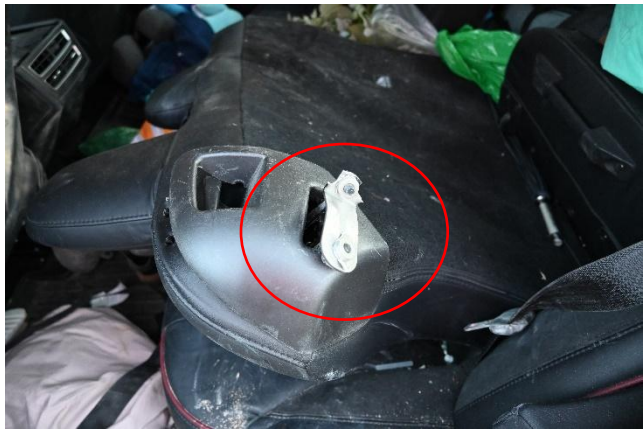
Figure 8: Torn-off striker that lodged in the lock of the rear seat-back (60-part). Photo: Norwegian Public Roads Administration

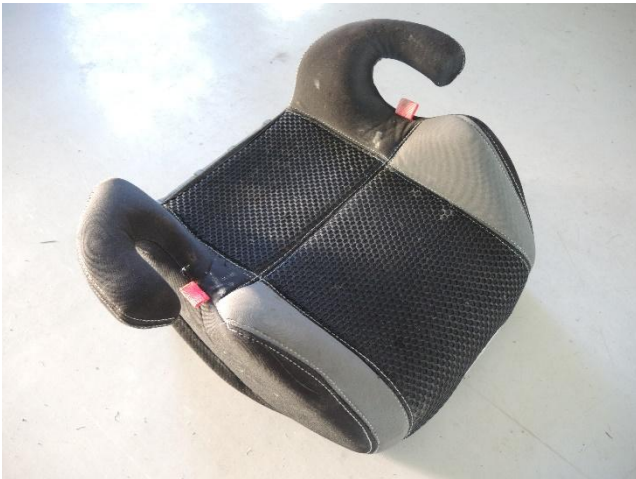
Two booster seats were in use in the car. Both were designed with relatively low lap belt routing. Both had signs of routing wear on the right side, which was most evident in the booster seat in the right front seat, where a belt pretensioner for the lap belt was also activated.

Figure 9: Booster seat right rear seat. Photo: NSIA

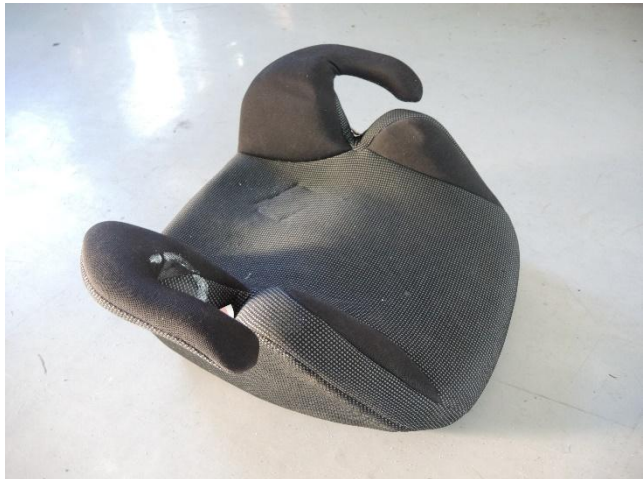
Figure 10: Booster seat right front seat. Photo: NSIA

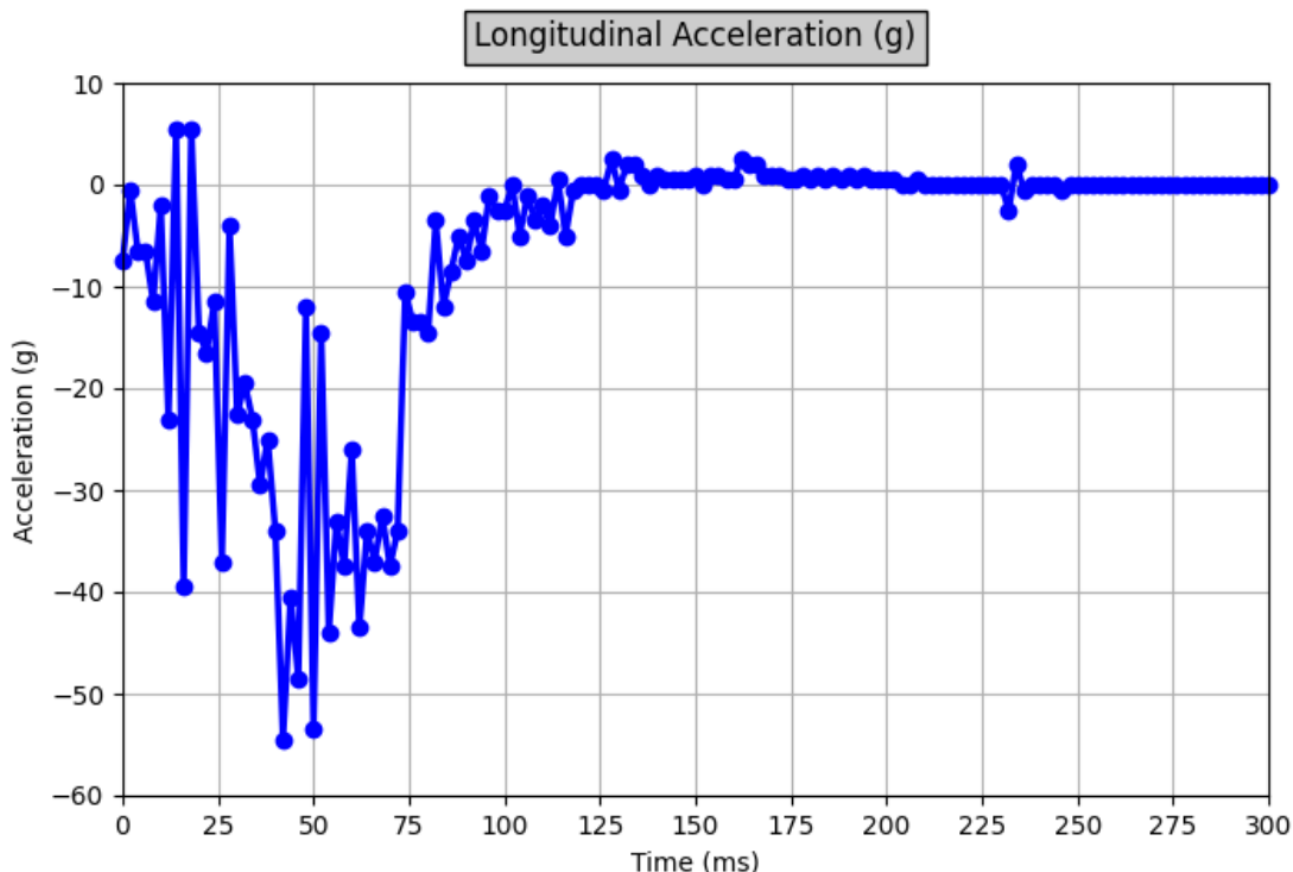
Figure 15: Longitudinal acceleration (g) of the passenger car in the collision. The highest g recorded was -54.5 g. Source: Tesla, (Event 1) EDR report

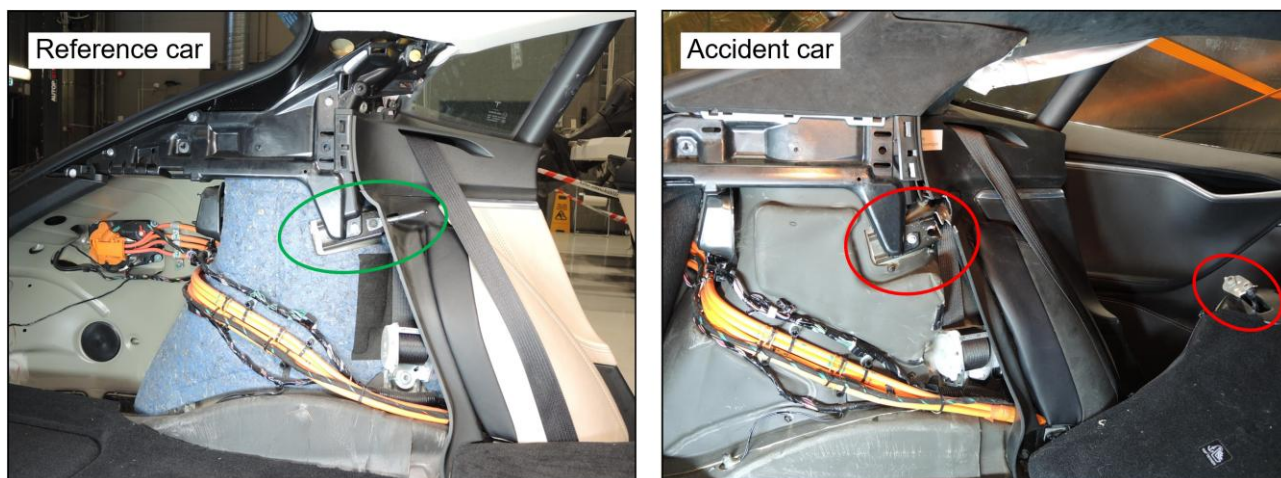
Figure 25: Examination of the striker in the reference car and the torn-off striker in the accident car.  
Photo: NSIA

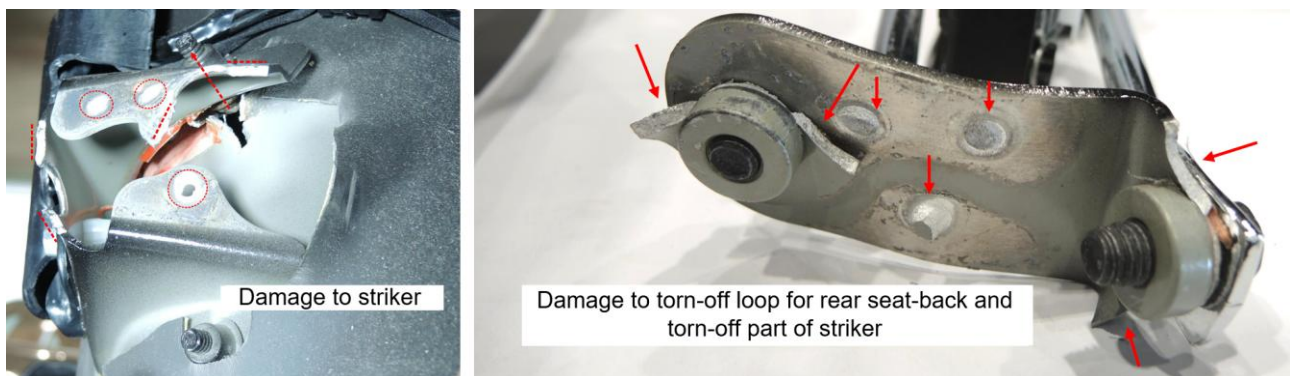
Figure 29: Striker in the accident car, torn-off bracket and torn-off striker loop. Photo: NSIA

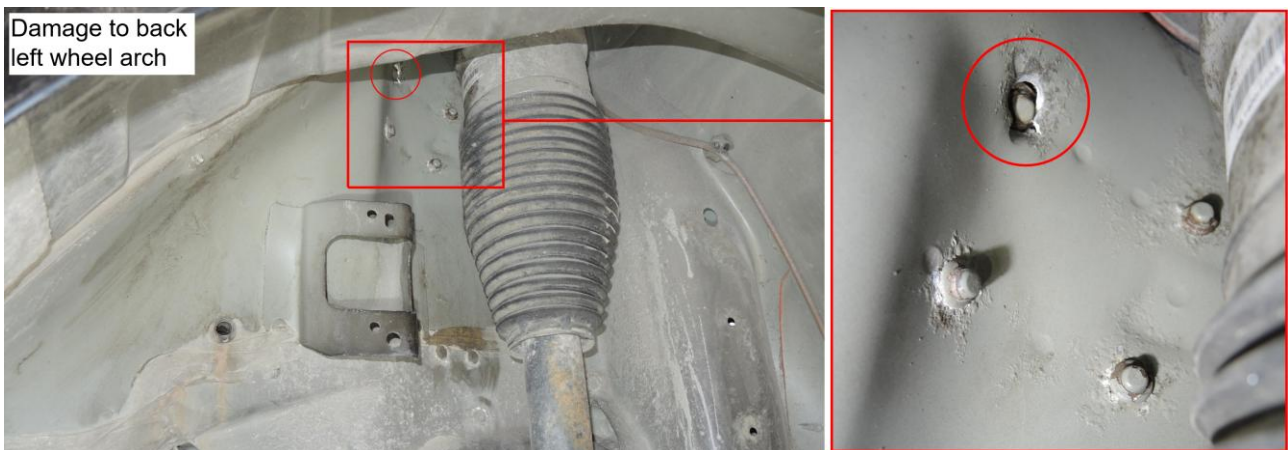
Figure 30: The accident car's striker and anchorage seen from the left wheel arch beside the shock tower. Photo: NSIA

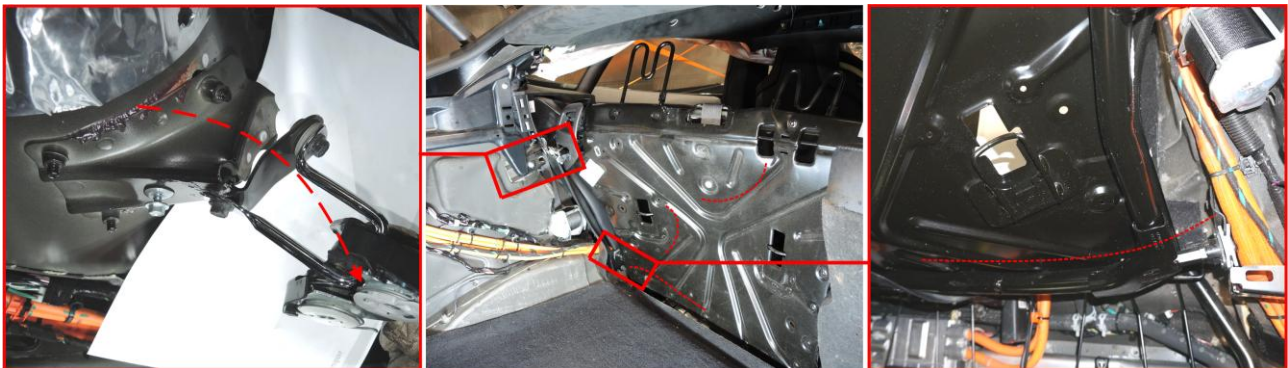
Figure 31: Examination of the torn-off striker for the rear seat-back's 60-part, and deformation of the anchorage of the rear-seat back. Photo and illustration: NSIA

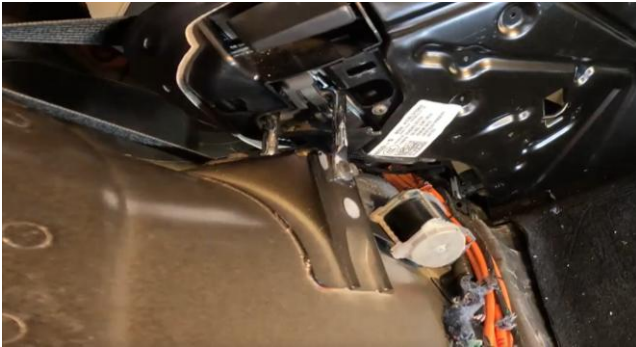
Figure 33: Test #1 distortion just before the shoulder belt broke at 1,660 kg. Source: NSIA

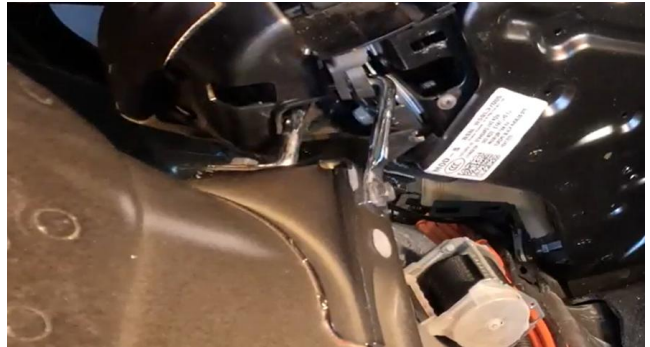
Figure 34: Test #2 distortion and contact between latch and striker loop at 740 kg. Source: NSIA

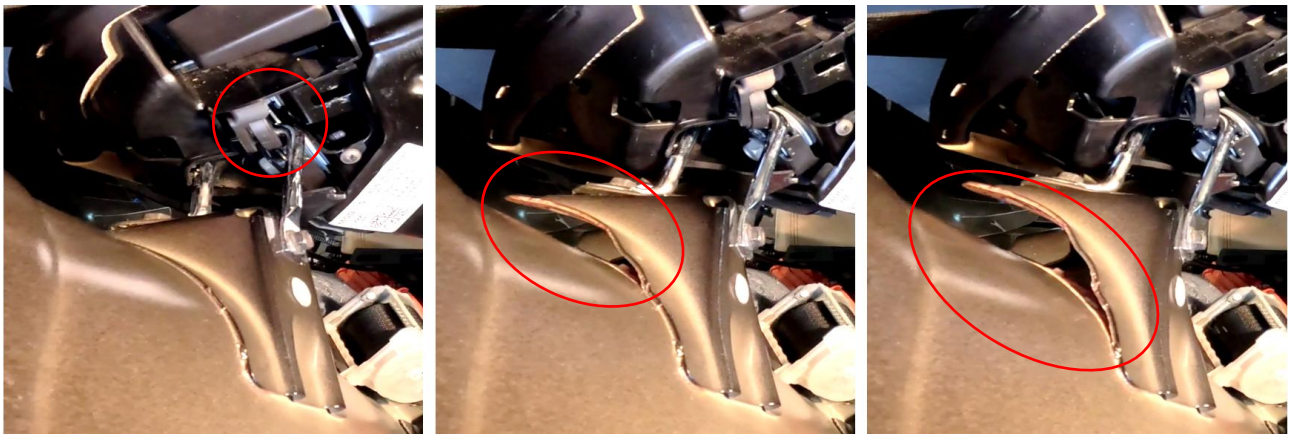
Figure 35: Sequence from test #2. Distortion of the rear seat-back as a result of tension led to the latch in the rear seat-back coming near the corner of the striker loop. There was lateral tension on the striker via the loop and the rear seat-back's striker to the wheel arch was torn clean off. Screenshot: NSIA

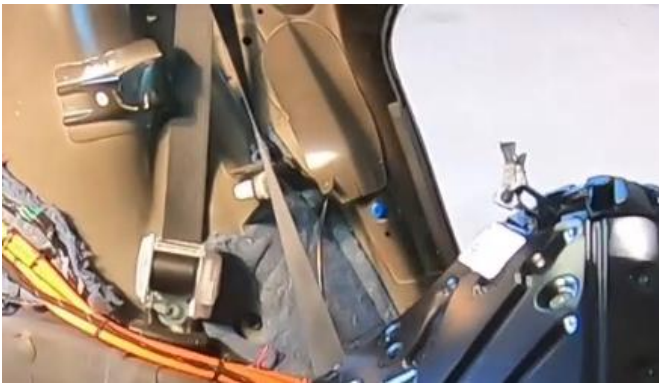
Figure 36: Torn-off striker and loop left hanging in the rear seat-back. Photo: NSIA

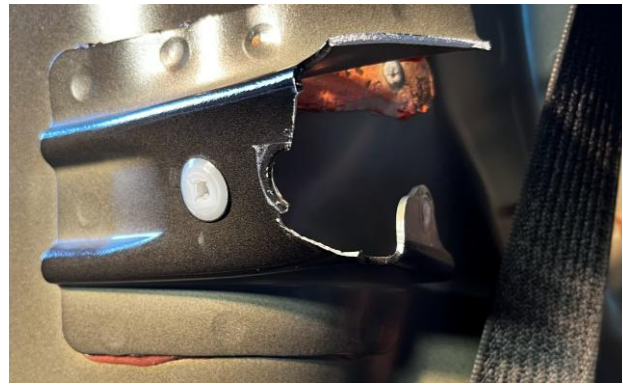
Figure 37: Torn-off striker beside the wheel arch. Photo: NSIA
