Issued December 2025

REPORT ROAD 2025/04

Part one report – Thematic investigation of accidents involving young people on light motorcycles

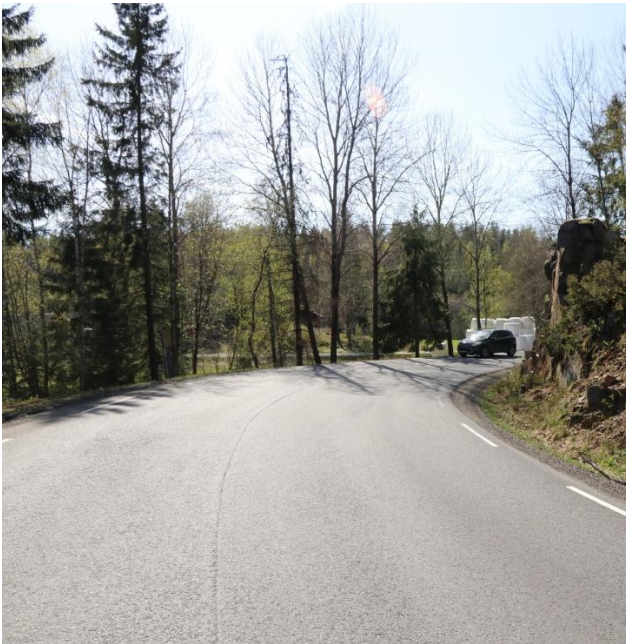
The accident occurred when the rider lost control of the motorcycle in a sharp right-hand curve with limited forward visibility. The rider and the motorcycle hit the ground and slid into the oncoming lane, colliding with an oncoming car (see figure 1). The car driver braked quickly but had no possibility of avoiding the collision. The rider of the motorcycle sustained extensive head injuries and died as a result of the accident.

Figure 1: The accident site on the FV 115 in Indre Østfold. Photo: The police.

Based on the combined factual findings, the NSIA assesses that high speed in relation to the curve and high front-tyre pressure caused the accident to occur. The right-hand curve in question is particularly demanding as it is a decreasing-radius curve, based on the motorcyclist's direction of travel. Coupled with obstructions to visibility, this can be challenging for motorcyclists as it requires both a reduction in speed and change of direction while already in the curve.

No safety recommendation to the local road authority is issued based on this investigation, as Østfold County Authority has already introduced measures to improve road safety on the section of road (see chapter 2.5.2).

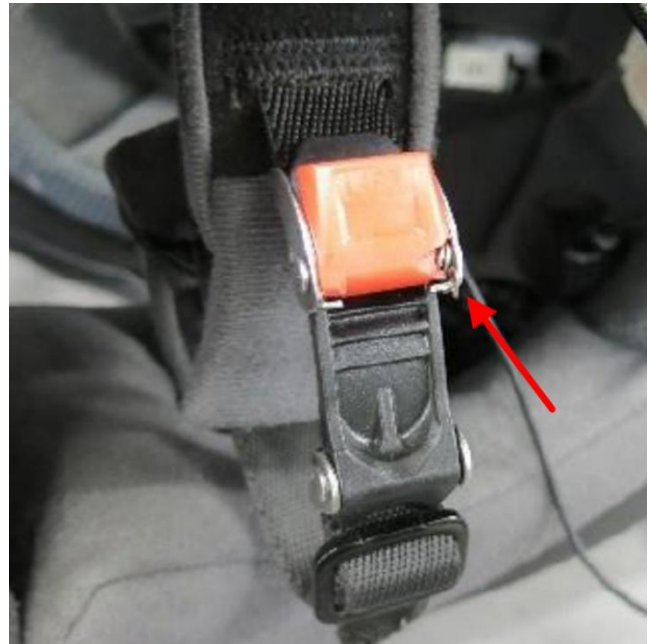
Figure 2: Damaged fastening mechanism (quick release) on the motorcyclist's helmet on county road FV 115 in Indre Østfold. Photo: The Research Institute of Sweden (RISE).

coupling on the helmet's chin strap had an adverse design feature that caused it to open as a result of mechanical forces (see figure 2). The rider sustained fatal head injuries when the helmet came off and the rider ended up underneath the car. The other injuries sustained in the collision with the car were survivable with rapid and appropriate medical treatment.

The Norwegian Safety Investigation Authority recommends that the Norwegian Public Roads Administration initiate work to assess additional requirements for protective equipment that can provide increased protection for the parts of the body most critical for survival, both for riders and passengers.

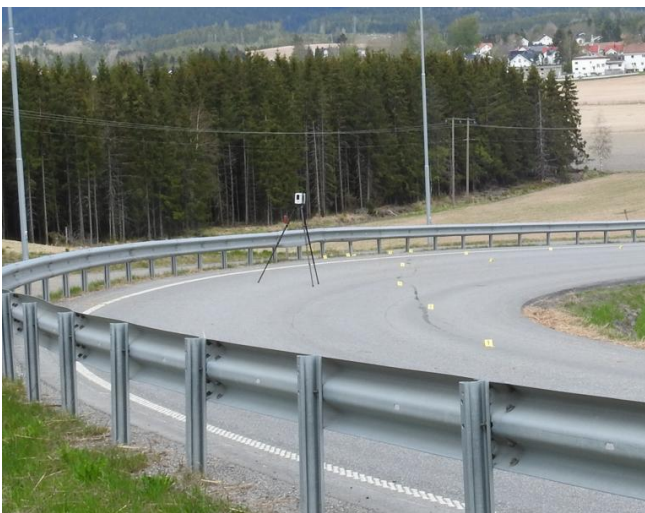
The accident occurred when the rider lost control of the motorcycle in a sharp right-hand curve with limited forward visibility (see figure 3). The rider fell off the motorcycle and hit a safety-barrier post on the opposite side of the carriageway (see figure 4). The rider sustained extensive injuries to the back and chest and died as a result of the accident.

Figure 3: The accident site on the FV 115 in Aurskog-Høland. Photo: NSIA

Based on the compilation of factual information, NSIA assesses that high speed in the curve and a large lean angle, combined with the motorcycle's technical condition, caused the accident to occur. The road slopes downward toward the right-hand curve, while the curve also has sight obstructions on the inside. This can be challenging for motorcyclists, as it requires both speed reduction and a change of direction when entering and navigating the curve.

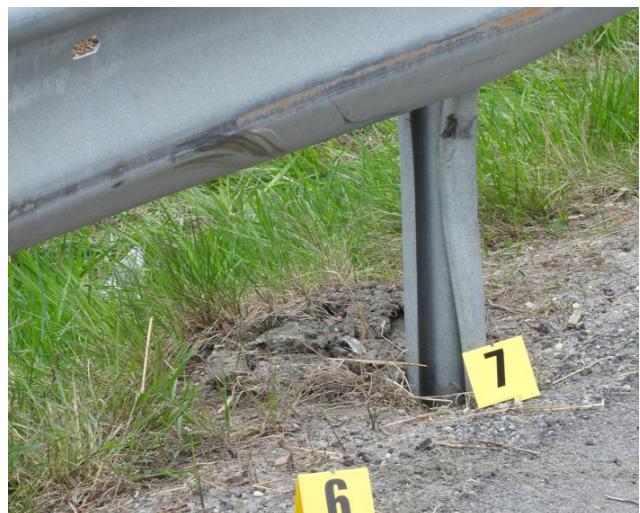
Figure 4: The motorcyclist on county road FV 115 in Aurskog-Høland struck a safety barrier post and died from the injuries. Photo: NSIA

The motorcyclist was wearing motorcycle-specific clothing and mandatory helmet. He was wearing a motorcycle jacket with a built-in soft back protector of the highest classification, motorcycle trousers and motorcycle gloves. The driver struck a safety barrier post with the right side of his back, which was partially covered by the back protector. The forces were so great that the NSIA considers the chances of survival to be low. A motorcycle protection system for road-side safety barriers, especially in combination with an airbag vest, could have significantly reduced the rider's injuries to a survivable level.

The Norwegian Safety Investigation Authority recommends that Akershus County Authority review high-risk curves with safety barriers on county roads with regard to motorcycle safety, and assess measures that could improve safety. This will provide a basis for prioritising safety measures.

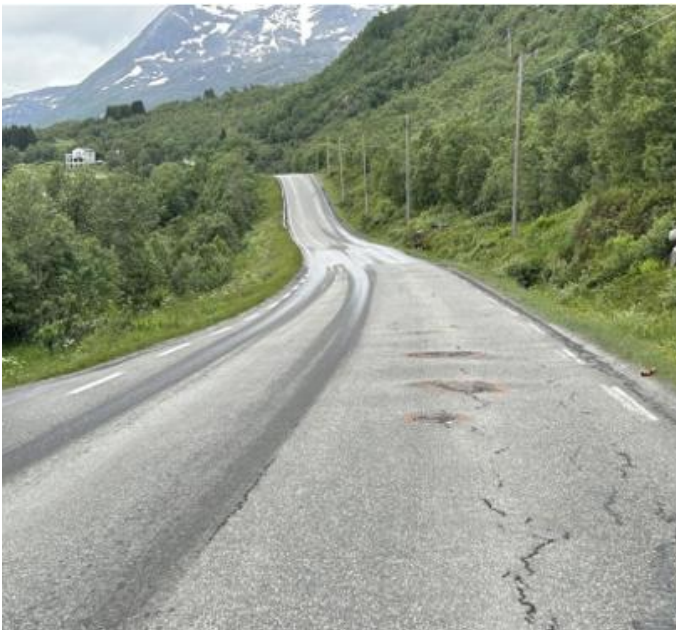
Figure 5: The accident site on the E10 in Tjeldsund with bumps in the road surface and rocks in the roadside terrain. Photo: The police

The road surface had bumps and unevenness due to frost heave located in the centre of the motorcycle's lane. The crest immediately before the accident site limited the rider's view of the road surface, so the bumps may have come unexpectedly. Alternatively, the rider may have attempted an evasive manoeuvre to the right in order to avoid the bumps, and in the process left the carriageway.

Based on the combined factual findings, the NSIA assesses that the condition of the road – with bumps and unevenness – combined with the motorcycle's mechanical condition, caused the accident to occur. The NSIA believes that a more experienced rider on a motorcycle in good mechanical condition would have been better equipped to deal with unexpected irregularities in the road surface

Prior to the accident, the operating contractor for that section of road and the Norwegian Public Roads Administration had assessed that the bumps did not present a hazard to traffic. Following the accident, the Norwegian Public Roads Administration installed a hazard warning sign. No safety recommendation is issued to local road authority based on this investigation.

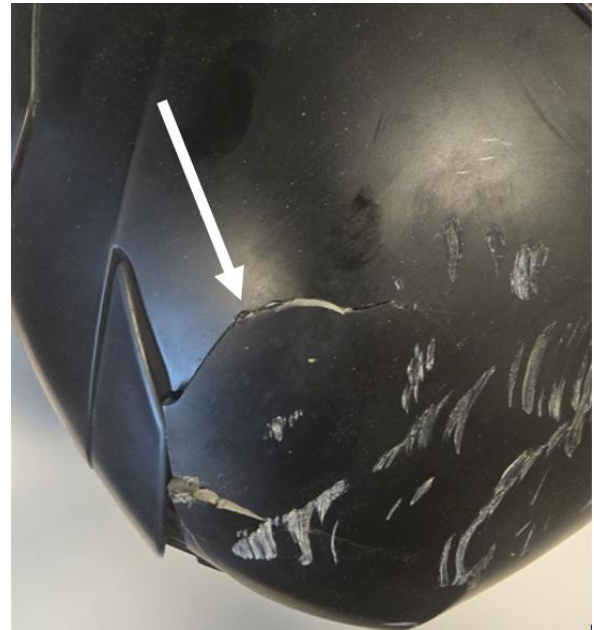
Figure 6: Crack (white arrow) in the rider's helmet from the E10 accident in Tjeldsund. Photo and labelling: NSIA

The motorcyclist was wearing motorcycle-specific clothing and mandatory helmet. He wore a motorcycle jacket with a back protector and motorcycle gloves. However, the protective equipment had limited potential to reduce injury severity due to the non-forgiving roadside terrain, with protruding stones and rocks. The helmet was unable to absorb and distribute the energy from the impact to the back of the head (see figure 6), making the accident fatal.

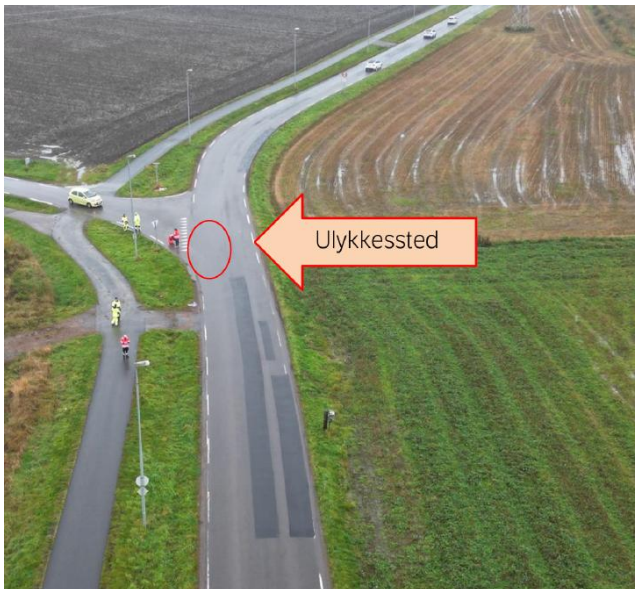
The accident occurred when the motorcycle attempted to overtake the car just before a junction, while the car turned left into the junction (see figure 7). The right-hand side of the motorcycle struck the car's left-hand front wing (see figure 8). The rider was thrown off the motorcycle, over the bonnet of the car, and landed in the roadside ditch. The driver sustained extensive injuries to the back of the head and died as a result of the accident.

Figure 7: Overview of the accident site county road FV 3092 in Færder. Photo and labelling: Norwegian Public Roads Administration

Based on the combined factual findings, the NSIA assesses that the motorcyclist's decision to overtake at high speed, coupled with the car driver's failure to detect the motorcycle before turning left into the junction, caused the accident to occur. The motorcycle was in good mechanical condition and there were no mechanical defects or deficiencies on the motorcycle that contributed to the accident.

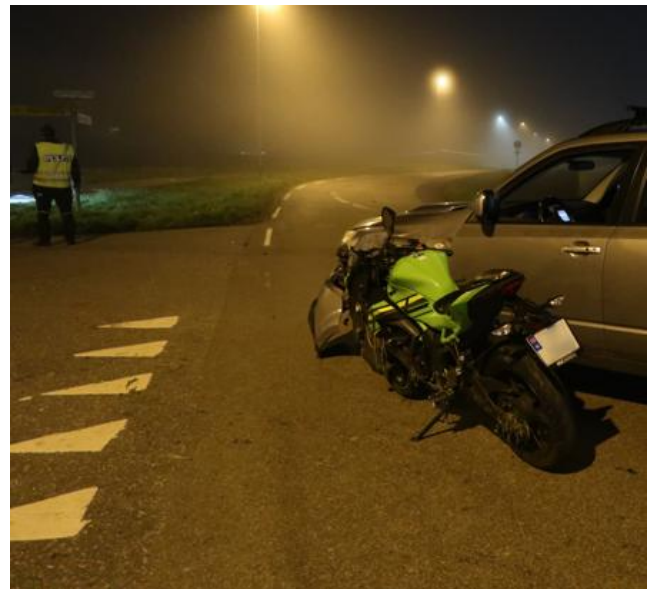
Figure 8: The position of the vehicles in the collision on county road FV 3092 in Færder. Photo: NSIA

The NSIA's calculations and simulations indicate that the motorcycle's speed was likely around 95 km/h just before the collision with the car. The NSIA has assessed that the car was traveling at approximately 30–40 km/h at the time of the collision.

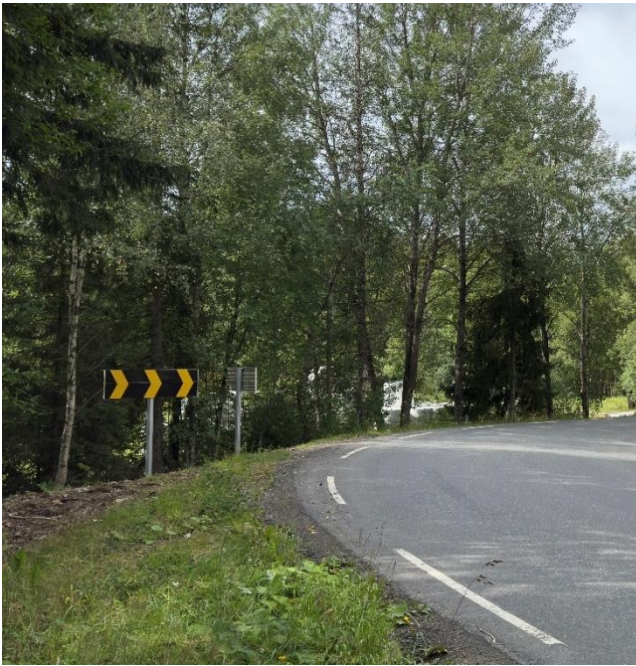
Figure 9: New chevron signs in the right-hand curve along county road FV 115 in Indre Østfold. Photo: NSIA

After the accident on county road FV 115 in Indre Østfold, Østfold County Authority renewed the existing hazard markers and warning signs on the section of road. In addition, two new chevron signs were installed, including one on the accident curve (see figure 9).

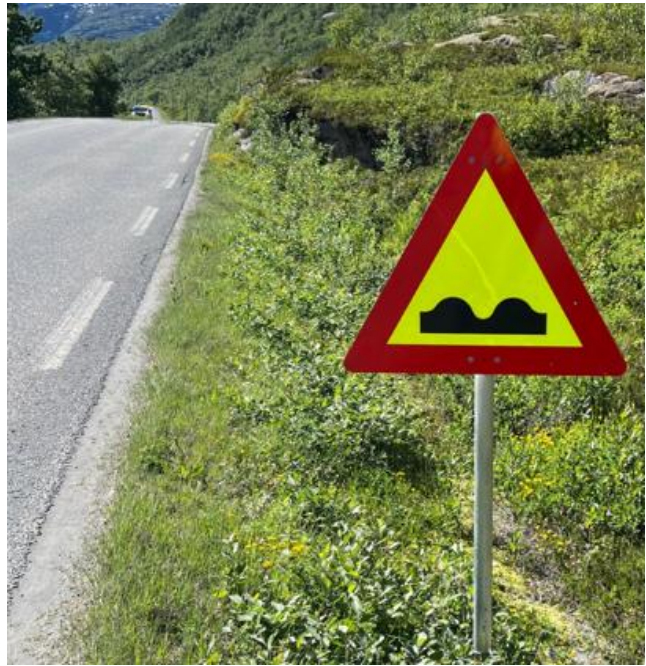
Figure 10: Temporary sign 108 uneven road on E10 in Tjeldsund. Photo: Norwegian Public Roads Administration 22 June 2024

Following the accident on the E10 in Tjeldsund, the Norwegian Public Roads Administration erected a temporary hazard warning sign about 150 metres before the accident site (see figure 10) warning of an uneven road (sign 108). On 31 March 2025, the Norwegian Public Roads Administration decided to erect a permanent sign 108 at the same location.
