Issued June 2026

REPORT ROAD 2026/02

Thematic investigation of frontal collisions involving buses: active and passive safety

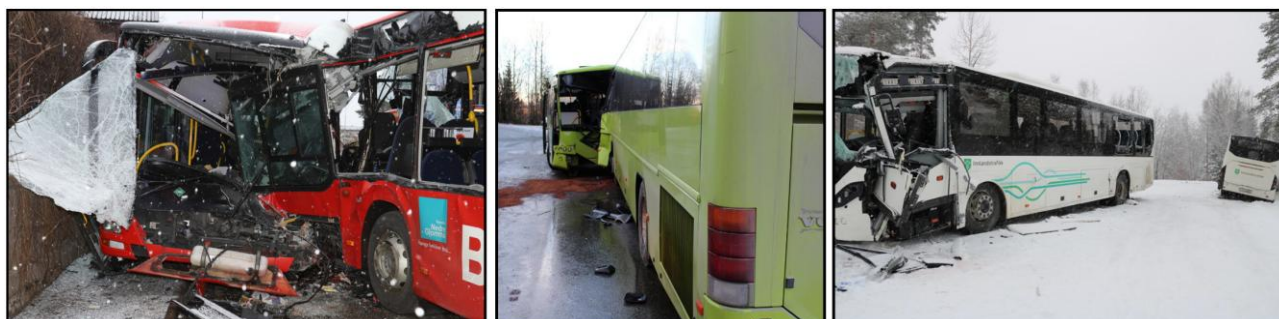
The three bus-to-bus accidents in the breaking zone were fatal accidents previously investigated by the NSIA, see Figure 6. The average damage profile for the buses is shown in Figure 5.

Figure 6: Frontal collisions between buses investigated by the NSIA. The accidents from left to right after descending energy: [Fredrikstad 2022](#), [Nafstad 2017](#) and [Tangen 2021](#). Photo: The police, Norwegian Public Roads Administration (from the reports).

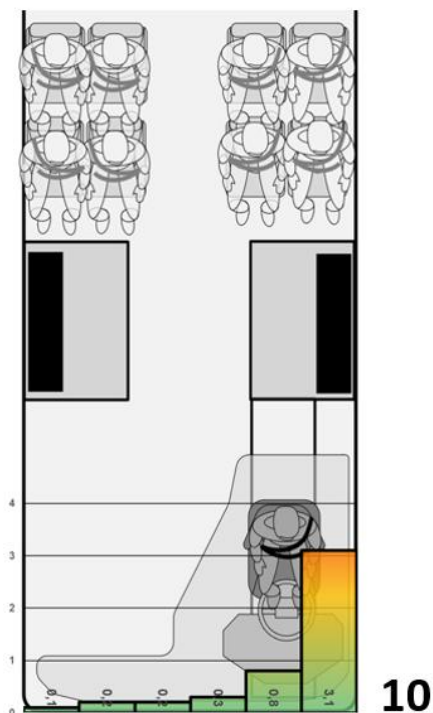
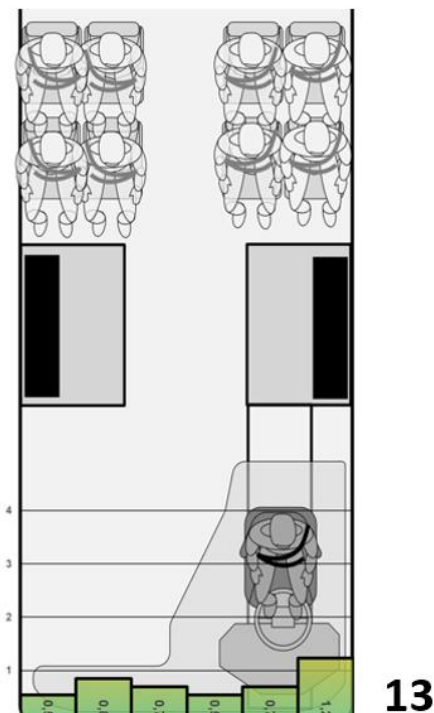
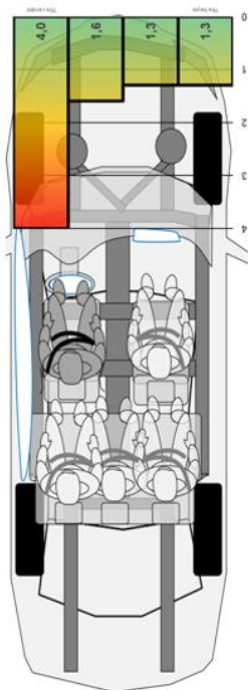
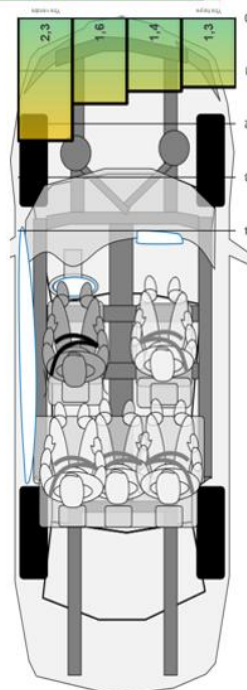
The damage profile of the vehicles is markedly different in the fatal accidents compared to the accidents involving serious injury. In the fatal accidents, the buses and the lighter vehicles show prominent damage to the front left corner. In the accidents involving serious injury, the depth of damage to the buses is shallower and also more evenly distributed across the entire front of the vehicle. The same is true for the lighter vehicles in the accidents involving serious injury, although it is the depth of damage to the front left corner that is most reduced.

Figure 8: Mapped vehicle damage and average damage profile in 23 frontal collisions between buses and lighter vehicles in the breaking zone (10 fatal accidents and 13 accidents involving serious injury).
Source: NSIA

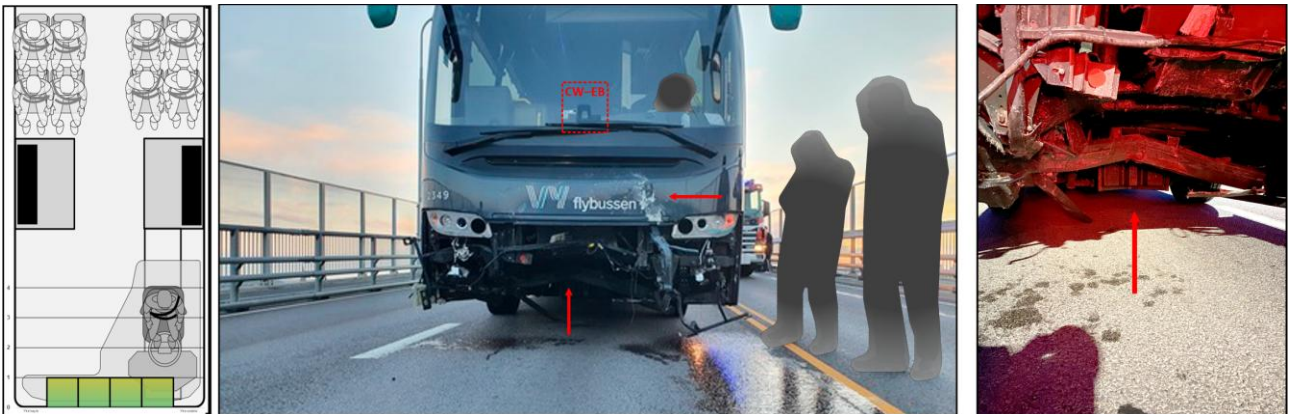
The coach (Class III) was fitted with a front underrun protection device. The damage to the coach was concentrated around the centre of the front of the vehicle, and the underrun protection device was pushed backwards, see Figure 11. There were vertical scrape marks on the right of the vehicle's front left headlight, as well as paint damage in a curved formation across the front. These scrape marks were made by the passenger car's bonnet and right-hand-side A-pillar, as shown in Figure 12. The damage to the passenger car indicates that the front of the coach overrode the car's bonnet to some extent during the impact, while the crumple zone on the passenger car's bumper was fully utilised.

Figure 11: Vehicle damage illustrated on the left. Camera and radar marked on the windscreen. Arrows indicate the point of contact with the car and the deformed underrun protection device. Photo: The police and the Norwegian Public Roads Administration. Markings and illustration: NSIA

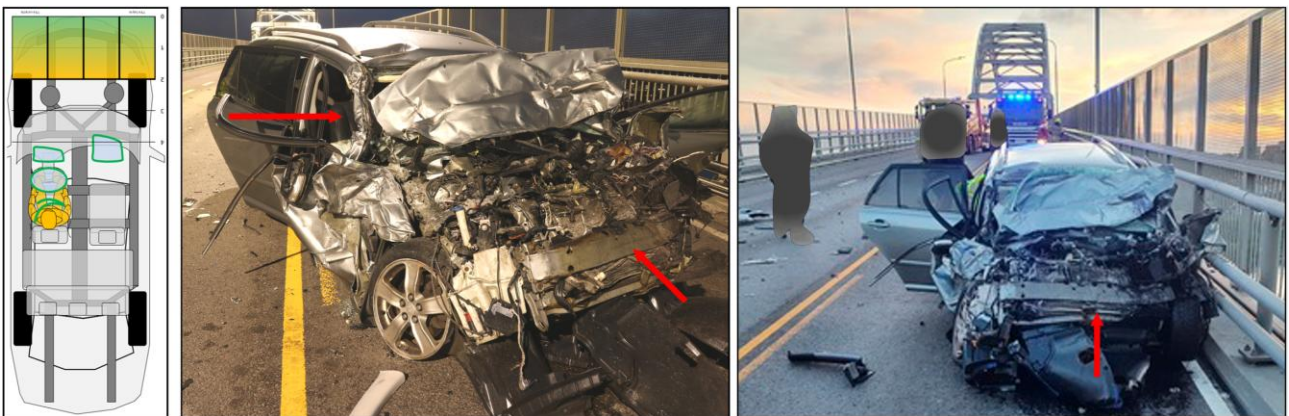
Figure 12: Vehicle damage and activated safety equipment illustrated on the left. Arrows indicate point of contact with bus. Photo: The police and the Norwegian Public Roads Administration. Markings and illustration: NSIA

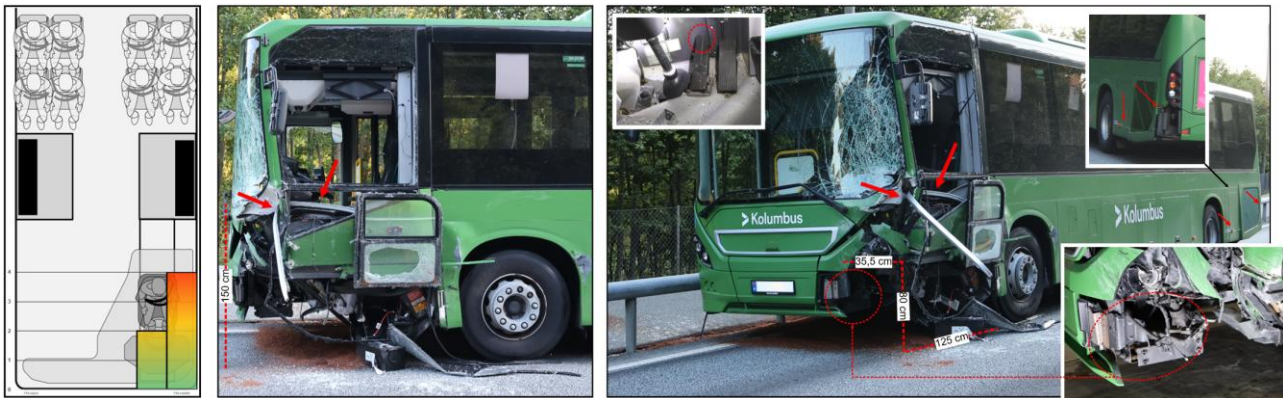
The bus, a regional bus (Class II), sustained damage to its front left corner. The left side of the bus's front crossmember was torn off. The damage to the front of the bus was located approximately 35 cm from the bus's front left corner, towards the centre, at a height of 80 cm, see Figure 14. The car's left-hand-side roof rail penetrated the bus's windscreen at a height of approximately 1.5 metres. During the collision, the bus's brake pedal was jammed upwards by the front panel, making it impossible to use. The bus's steering column was fractured but remained functional. The bus driver slowed the bus by steering into the safety barrier.

Figure 14: Vehicle damage illustrated on the left. Images of the jammed brake pedal, the area around the bus's front left crossmember, and scrape marks extending rearwards along the left-hand-side of the bus. Photo: Norwegian Public Roads Administration. Markings and illustration: NSIA

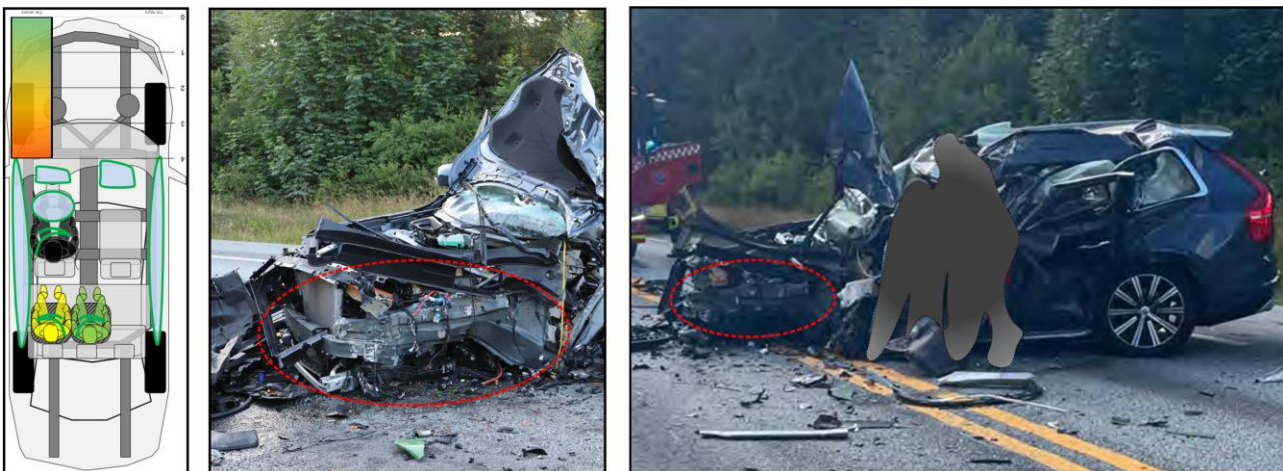
'The passenger car's chassis rails and bumper were relatively intact after the collision. The car's front left wheel was torn off, and the A-pillar was severely deformed, see Figure 15.

Figure 15: Vehicle damage and deployed safety equipment illustrated on the left. The passenger car's front left wheel was torn off, but there was little damage to the left chassis rail. Photo: Norwegian Public Roads Administration and the police. Markings and illustration: NSIA

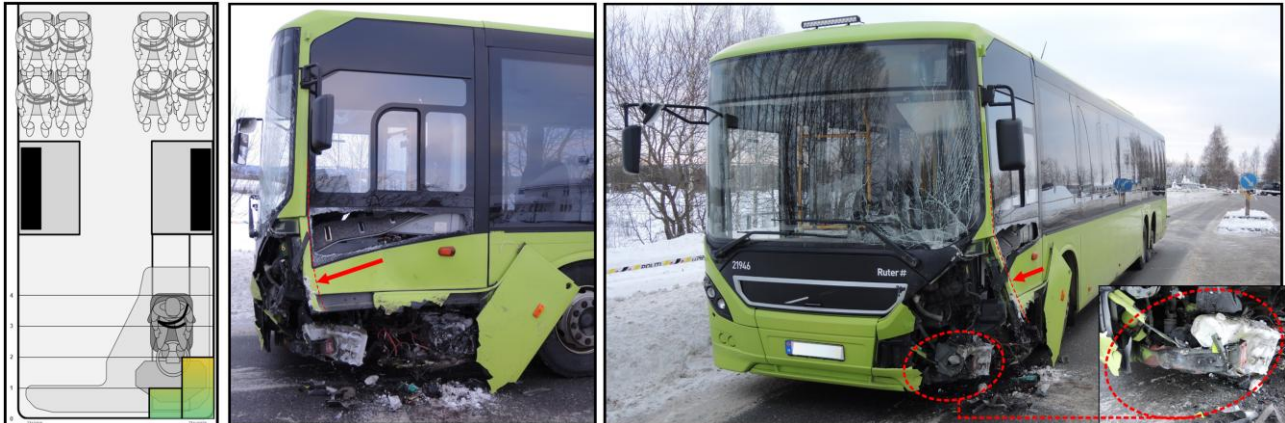
The bus, a regional bus (Class II), sustained damage to its front left corner. The left section of the bus's front crossmember was bent backwards in the collision, and the lower portion of the bus's left-hand-side sidewall was twisted outwards, see Figure 20.

Figure 20: Vehicle damage illustrated on the left. The bent front crossmember and outward twisting of the left sidewall are marked. Photo, markings and illustration: NSIA

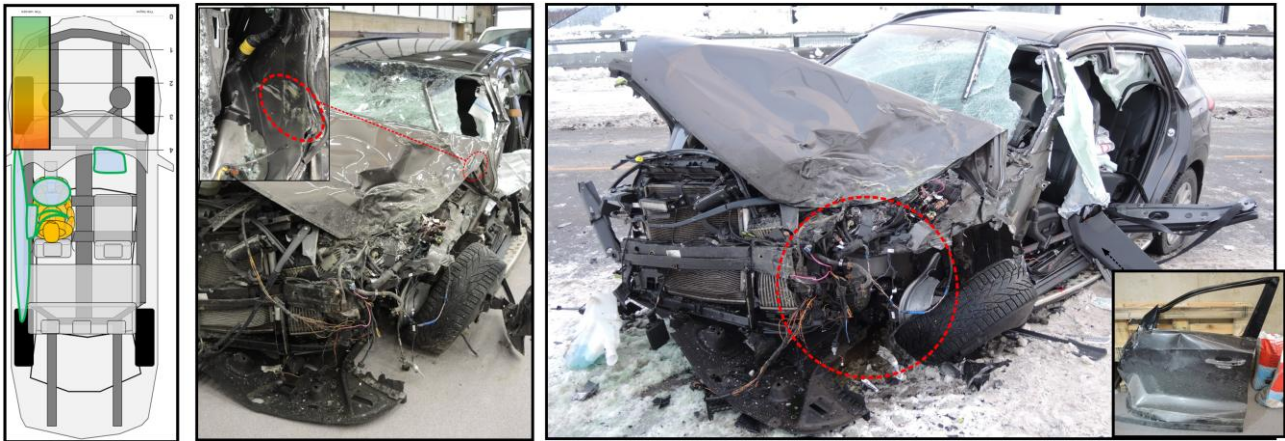
The passenger car's chassis rails and bumper remained relatively intact following the collision, with the front left wheel forced backwards. Traces of green paint matching the bus's paint colour were found on the inside of the passenger car's A-pillar. The driver's door, which was removed during the extrication, was only slightly deformed, see Figure 21.

Figure 21: Vehicle damage and activated safety equipment illustrated on the left. Traces of green paint on the inside of the A-pillar, and minor damage to the left chassis rail. Photo, markings and illustration: NSIA

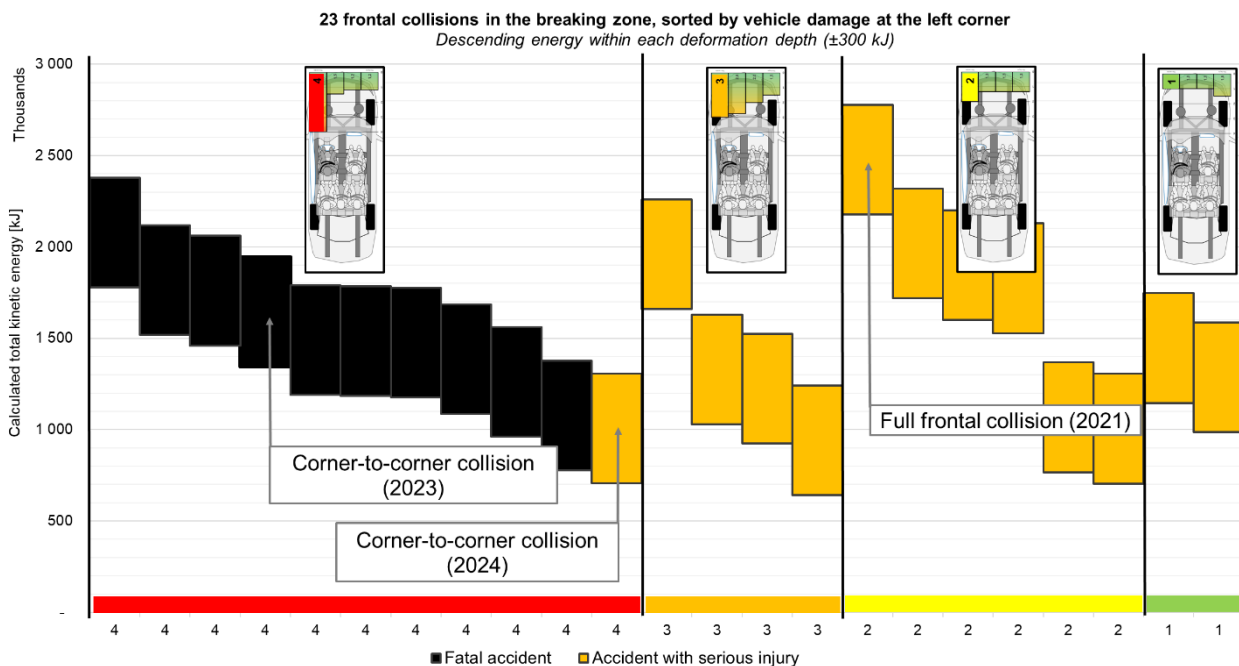
Figure 31: 23 frontal collisions in the breaking zone categorised by vehicle damage to the front left corner. The illustration demonstrates that in fatal accidents, the lighter vehicle has more pronounced damage to the front left corner than in accidents involving serious injuries. Illustration: NSIA
