BULLETIN

AIRCRAFT ACCIDENT INVESTIGATION BOARD/NORWAY (TRANSLATED FROM NORWEGIAN)

Telefon: (+47) 67 12 23 19 - 67 59 36 55 BUL 12/97

- type & reg.: B-737, D-ABFM / DC-9-51, OH-LYV
Radio call sign: DLH 3101 / FIN 423
Date and time: 7 September 1996 at 1314 hours
Location: Fornebu sector in Oslo TMA
Type of occurrence: Air traffic incident, separation between flights below minimum
Type of flight: Commercial, line flights for both aircraft
Weather cond.: Oslo/Fornebu METAR at 1320: Wind 140°/03 kts - CAVOK - Temp. +16 °C, dew point +03 °C - QNH 1024 hPa - NOSIG
Flight cond.: VMC
Flight plan: IFR, both flights
Information sources: Reports from ATS, from both Pilots in Command and AAIB/N's own investigation

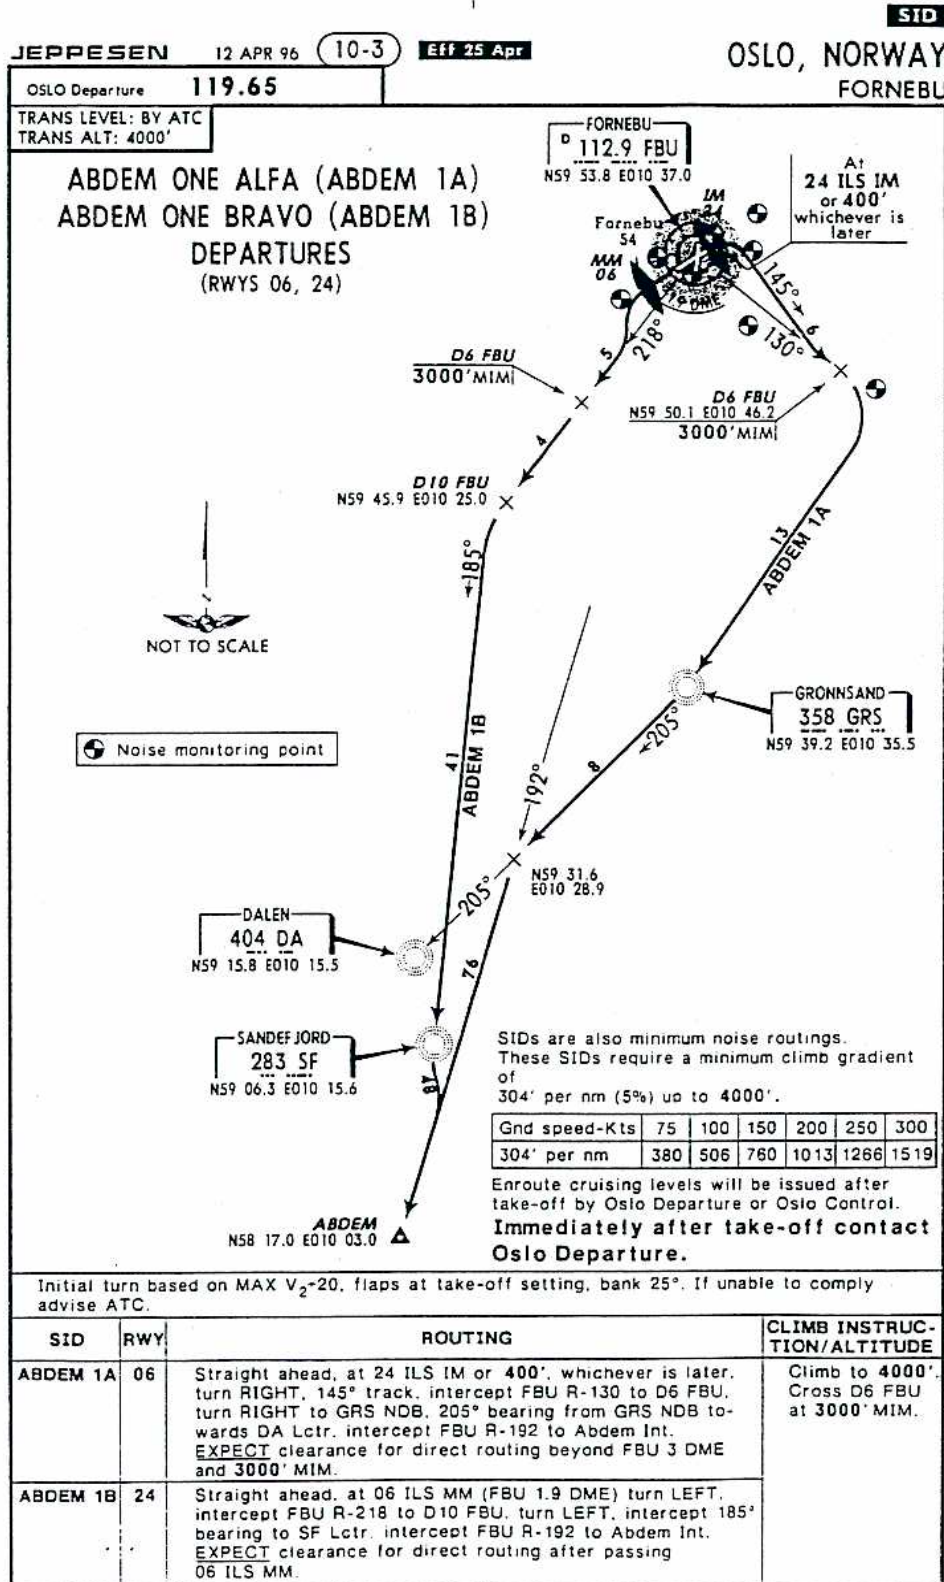
APPENDIX

This occurrence took place when the prescribed separation minimum between the two flights was violated. The flights were a Finnair aircraft, en route from Helsinki and Stockholm, descending towards the Grønnsand (GRS) radio beacon for an approach to Oslo Airport Fornebu and a departing Lufthansa aircraft climbing out from RWY 06. The traffic in the TMA was controlled by Oslo Approach (APP), with both the APP and Departure (DEP) sectors combined, operating on the DEP frequency, 119.65 MHz. Parachute jumping was in progress over Ski Airfield, a GA airfield south-east of Oslo Airport Fornebu. This initially restricted the FIN 423's descent to FL 100 until the parachute aircraft reported leaving flight levels below, after releasing the jumpers. See Appendix, SID RWY 06/24 Oslo, Norway, Fornebu, (Jeppesen).

The speed limit below FL 100 is 250 kts IAS. DLH 3101 did not adhere to this. The speed (ground speed) recorded on radar, increased into the range of 290 - 300 kts when 4 000 ft was maintained and during the climb from 4 000 ft to FL 90. The speed limit is according to the Norwegian Civil Aviation Requirements (BSL) F 1-3 para. 3.8.1 and is also published in AIP Norway, RAC 1-5 and 1-18. This information is not found in the AIP RAC 4-FB-1 (SID = Standard Instrument Separature) and not in the Jeppesen Route Manual pages for Oslo/- Fornebu (SID, departures RWYS 06, 24).

AIP-Norway, RAC 4-FB-1, does not contain information about speed limit 250 kts IAS below FL 100. As a consequence, neither does the corresponding page in the Jeppesen Route Manual. CAA-N is recommended to bring the Oslo/Fornebu pages in line with the information for other Norwegian airports with SID/STARs and speed limitation implemented.
