REPORT

SL 2009/02

REPORT ON THE SERIOUS INCIDENT OVER
GLACIER FOLGEFONNA, NORWAY ON
14. SEPTEMBER 2005 WITH ATR 42-320, LN-FAO,
OPERATED BY COAST AIR AS

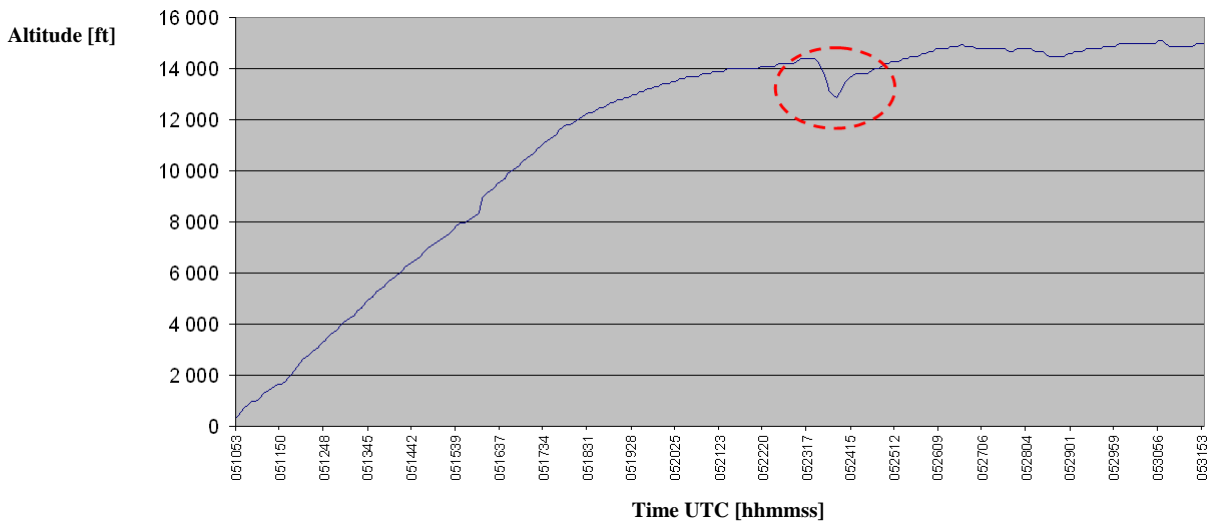
1.1.17 Radar data shows that, on the first occasion, the aircraft lost 1500 ft of altitude before beginning to climb again 28 seconds later (Figure 2: The flight profile for CST602 from take-off until the aircraft was established at cruising altitude (based on Mode C every 5 seconds). The period during which the incident lasted has been circled. See also figure 3.). The second loss of control is not shown quite so clearly.

Figure 2: The flight profile for CST602 from take-off until the aircraft was established at cruising altitude (based on Mode C every 5 seconds). The period during which the incident lasted has been circled. See also figure 3.

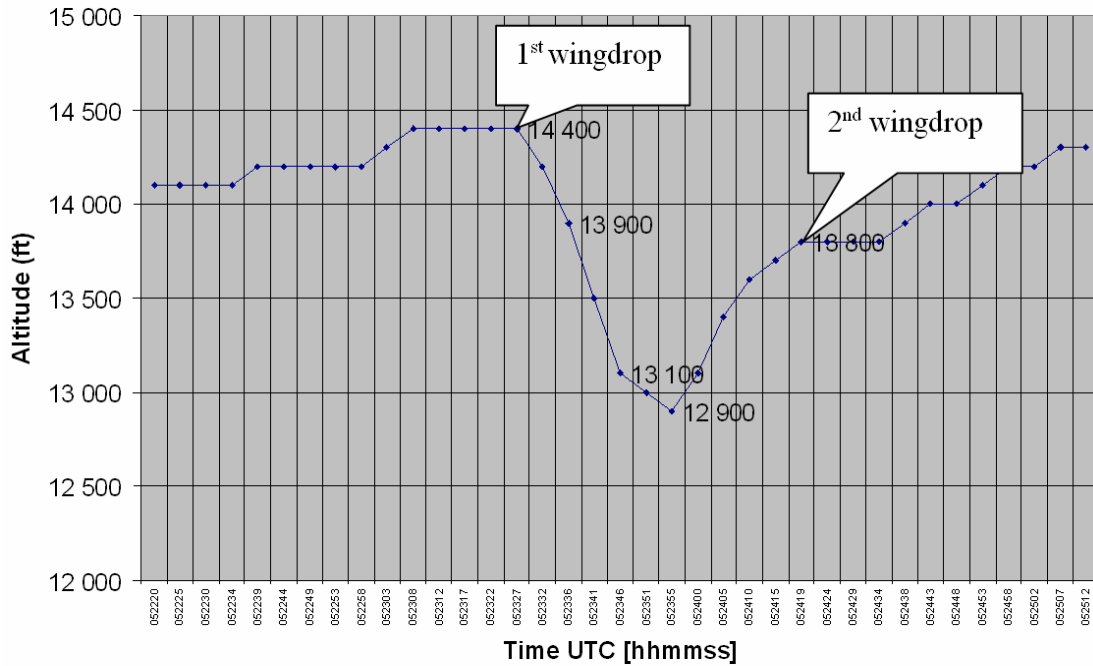
1.1.18 An extract of the period when the incident occurred is shown in the figure below. Combined with the crew’s explanation it is possible to establish that the aircraft lost approx. 1500 ft in height the first time the wing dropped. It is equivalent to an average descent speed of approx. 3200 ft/min for the 28 seconds that passed before the aircraft again commenced climbing. At its steepest, the descent was around 5000 ft/min.

Figure 3: The flight profile for CST602 during the period 07:22:20 to 07:25:12 (based on Mode C every 5 seconds).

1.1.19 Once the descent stopped, the radar plot shows that the aircraft went into a relatively steep climb. According to the radar readings, it climbed 700 ft in the first 15 seconds, which corresponds to 2800 ft/min. Then the radar plot shows that the climb decreased somewhat during the following 10 seconds, before the aircraft maintained a constant altitude of approx. 15 seconds. Once it began to climb again, the climb rates were approx. 900 ft/min.

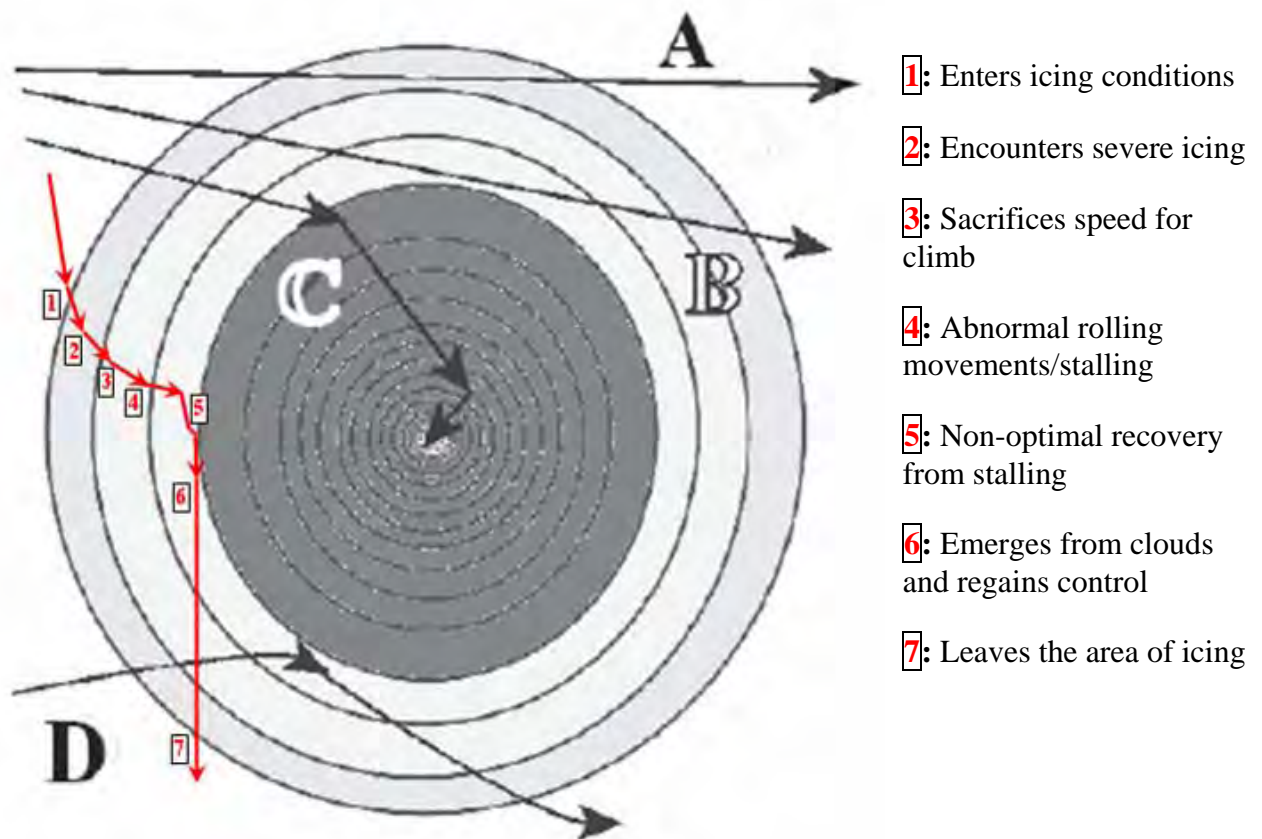
2.1.5 The AIBN believes that this "black hole model" can be used to illustrate what happened to the CST602 when the aircraft flew into an area of severe icing. The path is indicated with red arrows in the following figure:

Figure 10: Plotting the course of the CST602 relative to the “black hole model”
