SL REP.: 25/2005

**REPORT ON THE ACCIDENT
AT BROKSKAR, TROMS COUNTY, NORWAY 17 MAY 1999,
INVOLVING EUROCOPTER (AEROSPATIALE)
SA 365N DAUPHIN 2, LN-OLT
OPERATED BY LUFTRANSPORT AS**

**SUBMITTED
May 2005**

**ACCIDENT INVESTIGATION BOARD, NORWAY (AIBN)
P.O. Box 213
N-2001 LILLESTRØM
NORWAY**

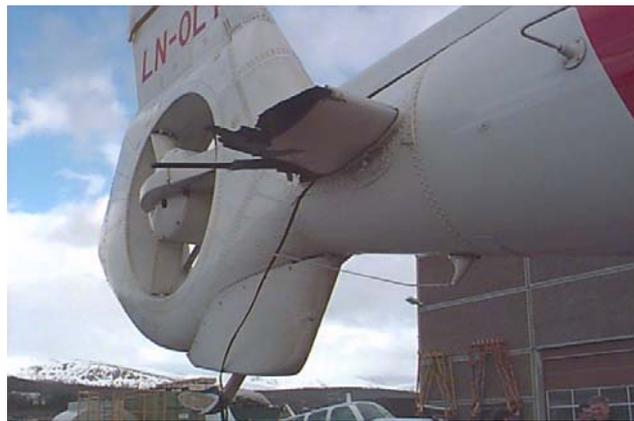
Image 1. Left Stabilizer

- A break on the RH stabiliser approx. 30 cm beyond of the right-hand mounting bolt (Image 2).
- A break on the LH stabiliser approx. 25 cm beyond the left-hand mounting bolt (Image 1).
- The upper part of the skin on the LH stabiliser between the crack and the vertical fin remained attached to the helicopter during landing.

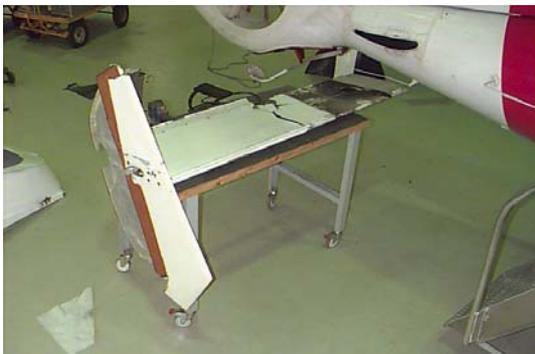
Image 7. Right Stabiliser

- The RH vertical fin separated from the horizontal stabiliser and tore off the skin along the entire length from the middle and backwards on the outer side (Image 7). All the torn-off parts of the stabiliser remained attached to the vertical fin. The left-hand vertical fin was slightly damaged with 10-20 cm of the horizontal stabiliser still attached to the fin (Image 12).

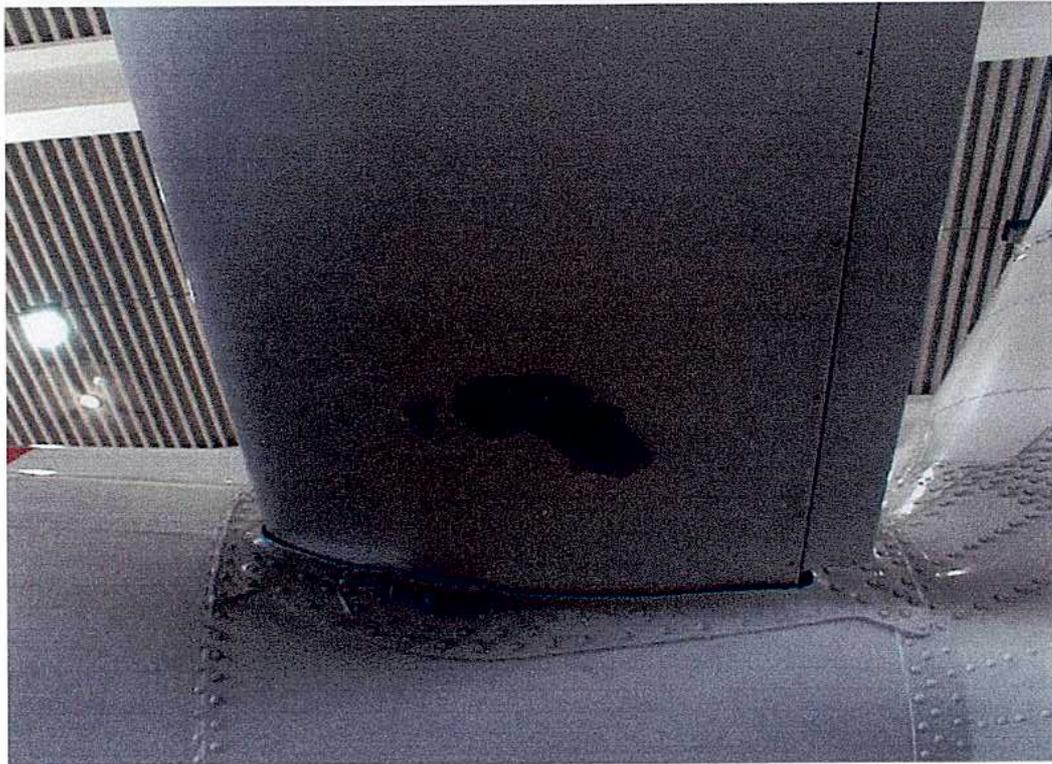
Image 13. Soft area Stabilizer 2

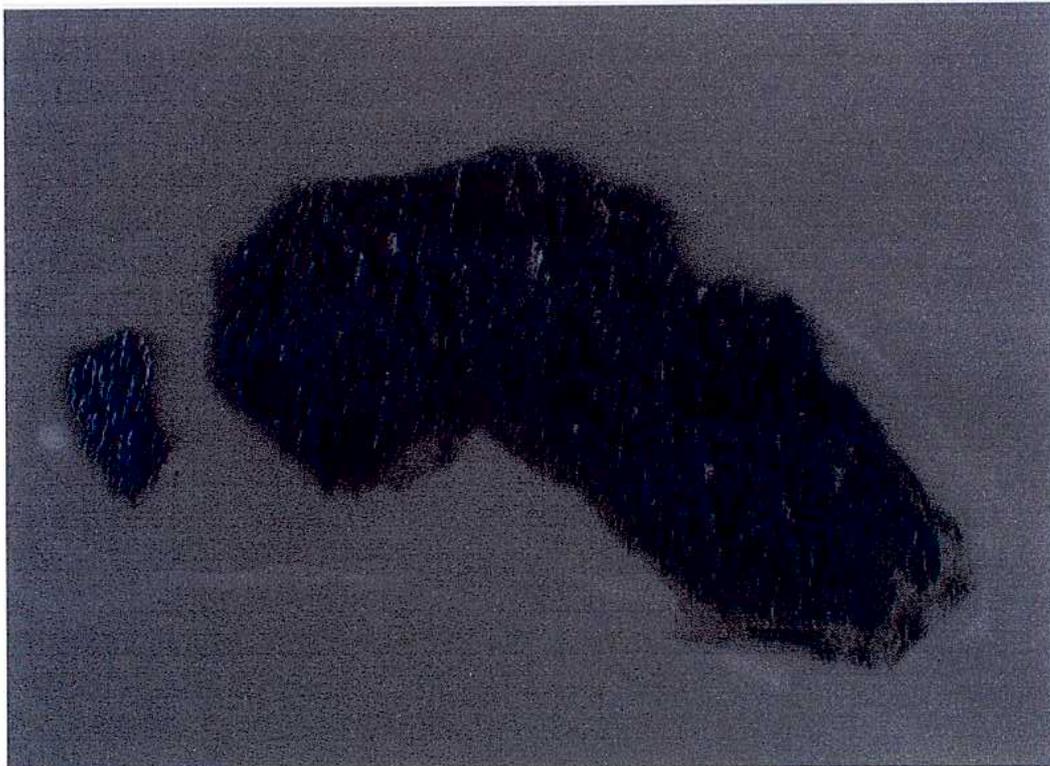
Image 14. Soft area Stabilizer 2
