## REPORT

SL REP: 43/2004

Date: 17 December 2004

-type & reg.:	Avro RJ85, unknown / Boeing 737-505, LN-BRH	
Radio call sign:	DLH 5219 / BRA 349	
Operators:	Lufthansa CityLine / Braathens	
Date and time:	Sunday 6 June 2004 at 1659 hrs.	
Location:	Bergen airport Flesland, Norway (ENBR)	
Type of occurrence:	Air Traffic Incident, Runway Incursion	
Type of flight:	Charter / Scheduled airline operation	
Weather conditions:	Flesland METAR 1650 hrs 26005KT 200V350 9999 SCT018 BKN035 12/08 Q1014	
Light conditions:	Daylight	
Flight conditions:	VMC	
Flight plan:	IFR	
No. of persons onboard :	Unknown	
Injuries:	None	
Aircraft damage:	None	
Other damage:	None	
Commanders	DLH 5219	BRA 349
-sex/age:	Male / 42 years	Male / 45 years
-licence:	ATPL	ATPL-A
-fl. experience:	ca. 8 000 h total, ca. 5 000 h on type	ca. 9 000 h total, ca. 5 000 h on type
Air Traffic Controllers	Flesland GND	Flesland TWR
-sex/age:	Female / 36 years	Male / 39 years
-certificate:	August 1993	March 1990

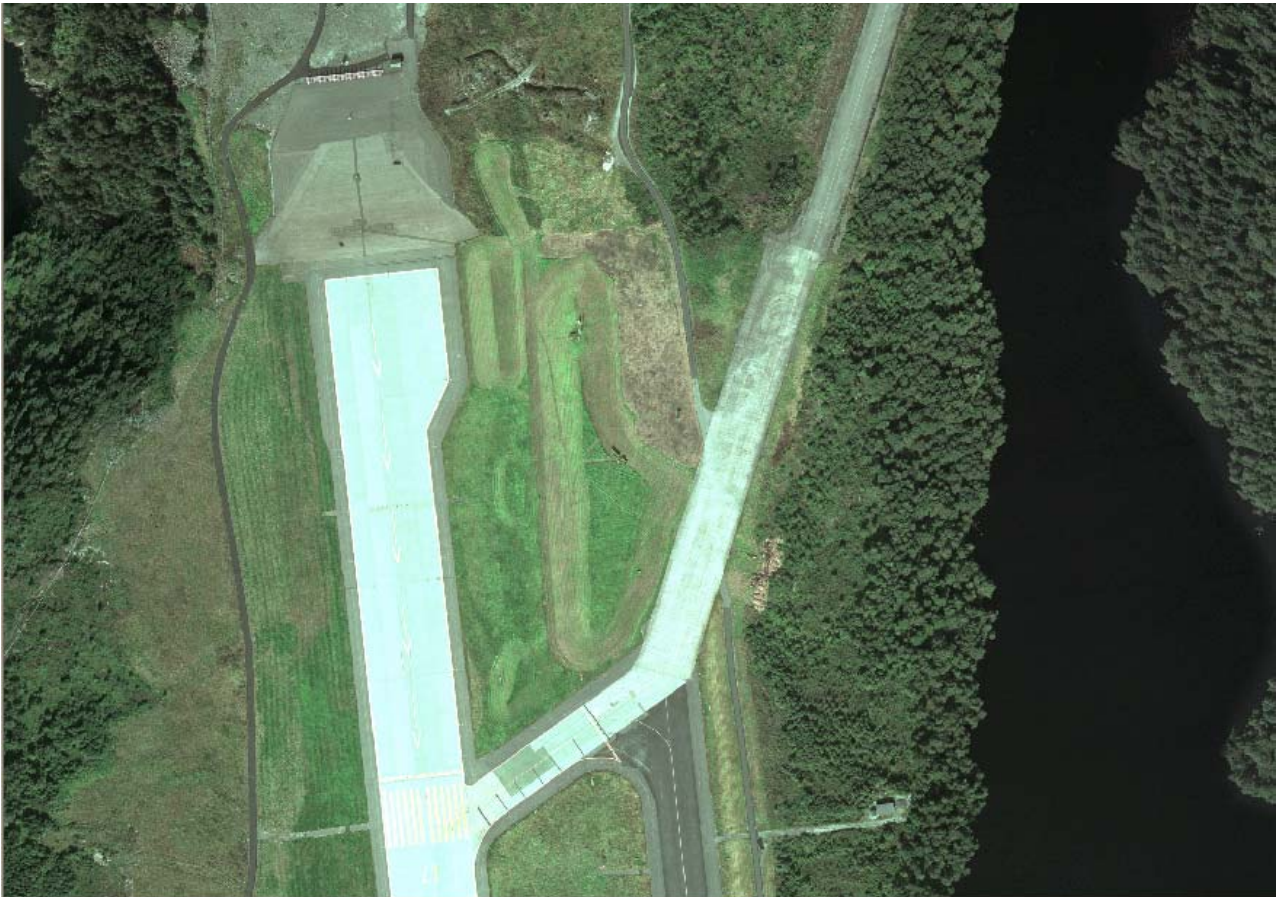
**TWY intersection and holding position RWY 17 on TWY A**

A study of taxiway lay-out and markings at Flesland shows that the holding position of taxiway A has an off-set between painted markings and signs on the edge. The sign on the left side is located some distance toward the runway while on the right side the sign is located before the painted markings. The signs are according to ICAO Annex 14 and have runway guard lights (“wig-wags”) next to them. The runway guard lights were serviceable and operating at the time of the incident. It is local policy for Flesland TWR always to operate runway guard lights when there is ground traffic, regardless of visibility and weather conditions. There are flushed red lights at the holding position, but these are not completely installed and do not operate to form a stop bar. Taxiway A itself intersects the runway at an angle of about 60 degrees after a curve from taxiway Y. This makes the holding position less than optimum with respect to pilot’s view of the final approach to the runway. AIB-N recommends a review of the holding position and signs in this area.

AIB-N recommends that the aerodrome operator of Bergen airport Flesland, Avinor AS, reconsiders holding position location of painted markings and signs on taxiway A and the need for additional signs on taxiway Y. (SL Recommendation No. 51/2004)

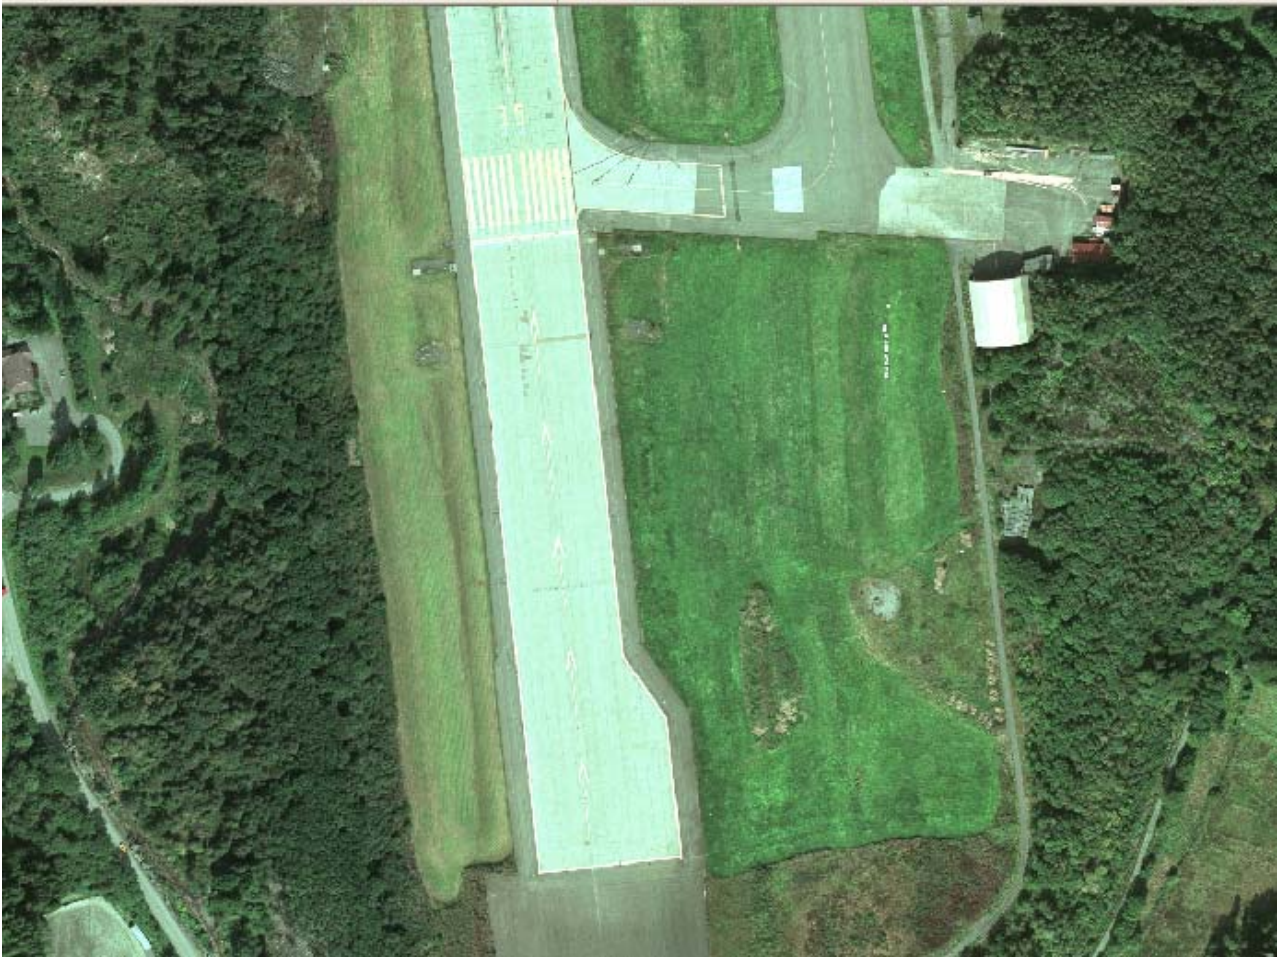
### **Holding position RWY 35 on TWY E**

For comparison the holding position for runway 35 at taxiway E has painted markings and signs almost perfectly in-line. This is an advantage during winter operations where painted markings may be covered by snow and/or ice. Taxiway E intersects perpendicular to the runway which gives a better view of the runway and final approach from the cockpit.

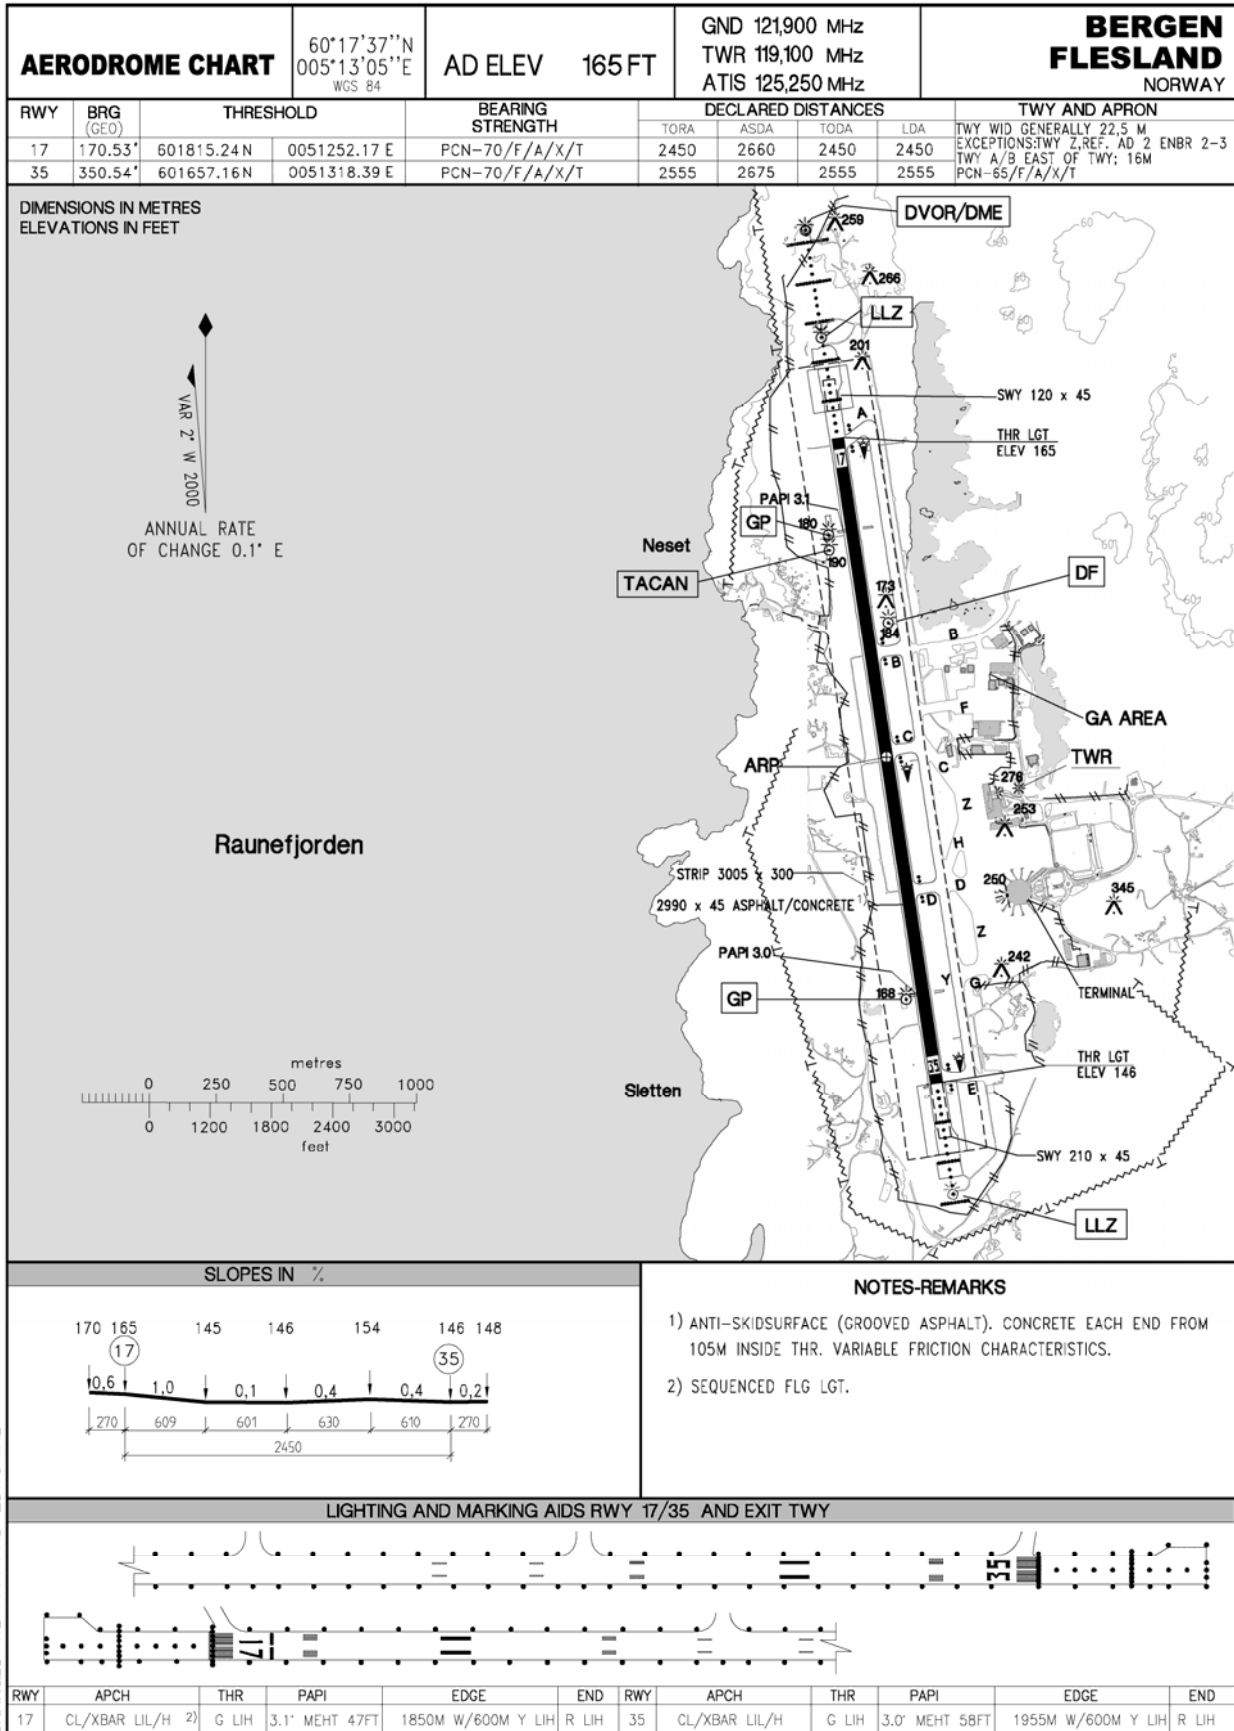
AIP Norway AD 2 ENBR 2-1 Aerodrome Chart

Aerodrome lay-out is shown in the appendix (AIP Norway AD 2 ENBR 2-1 Aerodrome Chart). The runway incursion took place at the holding position for runway 17 on taxiway A. The aerodrome chart does not show the taxiway going to the military apron from the intersection of A on Y.

The aerodrome chart of Flesland does not show the taxiway intersection of A and Y in full detail as the taxiway going to the military apron is masked away. AIB-N recommends a revision of aerodrome charts to correct this lack of information.

AIB-N recommends that the Aeronautical Information Service of Norway, operated by Avinor AS, revises aerodrome and landing charts of aerodromes with military installations so that taxiways and intersections available to civil aircraft are depicted as clearly as possible. (SL Recommendation No. 52/2004)
