REP.: 06/99

**REPORT ON THE ACCIDENT IN GEIRANGERFJORDEN, AT
GEIRANGER ON 11 JULY 1998 WITH FIRDAFLY AS CESSNA U206G,
LN-DBZ**

SUBMITTED OCTOBER 1999

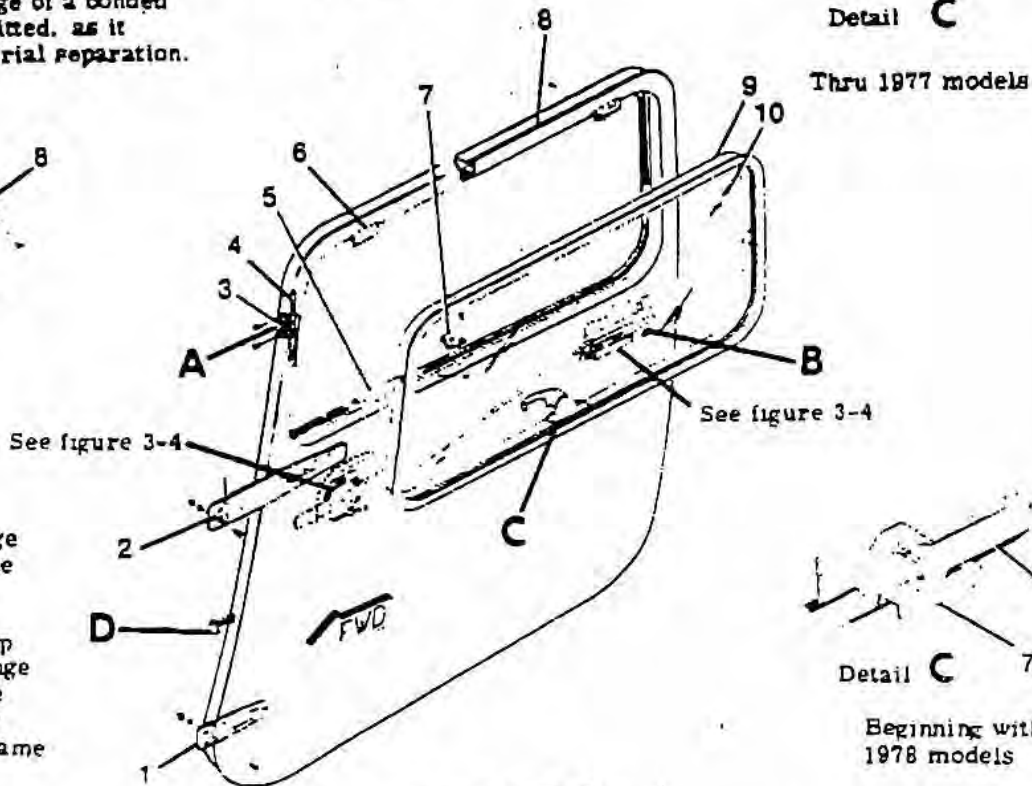
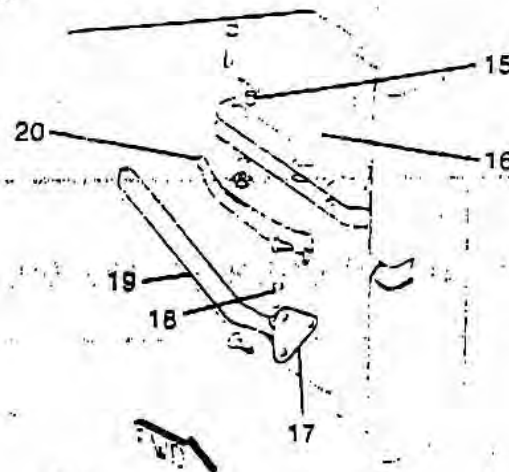
Figure 3-3. Cabin Door Installation

- 1.6.4 The cabin-door window is hinged in the upper part and may be opened 30°, limited by a window stop (ref. fig. 3.3, item 5). With this window stop installed, which is normal, a full opening of the window is impossible, thus preventing an evacuation through this window. This window stop had been removed from LN-DBZ.

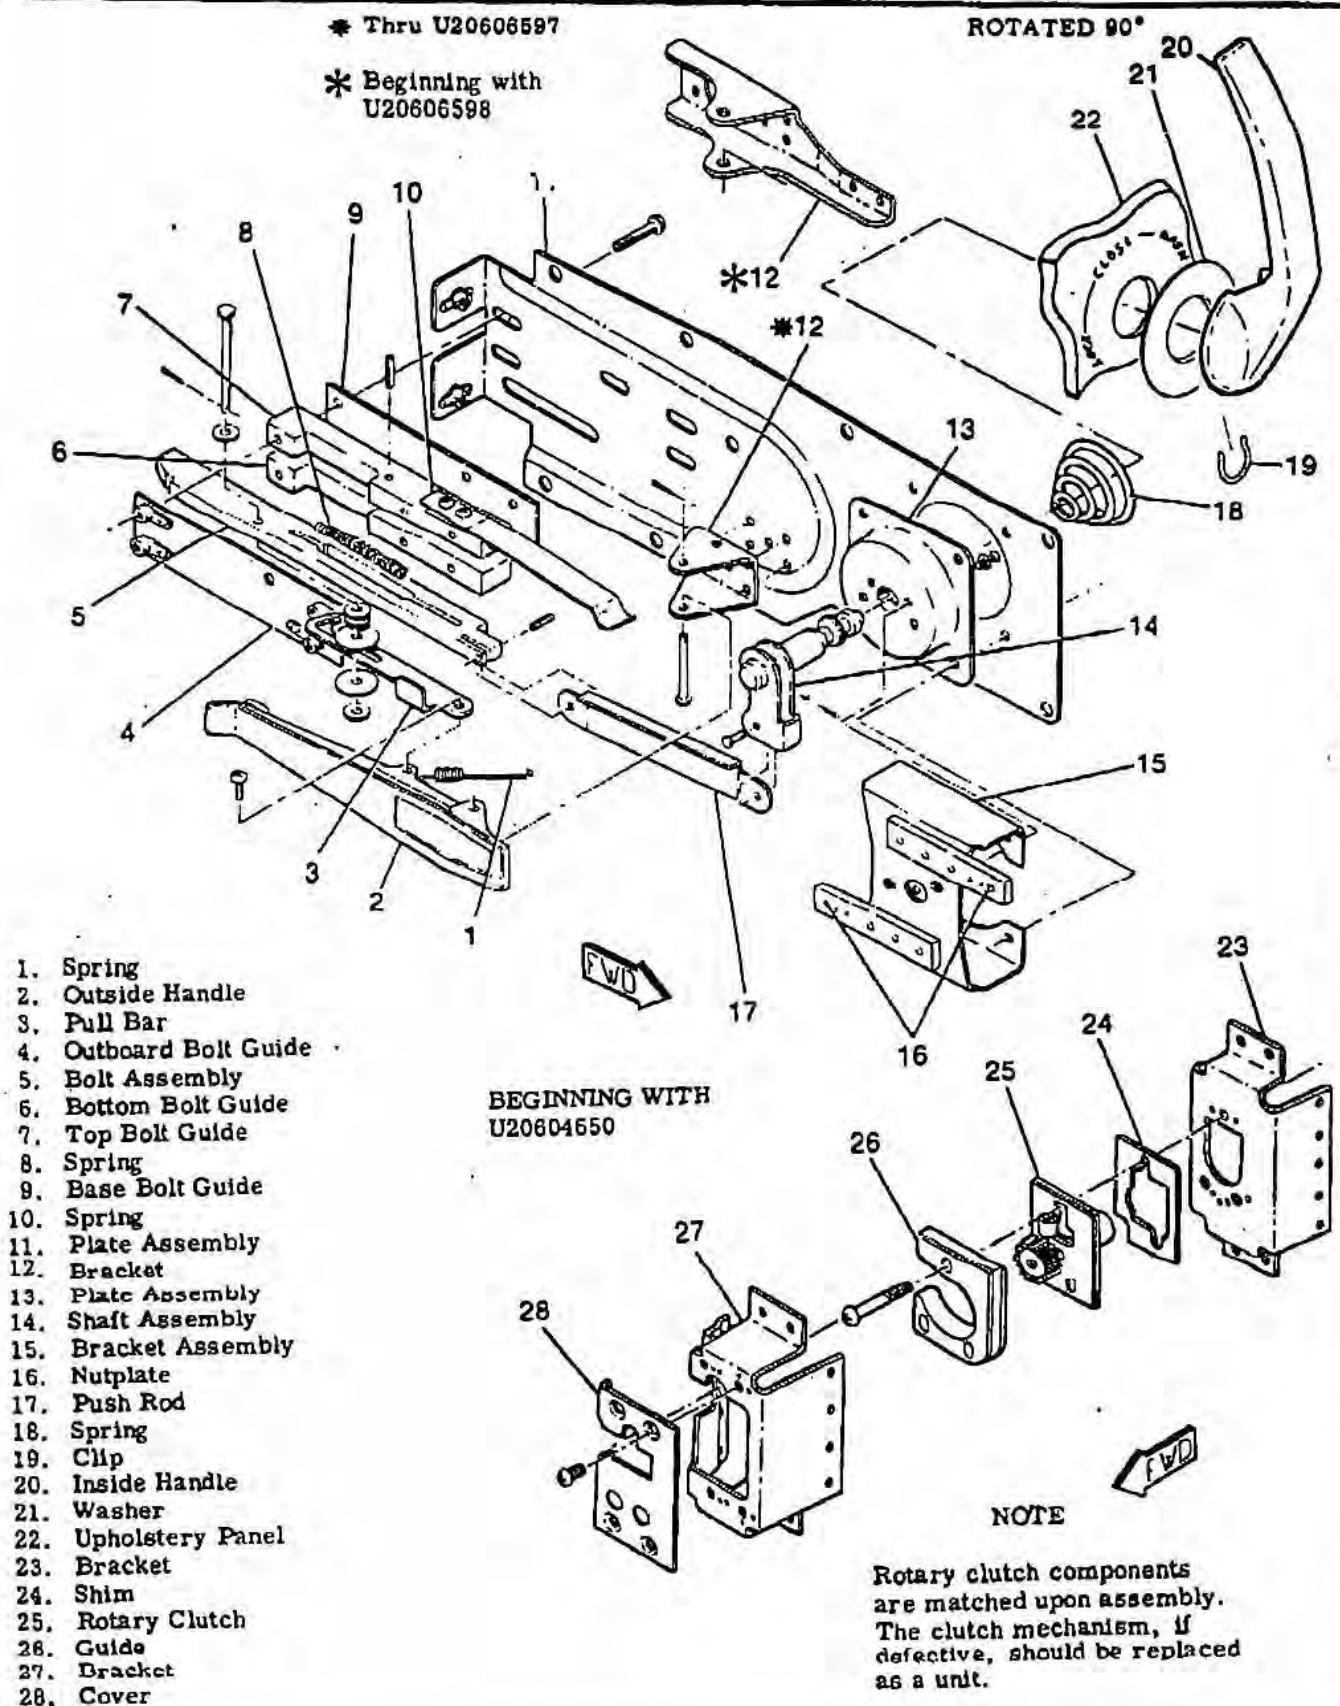
Figure 3-6. Cargo Door Latch Installation (Sheet 2 of 2)

- 1.6.6 To open the cabin-door from the outside, the forward part of the door handle (ref. fig. 3.6, item 2) must be pushed inwards, and the door handle may then be pulled outwards. This procedure is not possible to perform if the door has been closed and secured from the inside. The door may be locked from the outside by using a key.

- 1.6.7 The cargo-doors are opened from the inside, by moving the door handle on the forward door from "locked" to "open" position. The door will then be open. The door handle on the rear door is moved forwards from the edge of the door. The handle must then be pushed downward, making the upper and lower hooks unlock. At this point it is important to note that, if the flap has been extended by more than 10°, the door opening will only be 8-10 cm. Despite this, the narrow opening will provide access to the door handle on the rear door, making it possible to open the

door. The position of the door handle on the rear door is making it very difficult to open the door, especially for people not being familiar with the opening procedure.
