## REPORT

SL RAP: 34/2005

### Aircraft

Type and reg.:	Jastreb Fabr. Aviona Jedrilica ST CIRRUS G/81, LN-GLO
year of manufacturing:	1983
engine:	None
Date and time:	Friday 18 June 2004 at time 1305
Location:	Østre Brumund, Hedmark. (N 60 59 628 E 010 59 453)
Type of occurrence:	Accident, crash during an outlanding of a glider
Type of flight:	Private
Weather conditions:	Wind: 120° 5 kt, gusting 10 kt. Light turbulence. Reduced visibility in rain. Overcast at 5,000 ft. Temp./dew point: 16 °C/3 °C. QNH 999 hPa
Light conditions:	Daylight
Flight conditions:	VMC
Flight plan:	None
Persons on board:	1
Injuries:	None
Damage to aircraft:	Substantial fuselage damage, cracked canopy, impact damage to leading edges of both wings
Other damage:	None
Commander:

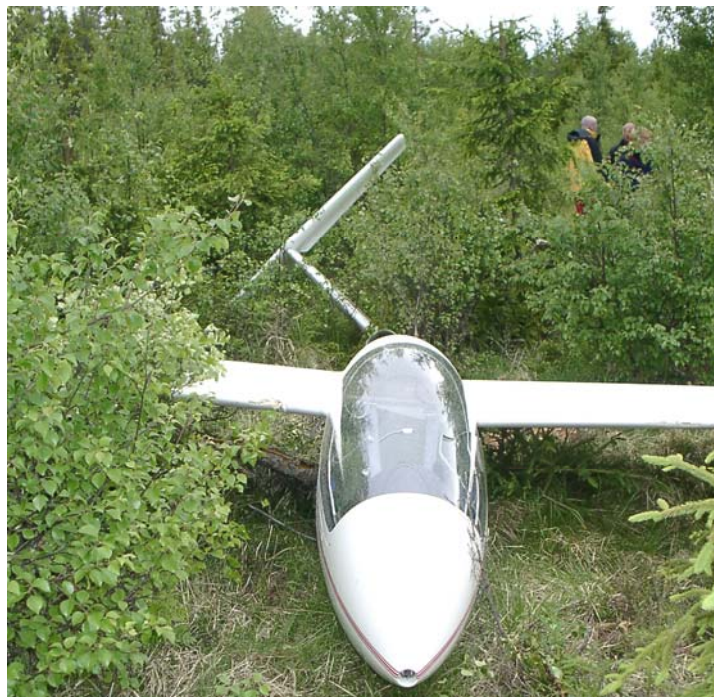
The aircraft suffered comprehensive damage. The tail section broke, there was a hole in the lower fuselage in front of the wheel, the leading edges of the wings were battered and the canopy cracked.
