AIR ACCIDENT INVESTIGATION BOARD, NORWAY (AAIB/N)

REP.: 47/2001

**REPORT ON THE AIR ACCIDENT 8 SEPTEMBER 1997 IN THE
NORWEGIAN SEA APPROX. 100 NM WEST NORTH WEST OF
BRØNNØYSUND, INVOLVING EUROCOPTER AS 332L1 SUPER PUMA,
LN-OPG, OPERATED BY HELIKOPTER SERVICE AS**

ISSUED NOVEMBER 2001

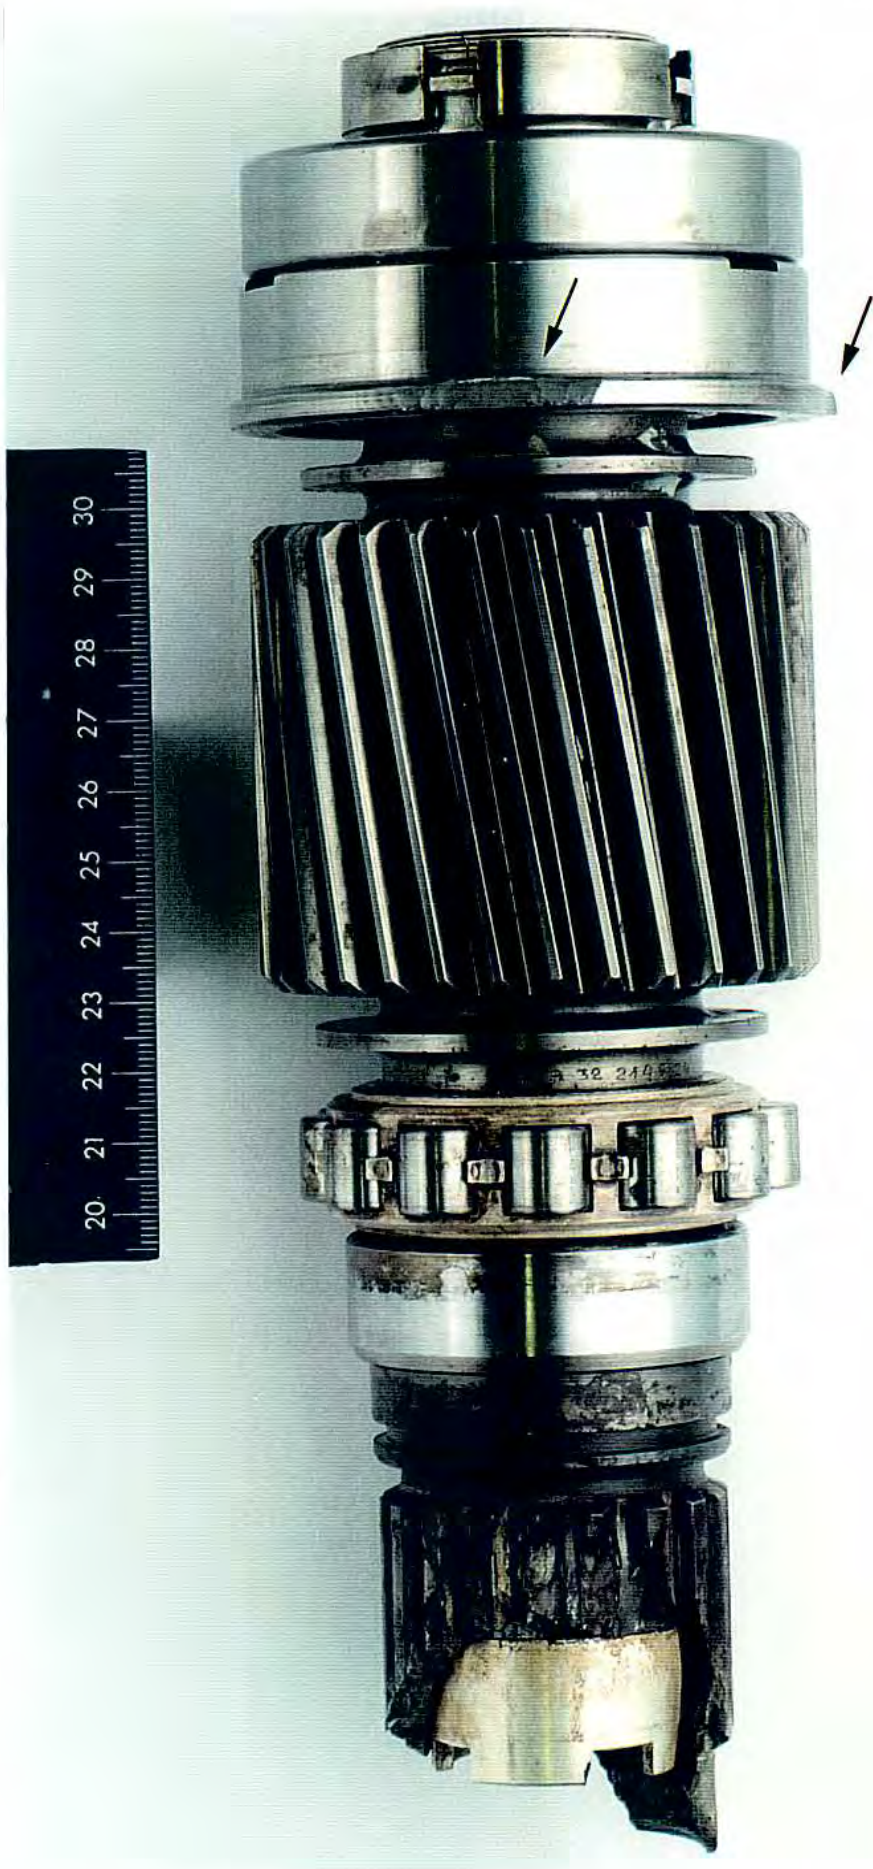
Side view (profile) of the front end retaining nut, the failed splined sleeve and the MGB R/H side input shaft assembly. The positions of the broken attachment lugs on the bearing retainer are arrowed.

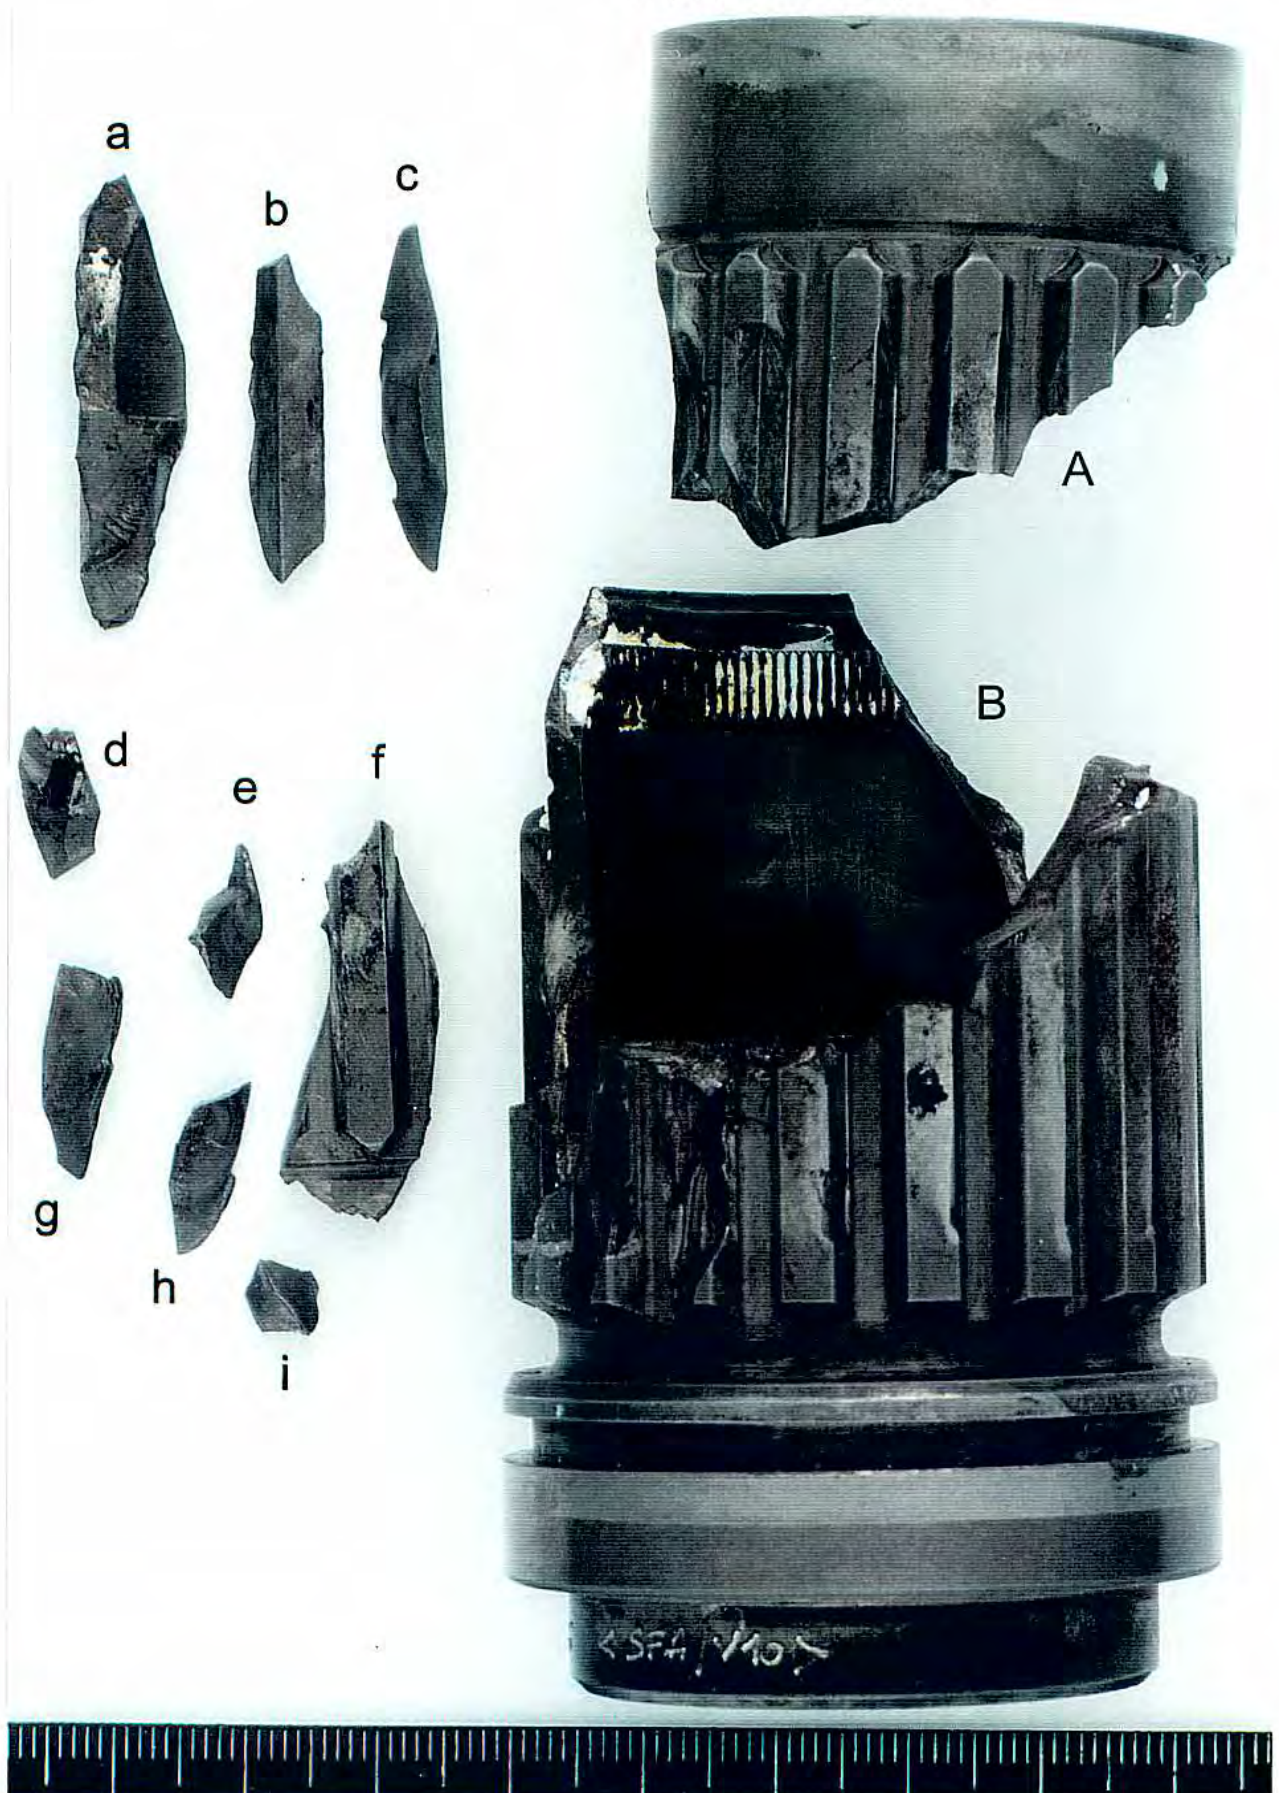
General view of the first received sections of the failed splined sleeve. Two large sections "A" and "B", and nine smaller sections "a" - "i" are shown.

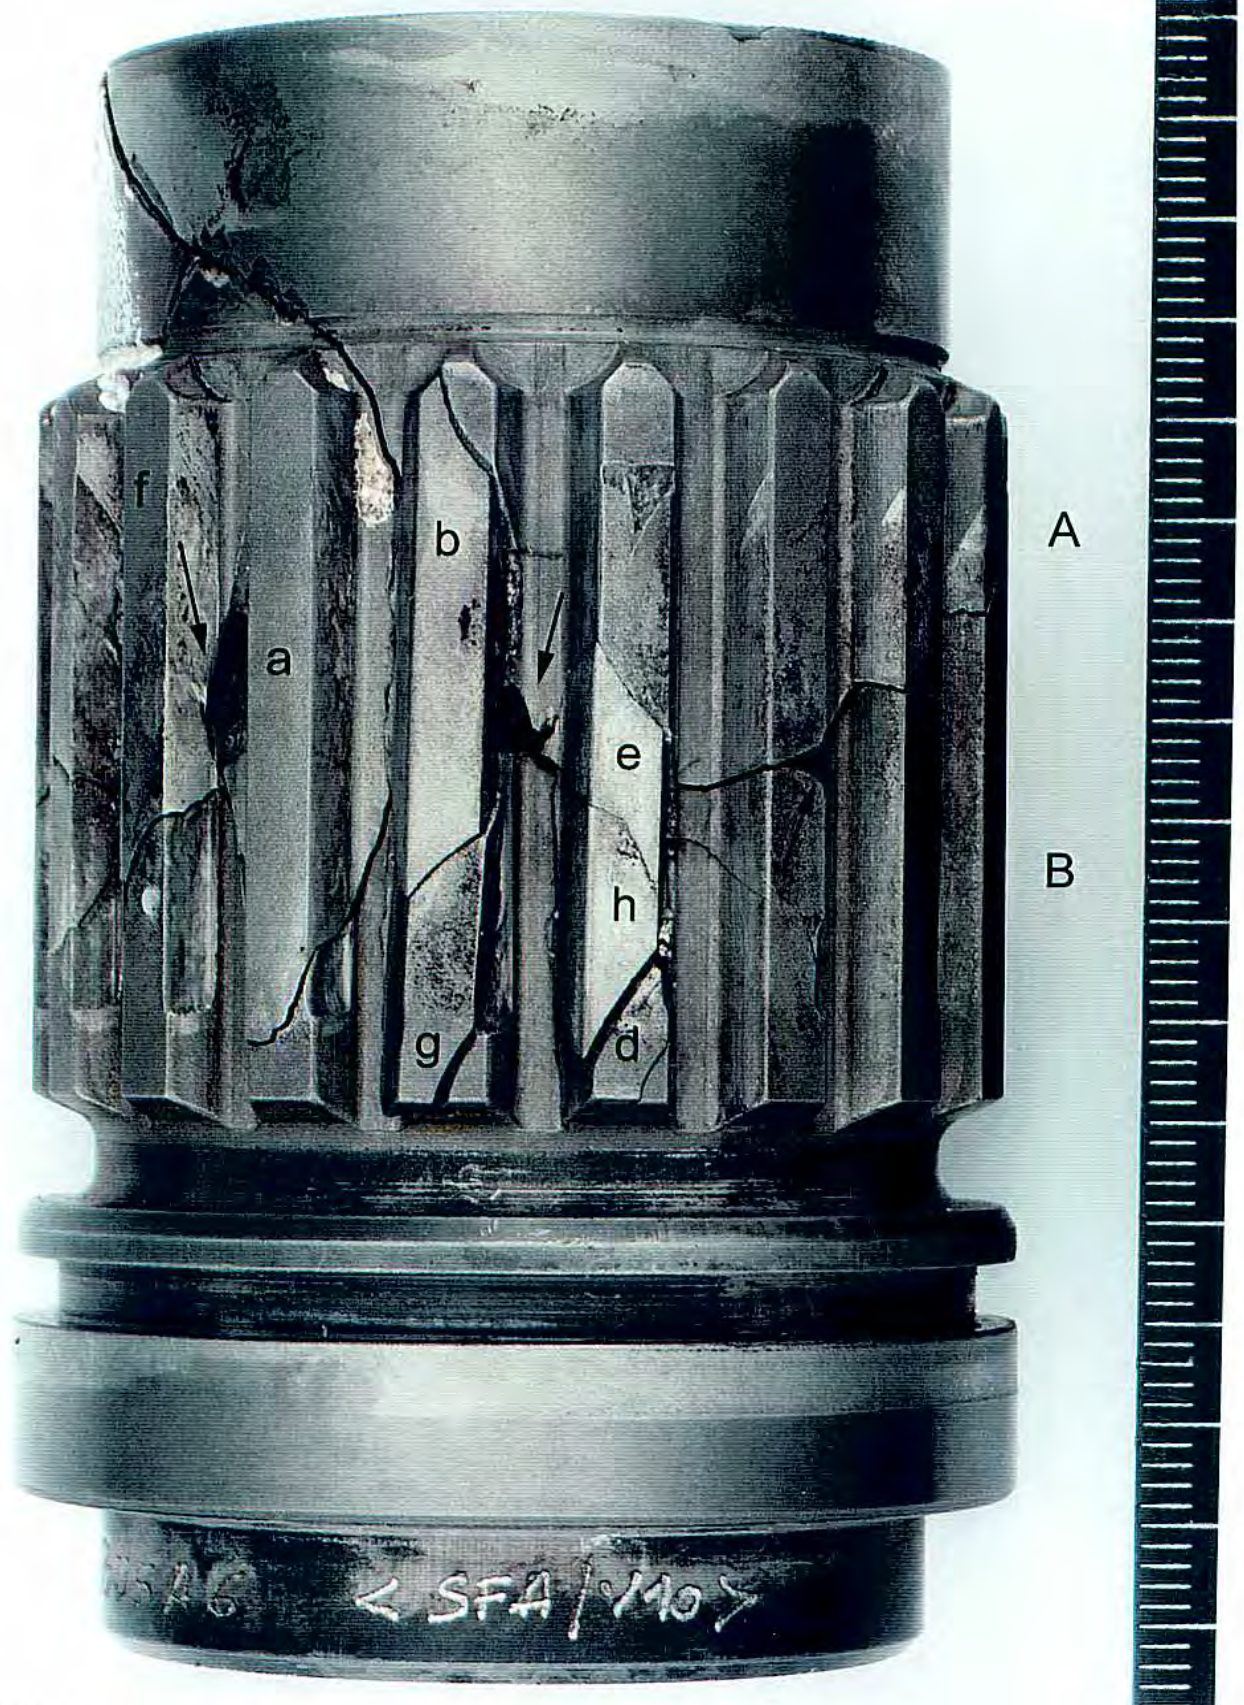
Same "side" appearance of the failed sleeve sections ("a" - "b" and "d" - "h", missing sections are arrowed.

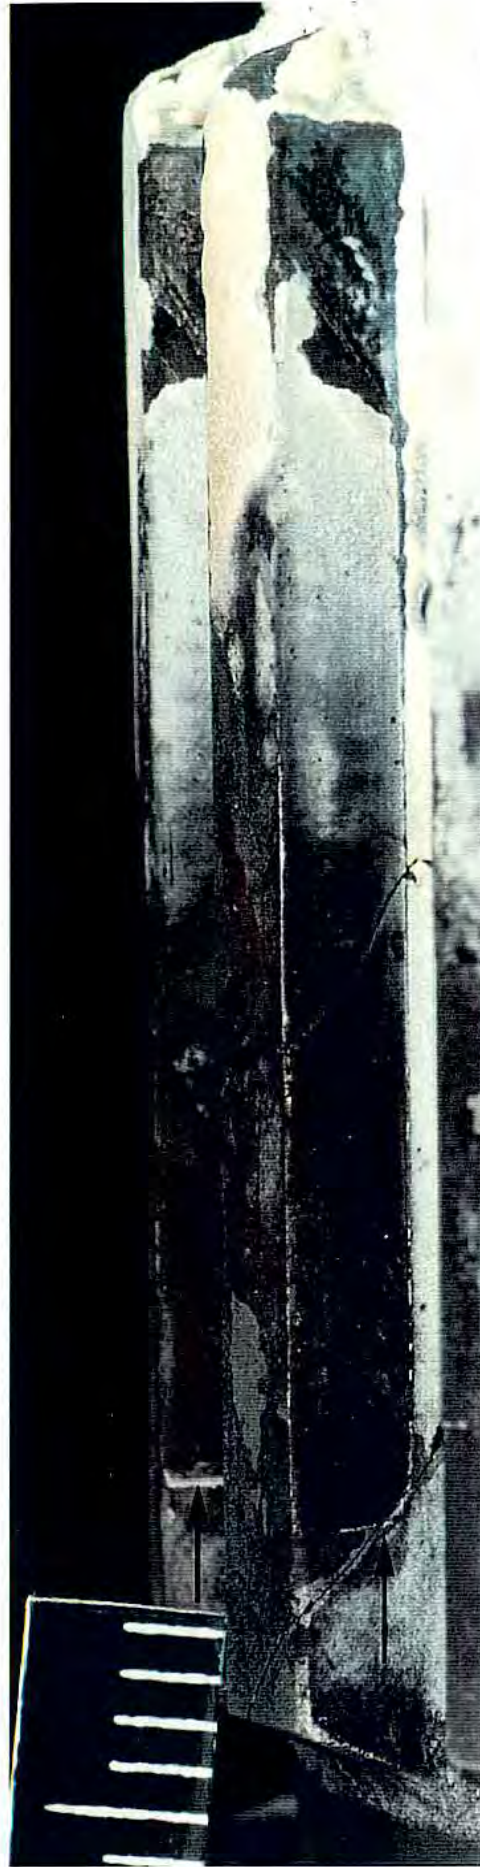
A general view of two active flank surfaces. Though partly covered by a white surface deposit, an oblique load condition for both flanks is indicated, with a maximum herzian load towards the left end of the engagement. (Flanks of the tooth No. 12 (top) and No. 1 and 2 (below) are arrowed).

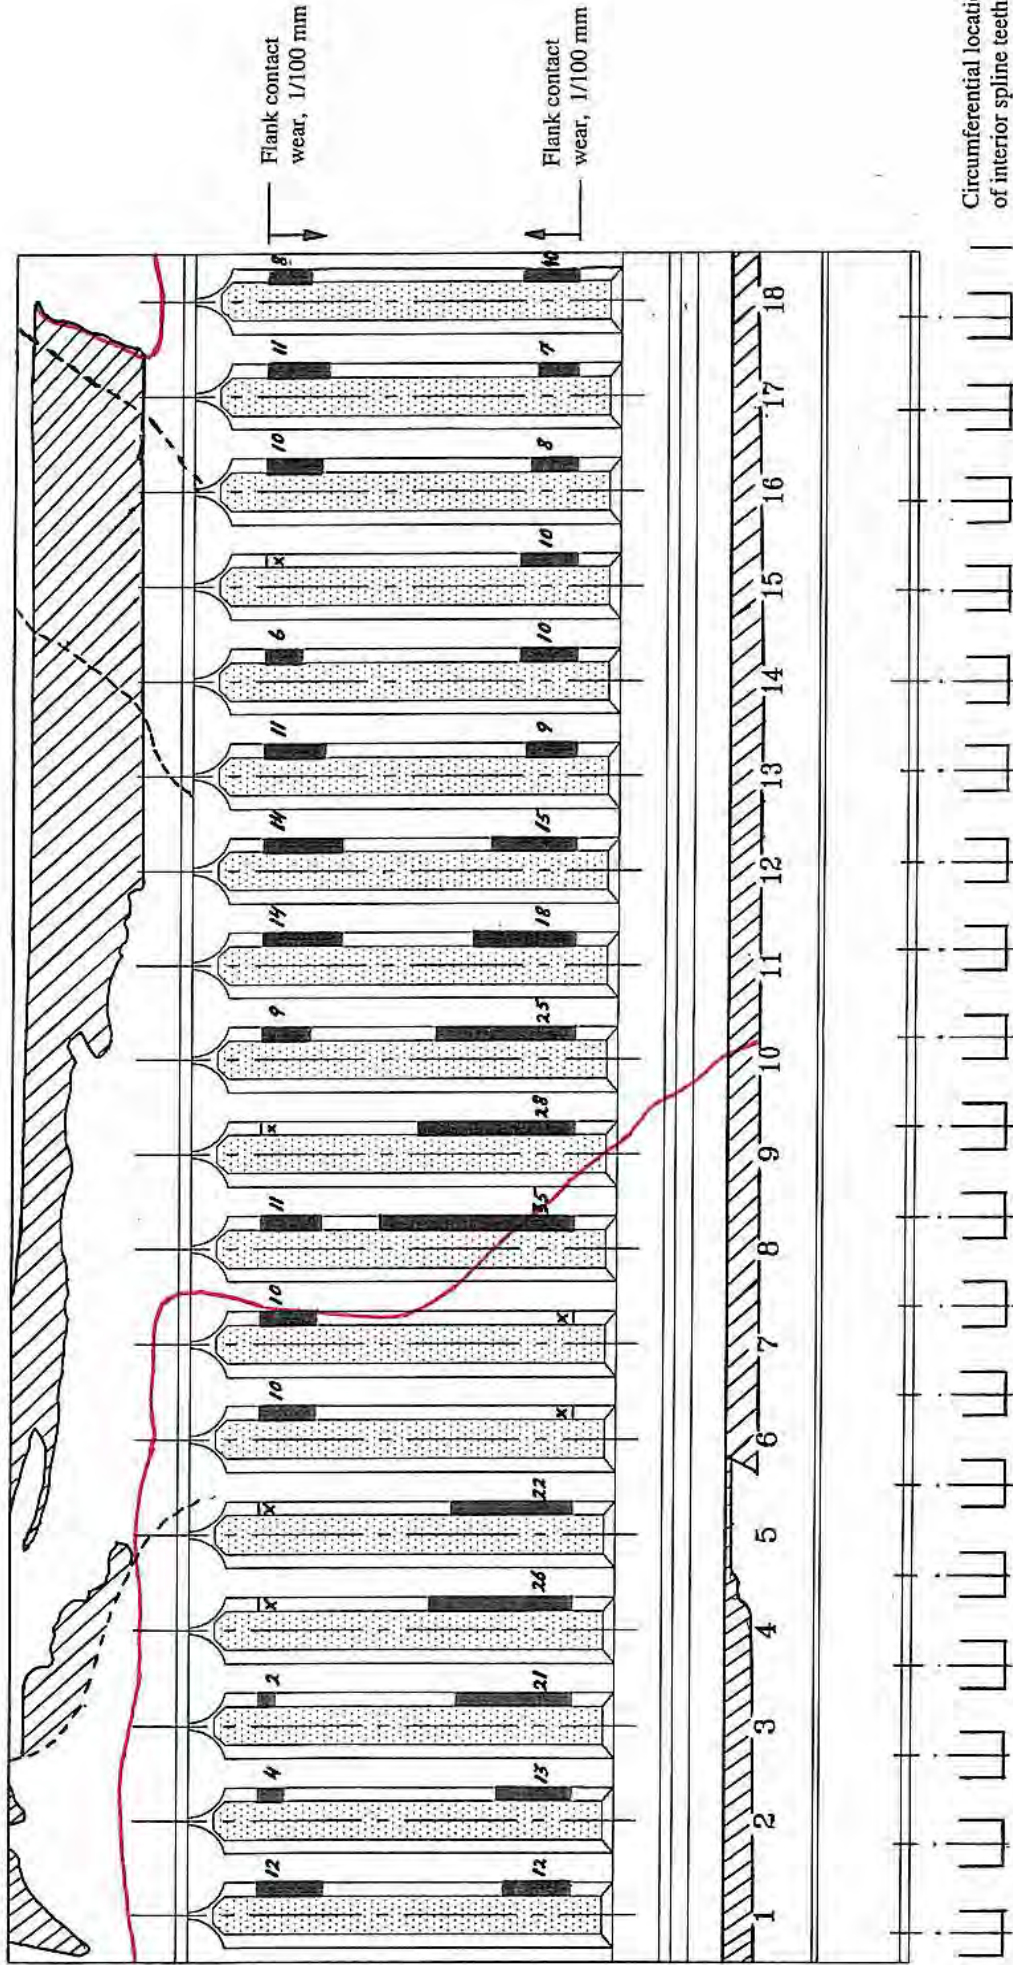
Recording of flank wear and end section fretting corrosion / surface battering.

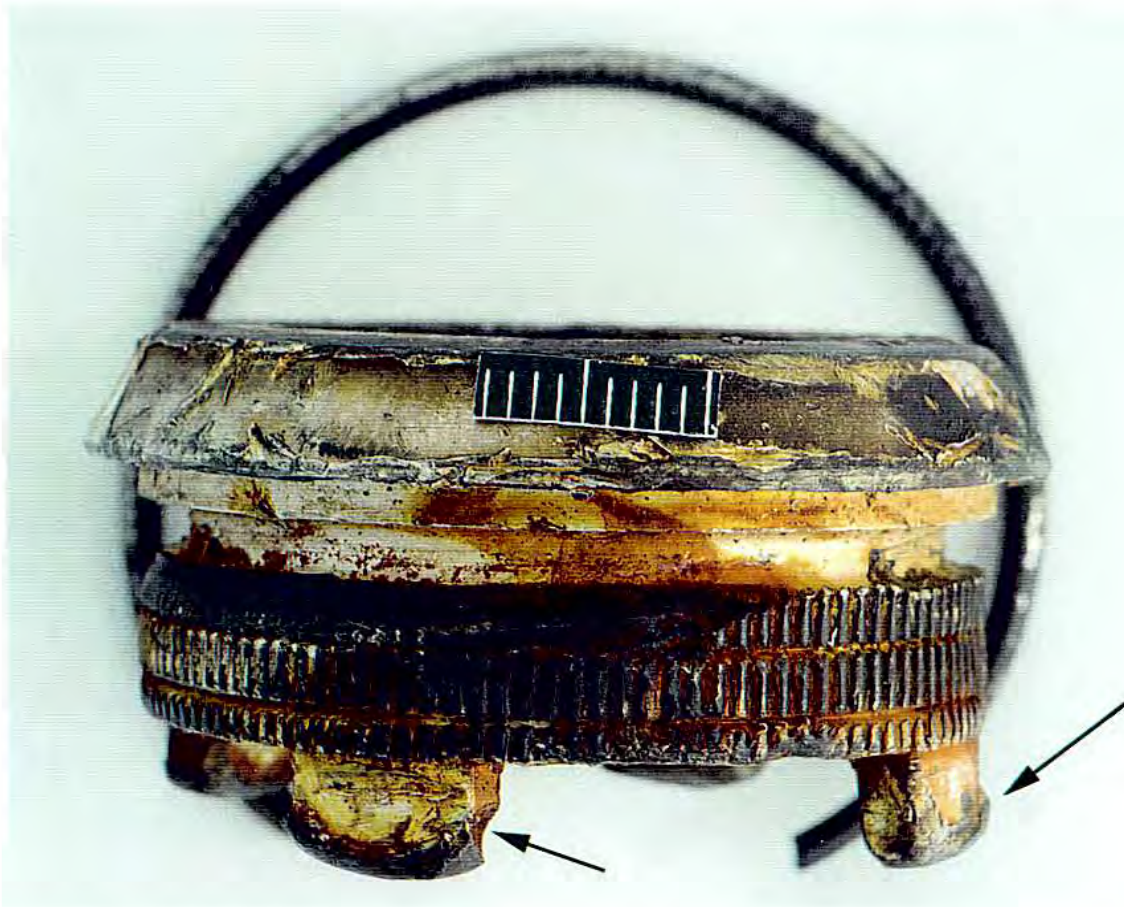
General view of the front end lock washer and its locking ring. The side surfaces of the four engagement claws had suffered deformation/indentation due to rotational contact wear. Two of these locations are arrowed.

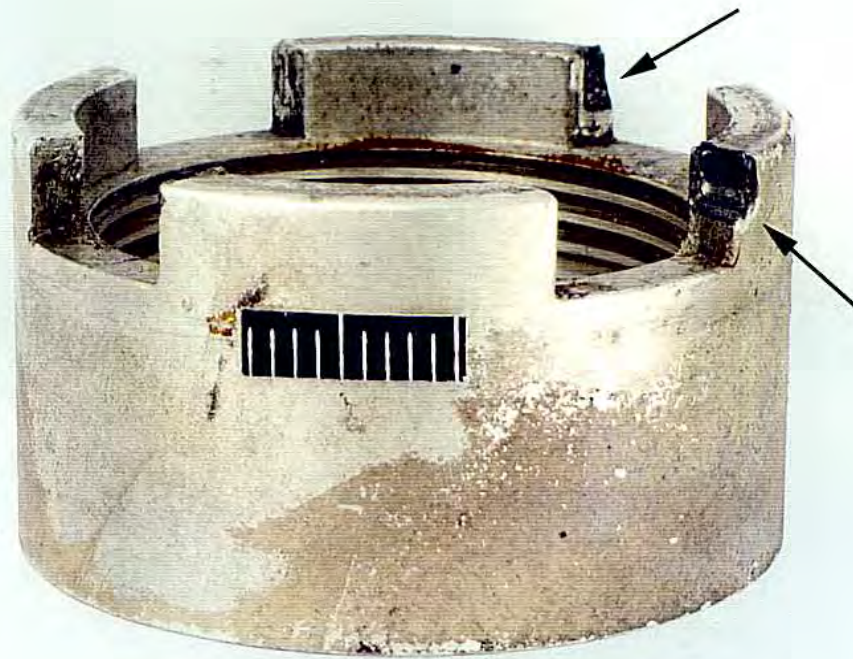
General view of the front end retaining nut, after a controlled torque disengagement from the MGB input shaft. The two locations arrowed on this photo clearly confirm a rotational contact wear towards the mating claws of the lock washer.

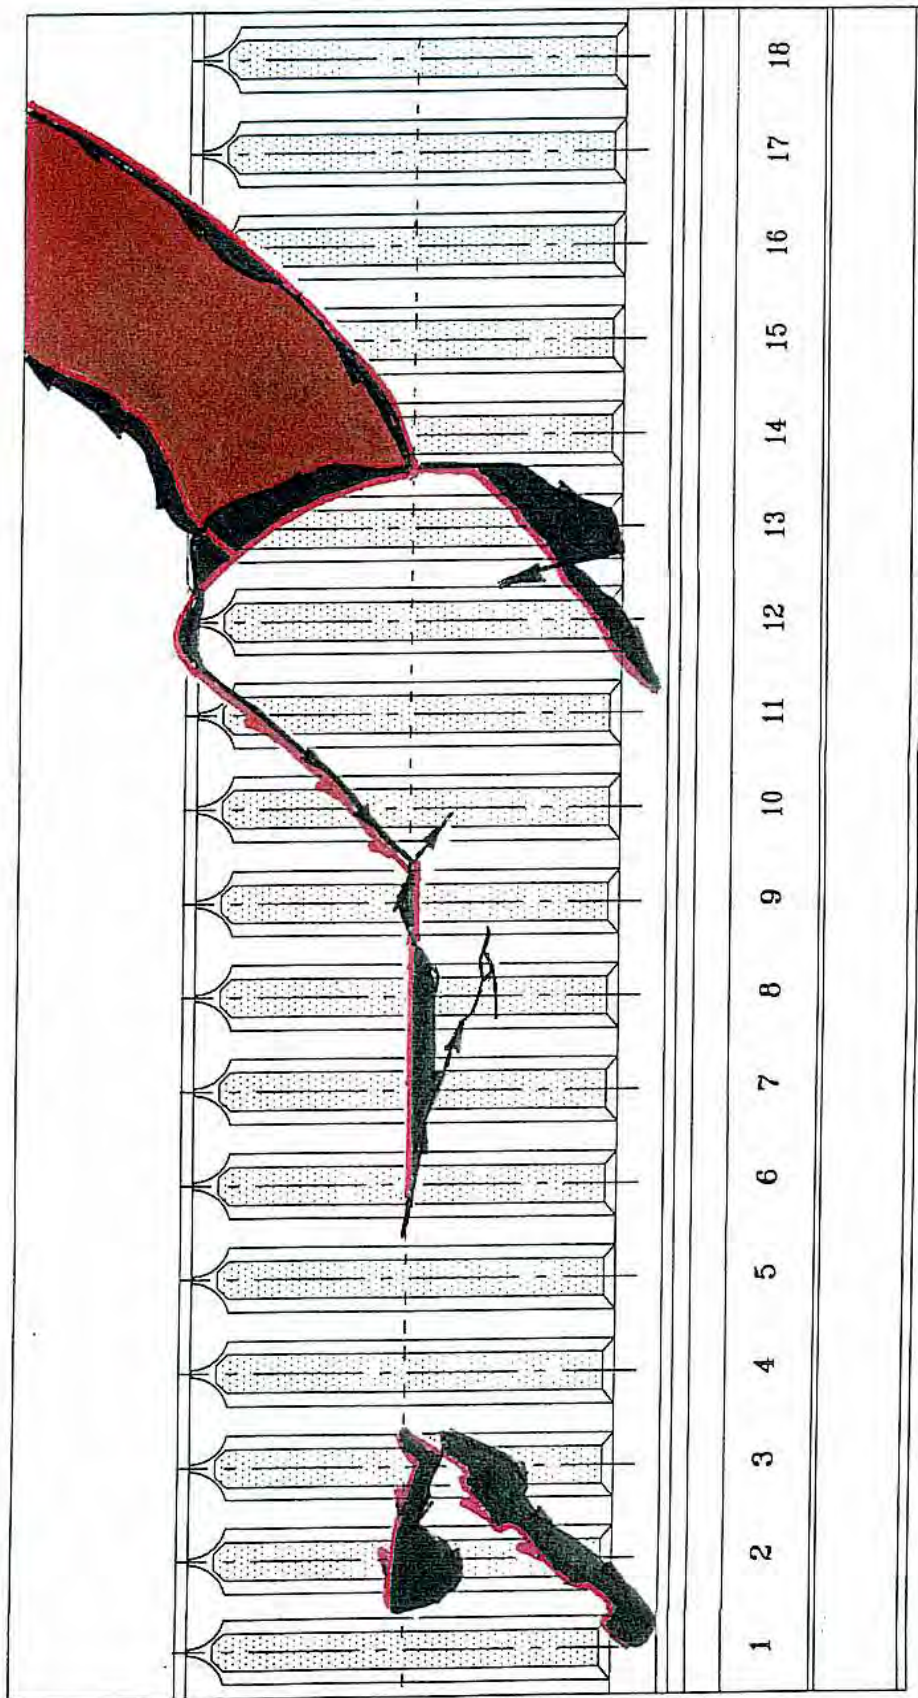
Following sequence II of failure

- Shaded area: Fatigue crack surfaces leading to fracture.
- Location of arrows: Starting from the crack initiation areas.
- Number of arrows: The total number of initiation areas for each tooth fracture.
- Direction of arrows: The direction of fatigue crack propagation.
- Dark line with arrows: Crack location, exterior surface.
- Red line with arrows: Crack location, interior surface.
- Dark red area: Interior surface being part of longer tooth fragments.
- Dark green area: Crack surface through the wall thickness of the sleeve.

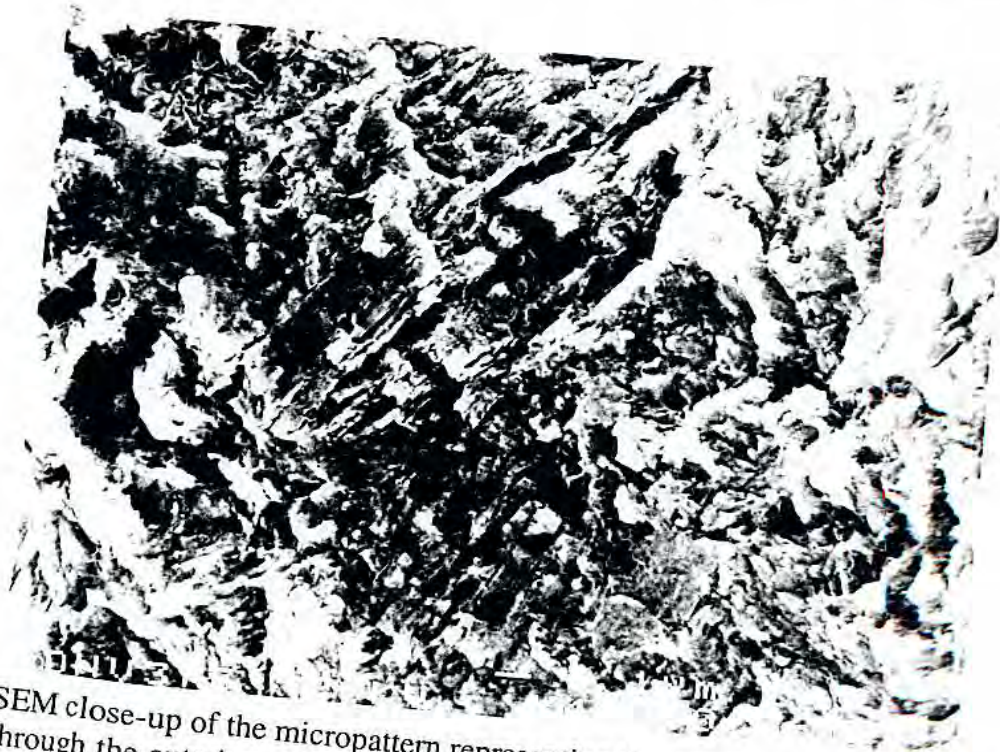
SEM close-up of the micropattern representing the transverse crack propagation through the exterior spline tooth No. 6. The presence of fatigue striations is stated. Magnification X 4000.

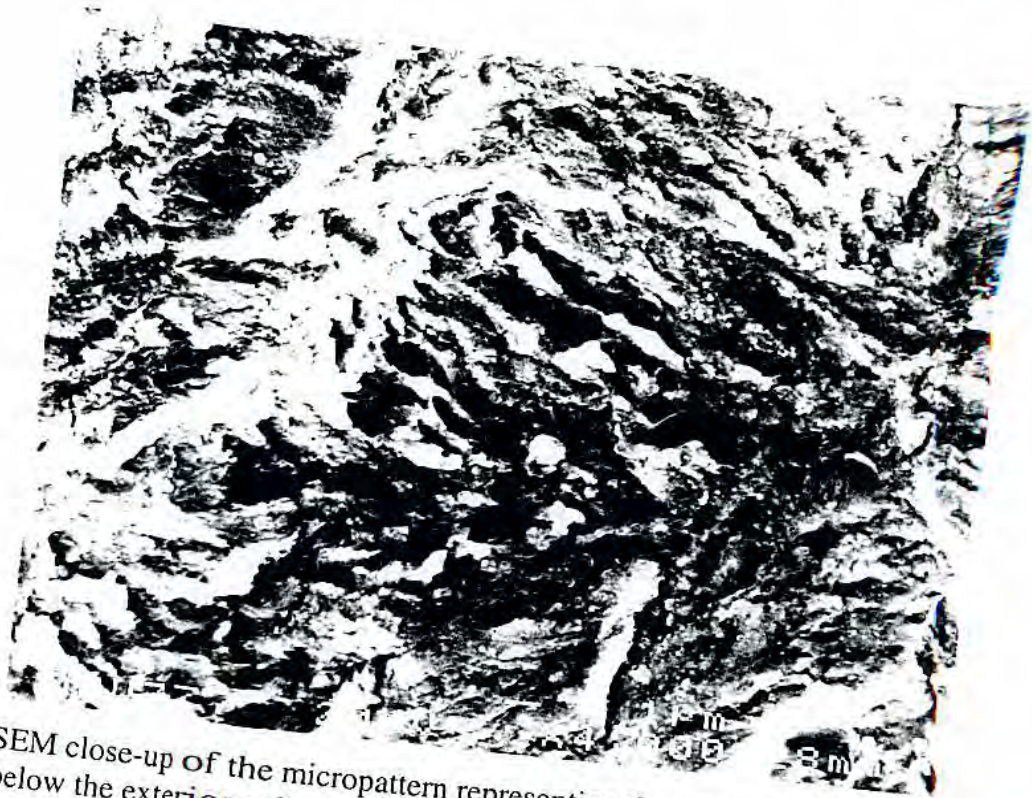
SEM close-up of the micropattern representing the tangential crack propagation below the exterior spline tooth No. 6. Also this local tooth breakage is confirmed to be a consequence of fatigue crack propagation. Magnification X 4000.

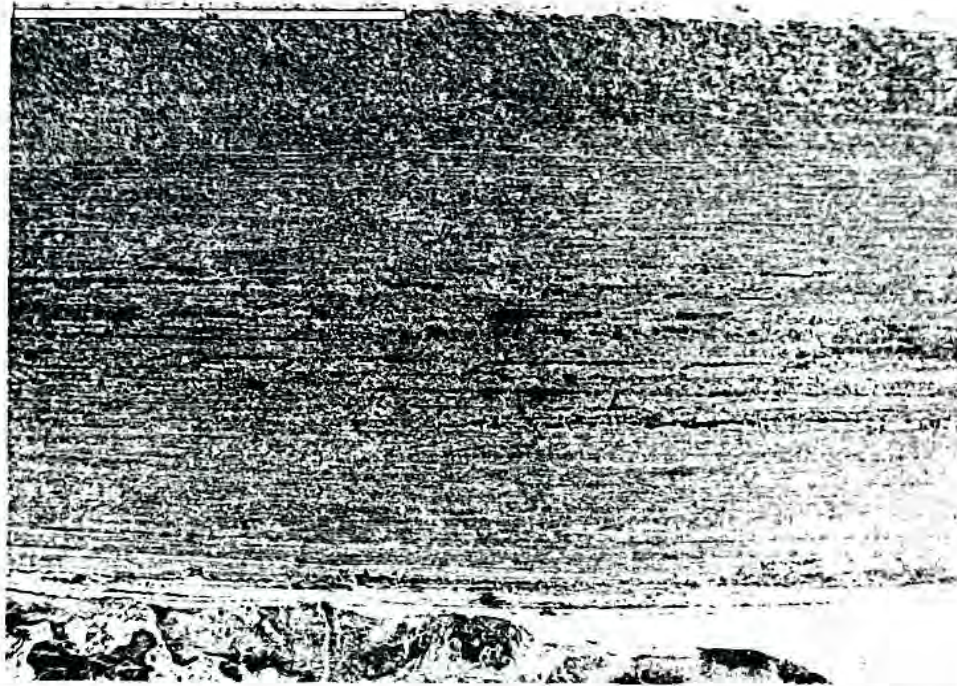
SEM-view of the inactive flank surface for the exterior spline tooth No. 6. The longitudinally directed pattern of dark lines found in the hardmetal coating was recorded both within and outside the contact area of the flank. Magnification X 25.

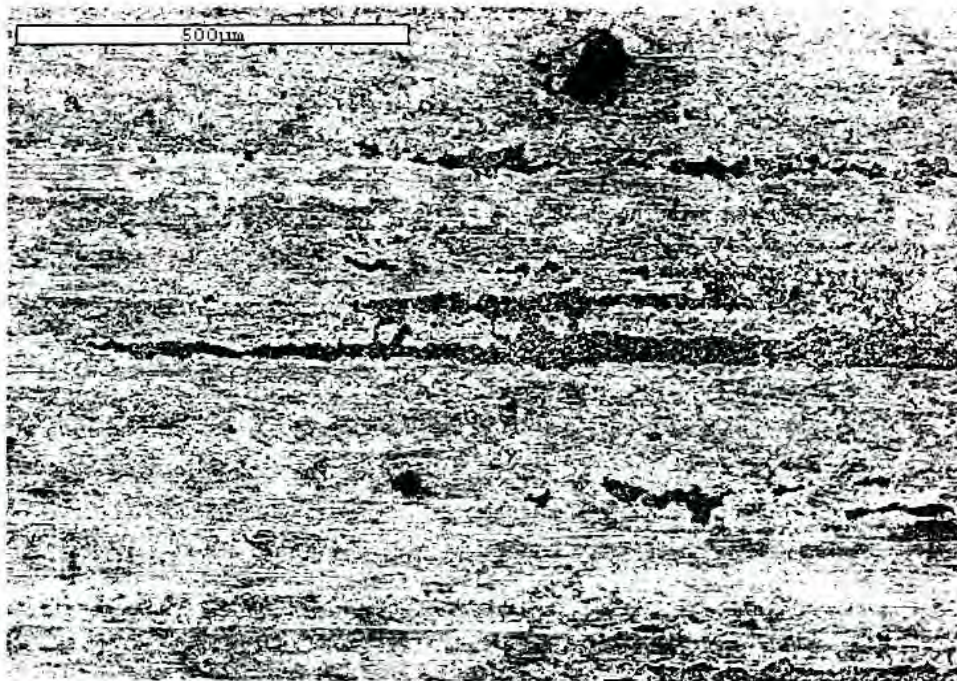
A closer SEM-view of the pattern of dark lines shown. Some process of longitudinal scoring and local tear of the hardmetal coating is indicated. Magnification X 100.

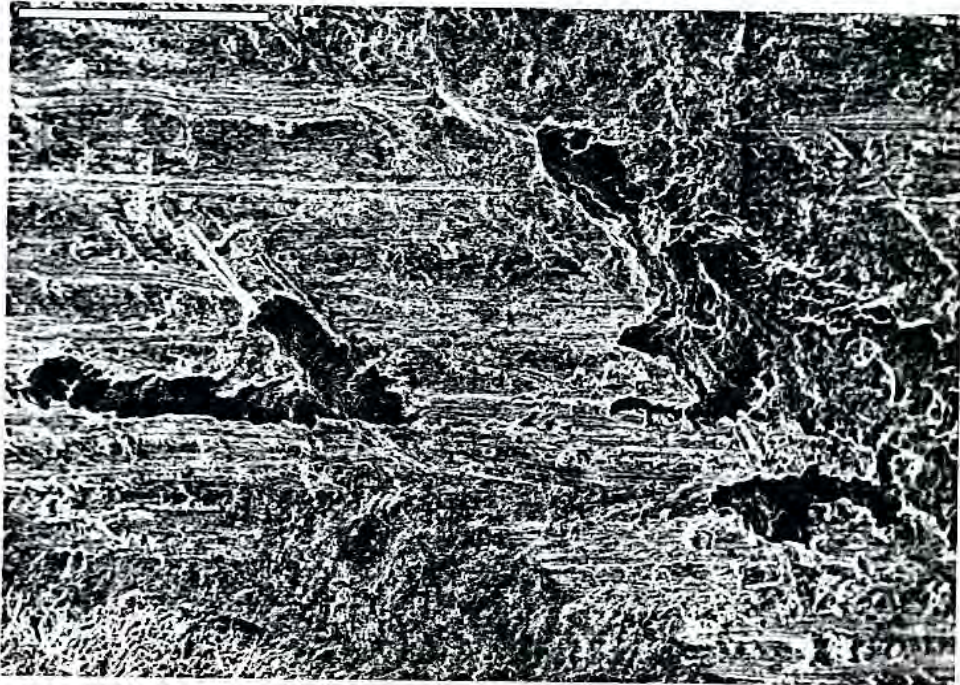
Another SEM-view representing the pattern of mechanical scratches/scores on the hardmetal coated inactive flank, tooth No. 6. The connection between local surface contact and missing hardmetal coating is found further documented. Magnification X 160.

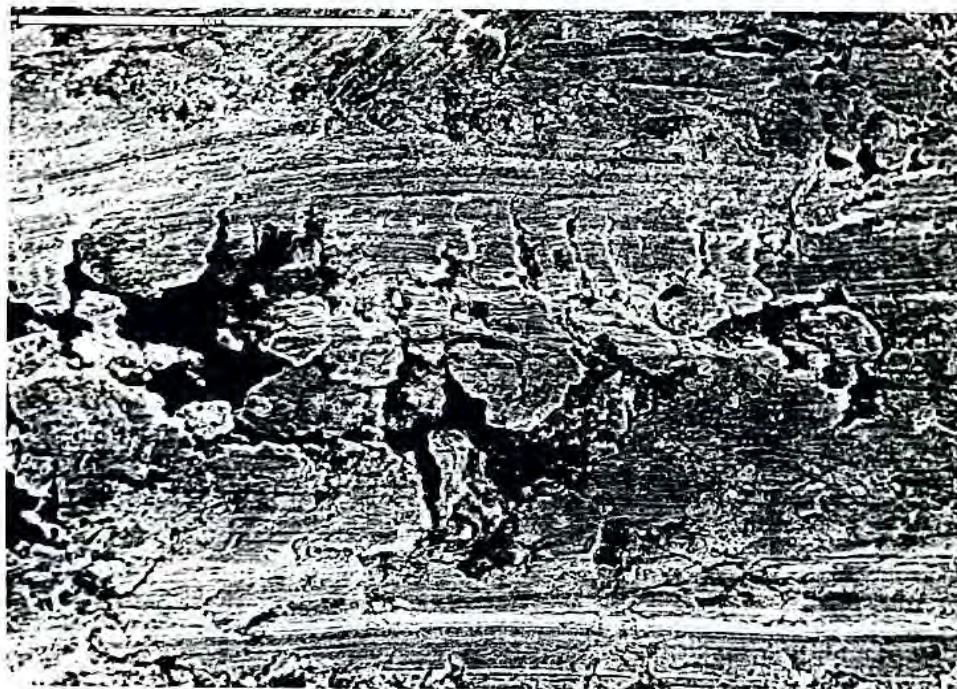
SEM close-up, illustrating that the mechanical scratches/scores are responsible also for a local surface "smearing" and transverse cracking of the hardmetal coating. Exterior spline, tooth No. 6, inactive flank. Magnification X 1000.

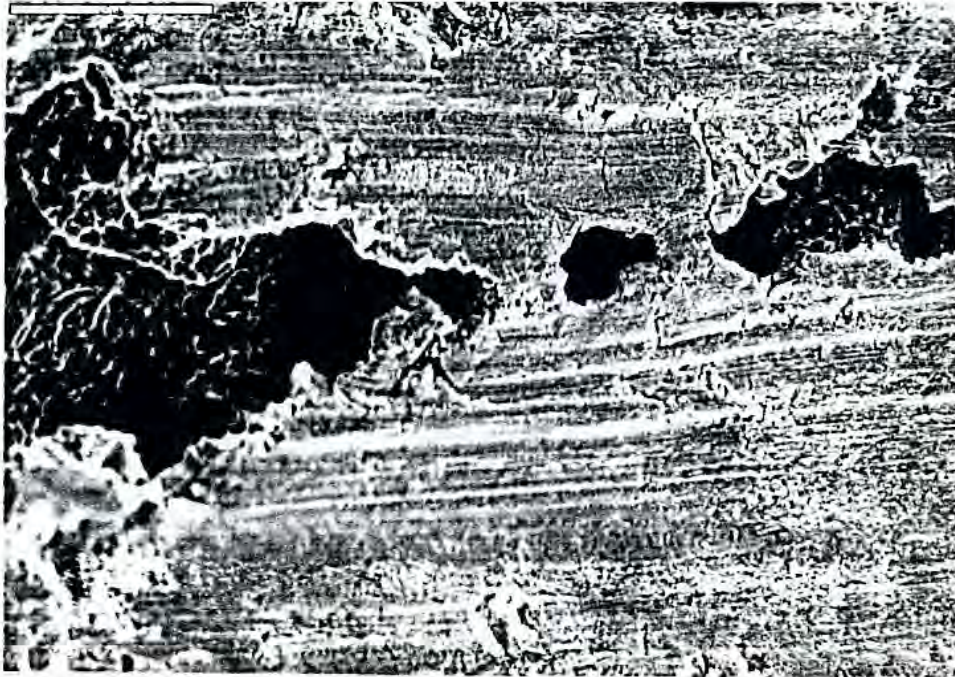
SEM close-up, showing a significant pit formation (cavity) below a "smeared" surface material. Exterior spline, tooth No. 6, inactive flank. Magnification X 1375.

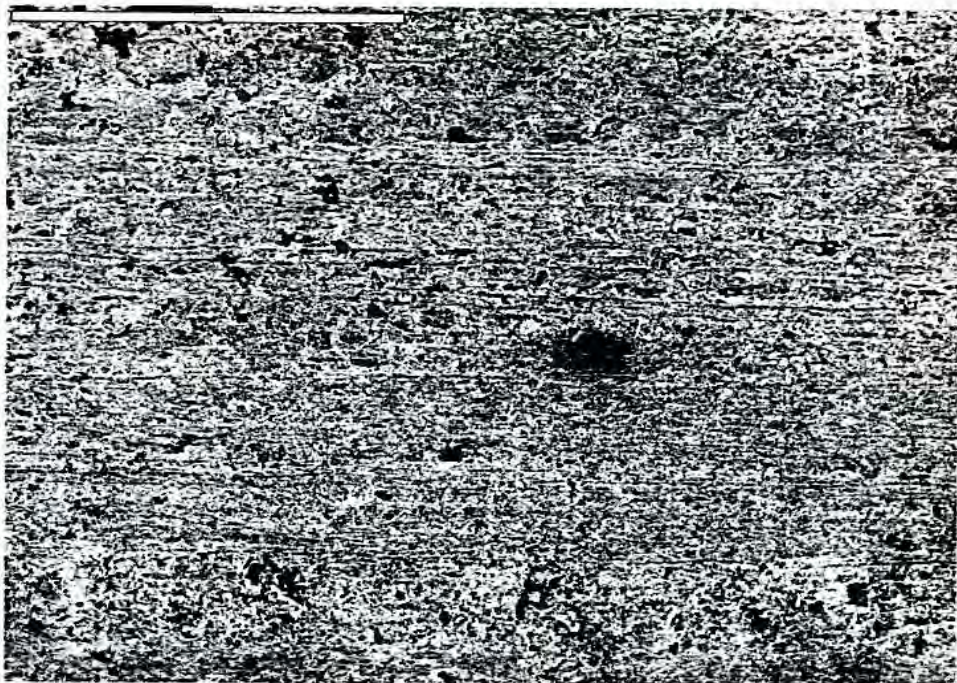
SEM-view of the hardmetal coated base (root) surface, adjacent to the exterior spline, tooth No. 6. Numerous surface pits (cavities) and a pattern of longitudinal surface wear are noted. Magnification X 100.

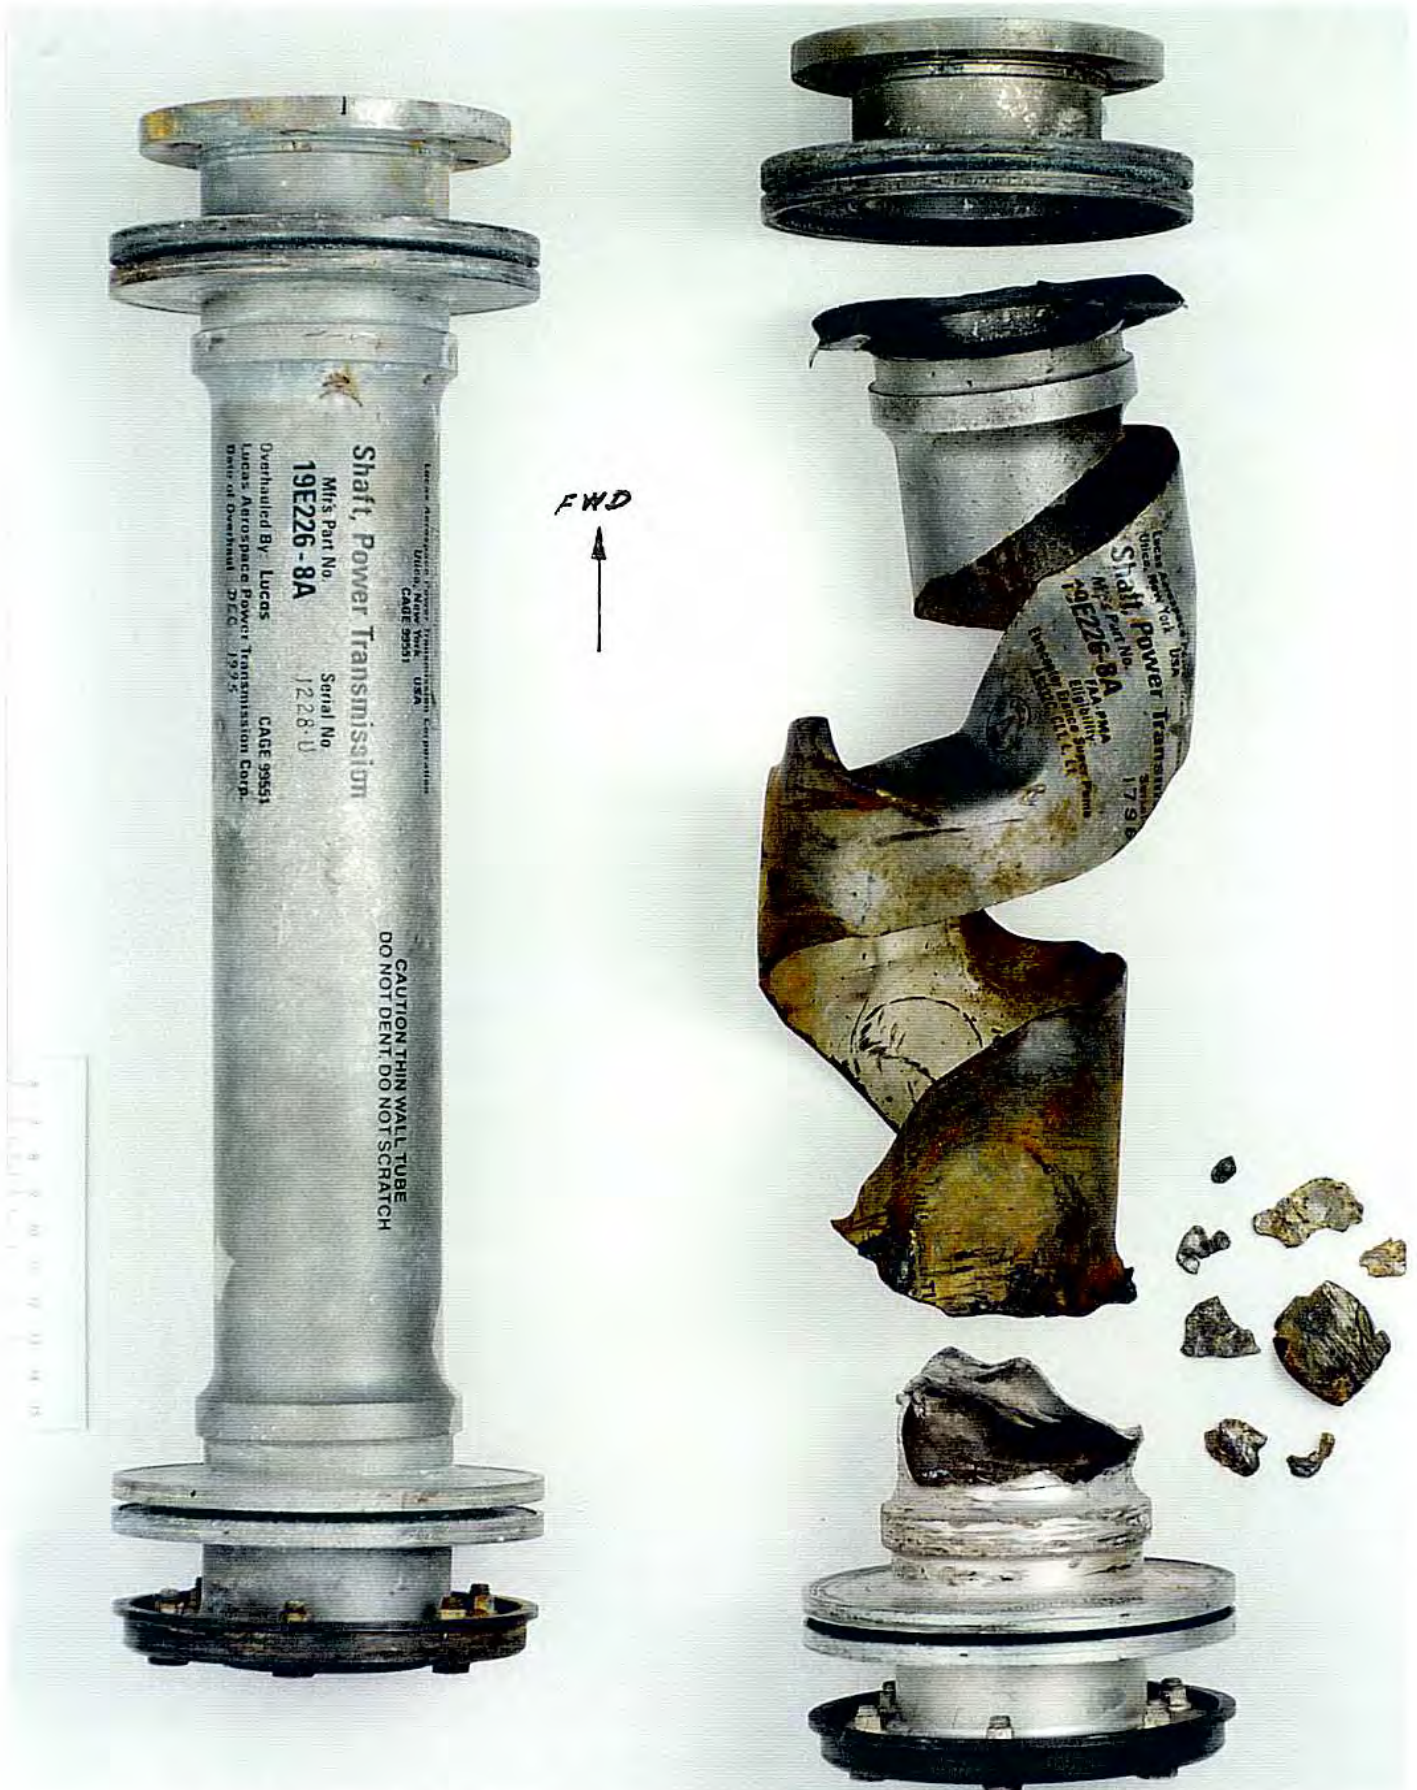
General view of the two power transmission shafts (Bendix shafts) from the Super Puma LN-OPG. The intact shaft seen to the left belongs to the L/H power transmission system (PTS) of the helicopter.

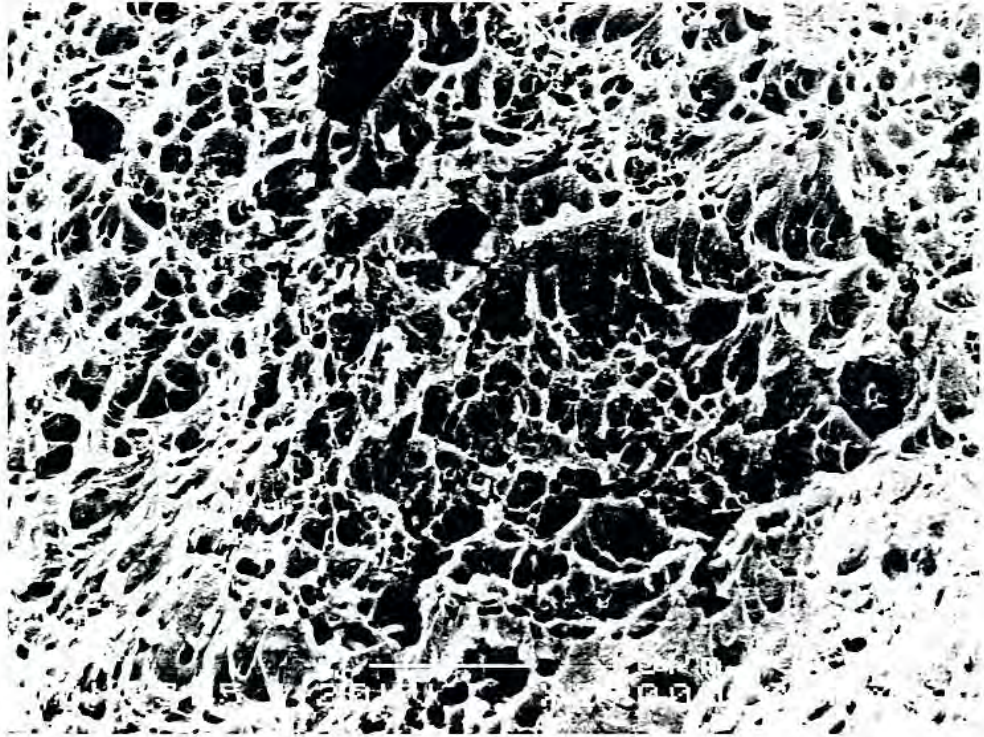
SEM micropattern representing the fracture location "B" of the thin-walled tubular shaft. Characteristic dimples are seen.
Magnification X 2000

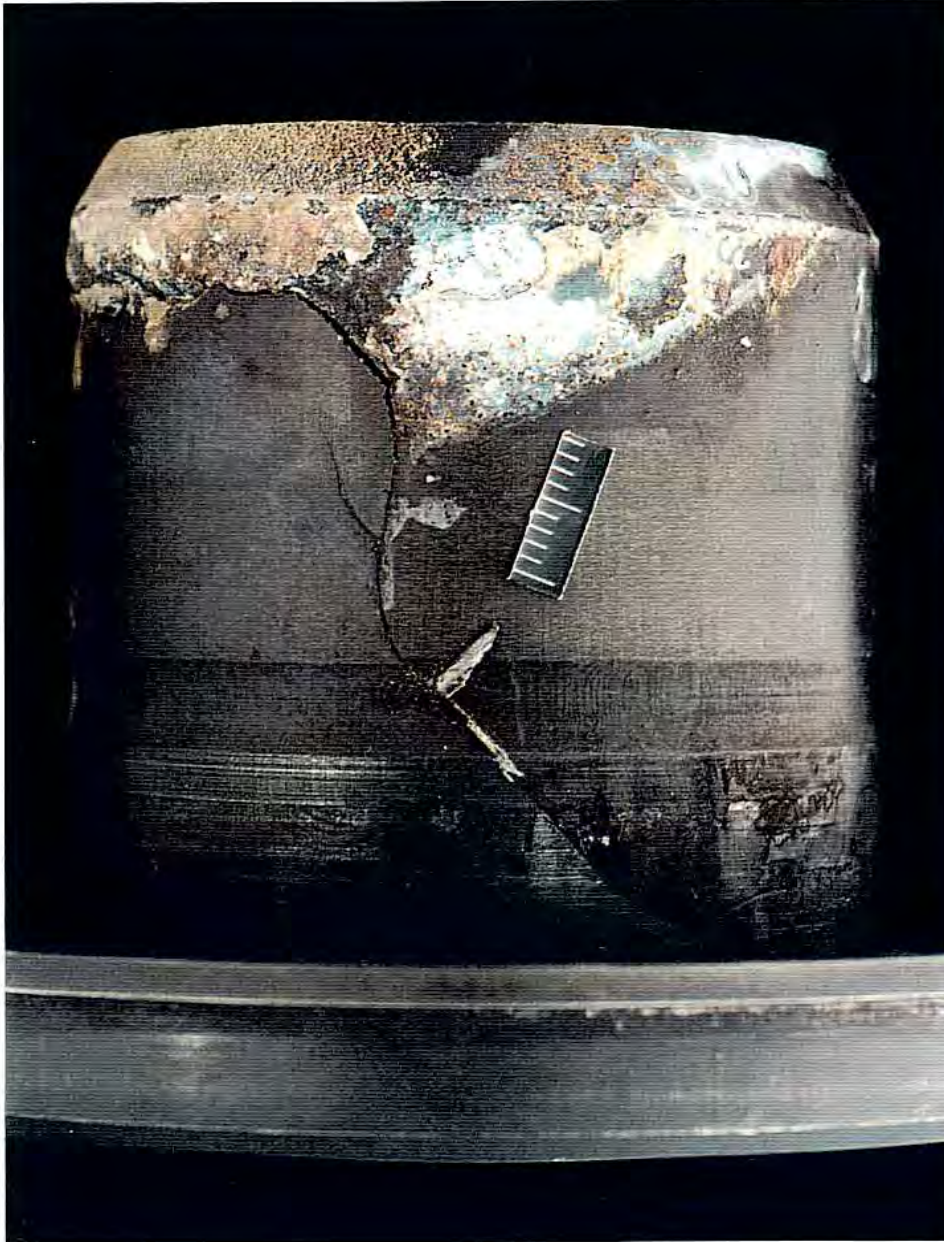
Another side view of the Bendix shaft end flange after disassembling from the tubular shaft section. The distinct crack formation can be followed all the way down to the rear end of the flange. At some locations a branched cracking is also noted.
