AIR ACCIDENT INVESTIGATION BOARD, NORWAY (AAIB/N)

REP.: 47/2001

**REPORT ON THE AIR ACCIDENT 8 SEPTEMBER 1997 IN THE
NORWEGIAN SEA APPROX. 100 NM WEST NORTH WEST OF
BRØNNØYSUND, INVOLVING EUROCOPTER AS 332L1 SUPER PUMA,
LN-OPG, OPERATED BY HELIKOPTER SERVICE AS**

ISSUED NOVEMBER 2001

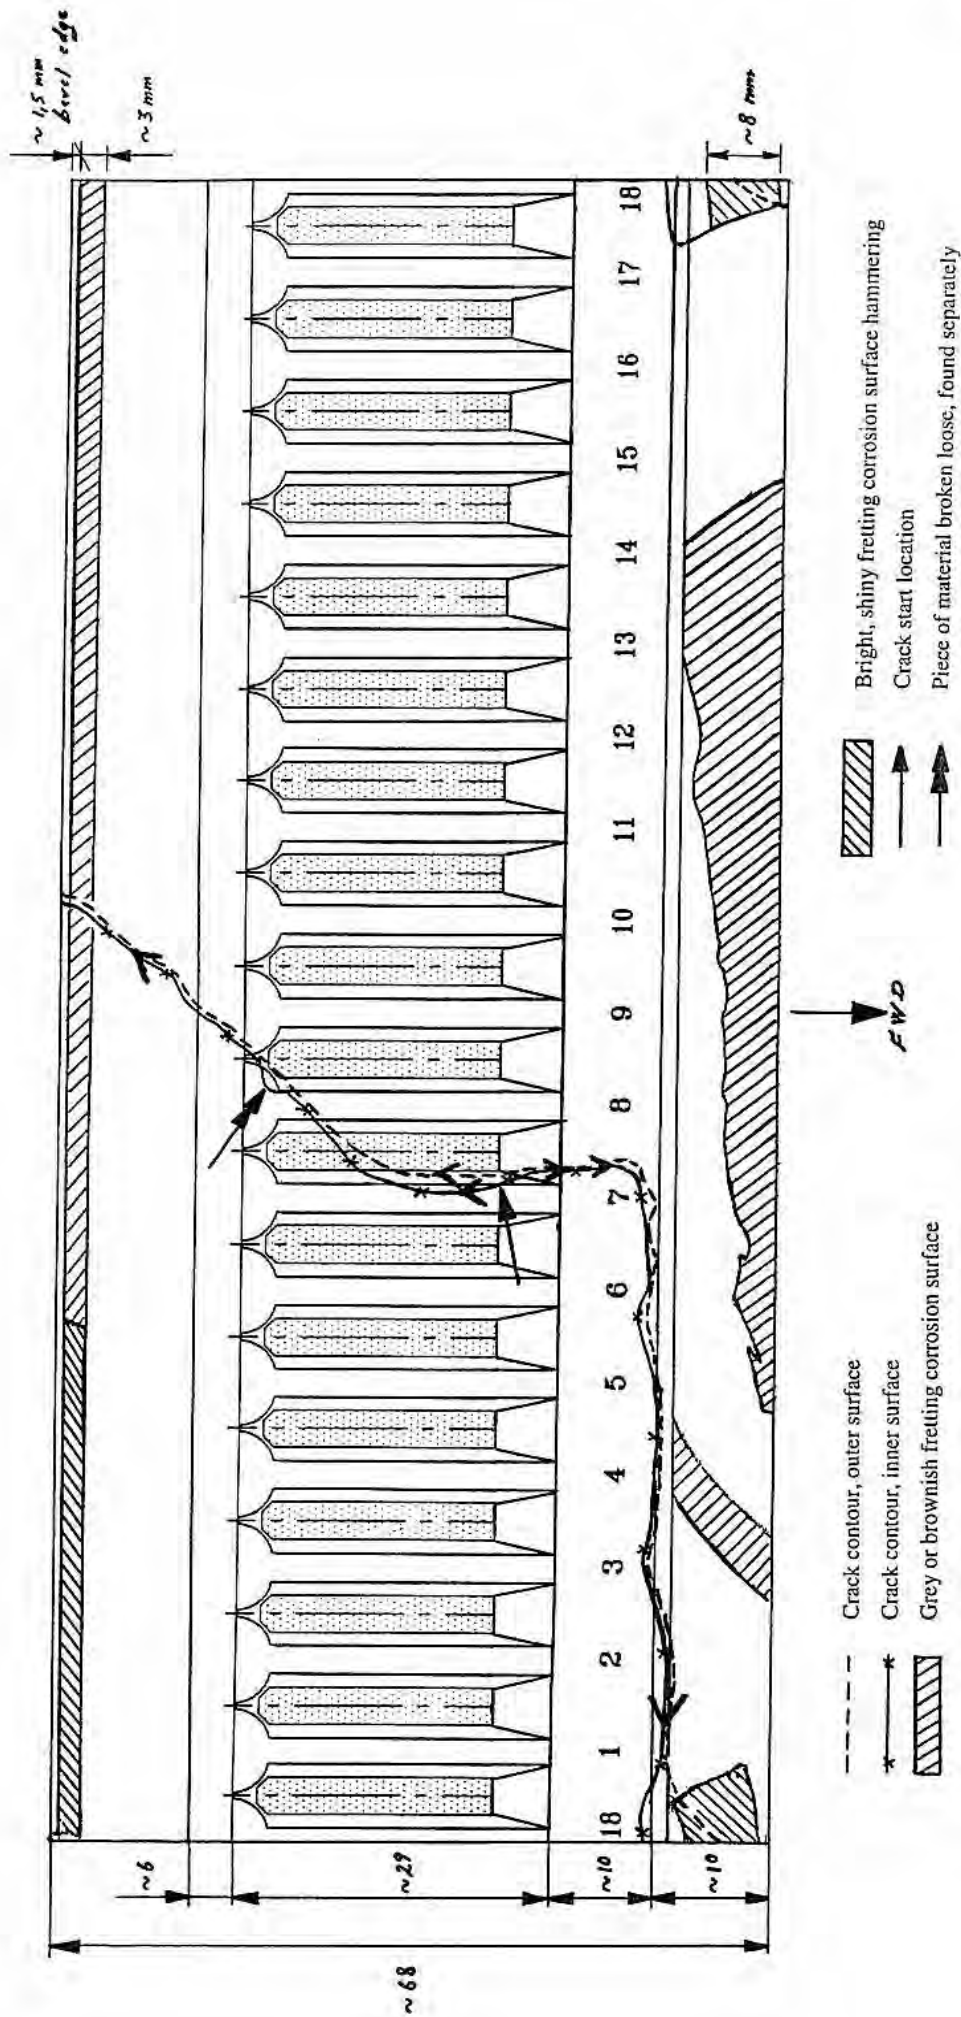
Sketch illustrating the crack geometry and mechanical contact wear for the interior surface of the end flange unit. The interval numbers seen on the sketch corresponds to the teeth numbers of the failed splined sleeve. (Ref DNV-report no. 98-1118).

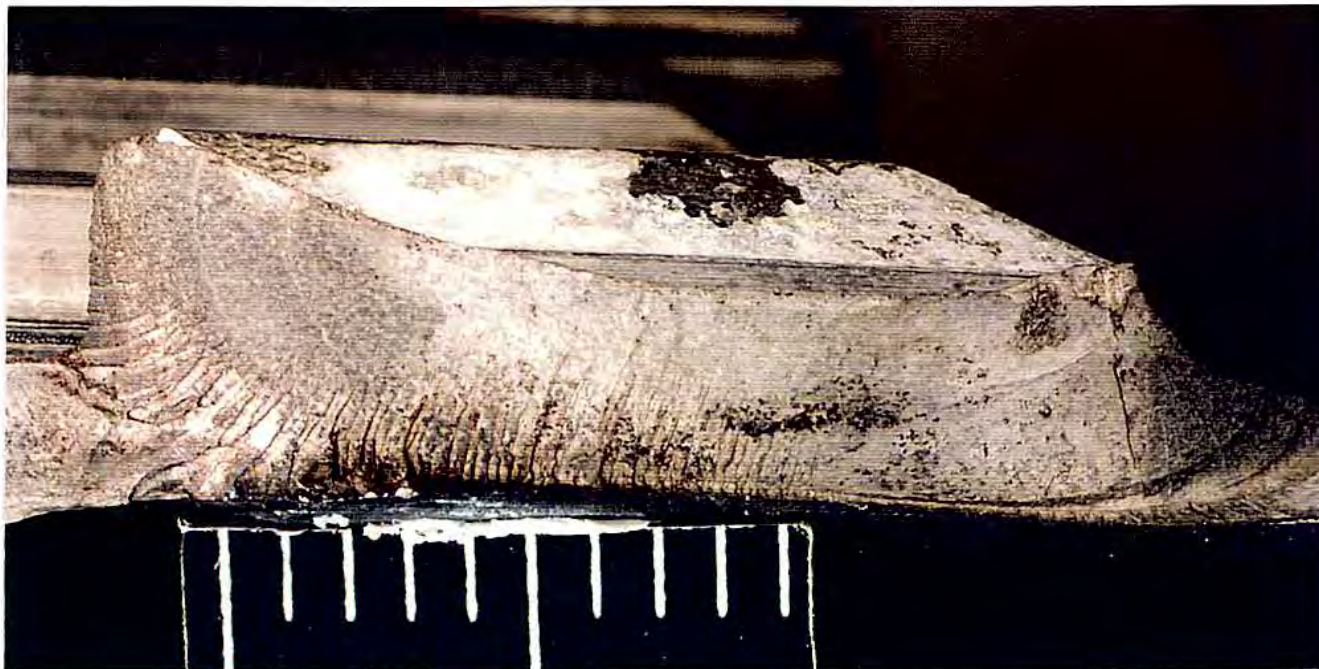
Close-up photo of the indicated crack start location of the splined end, in the condition "as received", i.e. covered by a white deposit. The location is found at interval No. 7.

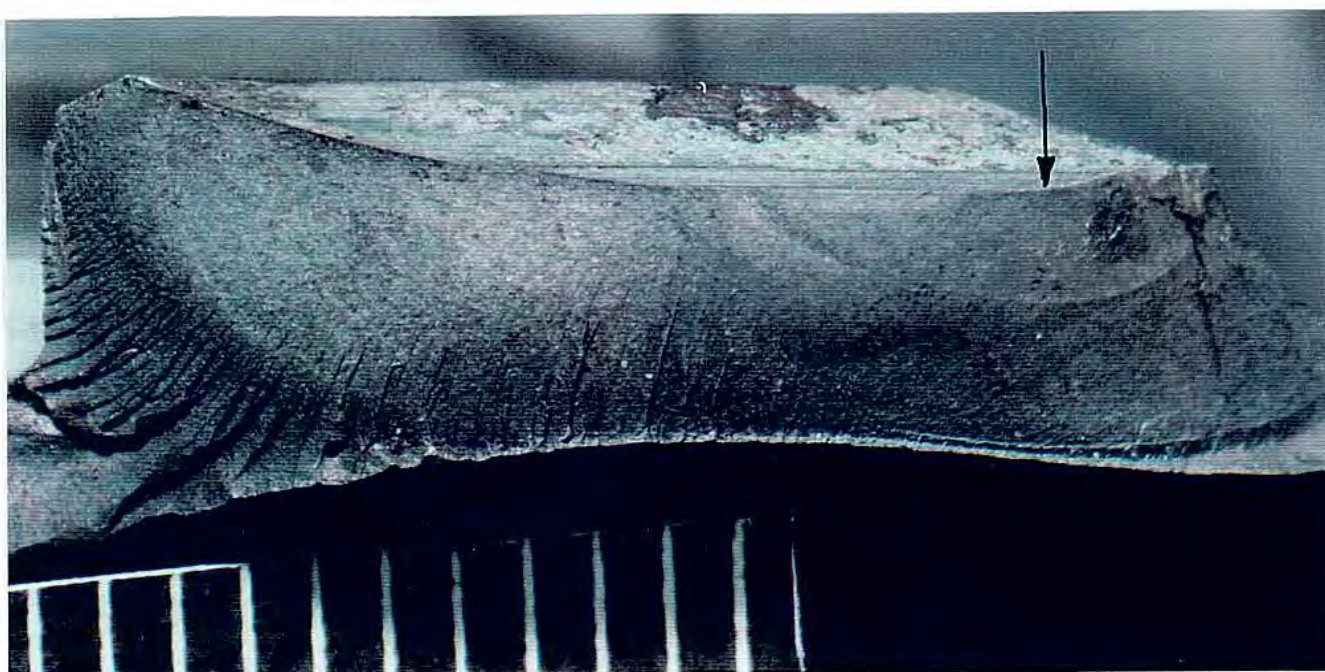
Same location seen after an ordinary chemical cleaning. The indicated crack start location is seen arrowed on the photo.

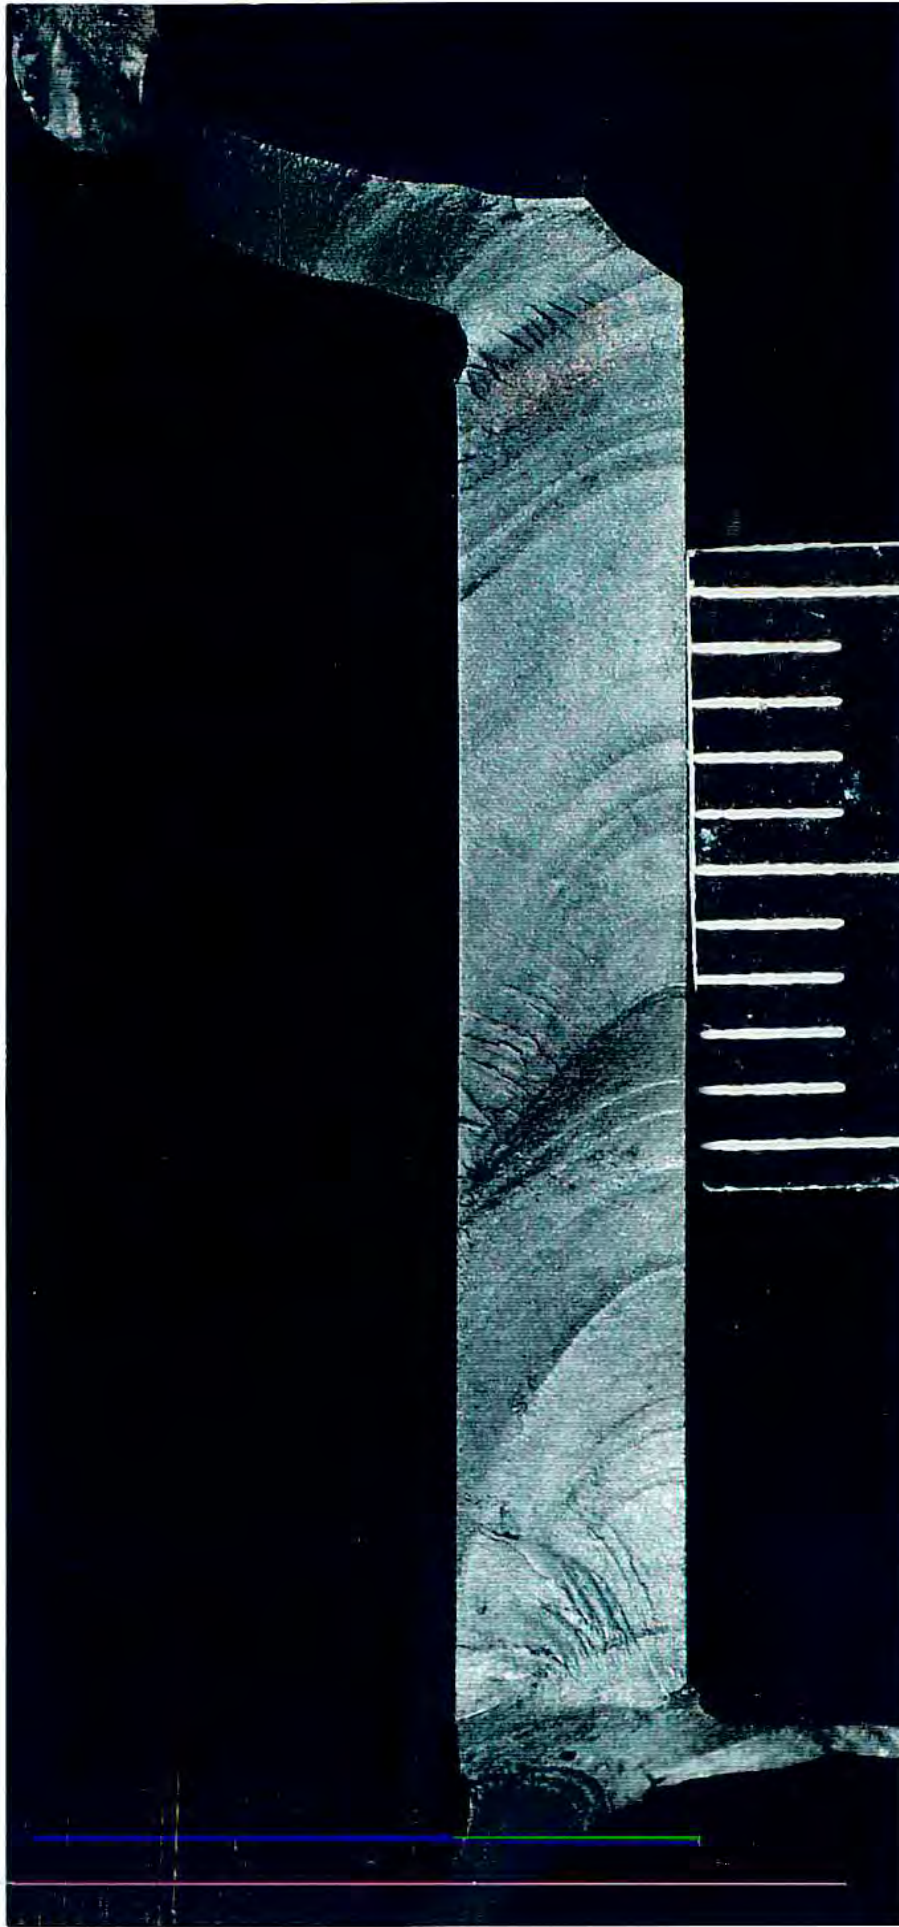
Close-up photo showing the crack surface in the rear section of the end flange unit (i.e. through the flange and the end flange collar, towards the location arrowed in the right, upper corner).

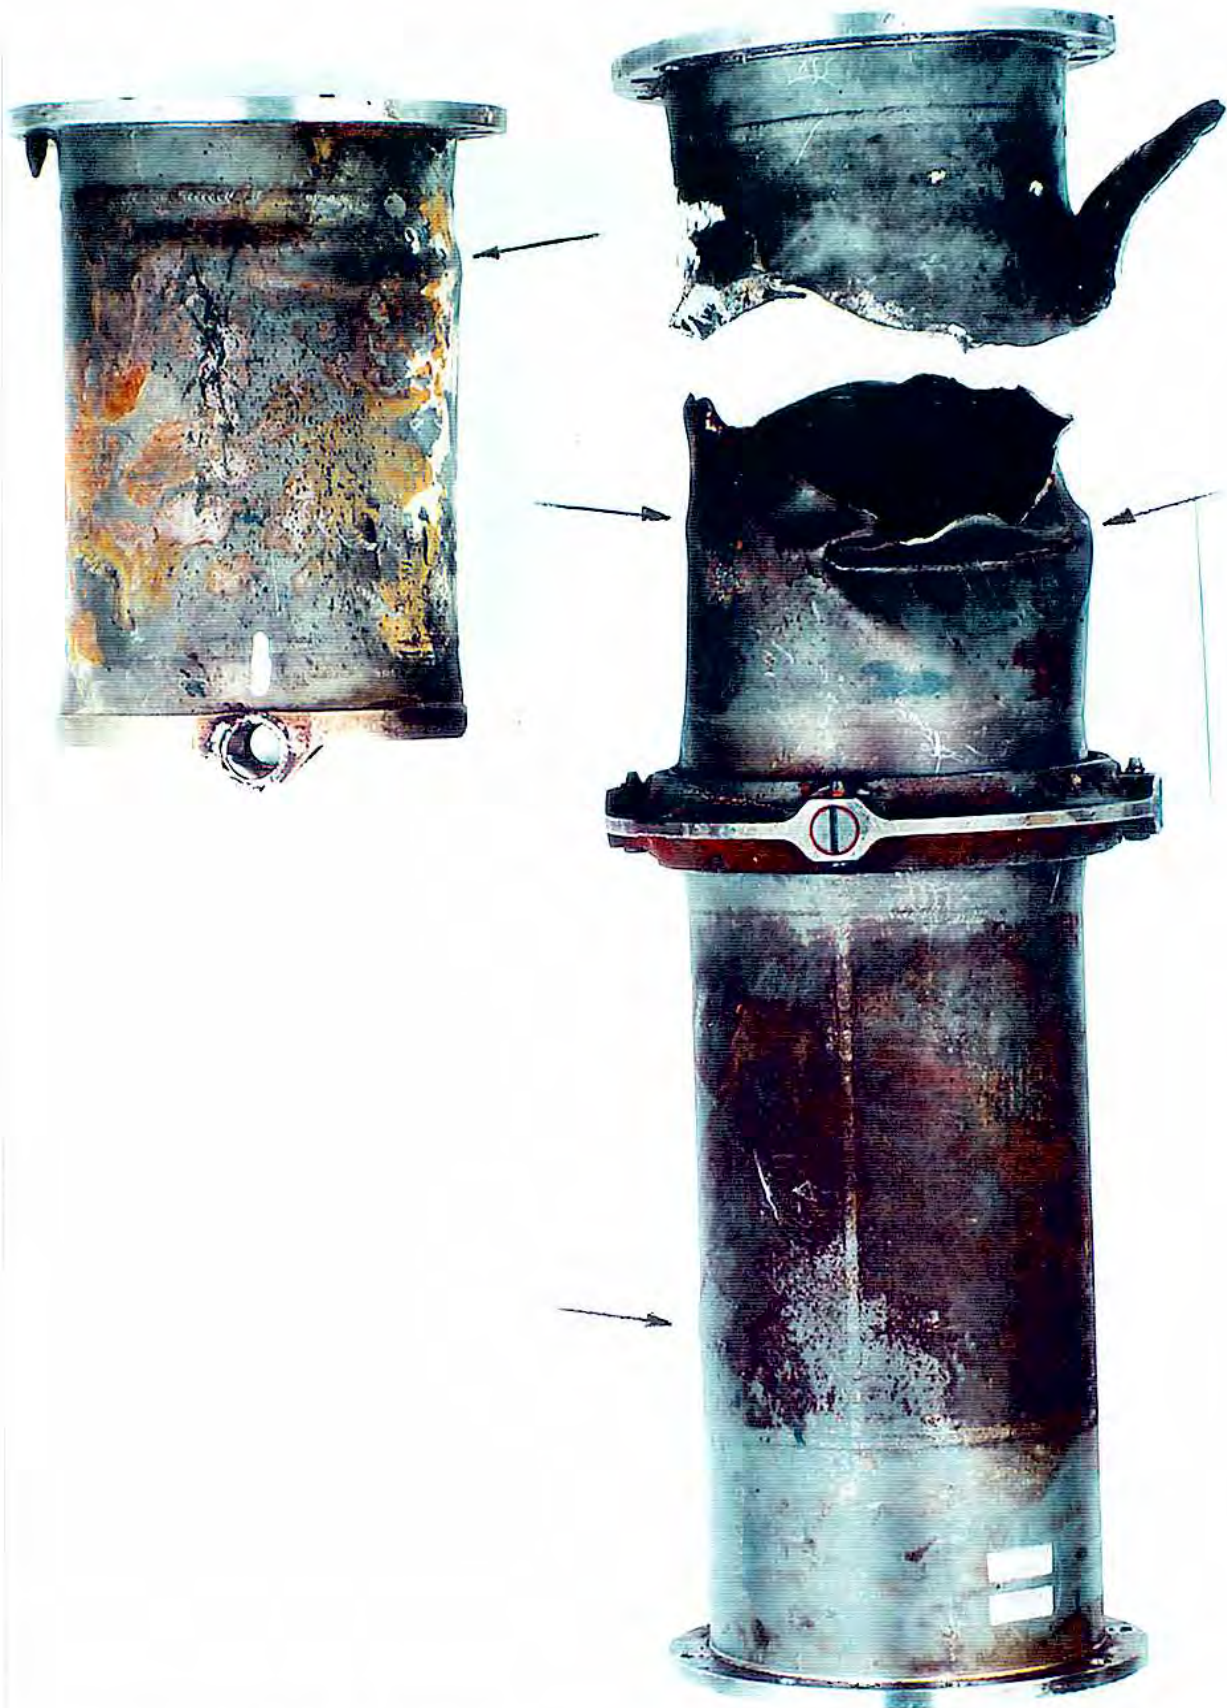
Close-up photo of the fractured R/H Liaison tube assembly (right), together with the AFT half-tube from the corresponding L/H assembly. Some exterior bulges (protrusions) are seen arrowed.

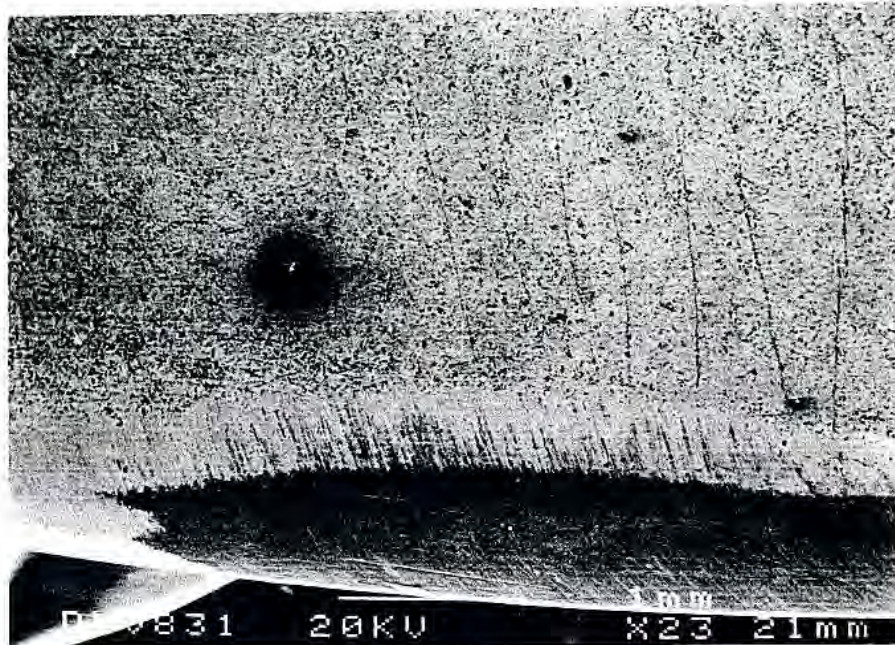
SEM-view of the R/H section of the ground front edge location "A" seen in Fig. 1. Some axially directed microcracks are indicated in the surface of the hard-metal coating.
 Magnification X 23.

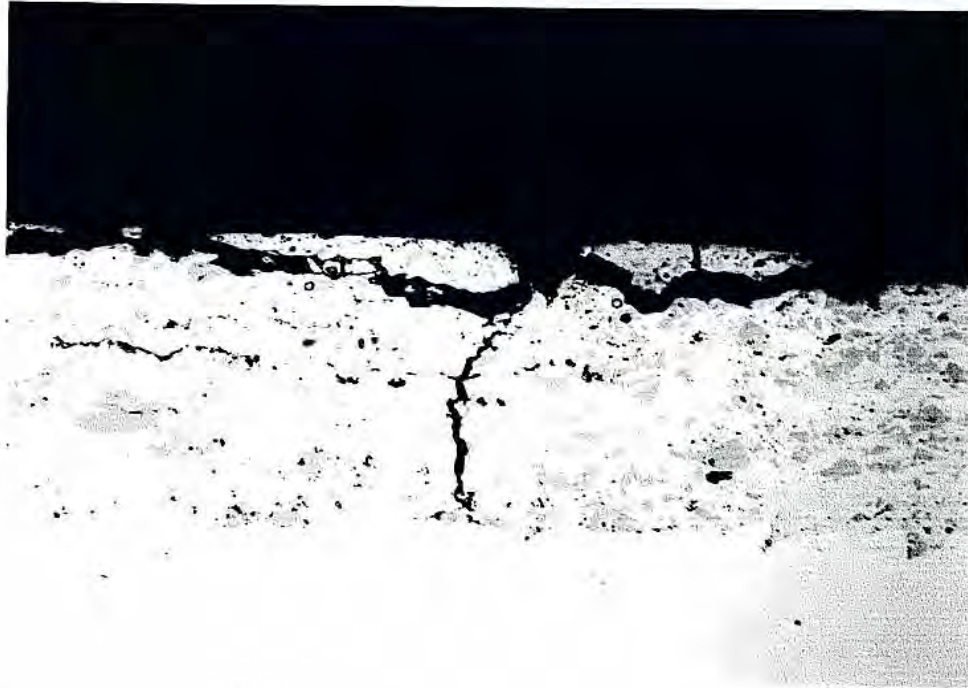
A transverse, metallographic section through a crack location where transverse cracking and also some lamination of the surface coating is observed. Magnification X 500.

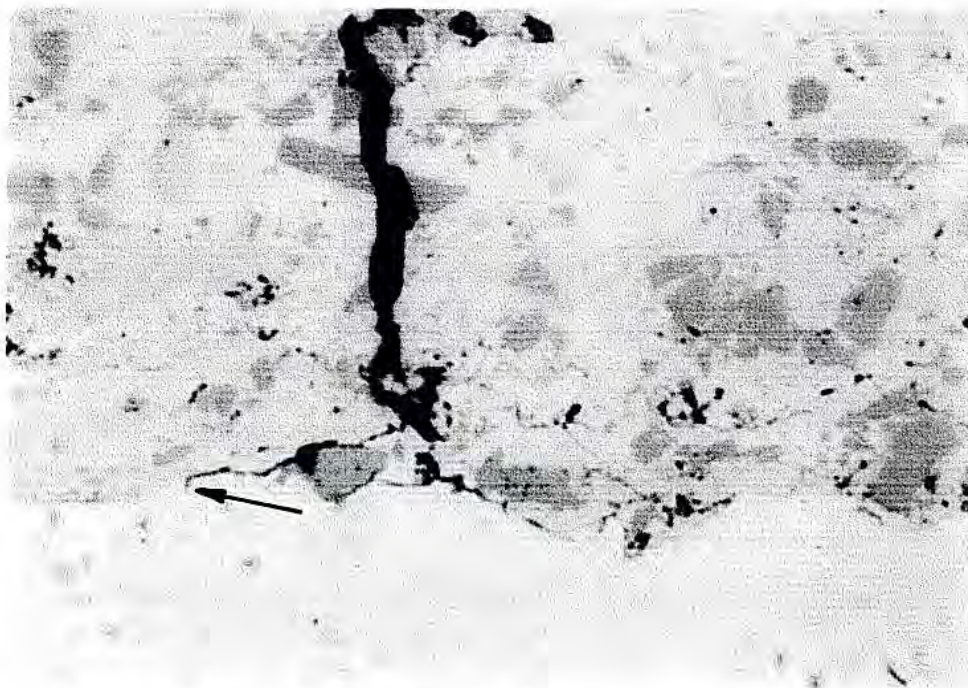
Detail from the location of the crack toe. Magnification ~X 1900.

An indication of the crack front slightly penetrating the steel surface is arrowed on the photo.

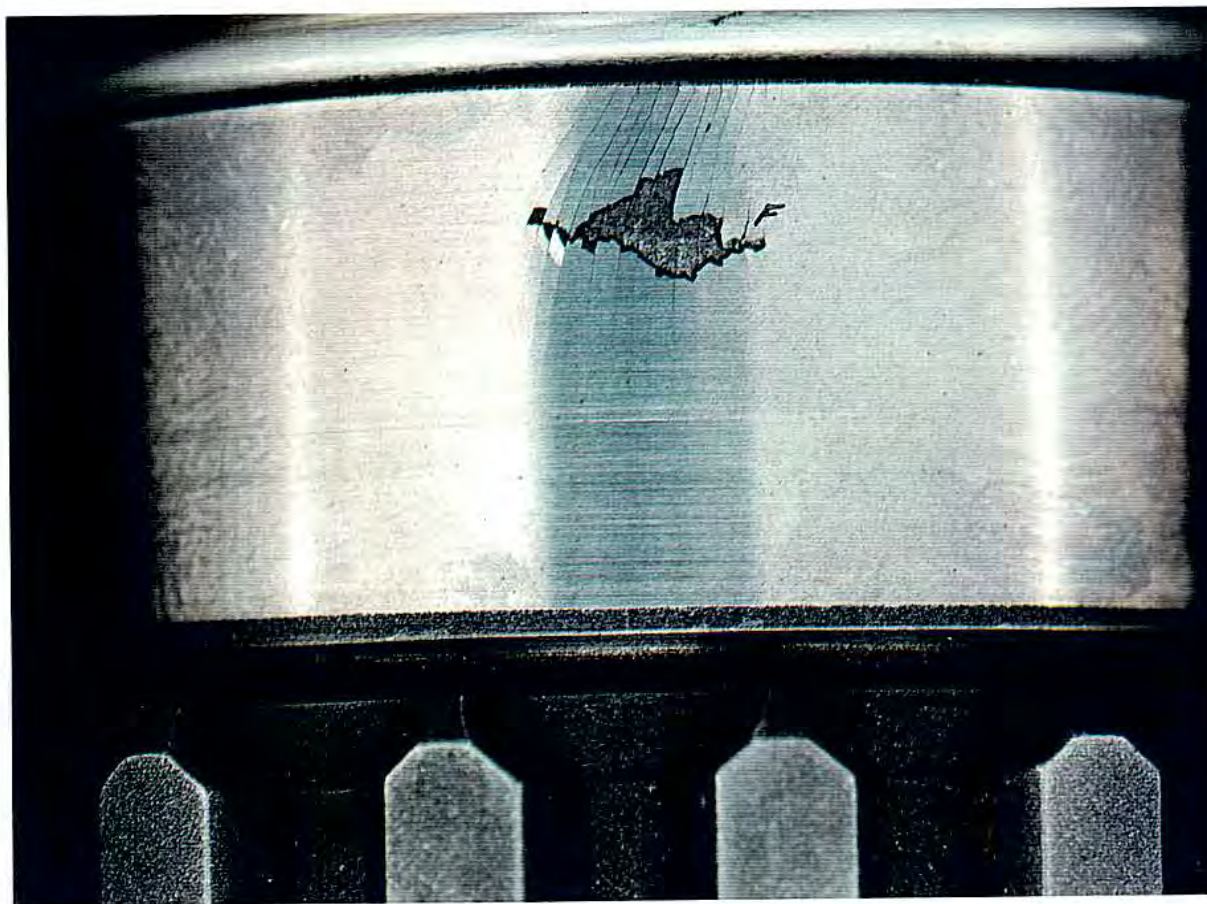
Fig. 6 Close-up view of the other surface damage on the splined sleeve
marked 332 A 32-2288-22 09 CY8 33 $\frac{ML}{3}$. The surface damage in question
is designated "F".
