REPORT

Date: 12.12.2005
SL Report: 45/2005

- Type and reg.:	Bombardier Aerospace DHC-8-311, LN-WFR	Boeing 737-800, Reg. not reported
Operator:	Widerøes Flyveselskap	Eurocypria Airlines
Radio callsign.:	WIF408	ECA978
Date and time:	Monday 29 November 2004 at 1219 and 1223 hrs.	
Location:	Bergen Flesland Airport, Norway (ENBR)	
Type of occurrence:	Air traffic incident, loss of separation	
Type of flight:	Commercial, scheduled / Commercial, non-scheduled	
Weather conditions:	ENBR METAR 1220 hrs.: 13005KT 110V170 9999 SCT025 BKN080 02/M00 Q1014 NOSIG	
Light conditions:	Daylight	
Flight conditions:	IMC	
Flight plan:	IFR (both)	
No. of persons onboard:	3+40 / Not reported	
Injuries:	None	
Aircraft damage:	None	
Other damage:	None	
Commander:	WIF408	ECA978

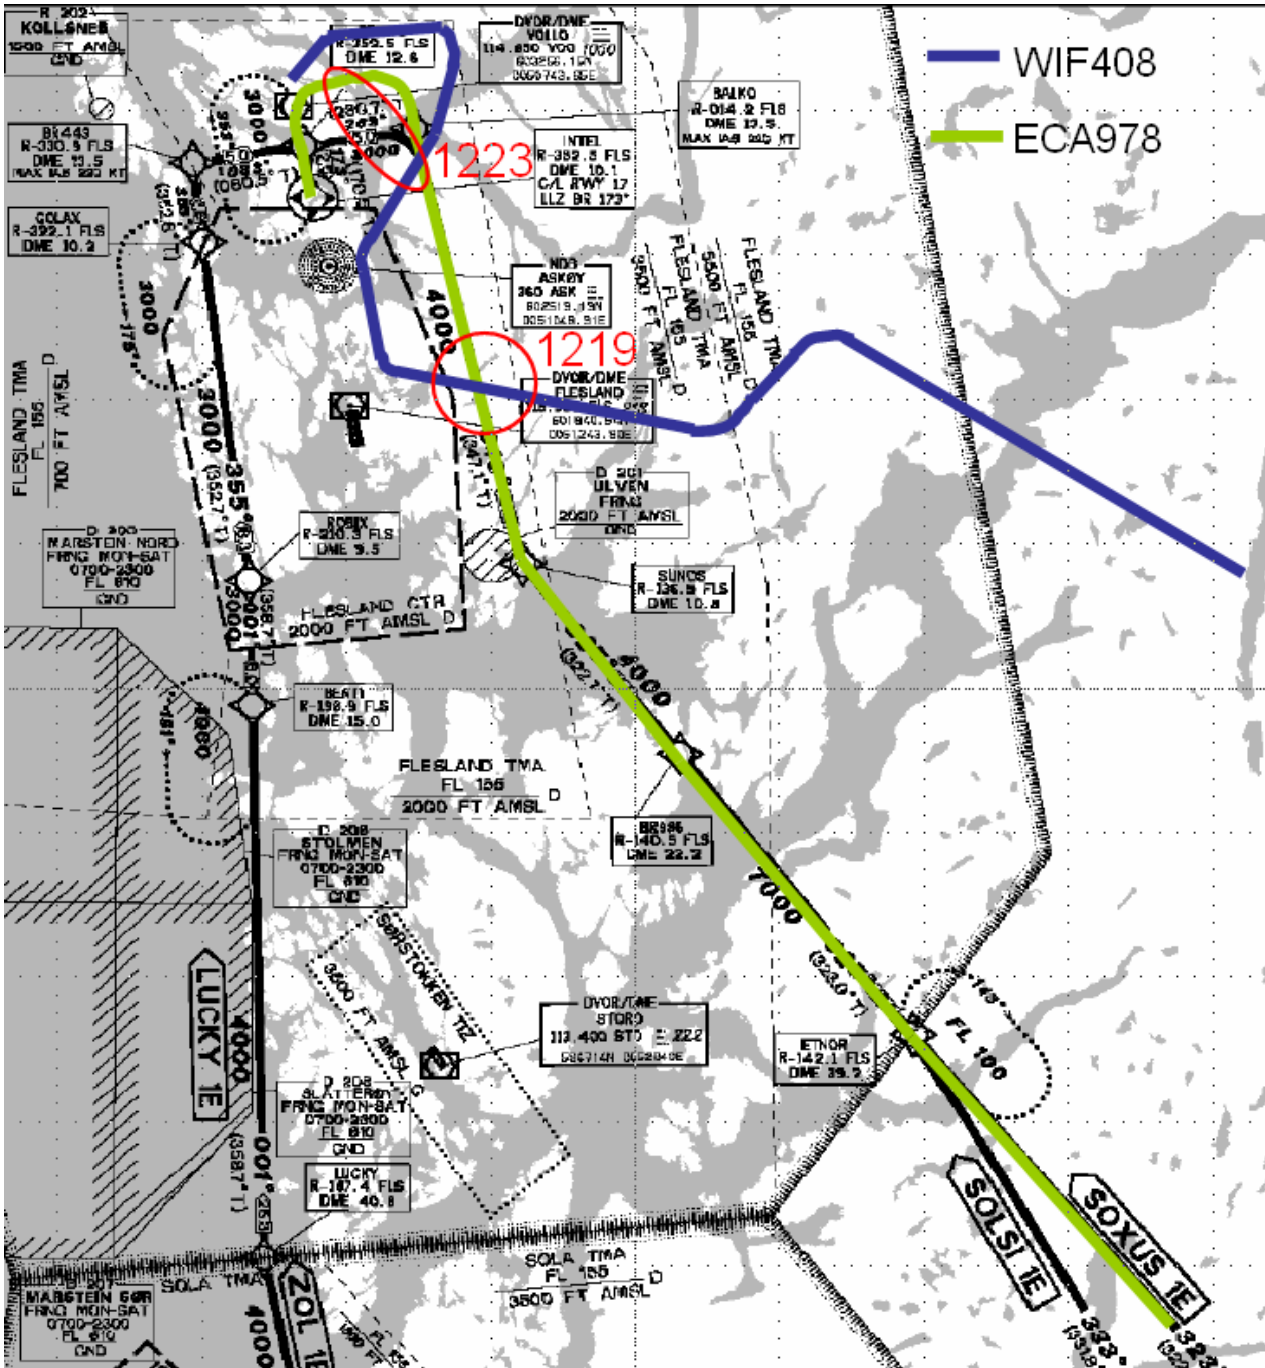
By mistake the air traffic controller cleared WIF408 direct to OKITO, a reporting point on extended centreline of RWY 35. This made WIF408 turn onto a southwesterly heading. When the air traffic controller observed the turn on the radar screen he corrected this by reclearing WIF408 direct INTEL, a point on the extended centreline of RWY 17. Sequencing was no longer favouring WIF408 due to the unintended delaying “dog leg” turn. The air traffic controller decided to keep the sequence with WIF408 as number 1 by giving WIF408 the opportunity to track direct to the field for a later visual approach. At 12:17:00 WIF408 was cleared by Flesland APP to fly heading 270° and to descend to altitude 5 000 ft, anticipating to get visual with the field in sight. Heading was adjusted to 280° one minute afterwards. Tracks of the aircraft are shown on a cut from the AIP Norway STAR Chart AD2 ENBR 4-18 in the Appendix (based on radar recording).

AIBN considers that a loss of separation occurred in Flesland TMA at 1219 hrs which lasted 30 seconds. Separation was lost due to descent clearances without rate restrictions. The descent profile of WIF408 was not like the air traffic controller assumed from previous experience and a change in descent rate led to less than minimum prescribed vertical distance to ECA798 during 30 seconds. The air traffic controller was not able to correct the reduction of vertical distance by alternate clearances.

A cut from AIP Norway AD 2 ENBR 4-18 “Standard Arrival Chart Instrument (P-RNAV STAR based on VOR/DME FLS or GNSS except Class A GPS) Arrival from S” with tracks of WIF408 and ECA978 marked, based on ATC radar recorded by Avinor.

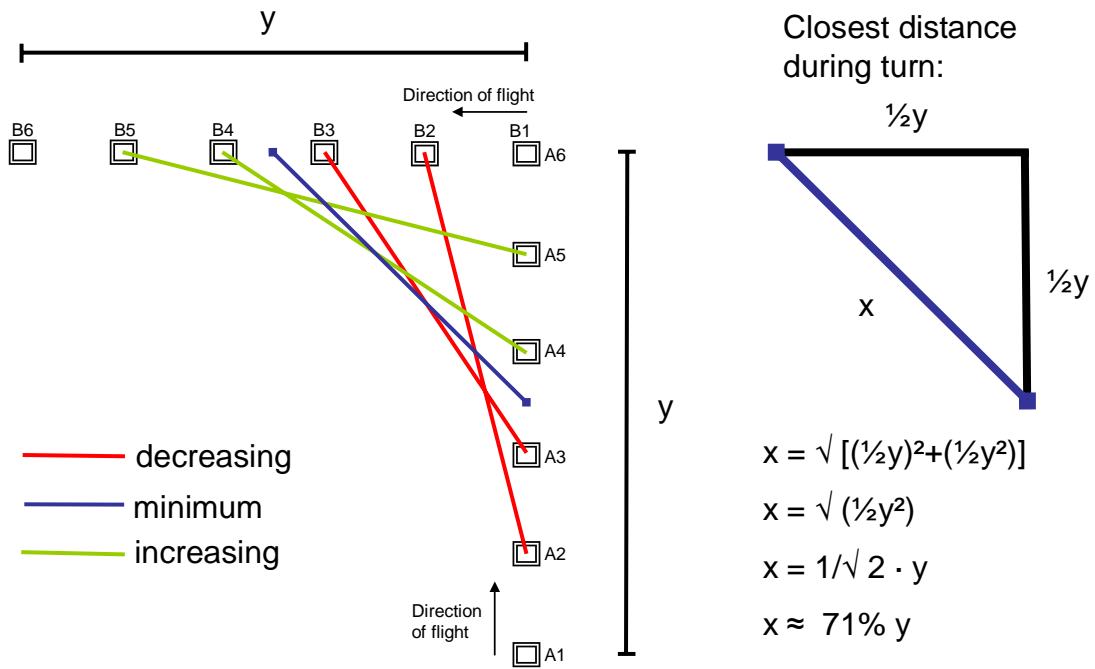
Reduction of distance during turn to base leg:

AIBN considers that a loss of separation occurred at 1223 hrs. which lasted 30 seconds. Separation was lost during the subsequent vectoring of the two aircraft to ILS-17 due to the 90° turn of the first of two trailing aircraft that were close to radar separation minimum (5 NM). After ECA798 made the turn to base leg, distance to WIF408 was reduced to a minimum of 4.6 NM before vertical separation was re-established.

The use of radar separation minima for aircraft with crossing tracks require attention to the fact that distance between them will decrease after the first has crossed ahead of the other. The same applies in this case where aircraft number 1 was given a 90° turn ahead of the other. The trailing distance immediately started to decrease until aircraft number 2 had number 1 in a position 45° away from its own track. From there on, distance started to increase.

A geometrical analysis of this situation is shown in the Appendix, depicting two aircraft. To simplify the example, both aircraft are considered to have same ground speed and follow a right angled (square pattern) radar circuit. Two aircraft with 5 NM trailing distance will have a minimum of 3.54 NM between them after a 90° turn of the first aircraft. To ensure 5 NM distance at their nearest point, trailing distance must be at least 7.1 NM at the beginning of the turn.

Aircraft A is trailing aircraft B with distance y when B is turned 90° left.
