REPORT

Sjø 2009/01

REPORT ON INVESTIGATION OF MARINE
ACCIDENT MV STAR JAVA - IMO NO 9310513
OCCUPATIONAL ACCIDENT IN SQUAMISH
18.AUGUST 2008

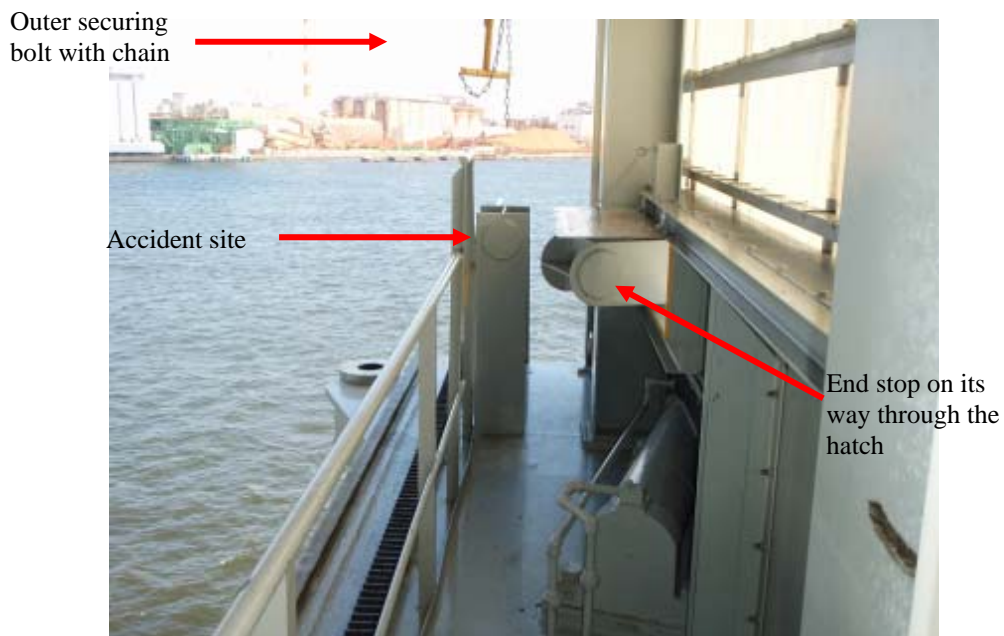
Figure 2: Accident site on top of the aft girder on starboard side, in gantry crane no. 1.

The boatswain told the cadet to open the hatch for the end stop at the port side of the aft girder. On his way towards the hatch the cadet saw that the boatswain was checking the work that he (the cadet) had done to secure the trolley. The cadet opened the port hatch and then checked that the sliding roof section was properly secured by the outer securing bolt, before moving inboard again, towards the centre of the girder. On his way in along the girder he saw the boatswain standing by the outer securing bolt at the aft end of the starboard sliding roof section (see figure 1). The cadet spoke to the boatswain, but received no answer. So he walked out towards the boatswain and saw that he had been struck by the end stop on the starboard aft jib. He shouted that the boatswain was trapped by the end stop. The seaman down on the manoeuvre platform heard the deck cadet cry out, realised that something was wrong and started to swing the jib back out.

The electrician also heard the deck cadet's shout and went into the crane to find out what had happened. He saw that the boatswain was trapped by the end stop. As he ran towards the site of the accident, he used his UHF radio to report that there had been an accident and to summon help.

The fact that the end stops move through the crane's protective walls without a sound, passing a walkway which may be occupied by personnel, is regarded as a safety problem. The AIBN recommends that the crane manufacturer seek alternative solutions for new cranes.

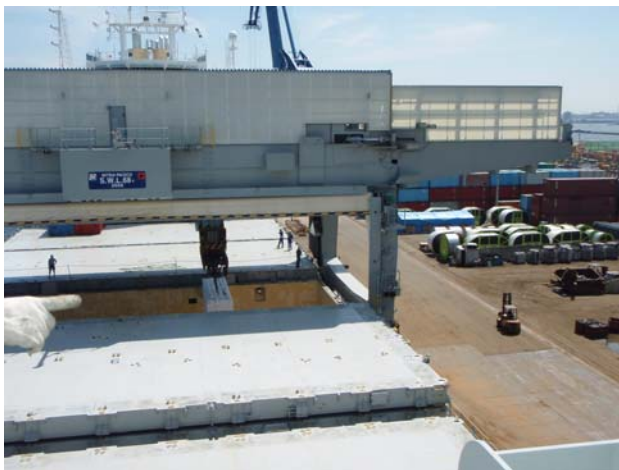
In addition to permanent roofs, the current generation of cranes have sliding roofs on the starboard and port sides, which can be extended over the jibs. In addition, the upper parts of the cranes are protected by fixed walls (from the girders and up to the roof) at the forward and aft ends. This is the most usual design for cranes delivered after 1994/95. Figure 6 shows gantry crane no 2 on MV *Star Java*, looking aft.

Figure 6: Enclosed gantry crane.

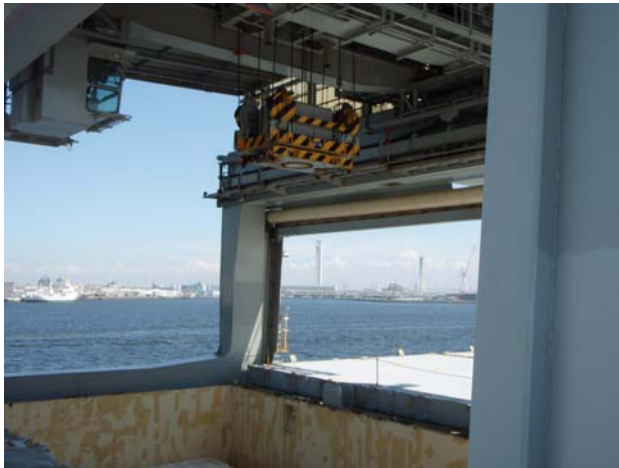
It is not possible to see the walkway on the forward girder or the walkway on the starboard side of the aft girder from the manoeuvre platform down on the crane leg (see figure 7). Depending on the shifting trolley's position it may also be impossible to see the walkway on the starboard side of the aft girder.

Figure 7: View from the manoeuvring platform.

In the Accident Investigation Board's opinion, the transfer of the manoeuvre panel to the fore port crane leg, combined with the top of the crane being increasingly enclosed, has contributed to reducing the overview of the securing operation as a whole and hence reduced the safety of the personnel involved.

Personnel safety has been reduced by the development towards increasingly enclosed cranes and centralisation and transfer of the manoeuvre panels, combined with the choice of operational solutions whereby personnel are present up on the crane during the securing operation. The AIBN recommends that the shipping company, on the basis of a risk assessment of the crane securing operation, reviews its procedures with particular focus on organisation, supervision and communication.

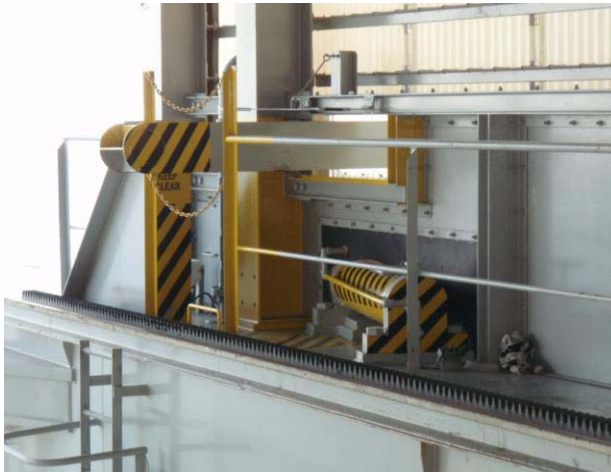
Figure 8: Accident site after marking.

The shipping company uses the reporting and improvement system SAFIR as part of its safety management system. On the basis of the accident on board MV *Star Java* on 18 August 2008 and the accident report in SAFIR, the shipping company has conducted a risk assessment of the work of securing the gantry cranes and implemented improvement measures. On all the shipping company's ships, the areas where the end stops pass over walkways on the girders are marked as dangerous (see figure 8). On those of the shipping company's ships that have the newest generation of enclosed cranes, an audio alarm is being installed, which is activated when the jibs are swung. The shipping company has discussed the accident on *Star Java* as a separate topic during its annual 'Officers conference' which is attended by all the company's officers who are at home on leave.
