**SL RAP.: 8/2006**

**REPORT ON THE AIRCRAFT ACCIDENT AT BERGEN  
AIRPORT FLESLAND, NORWAY, ON 31 JANUARY 2005  
INVOLVING ATR 42-320, OY-JRJ, OPERATED BY DANISH  
AIR TRANSPORT**

Manufacturer and model:   Aerospatale/Aeritalia ATR 42-320  
Nationality and registration:   Danish  
  OY-JRJ

Accident time:         Monday 31 January 2005, at time 1128.

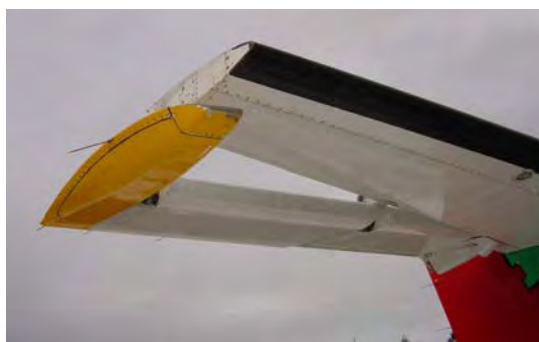
After landing it was found that the control problems were caused by the right elevator hanging below the horizontal stabiliser, attached only by the inboard of the three hinges that normally connect the elevator to the stabiliser. A bolt was missing from both the centre and outer hinges. Both of the bolts and one of the nuts that normally should connect the hinge assemblies together were found. One of the bolts was found on the runway, the other inside the elevator.

- 1.1.9 When the crew left the aircraft and inspected the aircraft the cause of the control problems became immediately apparent. The right elevator had detached completely from the hinges that normally connect the elevator surface to the horizontal tail surface (the stabiliser). Only the inboard hinge next to the tail fin was still intact. The tip of the elevator was hanging 30 cm below the stabiliser.

Fig. 1 OY-JRJ's elevator seen after landing

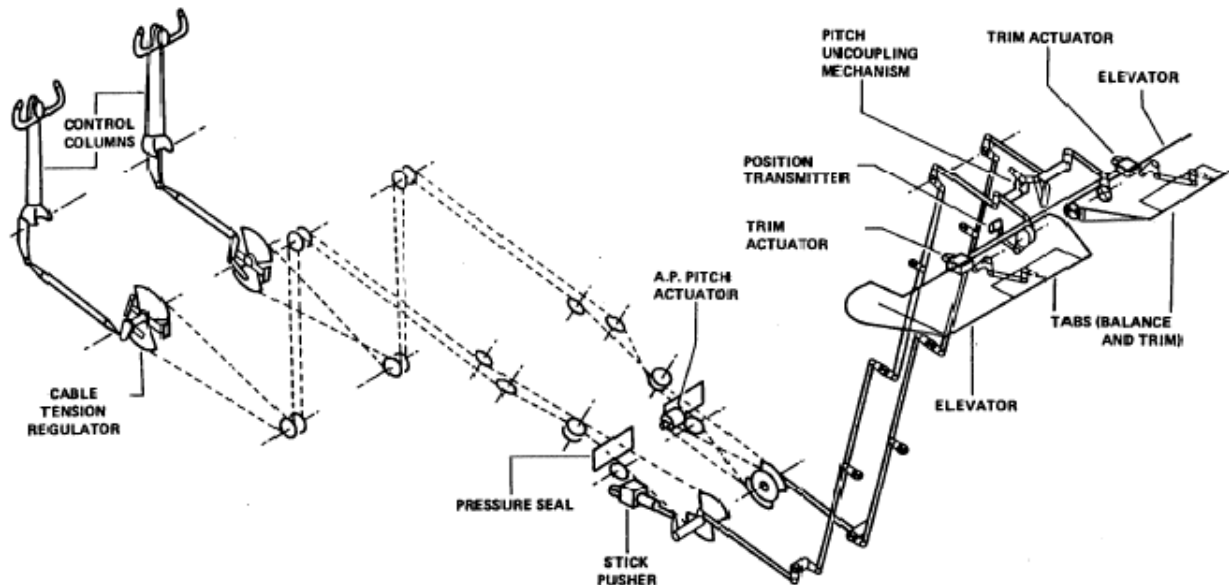
The movement of the aircraft around its lateral axis is controlled by two elevators, both equipped with tabs. The elevator and tabs are controlled mechanically, while the tabs are also controlled electrically for the trim function. The commander's and first officer's control columns operate the left and right elevators respectively, using rod and cable linkages. The links from the left and right systems are interconnected in a mechanism that is located between the elevators, inside the horizontal tail surface. If one of the systems jams for some reason, the connection will break when the column force exceeds a set value (525 N +/- 25 N). (Pitch uncoupling mechanism). This means that it will still be possible to control the aircraft using the other system.

The connection between the right and left systems was still intact on OY-JRJ after landing.

Fig. 2 Mechanical elevator controls

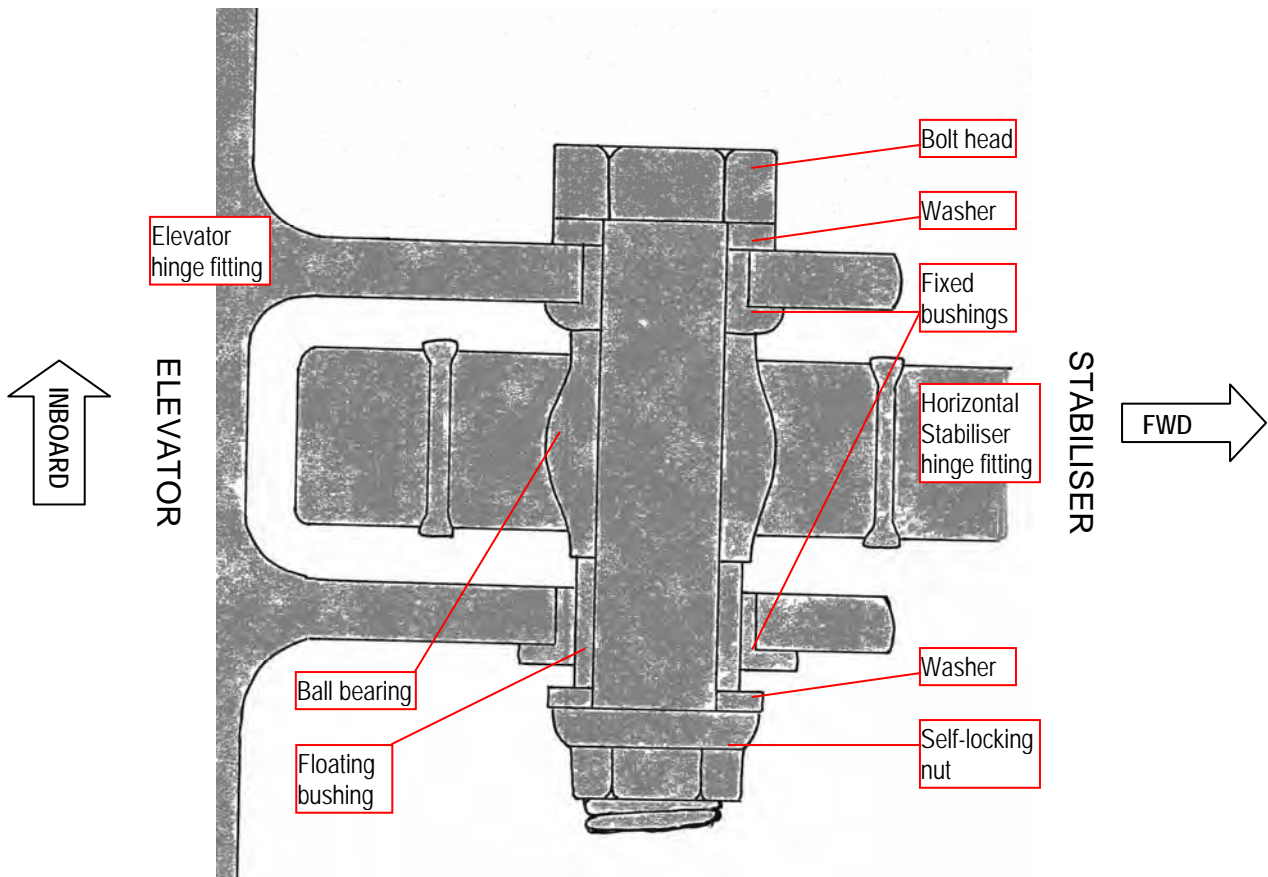
The three hinge assemblies that connect the elevator to the horizontal stabiliser have all been constructed in the following way (See fig. 3): A hinge lug on the stabiliser has a ball bearing fitted in its opening. A cadmium plated bolt is led through the ball bearing and the associated flange on the elevator. The bearing is a spherical ball bearing that can move a limited number of degrees in relation to the longitudinal axis of the bearing. This allows the centre of all three bearings to be adjusted linearly with respect to each other when the bolt/nut assembly is tightened. The assembly consists of a “floating bushing” and two washers, and the parts are kept in place by a self-locking nut. Tightening torque for the nut which holds everything together should, according to the installation instructions, be 3.9 – 4.5 MDAN (343 – 396 lb in).

Fig. 3 Simplified sketch of elevator hinge assembly

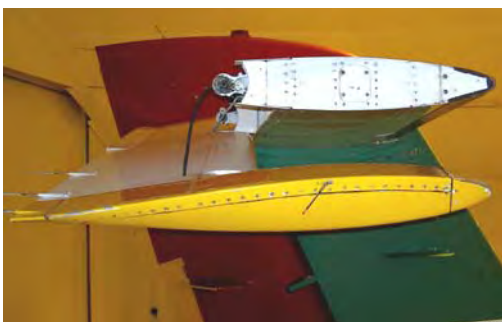
Visual inspection was made and photographs taken before the elevator was dismantled. There was a bolt missing from both the centre and outer hinges. The condition of the inboard was normal; the nut was tightened, washers and bushings were in place and the bolt was not bent. There was no sign of deformation of the stabiliser.

Fig. 4a The right tail surface from the side

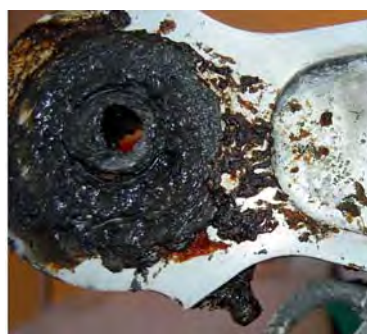
Fig. 4b Outboard hinge point

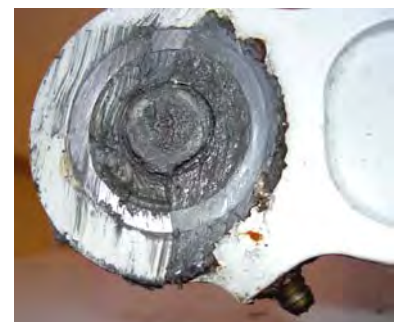
Fig. 4c Centre hinge point

- 2.3.5 The following findings indicate that the centre hinge bolt fell out earlier than the outboard bolt:
- Presence of grease in the centre bolt hole indicates that lubrication has taken place while the bolt was missing

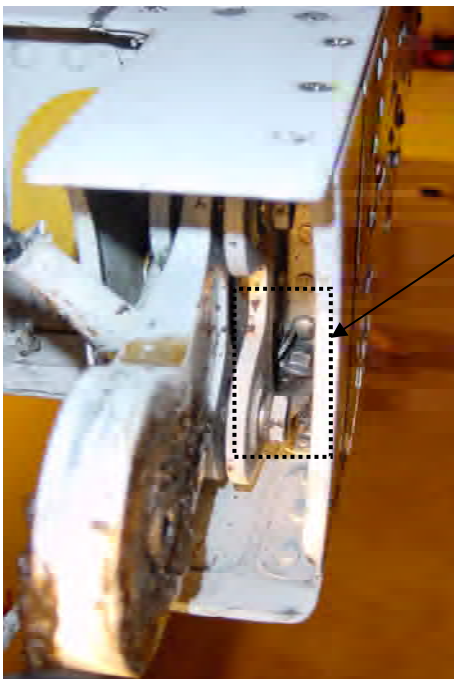
*Fig. 6a Outboard hinge point right stabiliser*

- 2.3.6 The nut that was found by the outboard hinge was not worn. The self-locking force, which is equivalent to 33 lb, would in the opinion of AIBN have been sufficient to keep the assembly in place if the nut had been tightened in accordance with the specifications.

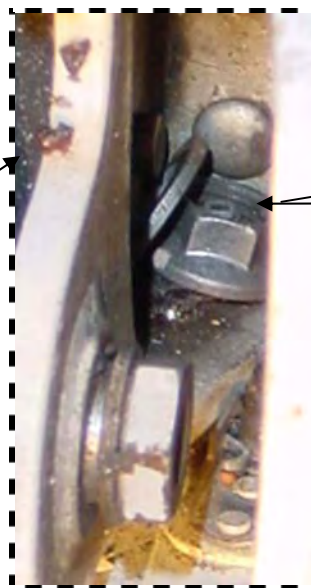
*Fig. 6b Washer and nut*

In connection with investigation of this accident, the self-locking nut from the outboard hinge screwed onto the bolt from the outboard hinge using finger force, and tightened with a tool until two threads of the bolt were visible on the "outside" of the nut. The torque that was necessary to turn the nut further was measured at 33 lb in. This is the torque that is necessary to break the self-lock on the nut in the condition that it was in when it was found (uncleaned and not lubricated). In comparison, the self-locking nut from the inboard hinge was installed on the same bolt (outboard hinge bolt). The equivalent measure torque was 50 lb in.

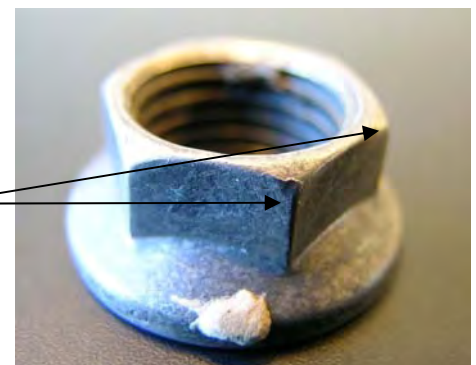
*Fig. 6c Nut with tool marks and torque seal*

- 2.3.2 In the opinion of the AIBN, the self-locking nuts on the centre and outboard hinges cannot have been tightened with the required torque, as they are not exposed to forces that could cause them to loosen. (No rotational forces). The maintenance documentation shows that the bolts/nuts have not been touched since 1999. This indicates that the installation carried out in France in 1999 was not according to specification. It is most probable that the two nuts were only applied/tightened finger tight, without this being discovered.

Incorrect installation of the nuts on the hinge bolts on the elevator was not discovered. The manufacturer's maintenance documentation does not specify that installation of elevators must be double checked. The maintenance organisation has responsibility for identifying which maintenance tasks and processes are critical to safety and require special measures for discovering and correcting any errors found. At the same time, the operator is responsible for specifying what maintenance work should be carried out, and to what standard it should be carried out, when it purchases maintenance services from a maintenance organisation. In the opinion of the AIBN this division of responsibility may lead to the systematic assessment and specification of which tasks should be double checked not taking place. For this reason, the AIBN recommends that

JAA/EASA consider whether the regulations should be amended in order that systems that are critical to safety are double checked following maintenance work. Special consideration should be made as to whether the manufacturer should be given a responsibility on this matter. (AIBN recommendation 12/2006).

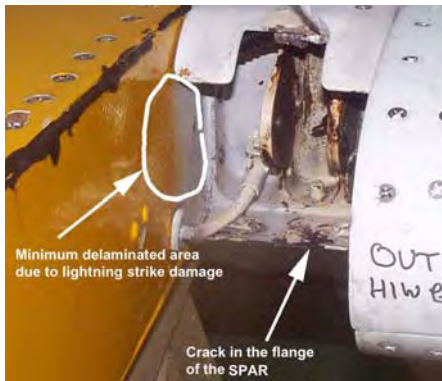
Closer investigation revealed that, in addition to the visible damage to the leading edge fairings, there was damage to the main beam. There were also traces of three lightning strikes. This meant that the elevator had to undergo comprehensive repair before being reintroduced to operations.

*Fig. 7a The damage to the main beam flange at the outboard hinge*

- 2.3.1 In the opinion of AIBN, the damage to the leading edge fairings and the flange on the main beam resulted from abnormal movement when the hinges became loose. The lightning strike marks that were discovered subsequent to the event are assumed to be of an earlier date, and had no effect on this occurrence.

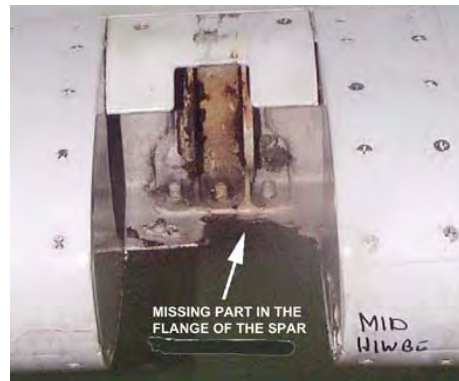
*Fig. 7b The damage to the main beam flange at the centre hinge*

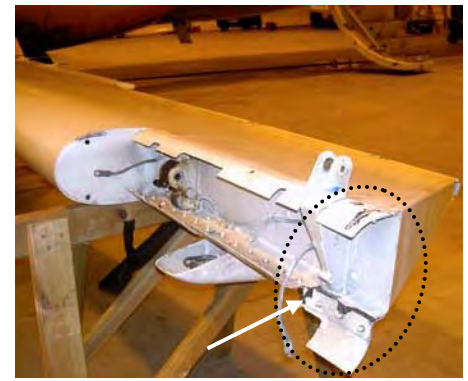
*Fig. 7c Damage to the elevator's leading edge fairings close to the tail fin*
