Investigation of an aviation incident after departure from the Linus offshore oil installation on the Ekofisk field

On 5 June 2023 a Sikorsky S-92A helicopter had an uncommanded engine failure shortly after take-off from the offshore oil installation Linus platform near the Ekofisk field in the North-Atlantic.

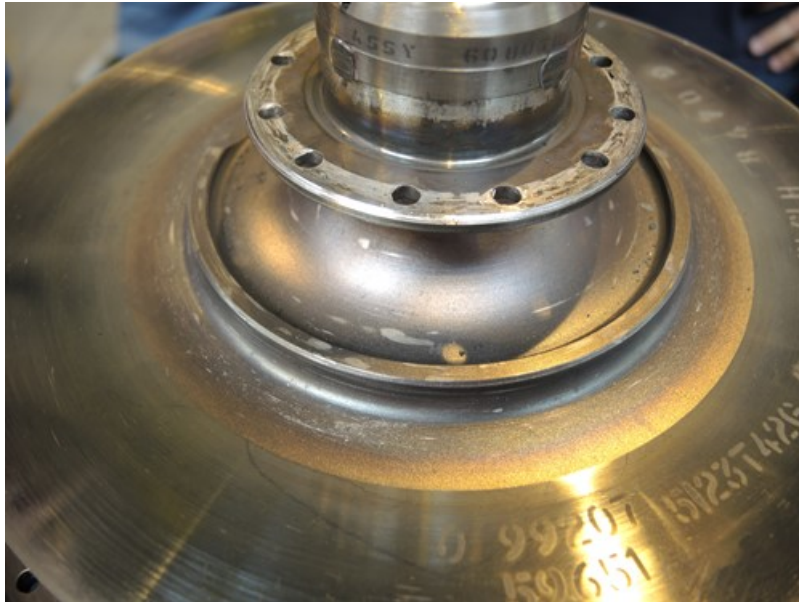
The investigation revealed that twelve bolts joining the compressor and gas generator turbine had ruptured.

Aft flange of the centrifugal Impeller. Photo: NSIA

The NSIA has carried out a metallurgical examination of the twelve bolts. Fatigue has probably started in two of the bolts. The load then increased on the remaining bolts and after a while all twelve bolts ruptured.

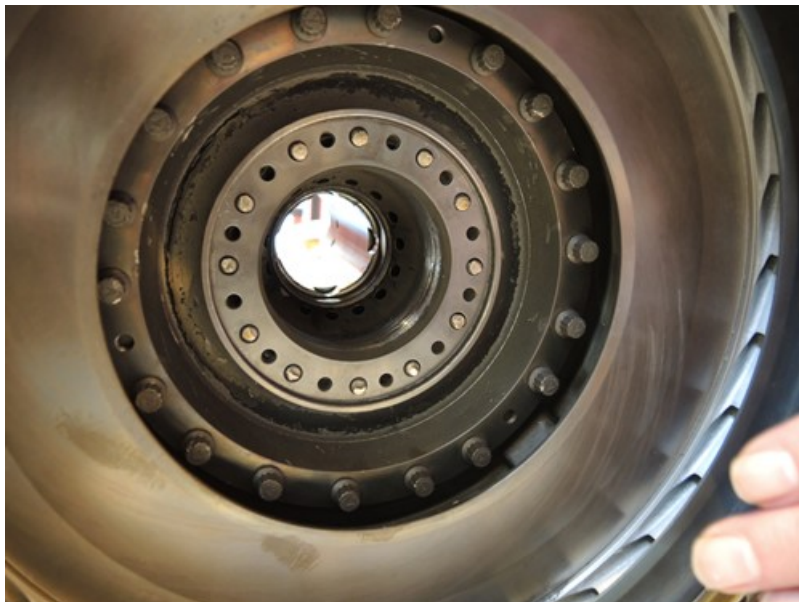
Forward flange of the turbine shaft. Photo: NSIA

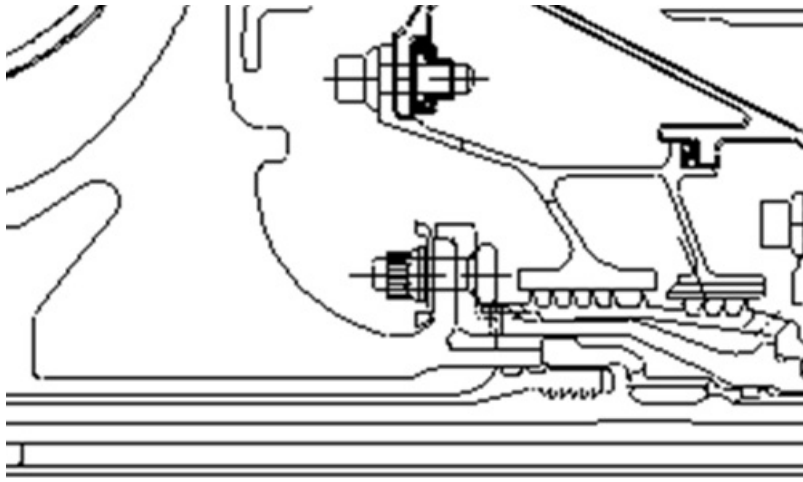
Close view of affected connection. Illustration: General Electric
