Report on collision involving a truck-mounted crane and a pedestrian bridge on the FV 5210 road in Bergen 31 July 2023

Road traffic report 2024/06

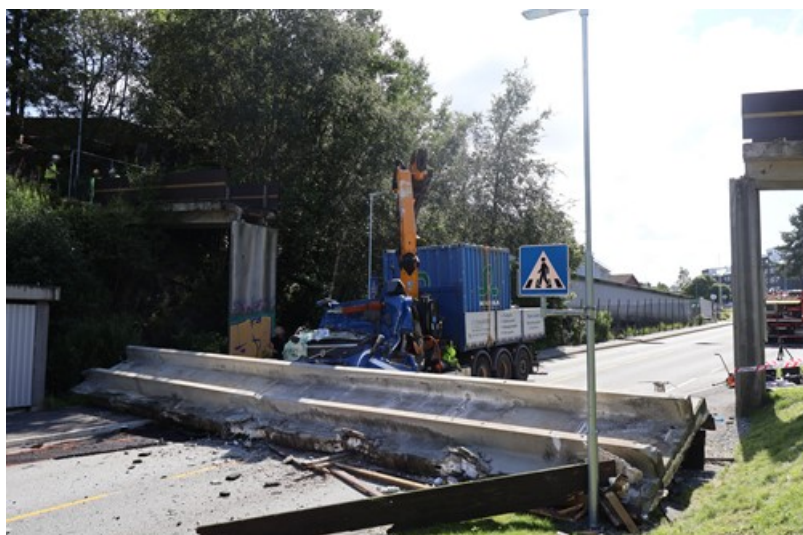
The accident on the FV 5210 road in Bergen on 31 July 2023 occurred when a truck with a raised crane arm struck a pedestrian bridge. The crane arm was 6,3 m high and the bridge was approximately 4,8 m above the roadway. The concrete element fell on the truck's cab and the driver died.

The accident site on the FV 5210 road in Bergen 31 July 2023. Photo: NPRA
