Investigation of aviation accident near Reinsvoll airport in Innlandet county, Norway

Update 10 January 2024

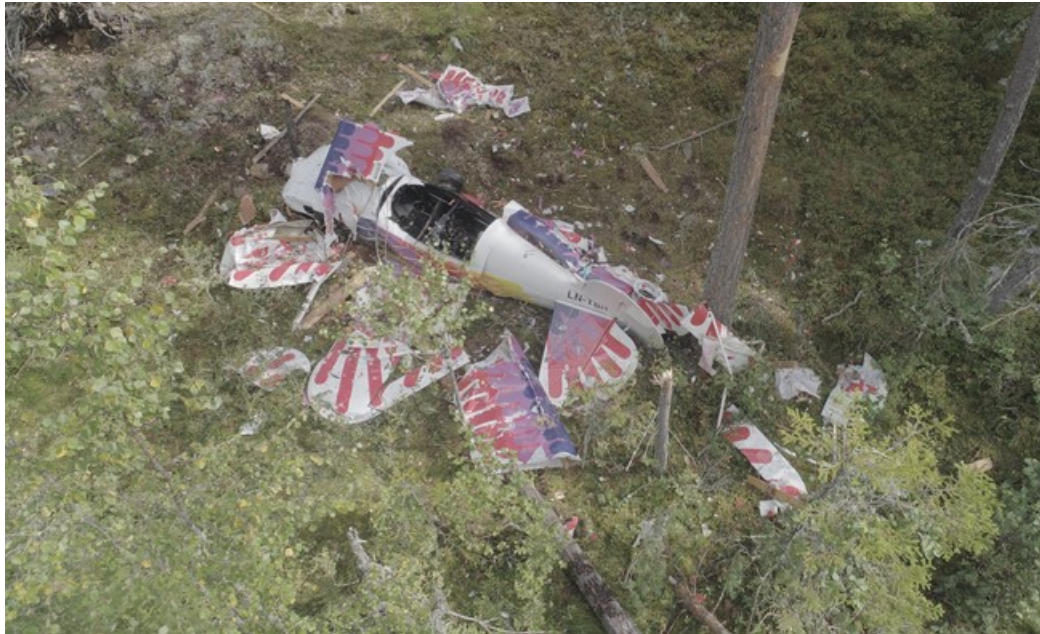
Several witnesses have reported to have heard the airplane during the flight and thought the noise from engine was abnormal, as if it was running rough or backfiring. So far it has been difficult to build a clear picture of when and where the airplane was when they heard this. One of the trees at the site of the accident was cut in a way that suggests the propeller was rotating as

the airplane went down. There are other signs as well that the engine was running at the time of the accident. Inspections of the engine, propeller and fuel supply systems have not uncovered any technical faults. However, engine problems cannot be excluded as a cause or contributing cause to the accident.

The crash site. Photo: NSIA
