Investigation of aviation accident near Reinsvoll airport in Innlandet county, Norway

Update 10 January 2024

Latest update: 16.09.2024.

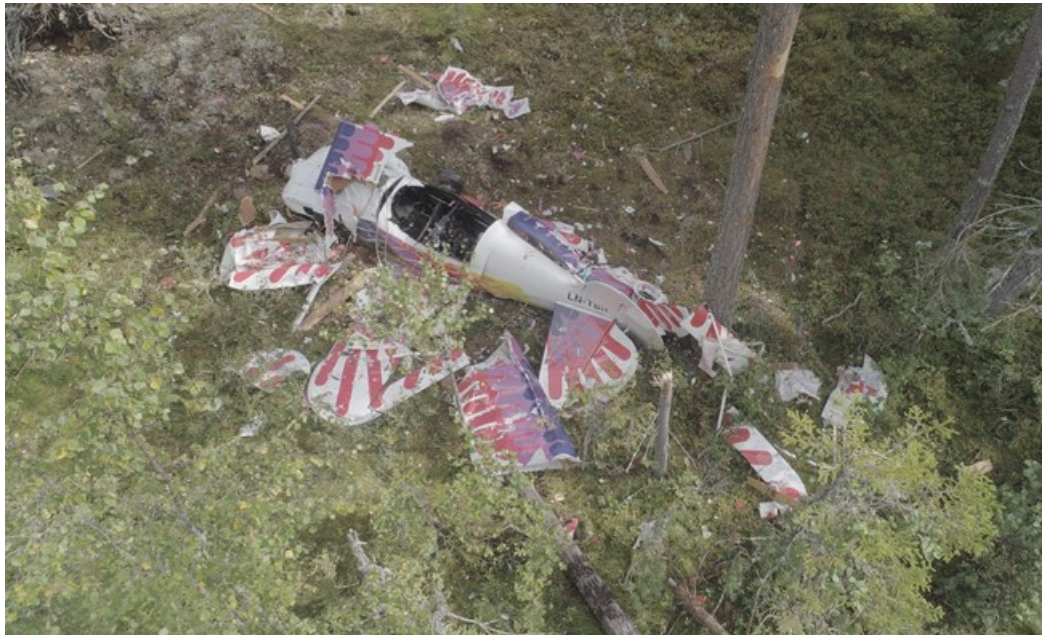
difficult to build a clear picture of when and where the airplane was when they heard this. One of the trees at the site of the accident was cut in a way that suggests the propeller was rotating as the airplane went down. There are other signs as well that the engine was running at the time of the accident. Inspections of the engine, propeller and fuel supply systems have not uncovered any technical faults. However, engine problems cannot be excluded as a cause or contributing cause to the accident.

The crash site. Photo: NSIA
