# Report on aviation accident near Reinsvoll airport in Innlandet county on 28 August 2023 with Christen Eagle II, LN-TBN

## Aviation report 2025/08

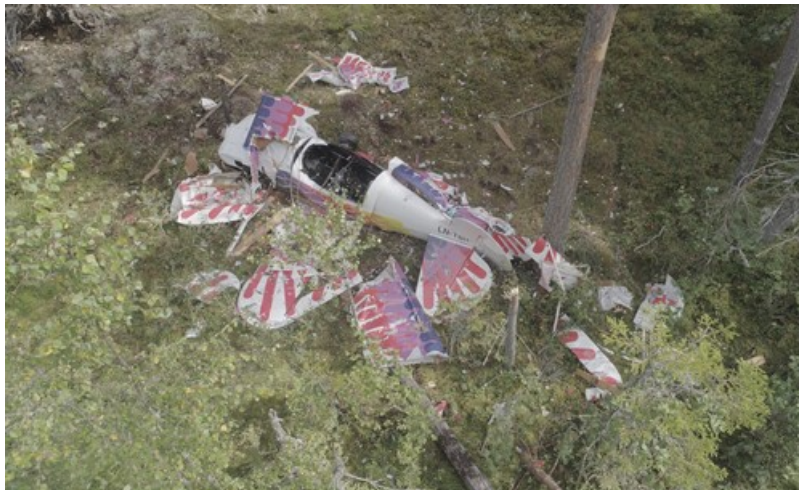
The airplane took off at 1817 hrs, and after flying sightseeing over Toten for approximately 30 minutes, they returned Reinsvoll where they performed some basic aerobatic manoeuvres over the airfield. After the last manoeuvre, they continued south for 2–3 km before turning back towards the airfield. At this point, witnesses described hearing the engine sputter for two or three seconds before running normally again. Just south of the airfield, they turned westward in a wide left turn before approaching the airfield again from the south-west. On the way towards the airfield, witnesses have stated that the aircraft nose suddenly pitched down. Three witnesses believe they heard a bang just before the aircraft pitched down. The aircraft was located in the forest about 550 metres south of the threshold of runway 34 at Reinsvoll.

*The accident site. Photo: NSIA*
