## Investigation of aviation accident west of Sotra

On the evening of Wednesday 28 February 2024, a Sikorsky S-92A helicopter, LN-OIJ, operated by Bristow Norway AS crashed during SAR training in night conditions after departing from Flesland (ENBR).

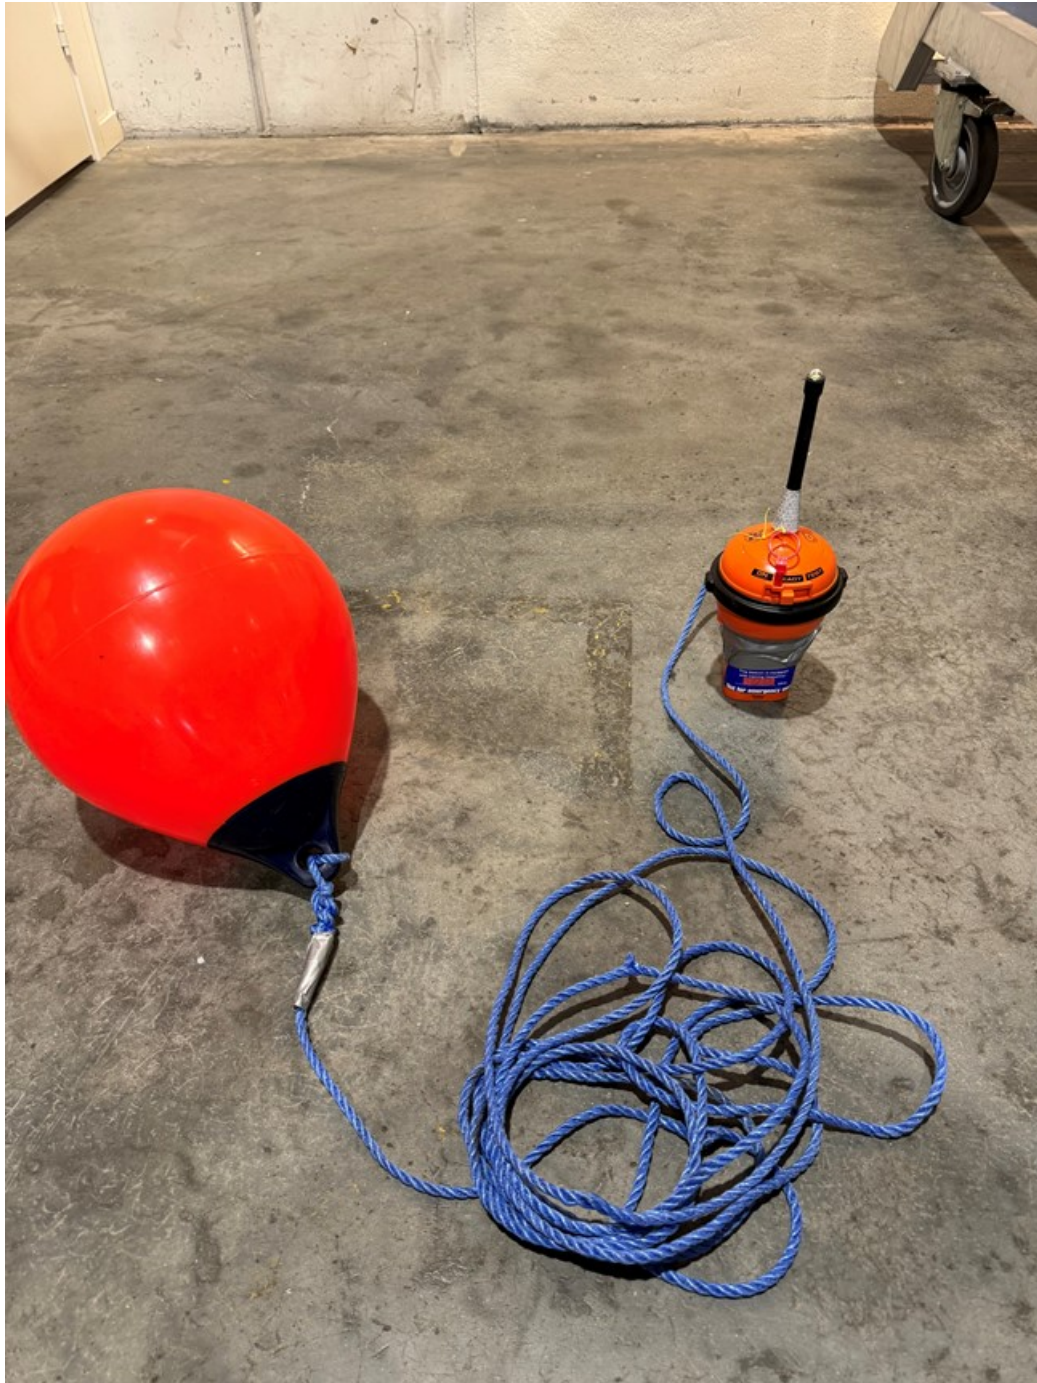
*A training beacon like the one the helicopter crew dropped: Photo: Bristow Norway AS / NSIA*

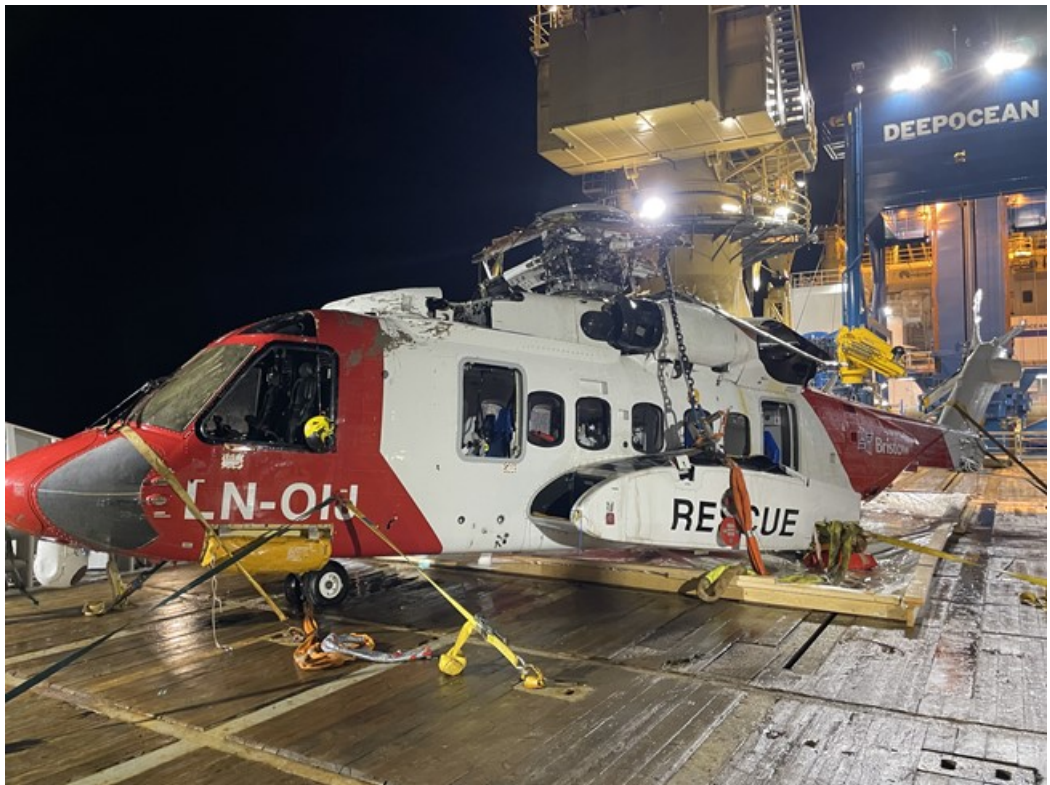
*The helicopter recovered on deck of the offshore vessel Normand Ocean. Photo: NSIA*

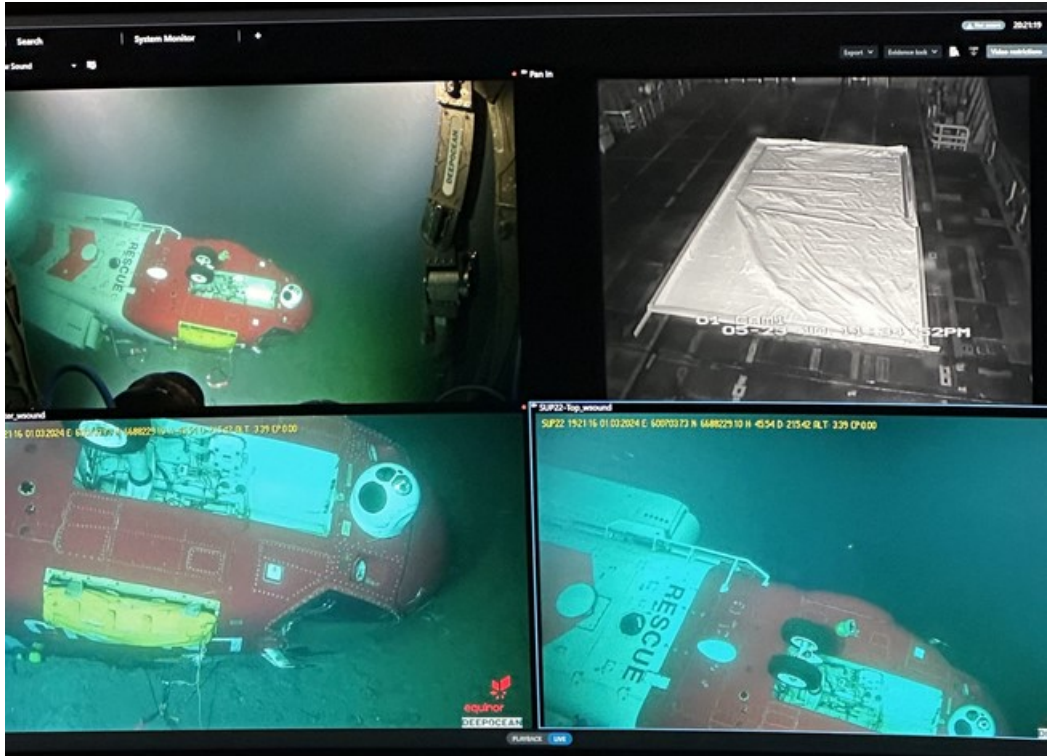
*ROV images of the helicopter when discovered on the sea bed. Photo: Normand Ocean/NSIA*
