# Investigation of aviation accident west of Sotra

On the evening of Wednesday 28 February 2024, a Sikorsky S-92A helicopter, LN-OIJ, operated by Bristow Norway AS crashed during SAR training in night conditions after departing from Flesland (ENBR).

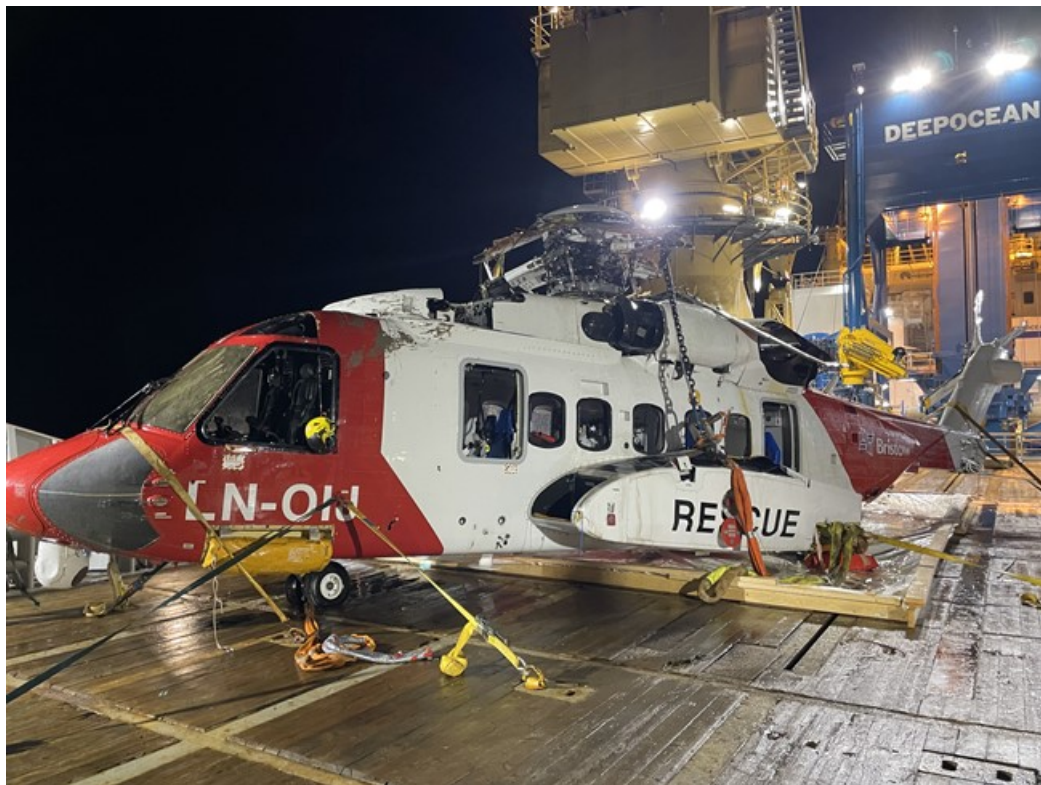
*The helicopter recovered on deck of the offshore vessel Normand Ocean. Photo: NSIA*

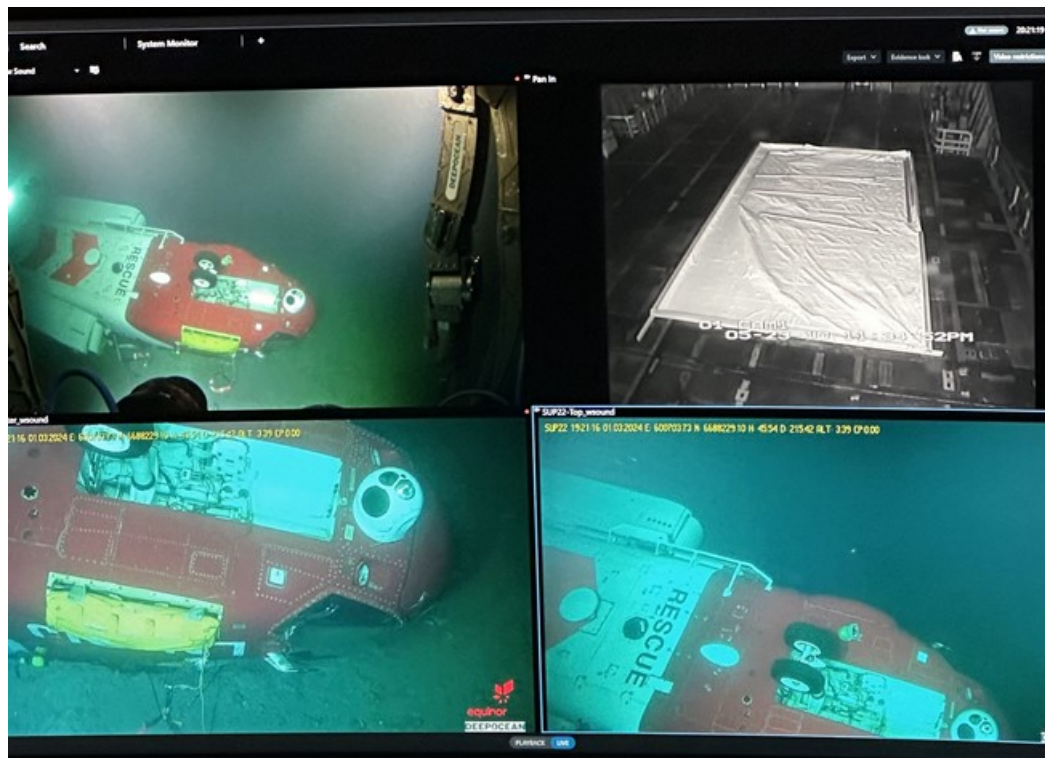
The NSIA has contracted an offshore ship to continue the search and recovery of the helicopter. During March 1st. 2024, the ship was in position at the accident site. The wreckage was found at 20:14 hours at approx. 220 meters depth. Recovery was carried out during the night and the helicopter was taken to Haakonsværn naval base.

*ROV images of the helicopter when discovered on the sea bed. Photo: Normand Ocean/NSIA*

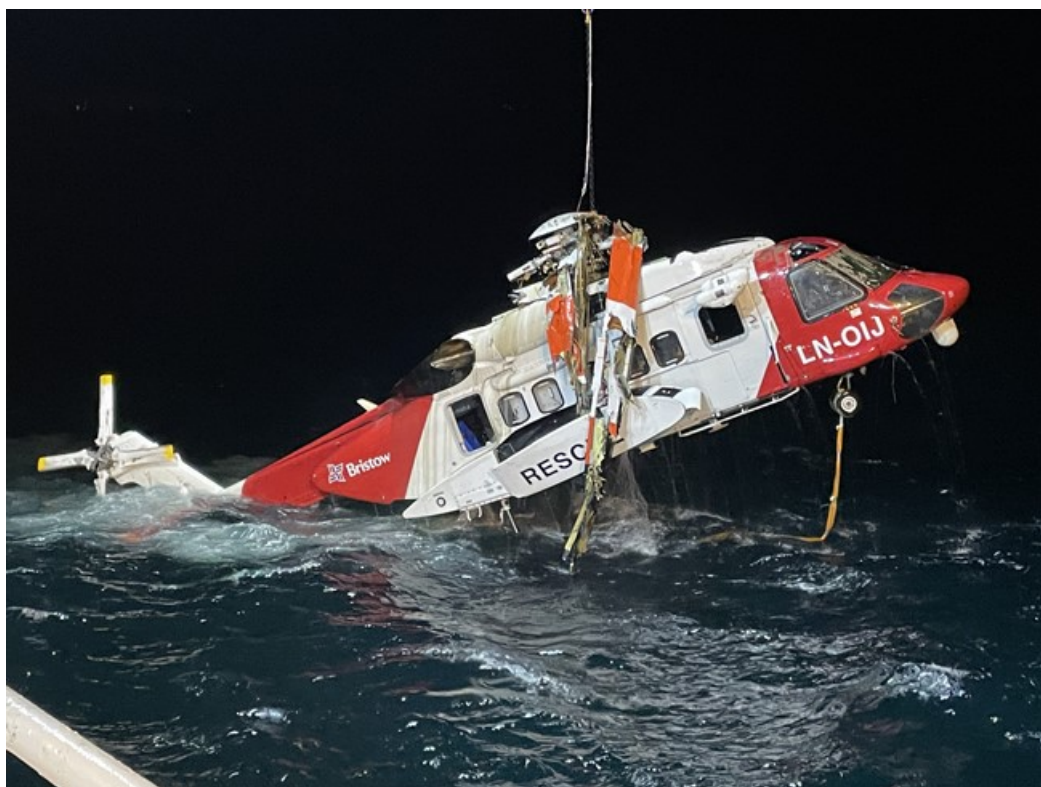
*Helicopter recovered in position west of Bergen. Photo: NSIA*

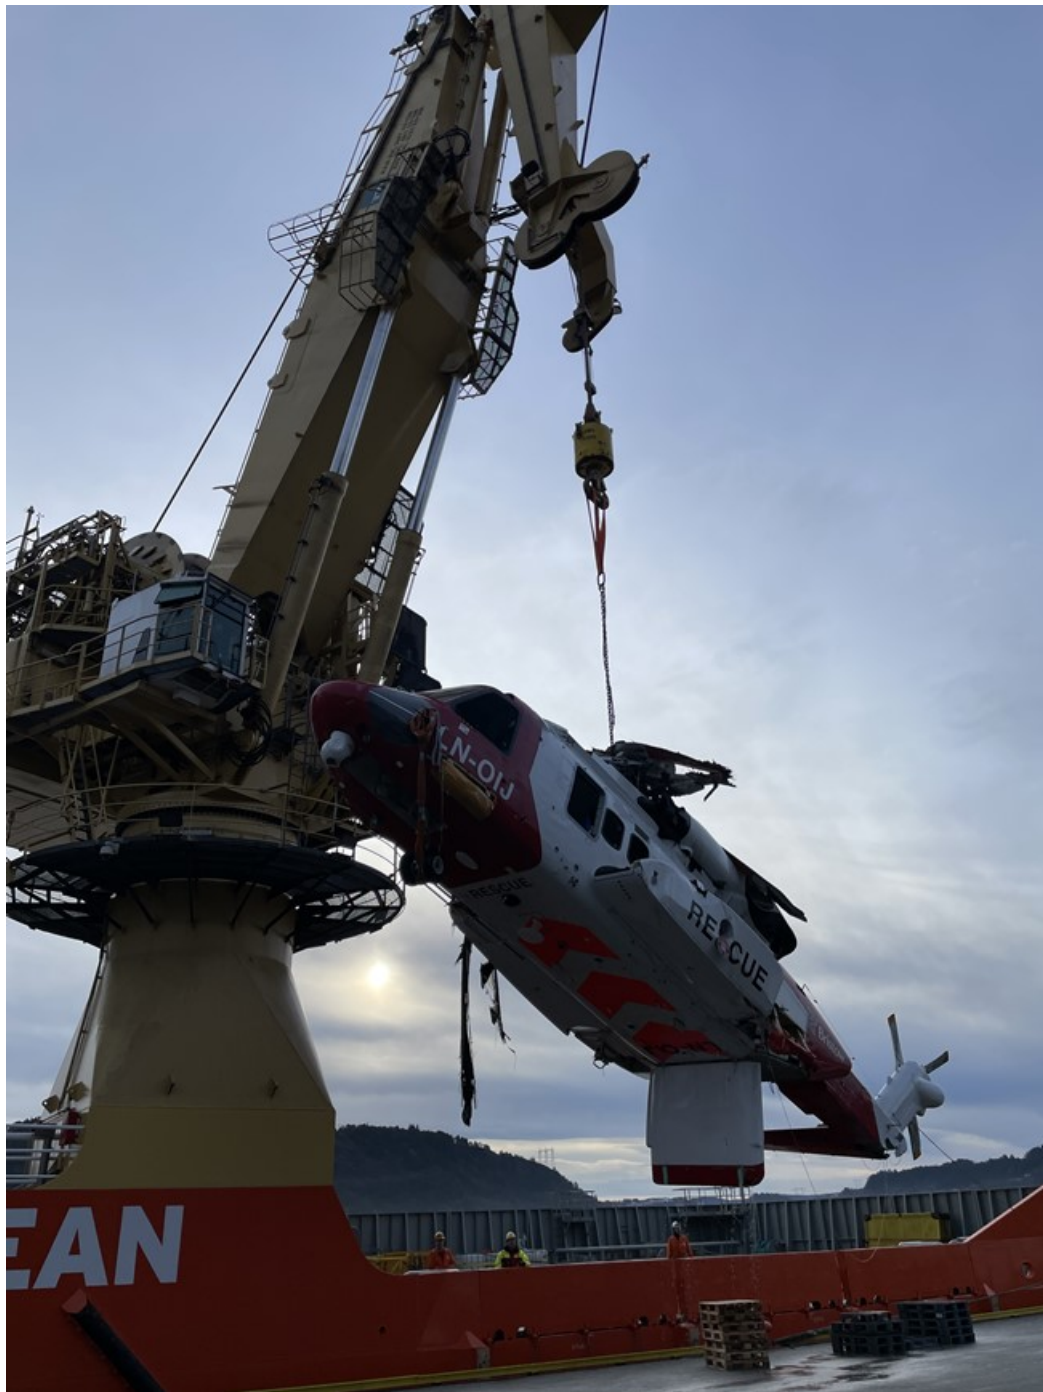
*Helicopter lowered onto the pier at Haakonssvern naval base. Photo: NSIA*

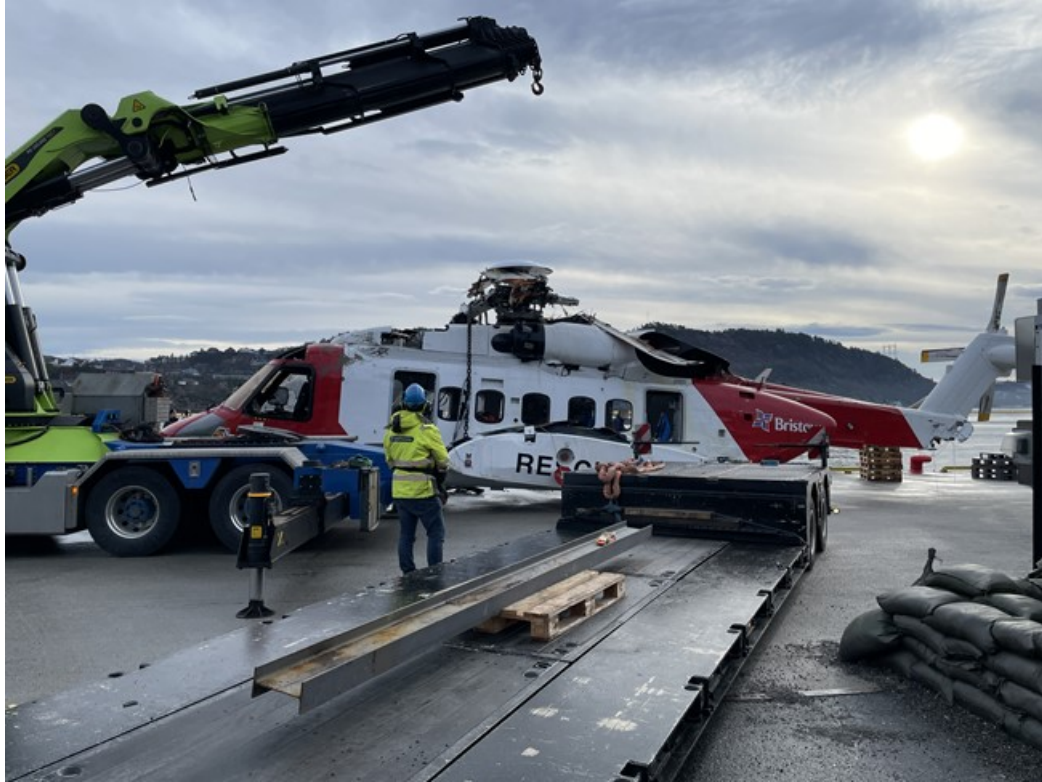
*Helicopter on the pier at Haakonsværn naval base. Photo: NSIA*
