# Report on railway accident at Arna station on 22 March 2024

## Railway report 2025/03

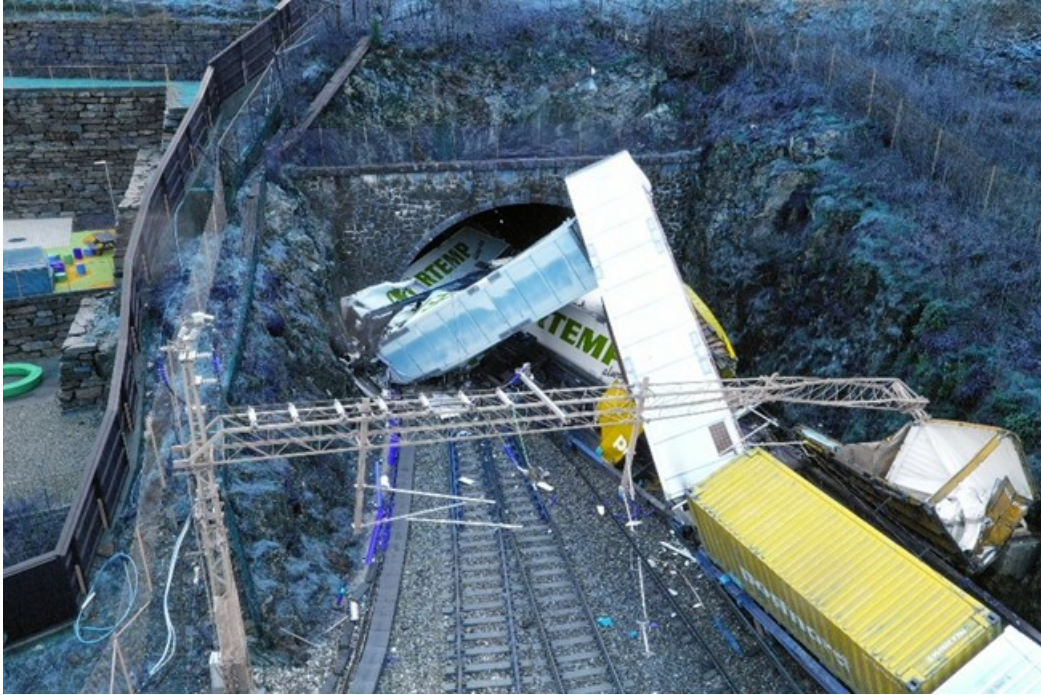
The accident occurred on Friday 22 March 2024, at 19:12, at Arna station. Freight train 5924 from OnRail AS passed the inner main signal 11016 at danger. The train, traveling at approximately 75 km/h when it passed the signal, continued through a diverting switch, collided with an end buffer, derailed, and came to a standstill in the entrance of the Arnanipa tunnel.

The train driver sustained minor injuries. The accident resulted in extensive material damage. The locomotive was a total write-off, and three wagons were condemned, totaling an estimated 52 million NOK in vehicle damage. Infrastructure rebuilding costs were estimated at 27.8 million NOK.

Drone picture. Photo: NSIA

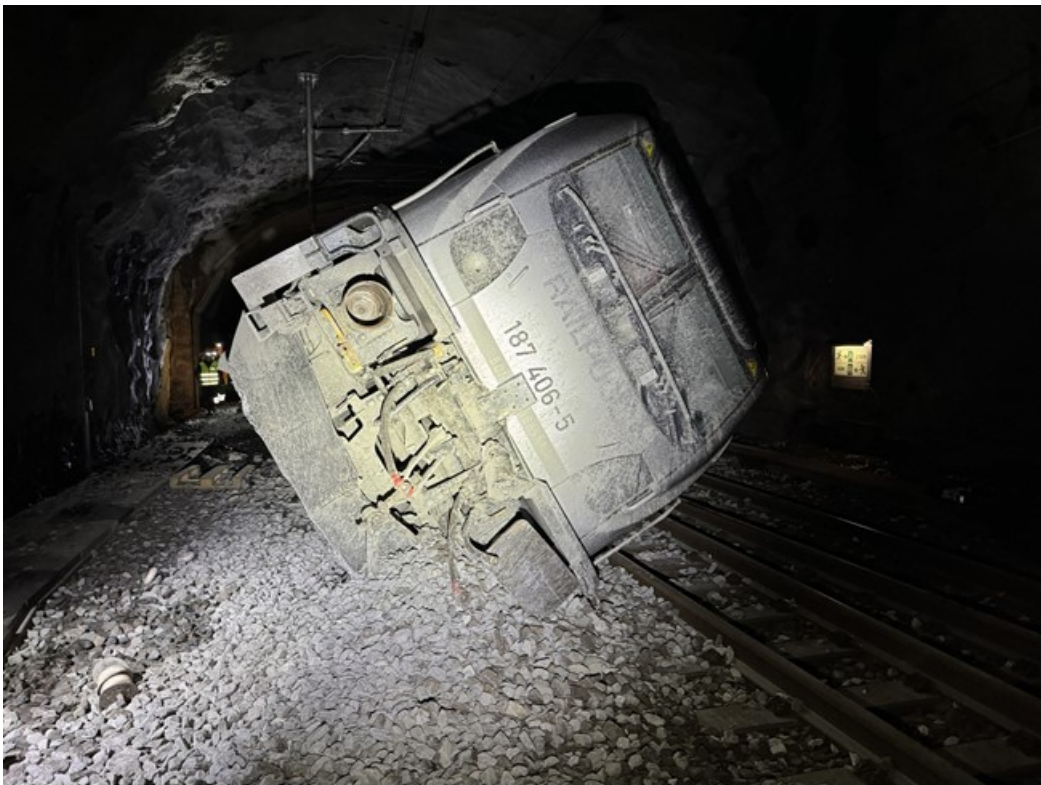
Inside the tunnel. Photo: NSIA

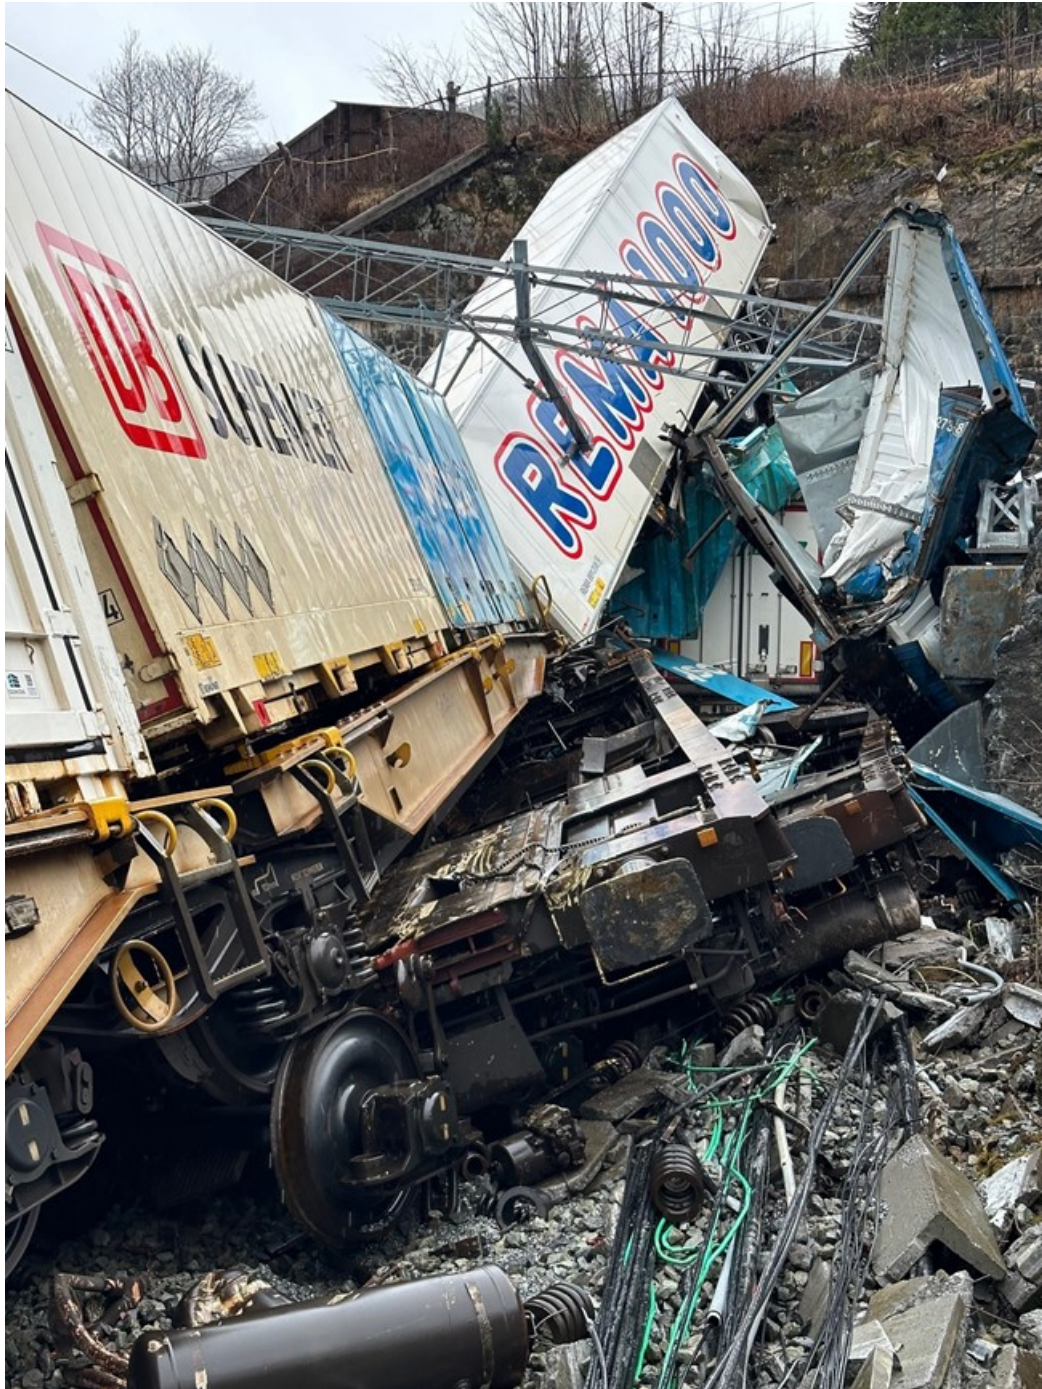
Outside the tunnel. Photo: NSIA
