**THE AIRCRAFT ACCIDENT INVESTIGATION BOARD/NORWAY
(AAIB/N)**

REP.: 01/96

**REPORT ON THE HELICOPTER ACCIDENT AT ÅS, NORWAY, ON
AUGUST 1, 1994, WITH BELL 206BIII JET RANGER, LN-OSL**

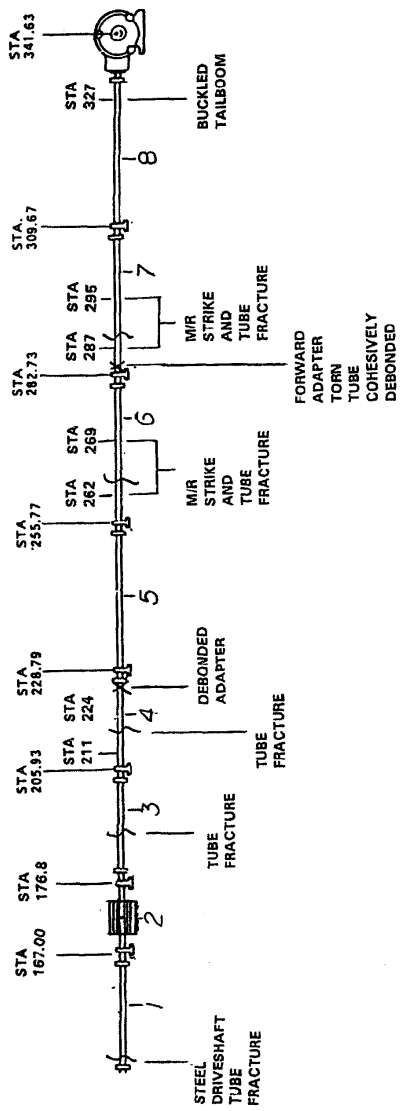
Bilag 2

- 1.12.2.5 The tail rotor drive system was severely damaged. The drive shaft between the engine and the tail rotor gear box, which consists of 8 steel and aluminium segments (see Appendix 2), was damaged partly by torsional forces and partly through direct truncation owing to main rotor hit and by crash forces when the fuselage and the remnants of the tail boom hit the ground. The first segment of the shaft was subjected to torsional forces which twisted the shaft off, indicating that the engine was in operation throughout the accident sequence. In addition to the damage mentioned, a loose bonding on shaft segment number four was discovered. This shaft consists of an aluminium tube and two bonded adapters. The adapters are coupling points to the next shaft segments. One of these adapters had worked its way loose from the tube and showed signs of overheating. The shaft tube had been pushed backwards and approx. 12.7 mm out of the adapter (see Appendix 4).

Illustration of tail rotor drive system and location of fractures and debonds

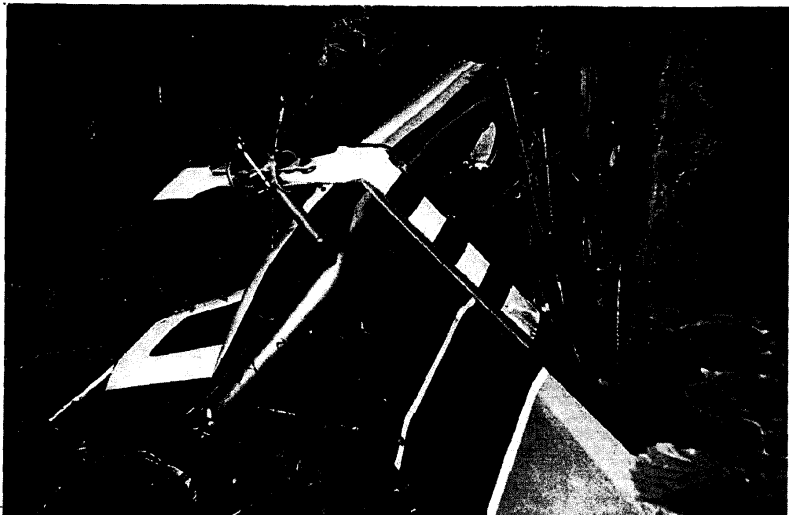
Bilag 3

- 1.12.2.4 Approx. one metre of the end of the tail boom, which had been cut away by the main rotor, lay near the remains of the helicopter. Amongst the parts found on the cut-off section was the tail rotor. No rotation damage was found on the rotor, and both blades of the tail rotor had been statically bent in the direction of the tail fin/tail boom on contact with the trees (see Appendix 3).

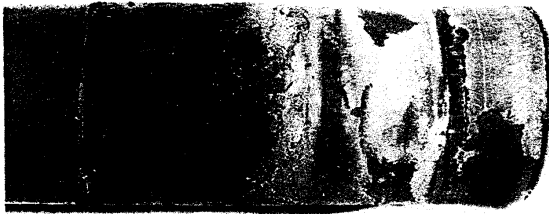
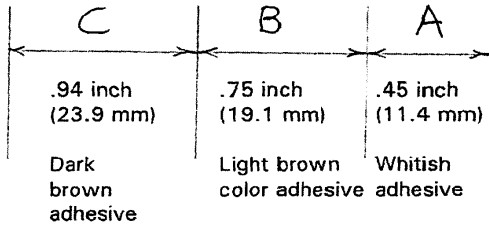
Figure 15

The conclusion reached by the report was that the bonding which held together the rear section of the drive shaft tube and the drive adapter for shaft segment no. 4 came loose in flight and caused the tube to rotate in the adapter, the result of which was that the tail rotor ceased to function. Under testing the adapter was split into two pieces so as to ensure that it could be loosened without affecting the adhesive surfaces. Traces of corrosion on the edge of, and approx. 20 mm inside, the adapter, were detected. The detection of corrosion inside the adapter indicates either that the bonding surface was never homogenous (insufficient application of adhesive) or that the bonding came loose at a time during operation of the helicopter. Three different areas (A, B and C) were detected on the section of the pipe which is normally bonded to the adapter (see Appendix 5). The three areas comprise the section of the

pipe which was found pushed approx. 11.5 mm out of the adapter, and two areas which were hidden by the adapter. These areas suffered different types of damage:

Area A (whitish adhesive surface): After the adapter had come loose from the tube there was relative rotation between the adapter and the tube, which can be seen in the adhesive surface. After the tail boom hit the trees and was thereby compressed, the tube was pushed backwards and out of the adapter as it continued rotating. The reason why the adhesive was not more discoloured by the friction of the rotation in this area was that in the beginning the heat was diverted through the thickest section of the adapter and that the tube section later rotated outside the adapter.

Areas B and C: There was evidence here that the adhesive surface was discoloured to a light brown coating in area B and a dark brown coating in area C. The frictional heat in these areas affected the adhesive surface over a longer period of time than in area A (because the engine continued to drive the shaft), and the adapter became steadily thinner in this area (see Appendix 6). This meant that the frictional heat did not dissipate so easily, and that the temperature of the adhesive surface increased significantly and discoloured it. Another result of this was that it was impossible to find any trace of any failure mechanism in this section of the adhesive surface.

View of the debonded end of the #4 tail rotor driveshaft with the adapter removed.

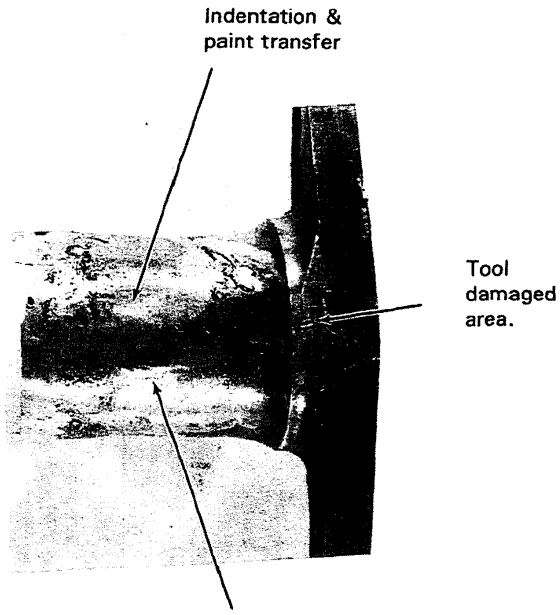
- 1.16.1.4 Sharp impression marks were found in the metal on the sides of the adapter, at an angle of 90° to the adapter flanges (see Appendix 7). The laboratory has characterised these marks as "tool marks". In addition to this, soft impression marks were found on the surface of the same adapter (see Appendix 7). The report concludes that the soft impression marks were caused by the adapter coming into contact with the drive shaft cover during the accident sequence.

There is reason to believe that the marks were made prior to the accident. It was not possible, however, to find out what caused them. Based on the assumption that the marks were made at some time during or prior to the last inspection they should have been discovered during the routine inspections carried out on the tail rotor shaft every 100 flight hours.

Figure 24
Opposite side view of adapter showing the tool damage.
