**THE AIRCRAFT ACCIDENT INVESTIGATION BOARD/NORWAY
(AAIB/N)**

REP.: 05/96

**REPORT ON THE AIR ACCIDENT AT
ÅLESUND AIRPORT VIGRA, NORWAY
5 JANUARY 1995 WITH FOKKER F-27 MK 50,
REGISTRATION LN-BBA**

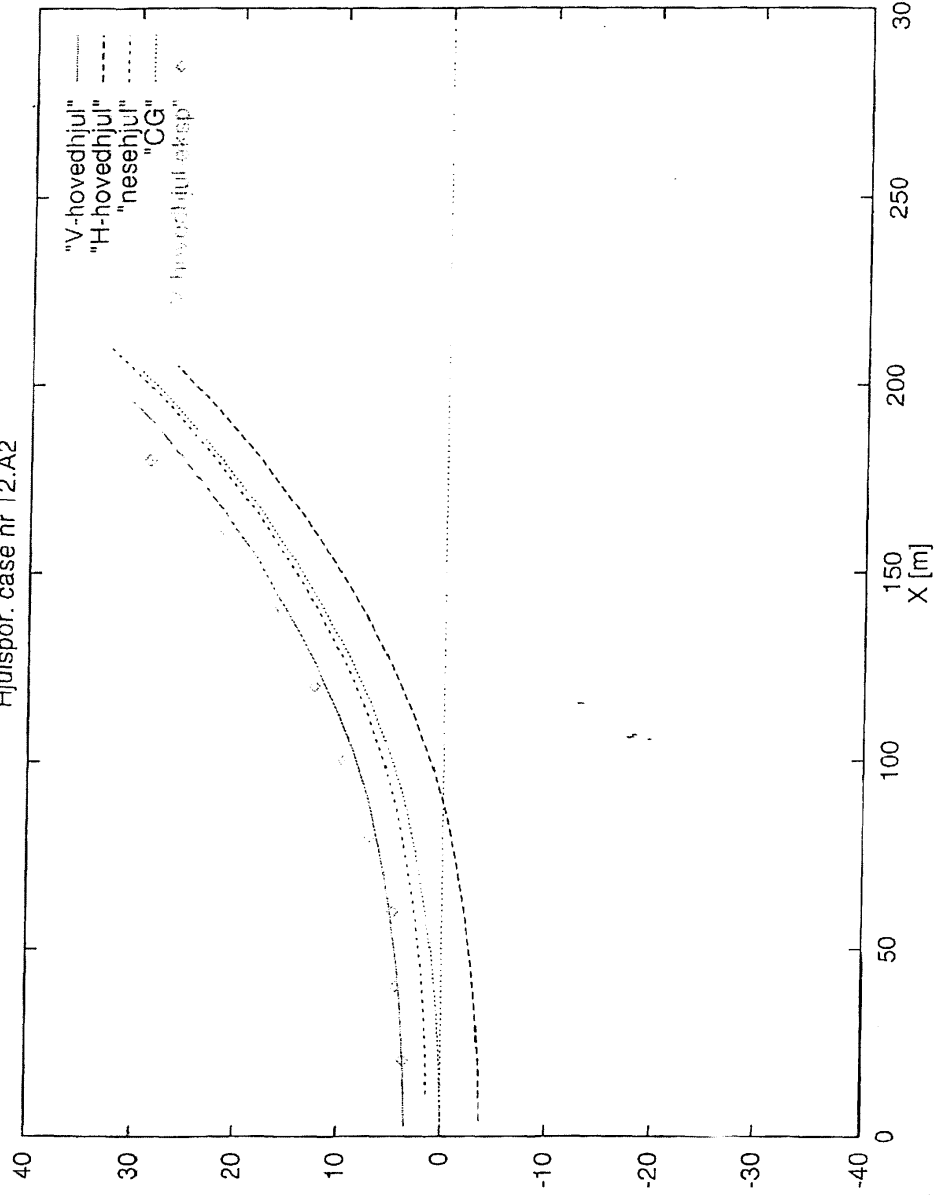
FIGUR 2

Picture 1 is showing the wheel tracks and the track of Center of Gravity projected on the runway from second 1888 to second 1896, as shown in Figure 2. The squares are indicating the track from left main wheel as it was found on the runway after the accident. It should be noted that the scale is not the same for length and width of the runway. This gives a turning radius out of proportion with other measurements. The runway is 45 m wide, with a 7,5 m shoulder area on each side, giving a total width of 60 m covered with asphalt.

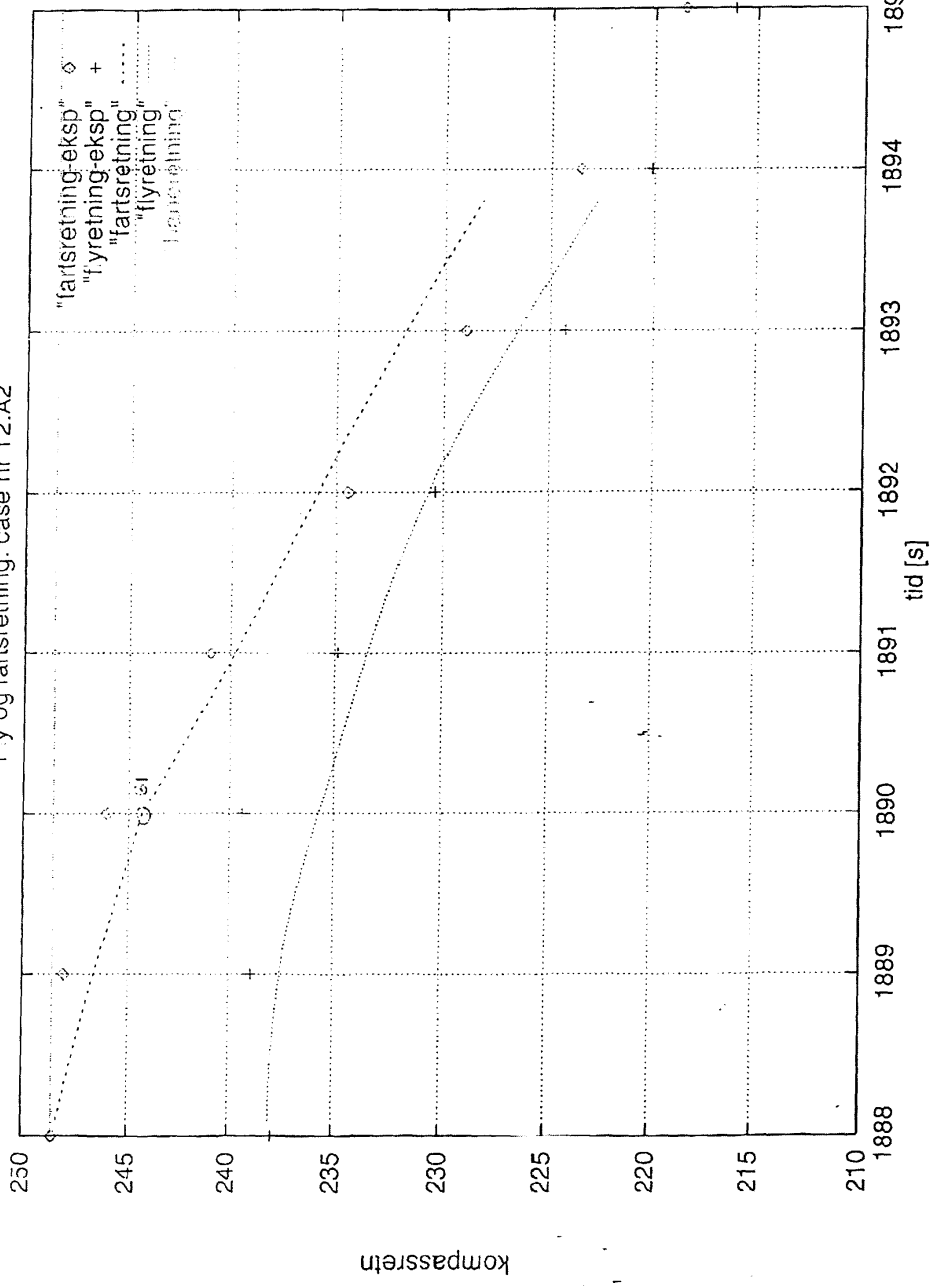
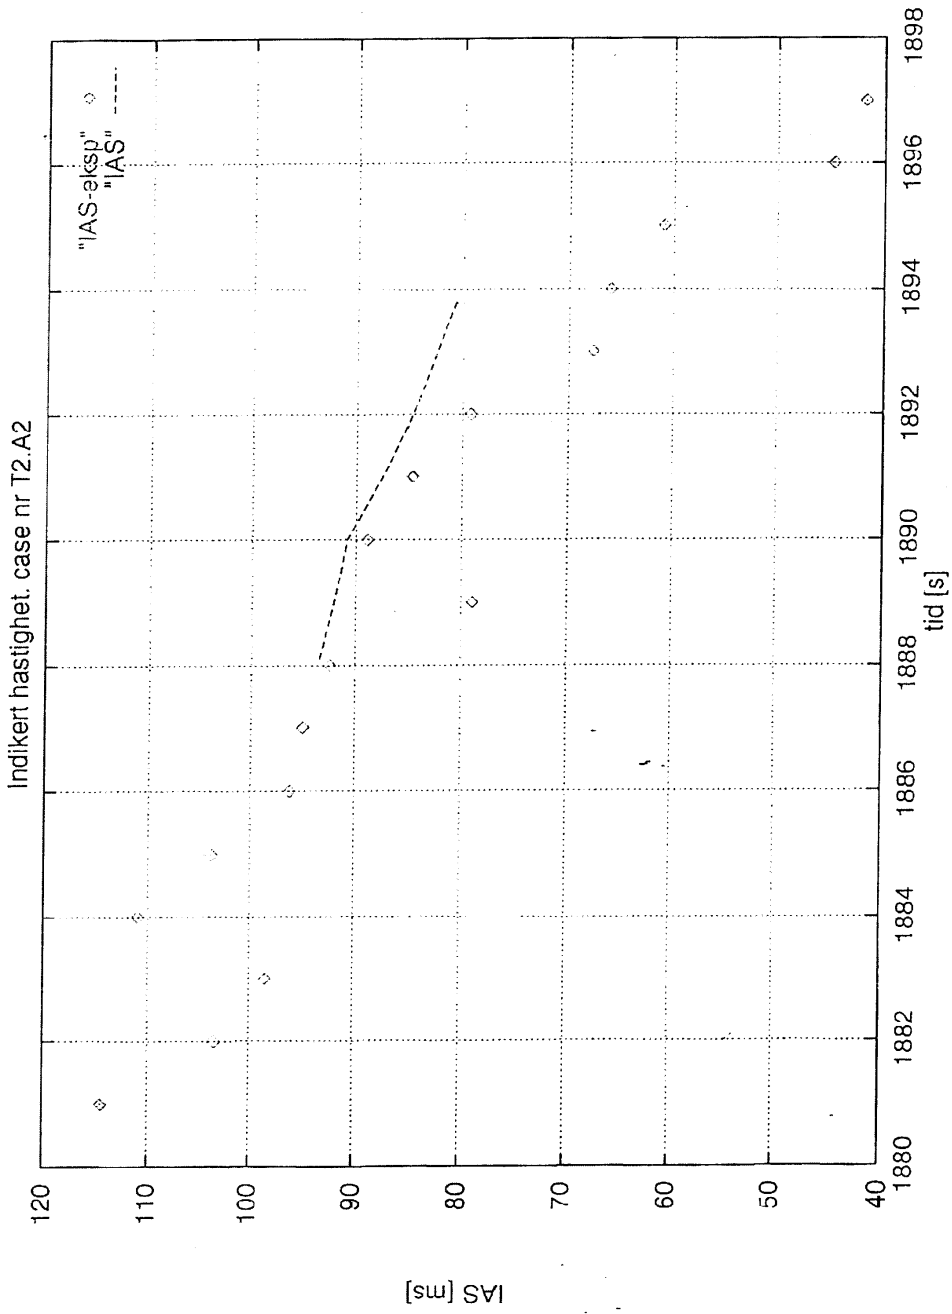
Picture 2 and 3 serve a special purpose as a control/corroboration in relation to Picture 1, where a perfect "fit" may be obtained with a number of combinations.
