Investigation of aviation accident west of Sotra

On the evening of Wednesday 28 February 2024, a Sikorsky S-92A helicopter, LN-OIJ, operated by Bristow Norway AS crashed during SAR training in night conditions after departing from Flesland (ENBR).

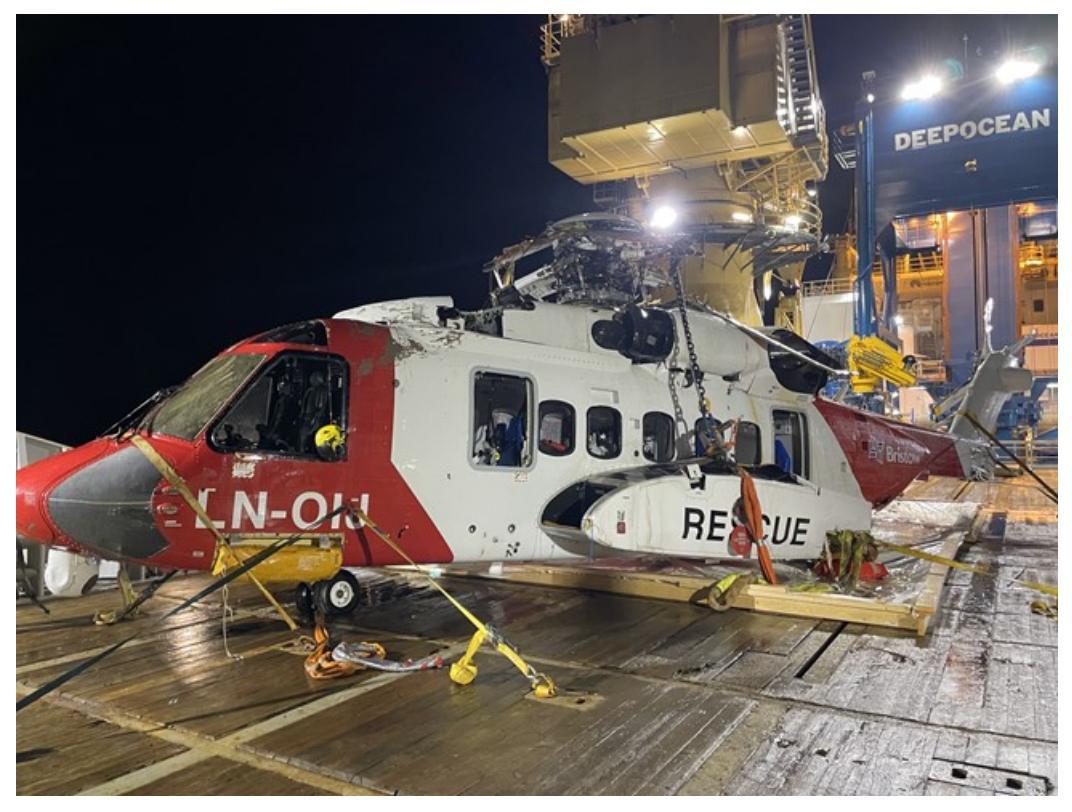
The helicopter recovered on deck of the offshore vessel Normand Ocean. Photo: NSIA

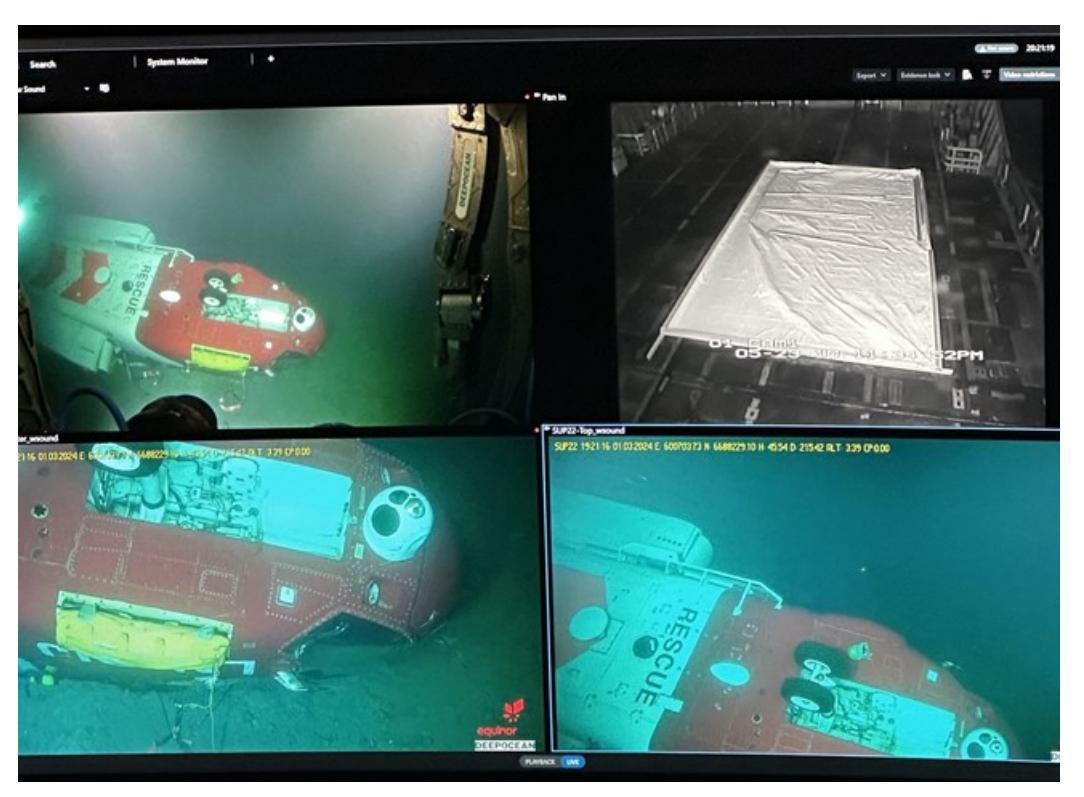
ROV images of the helicopter when discovered on the sea bed. Photo: Normand Ocean/NSIA

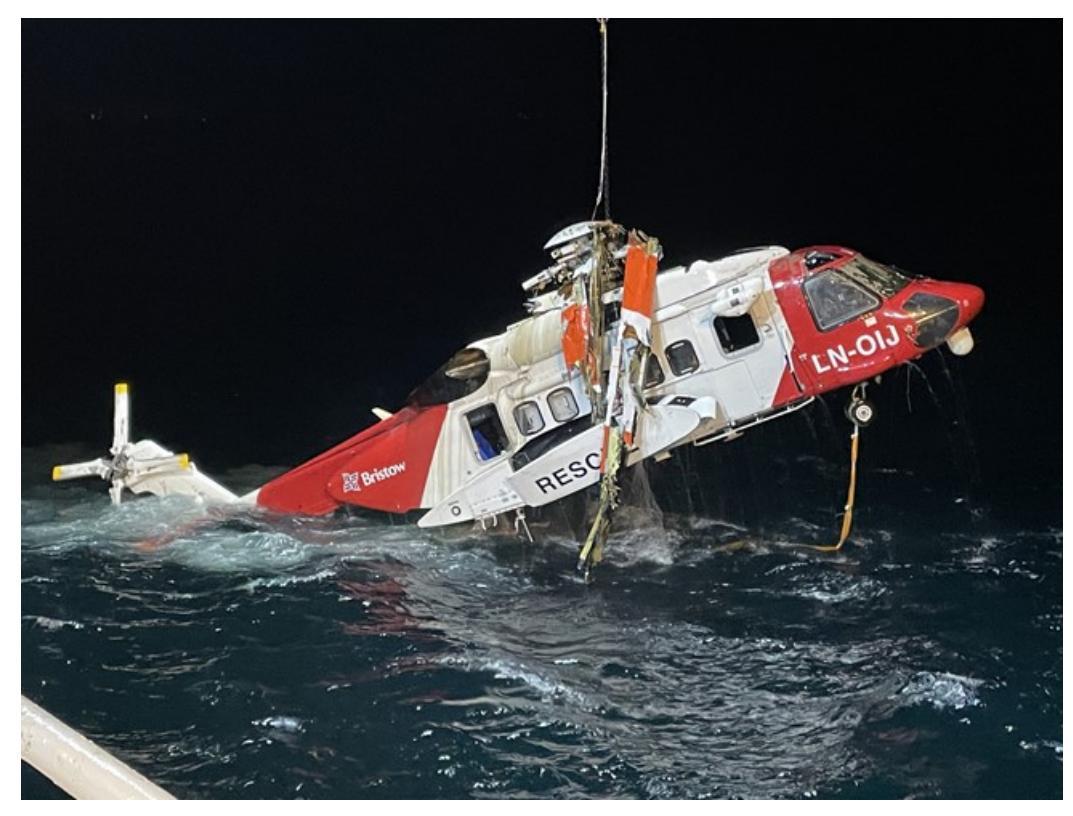
Helicopter recovered in position west of Bergen. Photo: NSIA

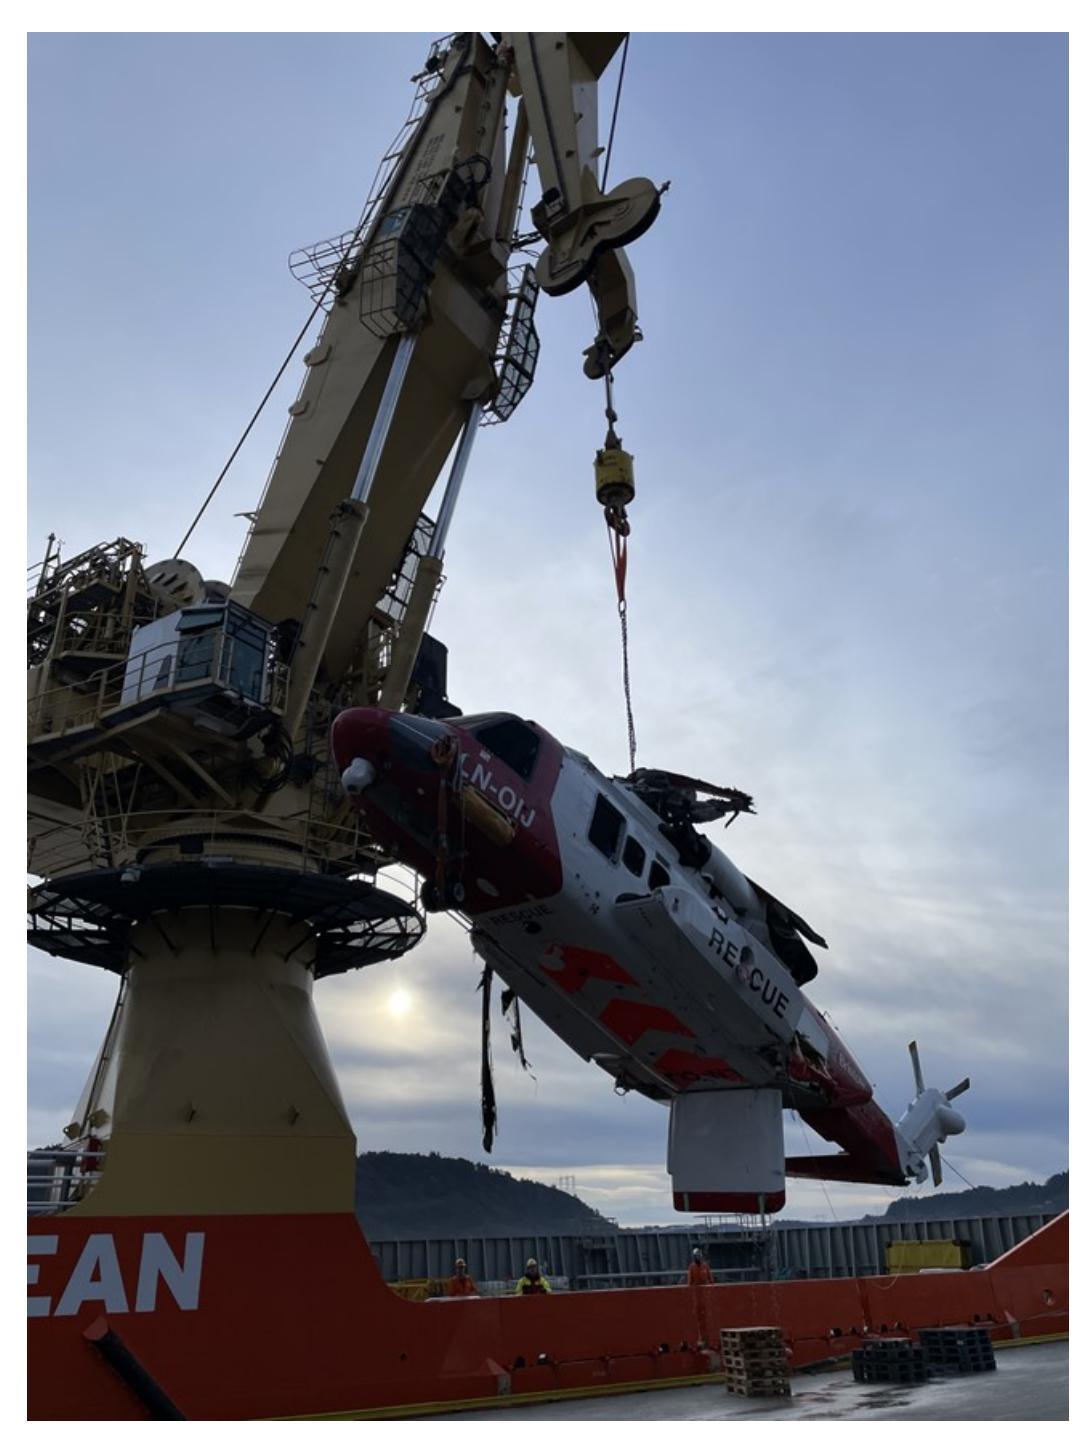
Helicopter lowered onto the pier at Haakonsvern naval base. Photo: NSIA

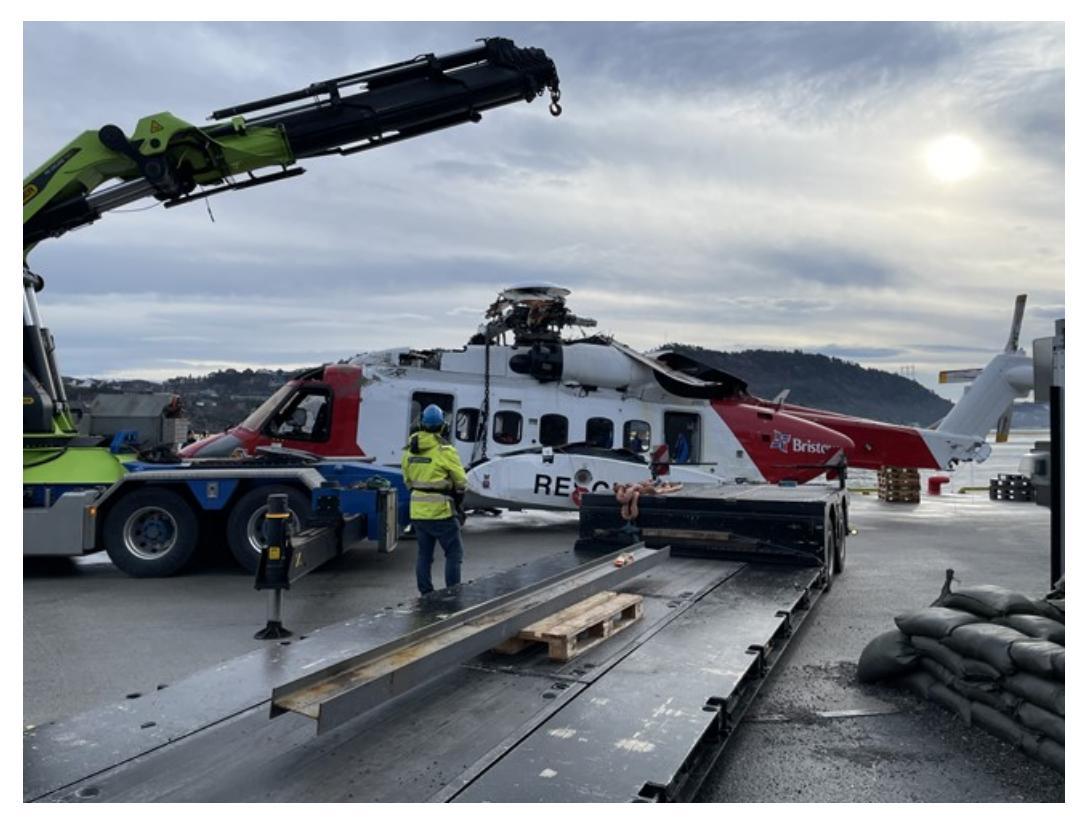
Helicopter on the pier at Haakonsvern naval base. Photo: NSIA
