## **PRELIMINARY REPORT ON ACCIDENT IN THE ISFJORDEN WATER AT SVALBARD, NEAR BARENTSBURG ON 26 OCTOBER 2017, INVOLVING MI 8AMT, RA-22312 OPERATED BY CONVERSE AVIA AIRLINES CJSC**

Aircraft:  
- Type and reg.: Mi 8AMT helicopter, RA-22312

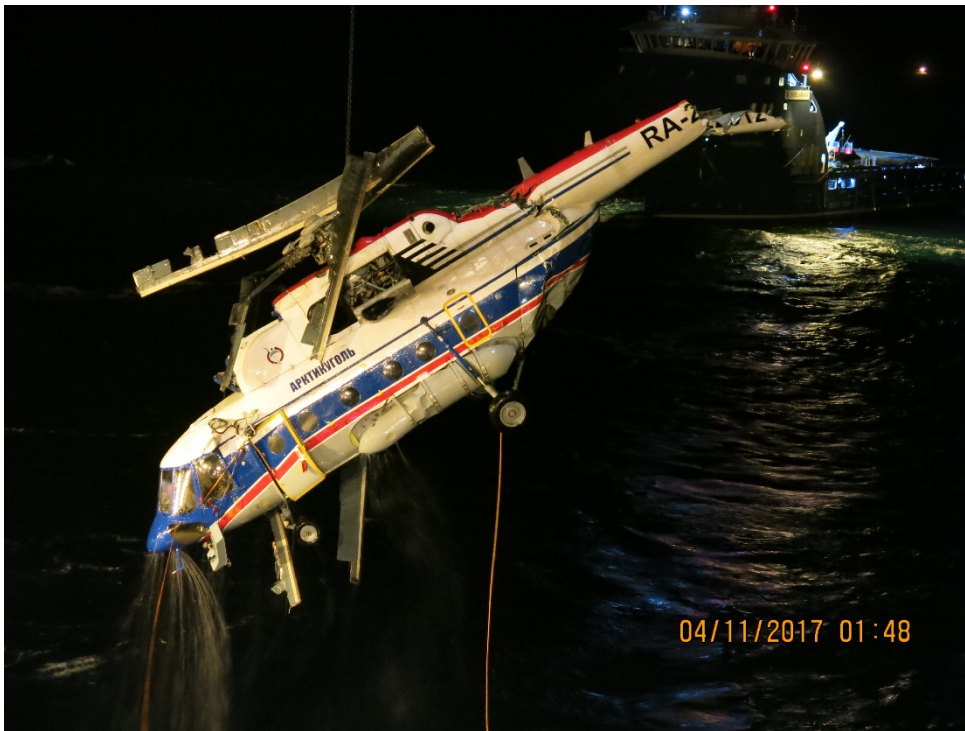
Figure 3: The helicopter is lifted up on Maersk Forza. Photo: AIBN

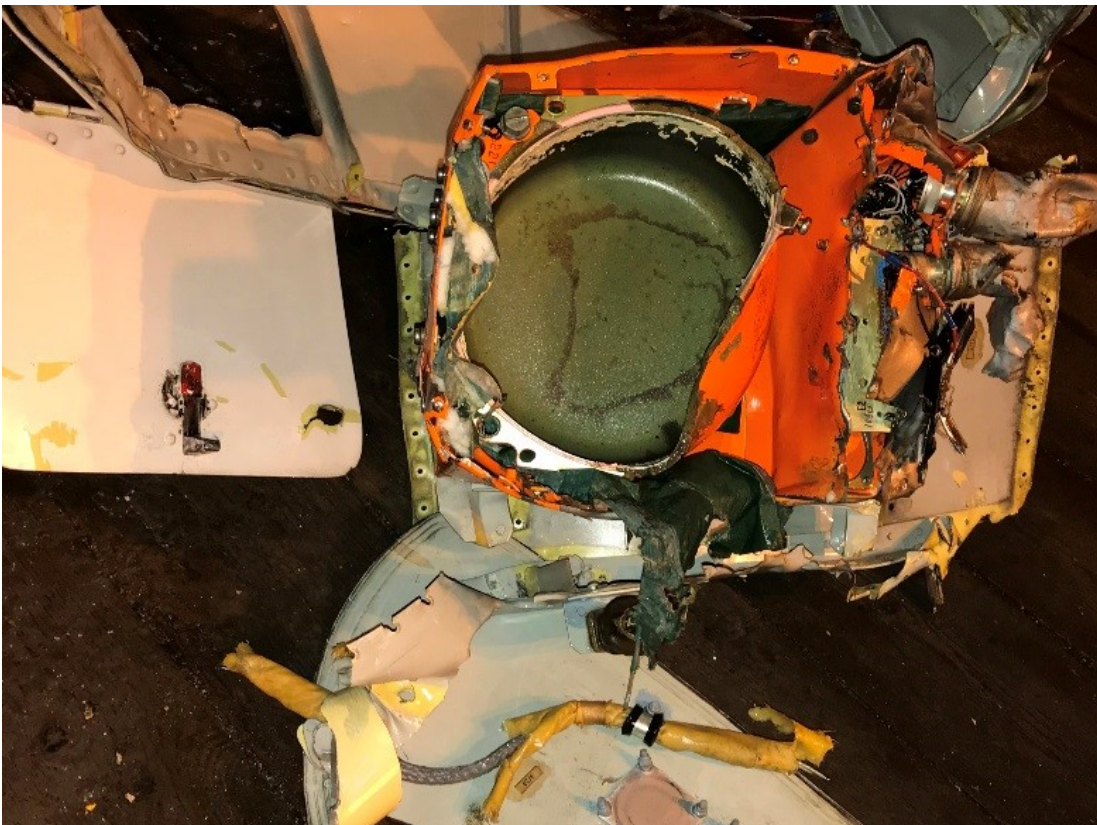
The helicopter's body, tail, Cockpit Voice Recorder (CVR) and GPS units were recovered early on 4 November. The Flight Data Recorder (FDR) was mounted on the underside aft on the tailboom. It had been hit by a main rotor blade and separated from the helicopter. The recorder was found severely damaged and without the memory unit one day later. Searched for the memory unit went on for another day. Based on the condition of the recovered parts of the FDR, it was decided to discontinue the special search for the memory unit. Neither the FDR nor the CRV were equipped with Underwater Location Beacons (ULB). ULB will normally ease search for recorders and, thereby the helicopter wreckage.

Figure 5: The destroyed Flight data recorder. Photo: AIBN

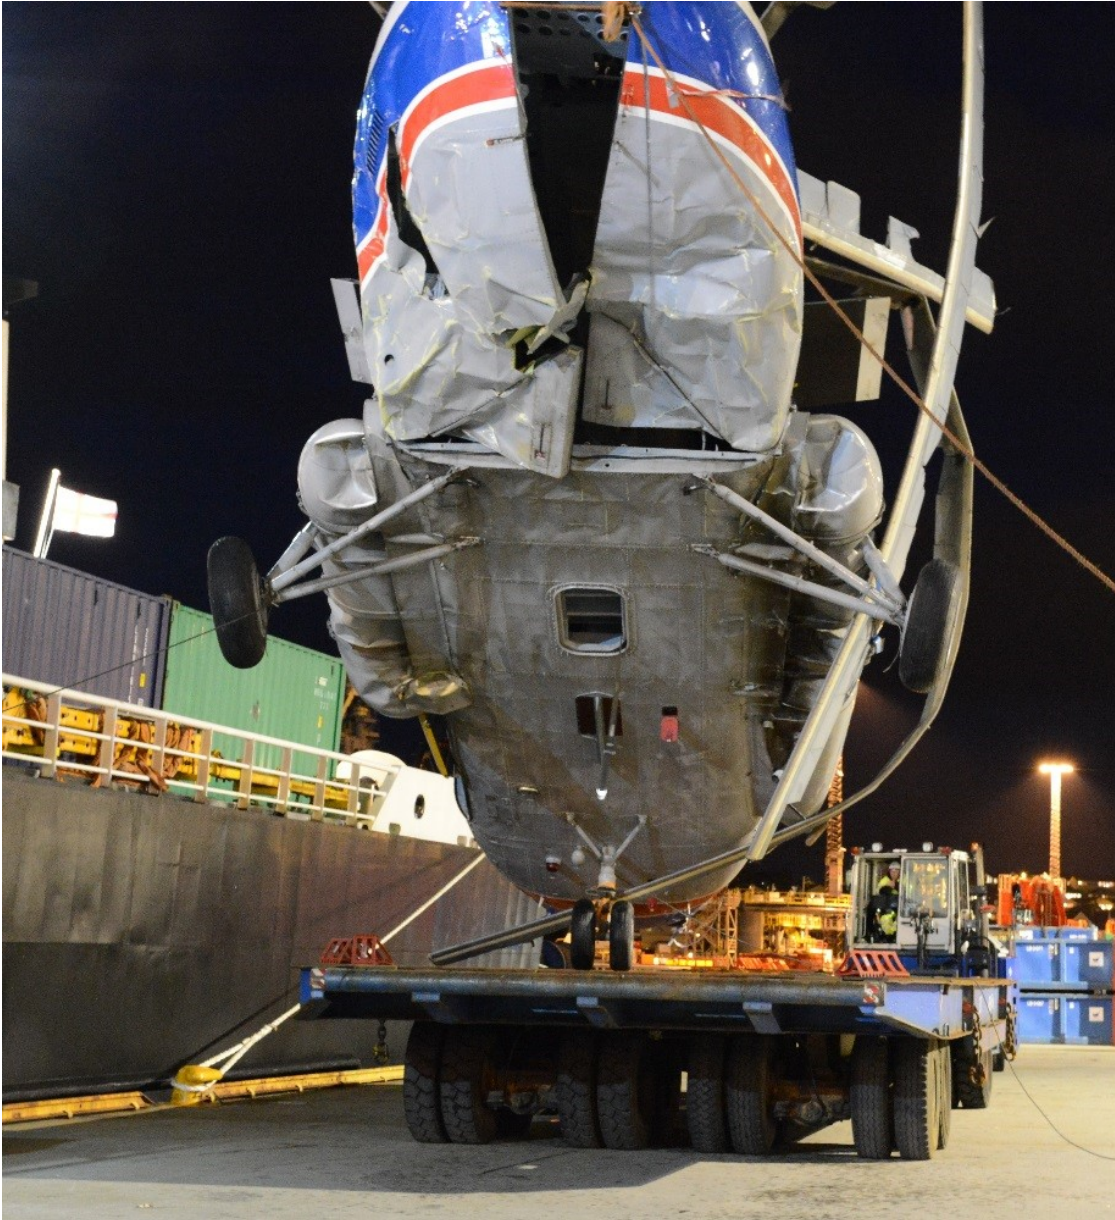
Preliminary analysis of the cockpit voice recorder indicates that the crew apparently did not identify any technical abnormalities before the helicopter impacted the sea. This is to be further investigated before any conclusions are drawn. Damage to the helicopter indicates that it struck the water

relatively flat with the tail low. It is reason to believe that all persons on board evacuated the helicopter before it sunk.

*Figure 6: Damage to the underside of the helicopter. Photo: AIBN*
