# REPORT

AVIATION 2025/08

***Aviation accident at Reinsvoll Airfield in  
Innlandet county on 28 August 2023 with  
MLP Aviation LTD Christen Eagle II,  
LN-TBN***

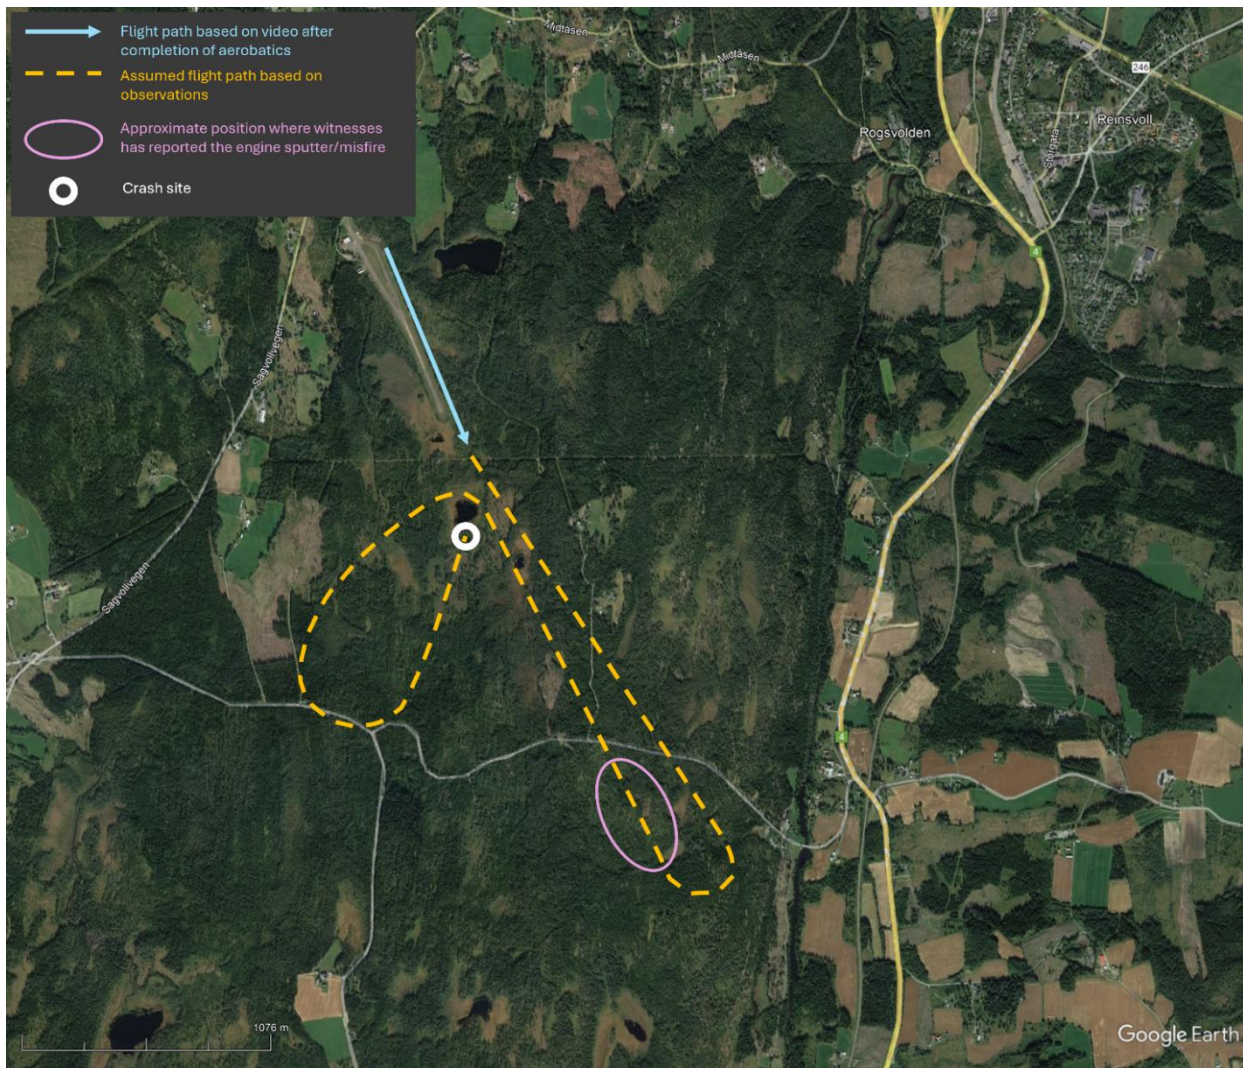
Several witnesses saw and/or heard the aircraft as it flew southwards. One of the witnesses has stated that he believed the aircraft was flying inverted during part of this stretch. The aircraft turned back towards the airfield shortly after it had crossed Vestbakkvegen<sup>1</sup>, at around 1850 hrs, see Figure 3. Shortly afterwards, several witnesses reported what they perceived as two or three loud

Figure 3: Assumed flight path for the last part of the flight (after performing aerobatics and up until the accident). Photo: Google Earth. Illustration: NSIA.

Several independent witnesses have testified that they heard the aircraft engine sputter at a point in time that coincides with the position indicated in Figure 3, shortly after the aircraft turned back towards the airfield. This sputtering was described as 2–3 loud bangs, or misfiring. The coinciding description and time of the observations leads the NSIA to believe that the engine may have sputtered or run rough at this point in time. According to the witnesses, the engine ran normally after this.

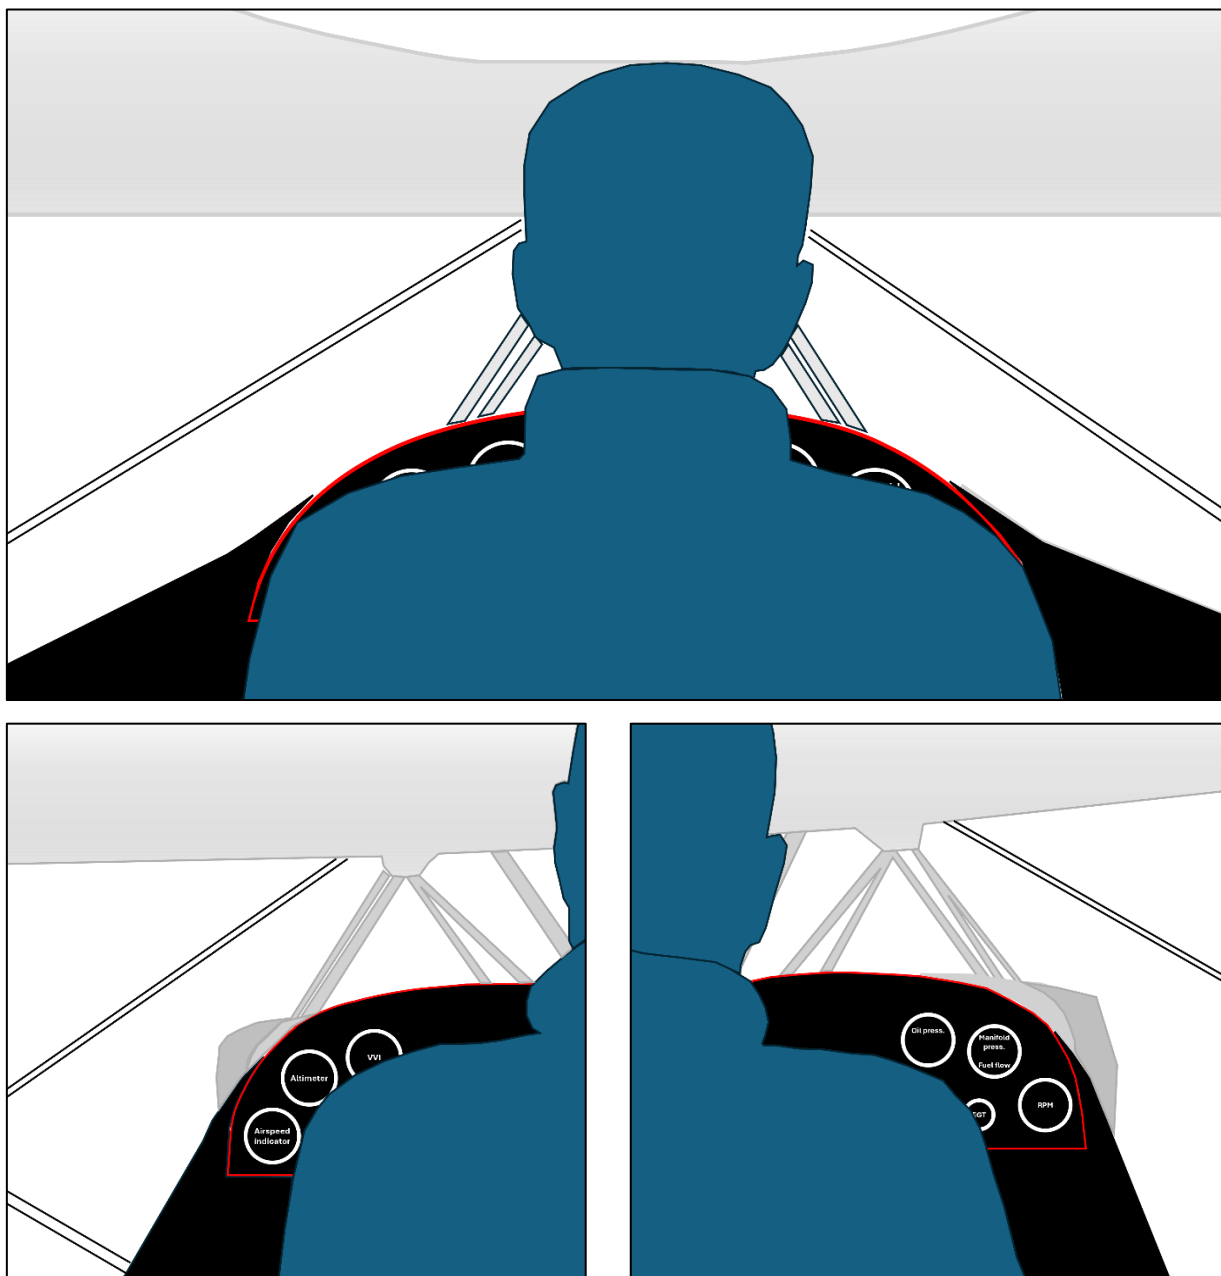
All aircraft and engine instruments were located on the instrument panel in the forward cockpit (see Figure 6). To gain a better understanding of the pilot's ability to observe the instruments with a passenger in the front seat, the NSIA got access to another Christen Eagle. The investigations showed that with a man of medium height and build in the front seat, the pilot was unable to see the instruments in a normal sitting position (see Figure 7). The airspeed indicator, altitude indicator and parts of the vertical speed indicator could be seen by leaning to the left. By leaning to the right, oil pressure, manifold pressure, fuel flow, RPM and parts of the EGT indicator could be observed. With a larger person in the front seat (or someone leaning to the side), the overview of the instruments would be further restricted.

Figure 7: Illustration of the pilot's view of the instrument panel with a passenger in the front seat, viewed directly from behind and with the pilot leaning to the left and right. Illustration: NSIA

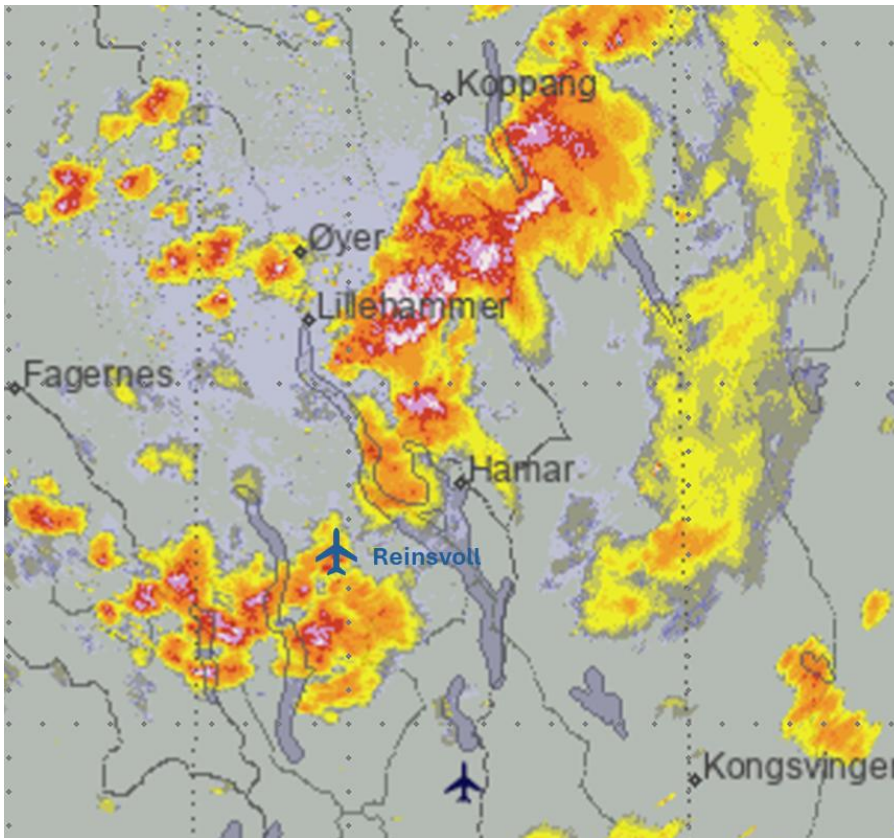
A radar animation shows a squall line passing over Reinsvoll around the time of the accident (see Figure 9).

Figure 9: Radar image from Hafjell weather radar at 18:50. Data: Norwegian Meteorological Institute

The weather report from the Norwegian Meteorological Institute indicates that there was a possibility of gusty winds from the strongest CB clouds and in connection with the squall lines. Lightning strikes were also recorded in the areas with the most convective and powerful shower clouds. Radar animation shows a squall line passing over Reinsvoll at around the time of the accident (see Figure 9) with some smaller but powerful shower clouds passing south of the airfield. However, the strongest showers appear to be in the area east of Lillehammer. Lightning strikes were also registered here. No lightning strikes were recorded near Reinsvoll. None of the witnesses the NSIA has spoken to have mentioned any particular weather or wind conditions at the time of the accident. Given that Christen Eagle is a relatively light aircraft with a lot of engine power and that it was cruising at approximately 1,000 ft above the ground, the NSIA does not find it likely that the reported weather conditions would have forced the aircraft down. The NSIA therefore finds it unlikely that the weather was a factor in the accident.

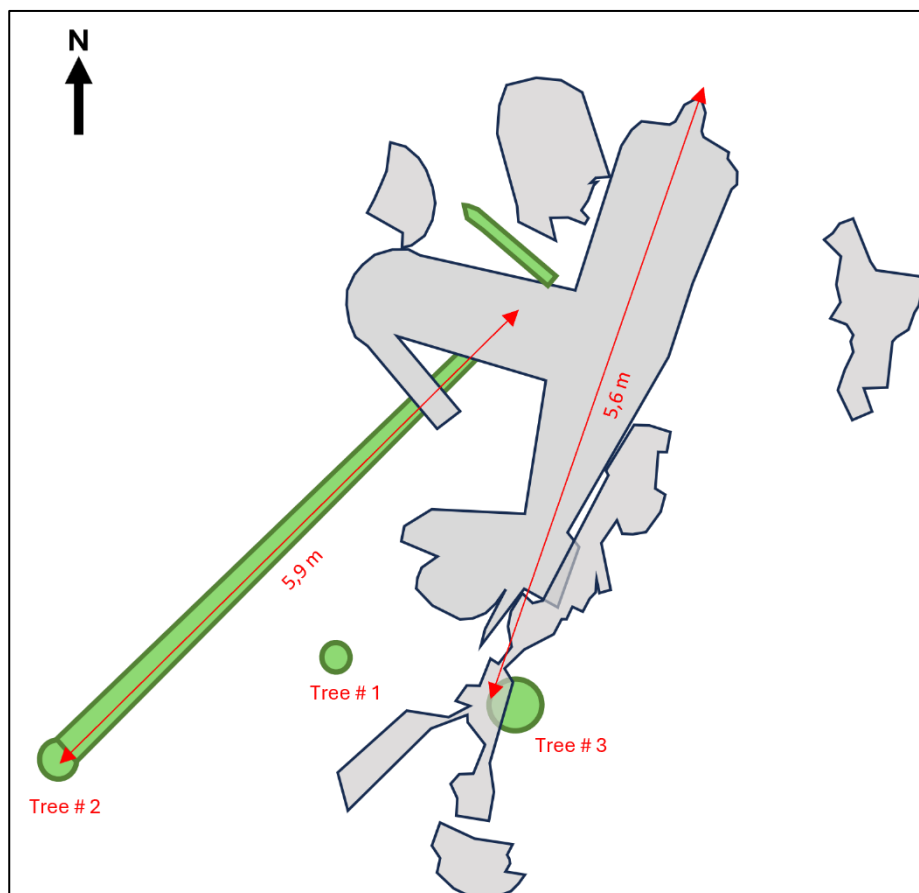
LN-TBN crashed approximately 50 metres south of Seterputten pond, which is approximately 500 metres south of the threshold of Reinsvoll's runway 34 (N 60°39'52" E 010°34'17"). The accident site was in the boundary between a marshy area and a copse (see Figure 10). Trees of varying sizes surrounded the accident site. However, it was relatively open to the west–south-west, which is the direction the aircraft is believed to have approached from. Three trees closest to the accident site were damaged by the aircraft (see Figure 11). The surrounding area was surveyed by a drone and no damage to other trees was observed.

Figure 11: Illustration of the aircraft and trees at the accident site. Illustration: NSIA

The aircraft cut through two smaller trees and left scratches and cuts in the bark of a larger tree. Tree number 1 was the smallest tree and was cut off just under two metres above the ground (see Figure 12). Tree number 2 was broken close to the root and cut into four pieces. The bottom section was 5.9 metres long and was lying across the ground from where the tree had been standing, pointing towards the left-hand side of the aircraft. The second-lowest section was approximately 0.8 metres long and was lying to the left of the aircraft. The second-highest section was approximately 1.3 metres long and was lying about 7–8 metres in front of the aircraft. The treetop had snapped backwards and was lying behind the aircraft. The total length of the tree was just under 13 metres. The centre cut through the tree appeared to run from the bottom upwards, seen from the aircraft's assumed direction of travel. The other two cuts through the tree were at an angle, with the lowest point on the tree's right-hand side (seen from the aircraft's assumed direction of travel).

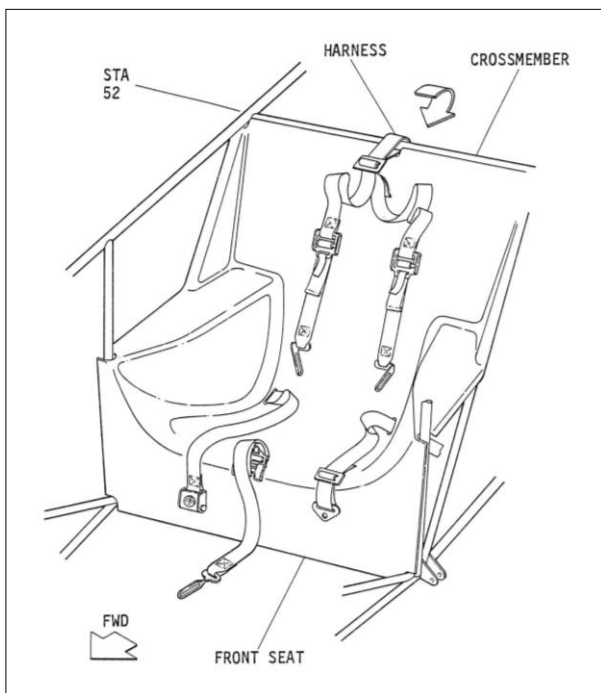
In the front cockpit, the shoulder harness was found to be loose, and there was no bending or damage to the crossmember to which the harness should have been attached. Above the crossmember was a bracket that concealed the crossmember itself. This had an oblong hole through which the harness should have been threaded (see Figure 18). The harness had no visible damage. Approximately 14 cm from the end of the harness there was a three-bar slide adjuster. The webbing should have been threaded back through the slide adjuster to lock the harness to the crossmember (see Figure 20).

Figure 19: Installation of shoulder harness in the front seat. Illustration: Christen Eagle/NSIA

The passenger's shoulder harness was found loose in the aircraft after the accident. Pre-departure photos show that the passenger was wearing a shoulder harness. The harness sat relatively tightly along the passenger's back, indicating that it must somehow have been fastened. The NSIA nevertheless believes that the harness would not have come loose if it had been installed correctly. The harness should have been threaded through a three-bar slide adjuster, around a crossmember behind the seat and back to the slide adjuster (see Figure 19). In a photo given to the NSIA, the three-bar slide adjuster appears to be placed so far up the passenger's back that the remaining part of the harness, which was measured at 14 cm (see Figure 20), may not have been long enough to reach around the crossmember and back to the slide adjuster to lock the harness. The NSIA cannot say whether the harness was installed incorrectly when the belts were replaced, or whether the harness has been adjusted at a later date. Normally, there will be no need to adjust the slider after installation, as individual adjustment of the length of the shoulder harnesses is done with the adjustment mechanism in front of the chest. There are no marks or depressions on the harness indicating that the slide adjuster has been moved. The harness must have been sufficiently secure for the discrepancy not to have been discovered in connection with the annual inspection of the aircraft, previous flights where the front seat was in use, or when the passenger fastened the harness prior to the accident flight. The inspection described in the maintenance procedures covers the general condition of the harness and signs of wear, damage and deterioration. The inspection does not specifically mention the harness attachment points. The cover over the crossmember where the front seat harness should have been attached may make it difficult to discover that the harness is installed incorrectly unless you specifically check for the harness being routed back through the slide adjuster. The deceleration forces during the crash were sufficient to cause the shoulder harness to loosen, resulting in the passenger being thrown forward, hitting his head on the instrument panel.

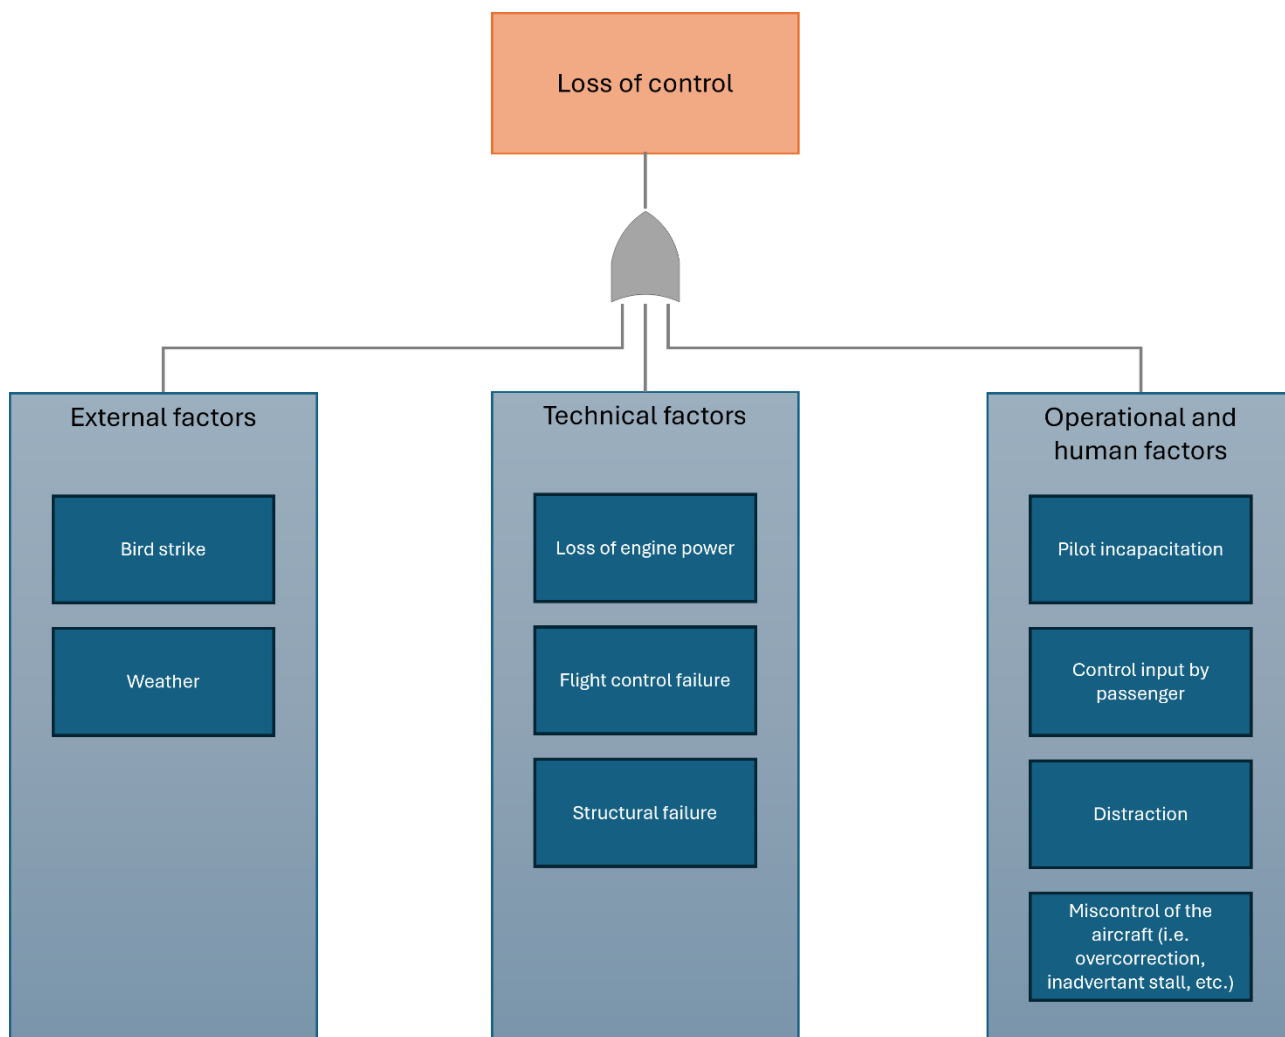
Various factors that may have contributed to the loss of control and thus to the accident, either individually or in combination, are discussed below. The factors listed below are not exhaustive, but are typical factors that contribute to accidents involving small and experimental aircraft.

Figure 21: Simplified fault tree analysis. Possible scenarios that can lead to loss of control. Illustration: NSIA
