REPORT AVIATION 2023/08

Serious aviation incident during approach to Stavanger Airport Sola on 25 September 2020 involving a Sikorsky S-92A, LN-ONQ operated by Bristow Norway AS

Report on serious aviation incident

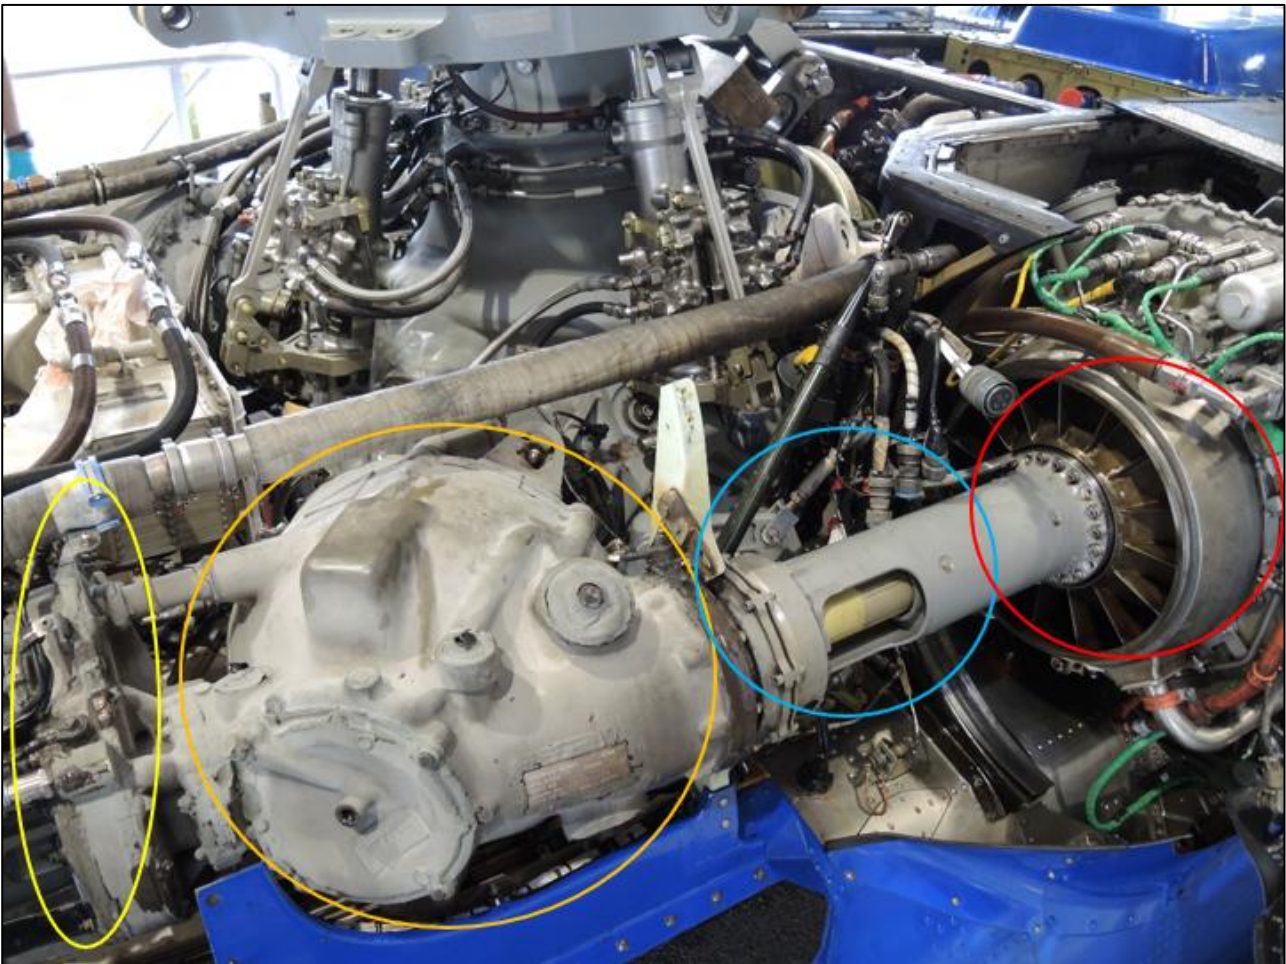
Once the helicopter was parked, it was observed that oil from the area near the left engine was running down the exterior of the fuselage along the cabin (see Figure 3). The cover plates in the area were opened, and personnel from the fire and rescue service measured temperatures close to 250°C on the outside of the left main gearbox's input module. There was smoke, but no fire. A check of the oil level in the main gearbox showed that approximately 4 litres were missing.

Figure 6: LN-ONQ photographed the day after the incident. Left accessory module (on the far left, yellow circle) and the left input module (in the centre, orange circle). The drive shaft (blue circle) and the front of the left engine (red circle) can be seen on the right. Photo: NSIA
