# REPORT

SL 2010/01

REPORT ON AIR ACCIDENT ON 11 MAY 2005 AT  
KOLSÅS IN BÆRUM, AKERSHUS, NORWAY  
INVOLVING EUROCOPTER AS 350 B3 ECUREUIL,  
LN-OPY, OPERATED BY AIRLIFT AS

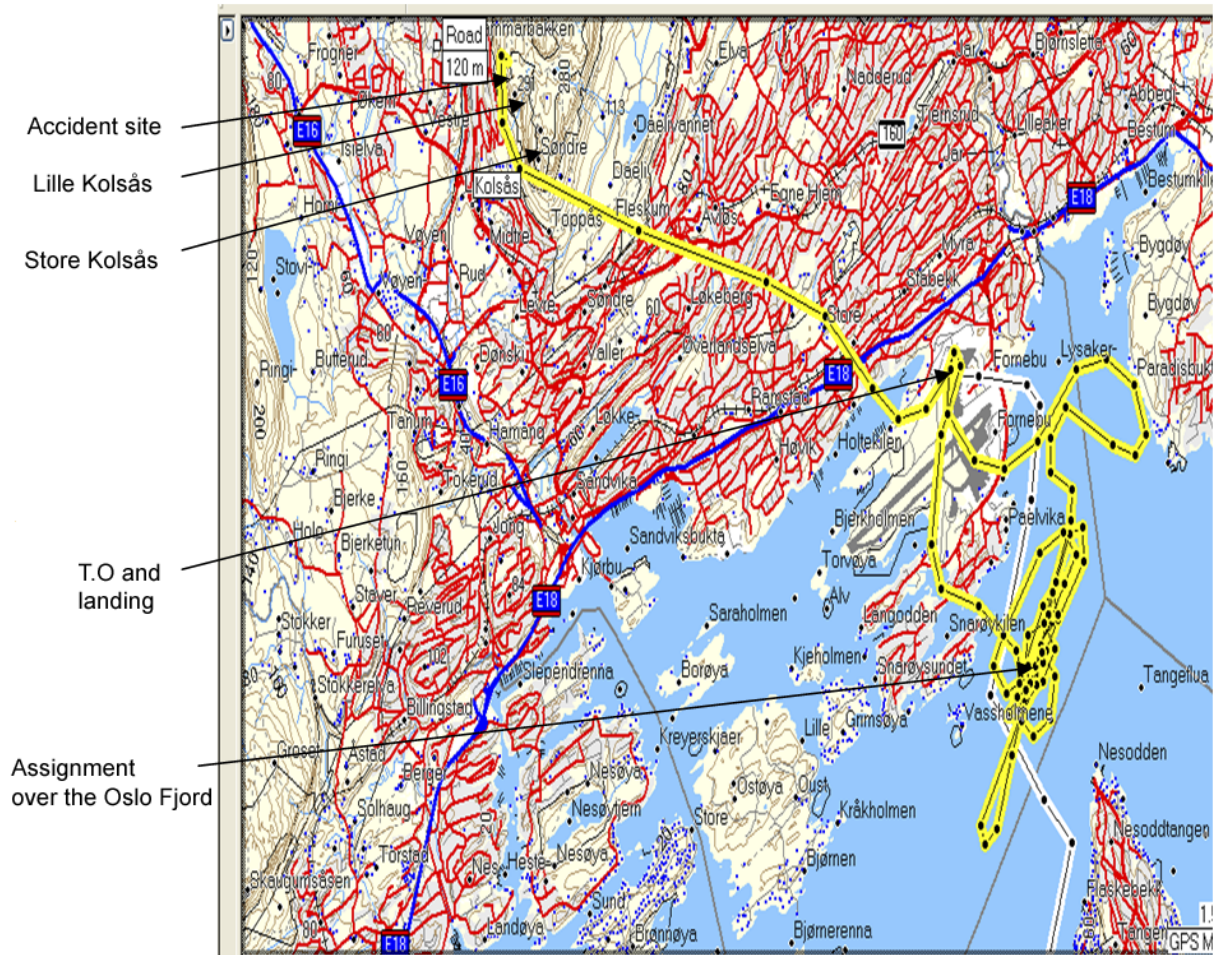
Figure 1: Track log from GPS showing route from time 2015 until the accident at time 2046.

- 1.11.2 The helicopter was equipped with GPS, which allowed a track log to be obtained. The track log contained automatic registrations of the helicopter's positions at each major course changes (see Figure 1). Altitudes were not registered.

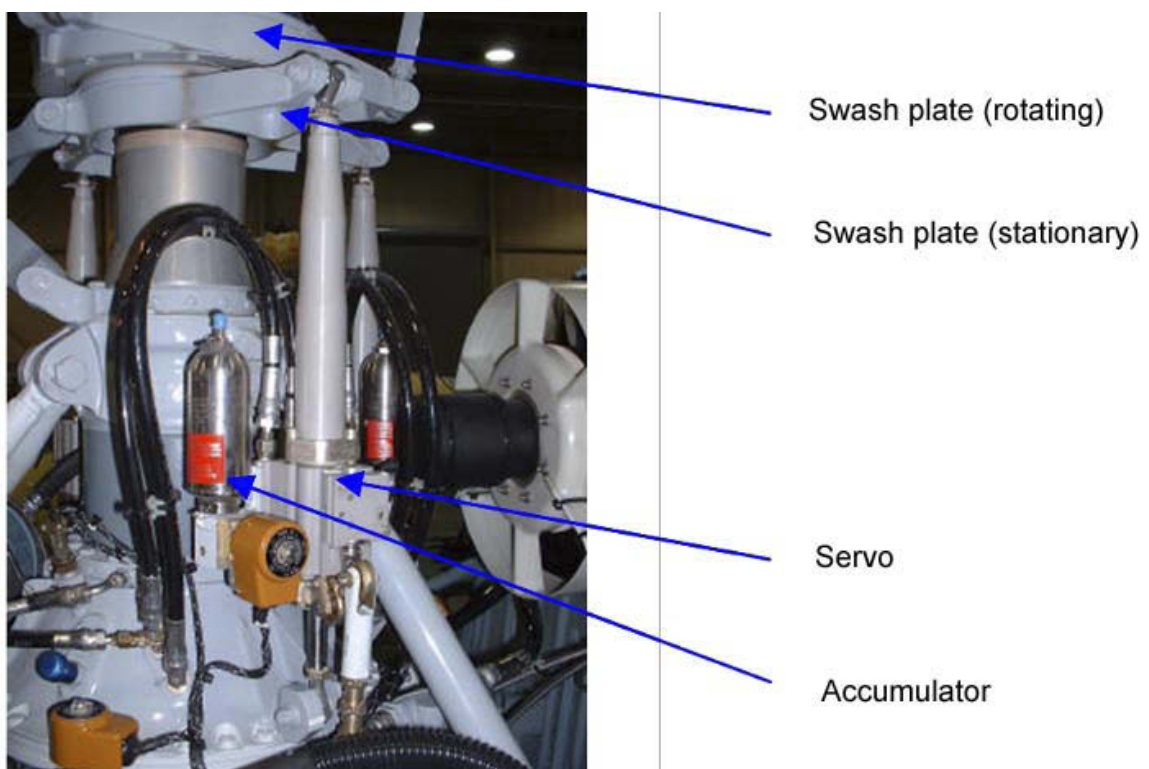
Figure 4: Rotor mast with hydraulic servos, accumulator and swash plates.

The servos on LN-OPY were of the SAMM type with part numbers SC5083 and SC5084 respectively.

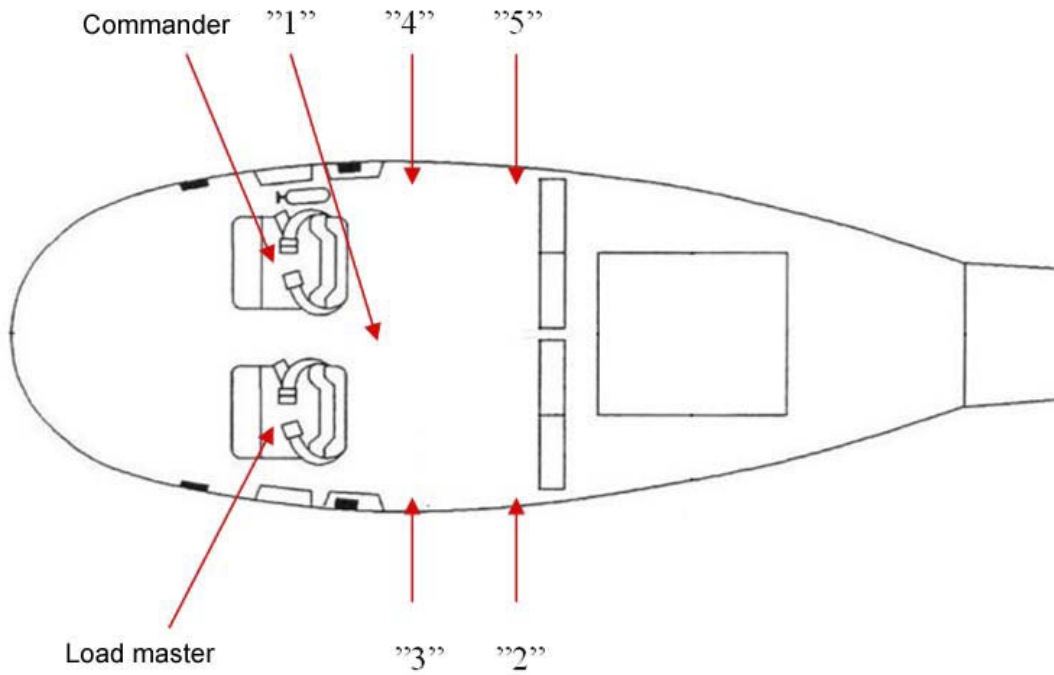
1.1.4.3 The commander has told the AIBN that he considered the sightseeing flight to Kolsås less demanding than the assignment over the Oslo fjord. However, the commander wanted to bring along the load master to keep an eye on the passengers. There were therefore a total of seven persons onboard as they took off towards Kolsås. The commander and load master<sup>3</sup> were seated at the front in the standard aircraft crew seats. The three students (passengers “2”, “3” and “4”), the PS-arrangements employee (passenger “5”) and the manager of PS-arrangements (passenger “1”) sat on the floor in the cabin (see Figure 9 and 10).

Figure 9: Diagram of the helicopter showing the position of those on board.
