REPORT

SL 2011/09

REPORT ON THE SERIOUS INCIDENT AT OSLO
AIRPORT GARDERMOEN NORWAY 31 JANUARY
2008 TO BOMBARDIER CL-600-2B19, OY-RJC,
OPERATED BY CIMBER AIR DENMARK

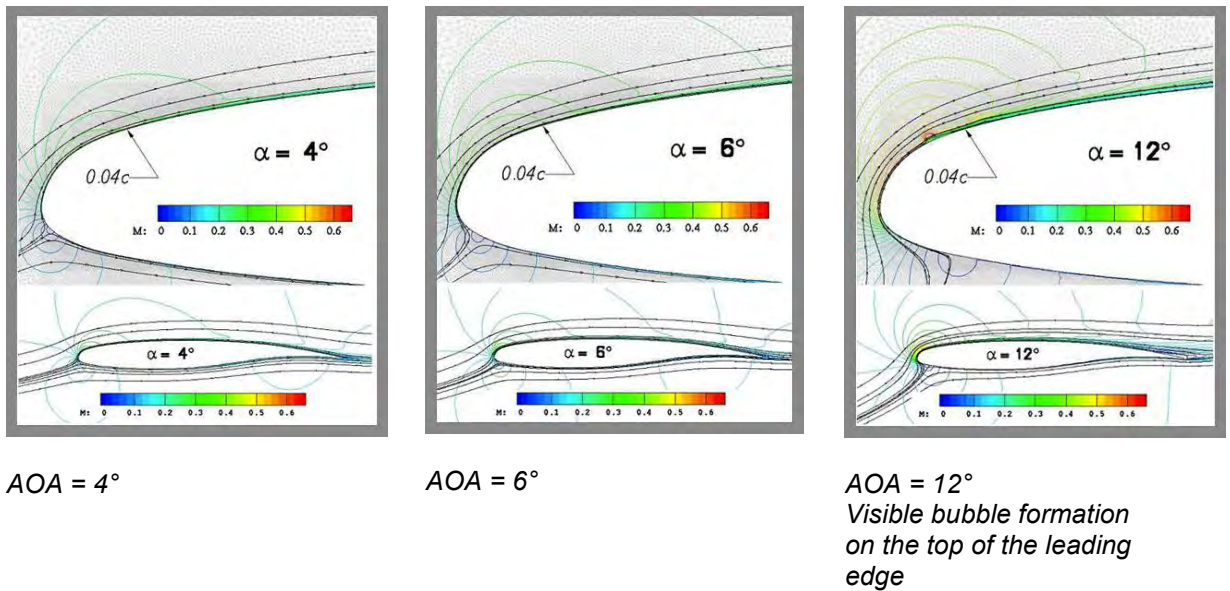
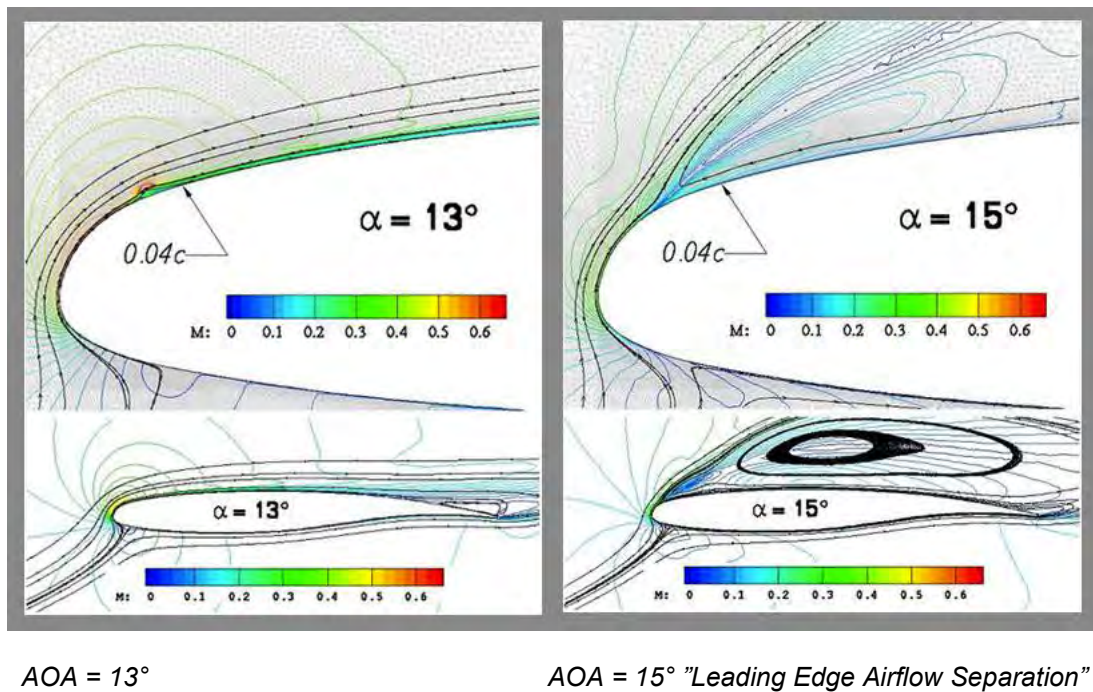
Figure 4: Airflow and pressure distribution during an increasing angle of attack until stalling occurs.

Bombardier refers to the wing profile as a "Thin, high-speed aerofoil". The profile's natural stalling characteristics when the angle of attack reaches a critical value, are that the airflow over the wing suddenly and without warning (like buffeting or vibrations), detaches from the leading edge of the wing and spreads rapidly backwards, causing the lift to be lost (so-called *leading edge stall*, see Figure 4).

The stall characteristics for the wing entail that it will suddenly and without warning lose lift if the angle of attack becomes too high (see Figure 4). The aircraft has therefore been equipped with a stall protection system which warns the crew visually, with audio and through stick shaker when the angle of attack approaches the theoretical stall angle. Activation of stick shaker disconnects the autopilot. If the crew does not correct the aircraft's position, the stick is automatically pushed forward (stick pusher) to avoid stalling.

2.7.2.1 The effect of a contaminated wing leading edge has been thoroughly explained earlier, for example in AAIB report 5/2004. In short, contamination contributes to premature *leading edge airflow separation*, see Figure 4. According to the manufacturer, wing contamination in the case of OY-RJC contributed to reduce the stall angle by about 3 degrees.

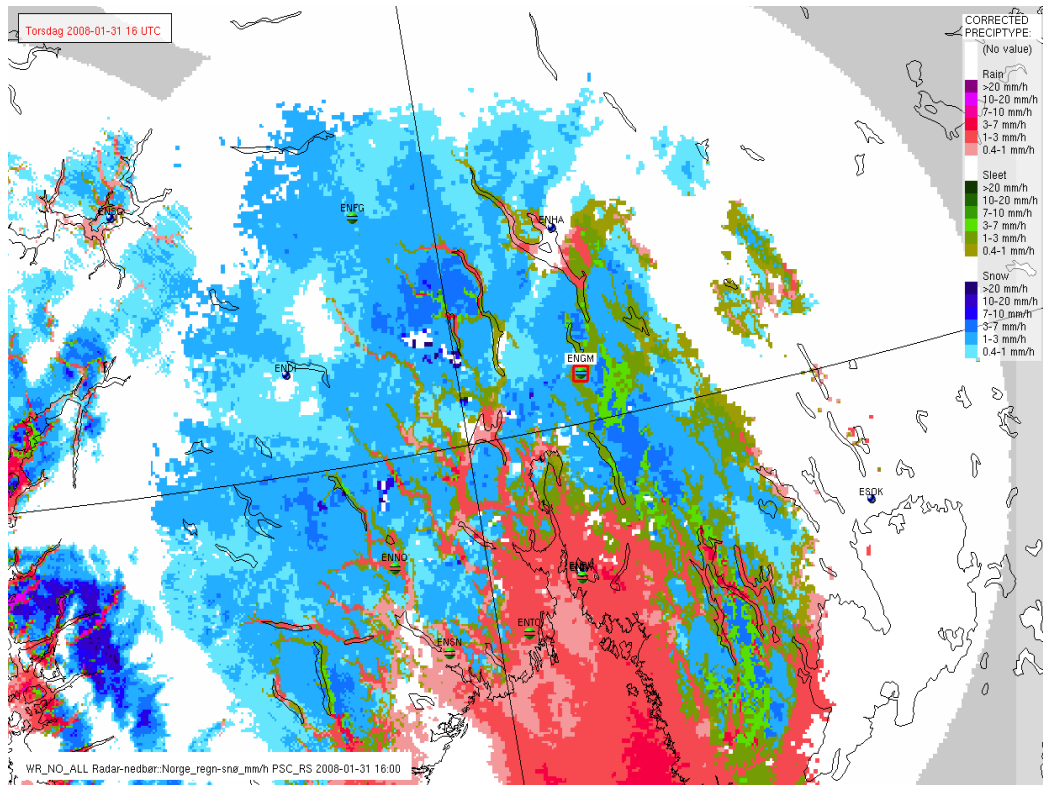
Figure 8: Radar image with indication of precipitation type and intensity at 1600UTC.

1.7.3.1 Below are radar images with indication of precipitation type and intensity at 1600UTC and 1615UTC. Blue is snow, red is rain and green is a mix of the two.

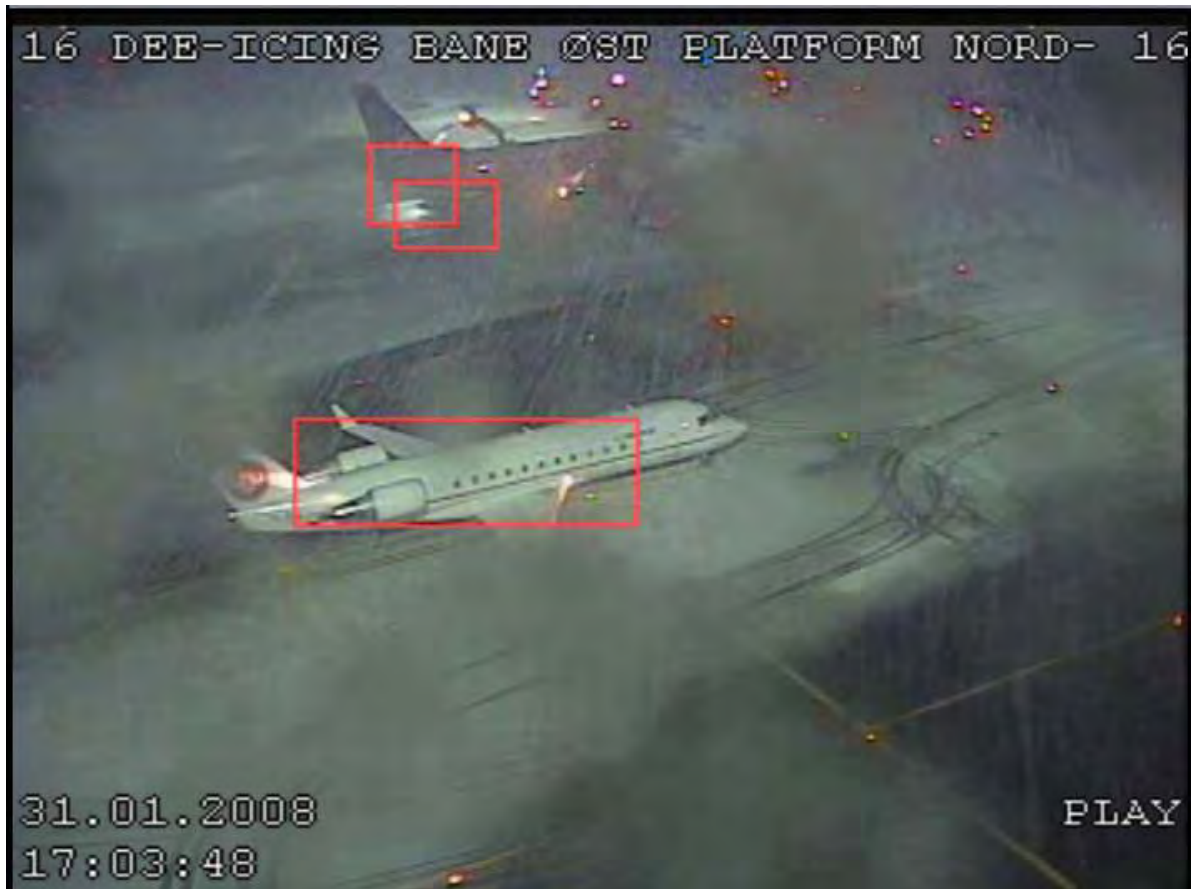
Figure 10: Video image from the de-icing platform as OY-RJC taxis in for treatment.

1.10.3.1 Oslo Airport has established a de-icing area near the runway thresholds. On the afternoon in question, runway 19L was in use for take-offs, and de-icing took place on platform B-North. The airport has a separate communication frequency for de-icing coordination, and the traffic is monitored with a ground tracking radar. In addition, the de-icing platform is monitored by cameras (see Figure 10).

- 1.10.3.8 OY-RJC taxied in for de-icing at 1703 hours. The wings and tail section were treated in two steps in parallel from two vehicles, one on each side of the aircraft. The first step was de-icing with hot water spray. The aircraft's flaps setting was then 45°. Treatment started at 1704 hours. Registrations show that a total of 708 litres of water were used. The Final Release Person (FRP) has explained that he, as usual, walked along the wing leading edge from tip to root feeling with a bare hand to check that the surface of the wing and leading edge was free of ice before the next step started. The operators in the special vehicles checked visually up close that the tail surfaces were clean.

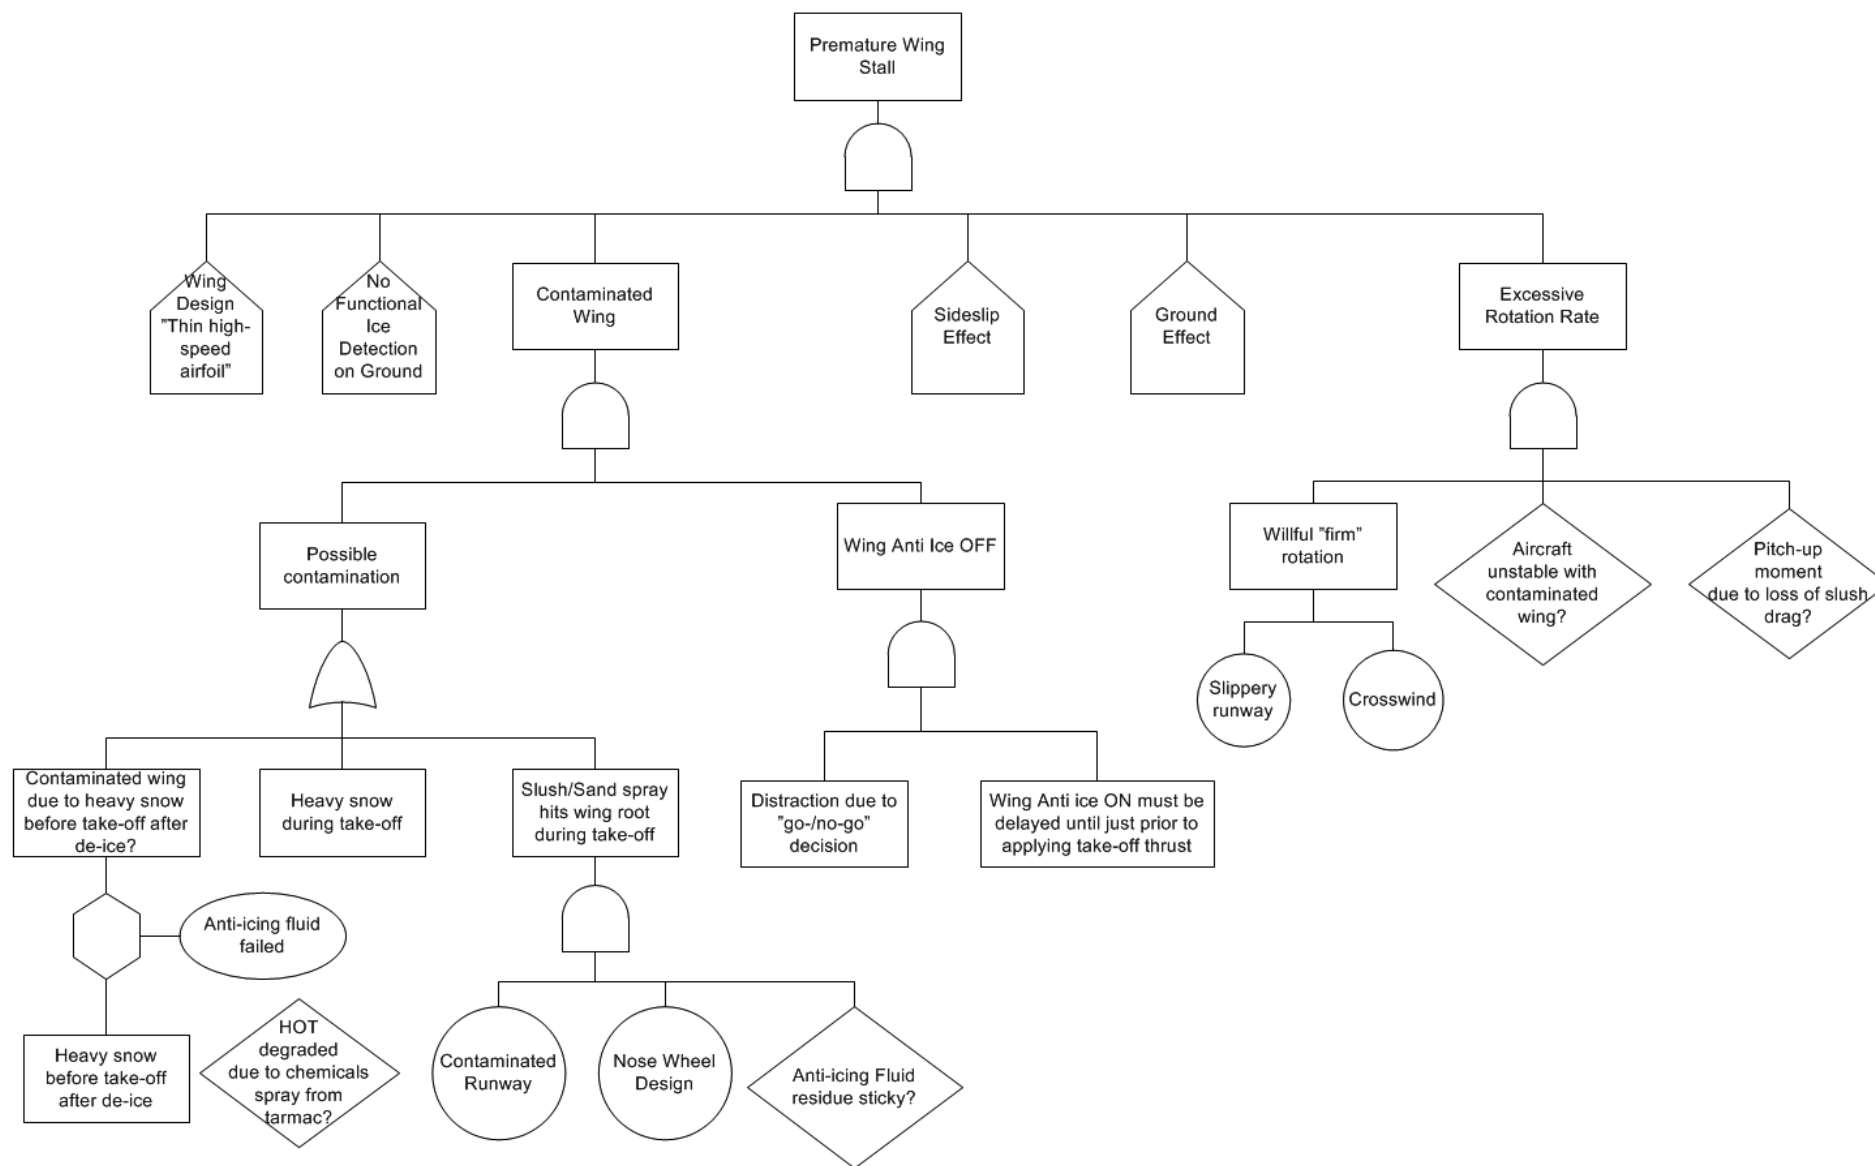
Barrier Analysis Worksheet – Adapted from Department of Energy (DOE), USA

Hazard: Contamination from precipitation and RWY surface			Target: Wing leading edge/upper surface contamination reducing stall margins			
<i>What were the barriers/ which were missing?</i>	<i>How did each barrier perform?</i>	<i>Why did the barrier fail?</i>	<i>How did the barrier affect the incident?</i>	<i>Safety Action Taken</i>	<i>(Further) corrective actions needed?</i>	<i>Priority</i>
De-/Anti-icing	De-/Anti-icing performed according to procedures.			New guidelines given on when de-/anti-icing is required and enhanced procedures provided	No	
Met reports	Precipitation intensity reported according to procedures, based on visibility.	High water content in huge, wet snow flakes. No information available for flight crew to verify this hazard, since visibility reduction indicated moderate snow intensity.	HOT guidelines may not have been valid. Possible fluid failure due to heavy snow? Fluid flows off leading edge first. Sticky, wet snow flakes may have covered the wing leading edge and upper surface at take-off.	None	Yes. North American guidelines for visibility versus precipitation intensity are more conservative than the Norwegian ones.	3
