SL 2011/20

## REPORT ON SERIOUS AIRCRAFT INCIDENT 2-3 NM NORTH OF RYGGE, NORWAY ON 2 JULY 2005 WITH DIAMOND DA40-D, LN-NEX

Aircraft: Diamond Aircraft Industries GmbH, DA40-D  
Nationality and registration: Norwegian, LN-NEX  
Owner: Oslo Flyveklubb, Norway  
User: Same as owner  
Crew/commander: Male, 26 years old  
Passengers: None  
Incident site: 2 – 3 nm north of Rygge Air Force Base (ENRY)  
Date and time of the incident: Saturday 2 July 2005 at 1158 hours

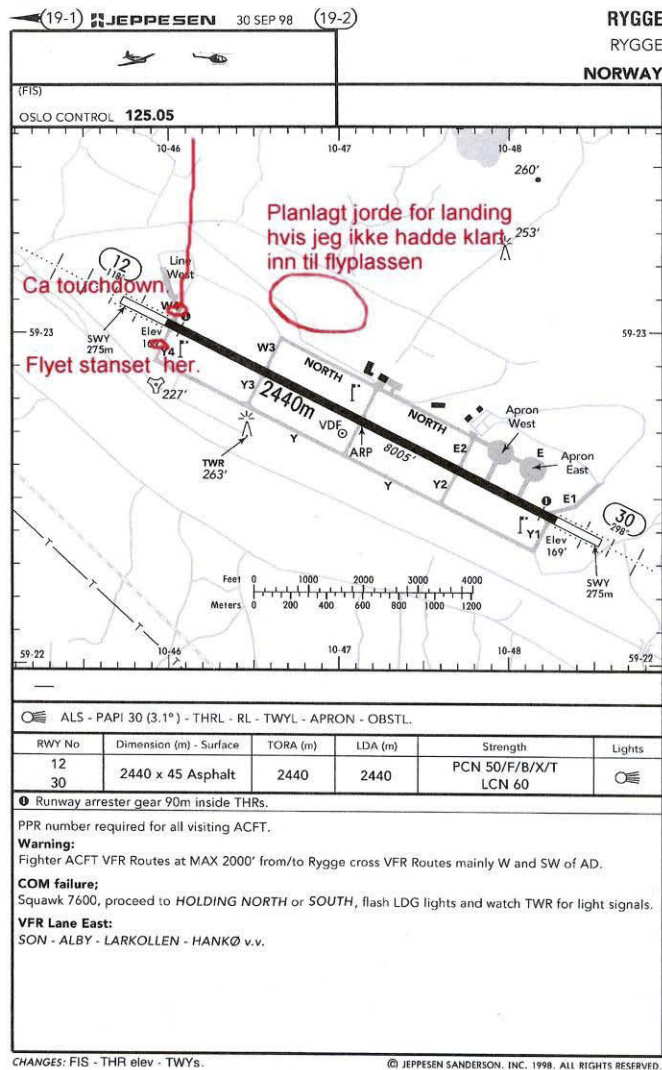
Figure 1: The commander's description of the approach and landing.

1.1.3 When the commander approached the airport he realized it would be possible to land on the taxiway W4 and Y4 across the runway (see Fig 1). According to the commander the decision to land on the taxiway was taken only approximately 300 m before the landing took place. He then realized that by adjusting his course somewhat he would manage to stay clear of a hangar and some trees. He reported his decision to the tower and landing took place approximately in the middle of W4. After braking for a short time, the commander released the brakes and rolled along Y4 for a bit and thus managed to move well clear of the runway. Having reported that the landing was successful and that the aircraft was clear of the runway, the commander switched off the power. Once outside the aircraft, he noticed that there was oil along the fuselage underside and on the left wing root, but that the plane seemed otherwise undamaged.
