REPORT

SL 2013/18

REPORT ON AIR ACCIDENT AT BRANNSLETTA IN NESSEBY IN FINNMARK COUNTY NORWAY ON 26 NOVEMBER 2009 WITH EUROCOPTER AS 350 B3, LN-OML OPERATED BY HELITRANS AS

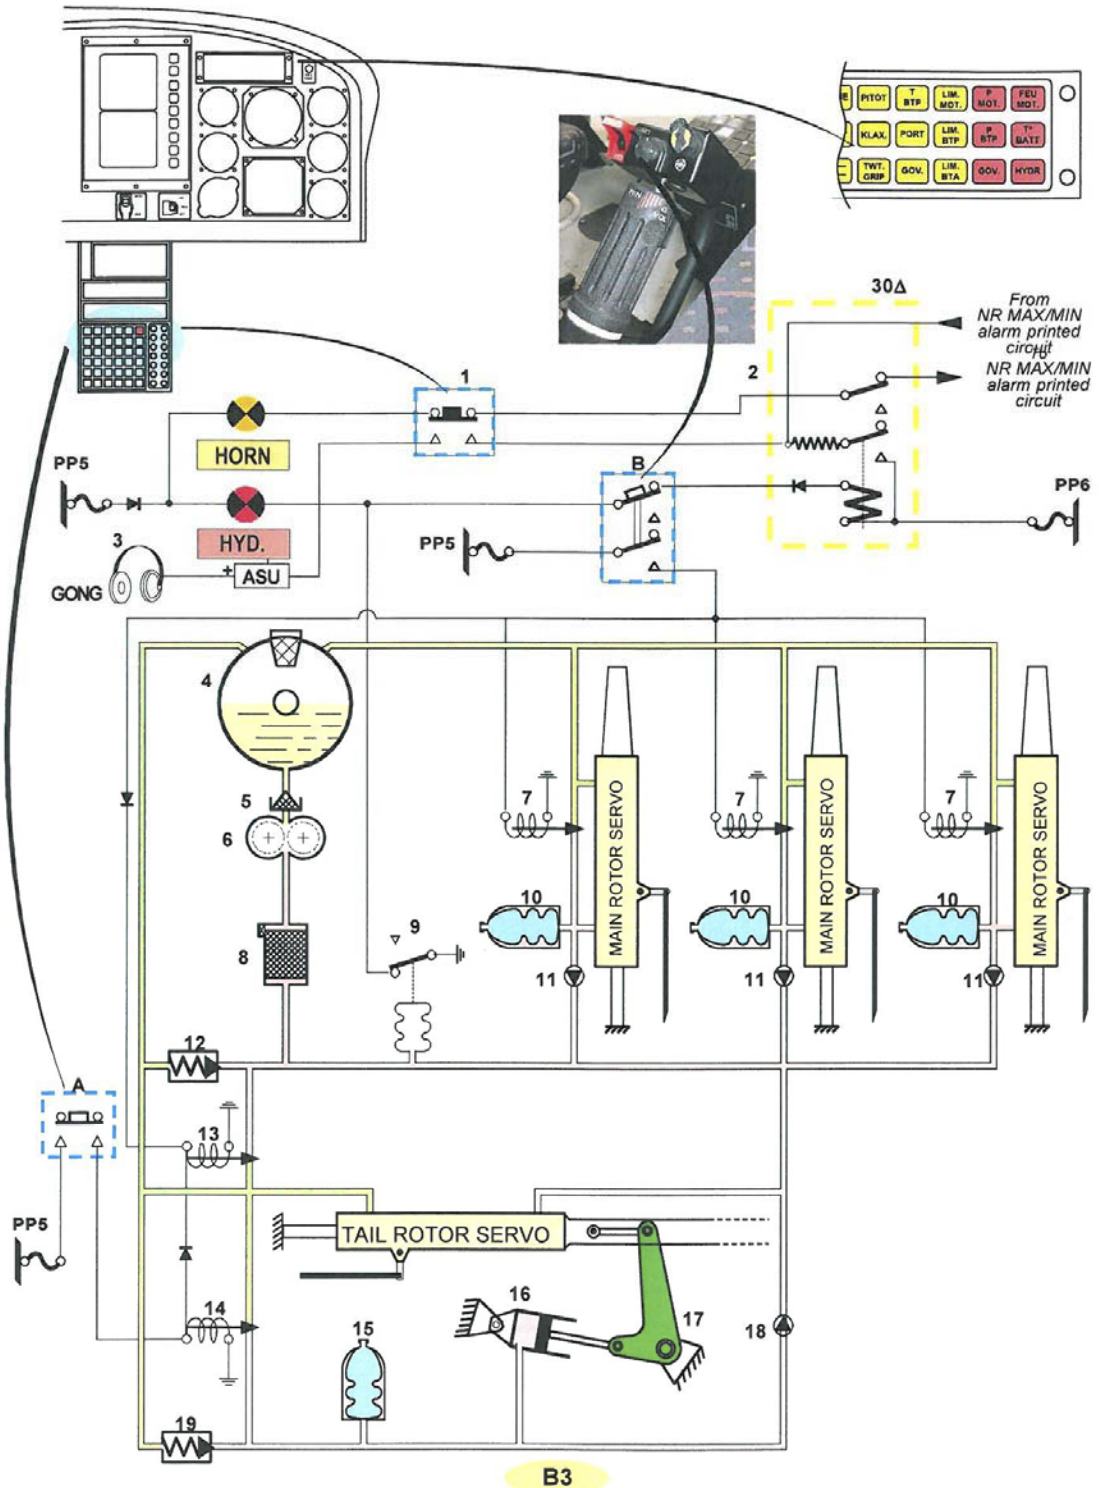
8.2.2. HYDRAULIC SYSTEM COMPONENTS AND THEIR FUNCTIONS
Aft Mod 073263

- 5 HYDRAULIC SYSTEM FAILURES
- 5.1 Yaw Servo-control Slide-valve Seizure
- In hover : If no movement about the yaw axis, land normally ; if rotation about the yaw axis, cut off hydraulic pressure by actuating the switch situated on the collective pitch control lever.
