REPORT

SL 2015/01

REPORT ON THE SERIOUS AIRCRAFT INCIDENT DURING APPROACH TO KITTILÄ AIRPORT IN FINLAND (EFKT) ON 26 DECEMBER 2012 WITH A BOEING 737-800, LN-DYM, OPERATED BY NORWEGIAN AIR SHUTTLE ASA

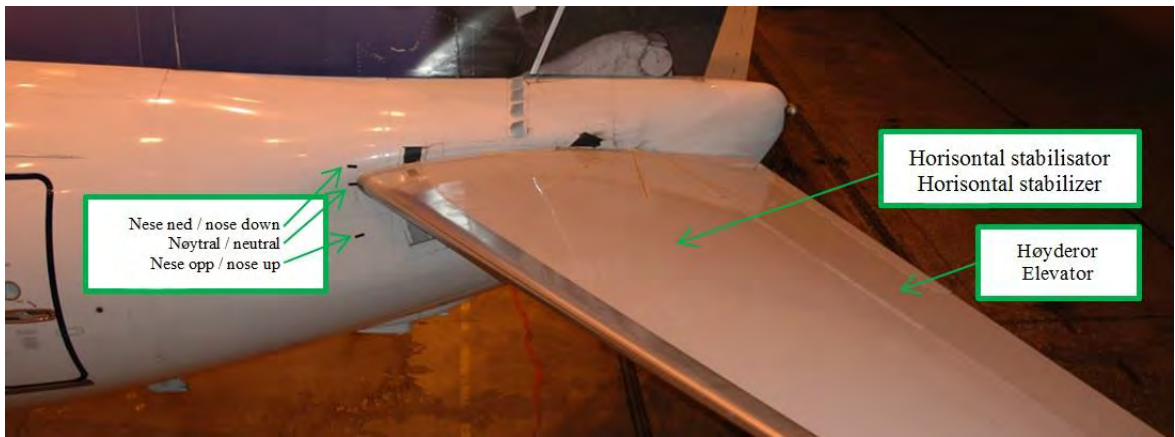
Figure 3: Shows the size ratio between the horizontal stabiliser and the elevator, as well as the range of motion for the horizontal stabiliser. Photo: AIBN

- 1.6.3.5 The elevator is located on the trailing edge of the horizontal stabiliser. The aircraft is trimmed by changing the mounting angle of the horizontal stabiliser. The trimming is electrical and is controlled automatically or via the trim switches on the control column at the flight deck. The horizontal stabiliser makes up a relatively large surface that largely affects the aircraft's aerodynamic forces around the lateral axis (pitch) (see Figure 3).

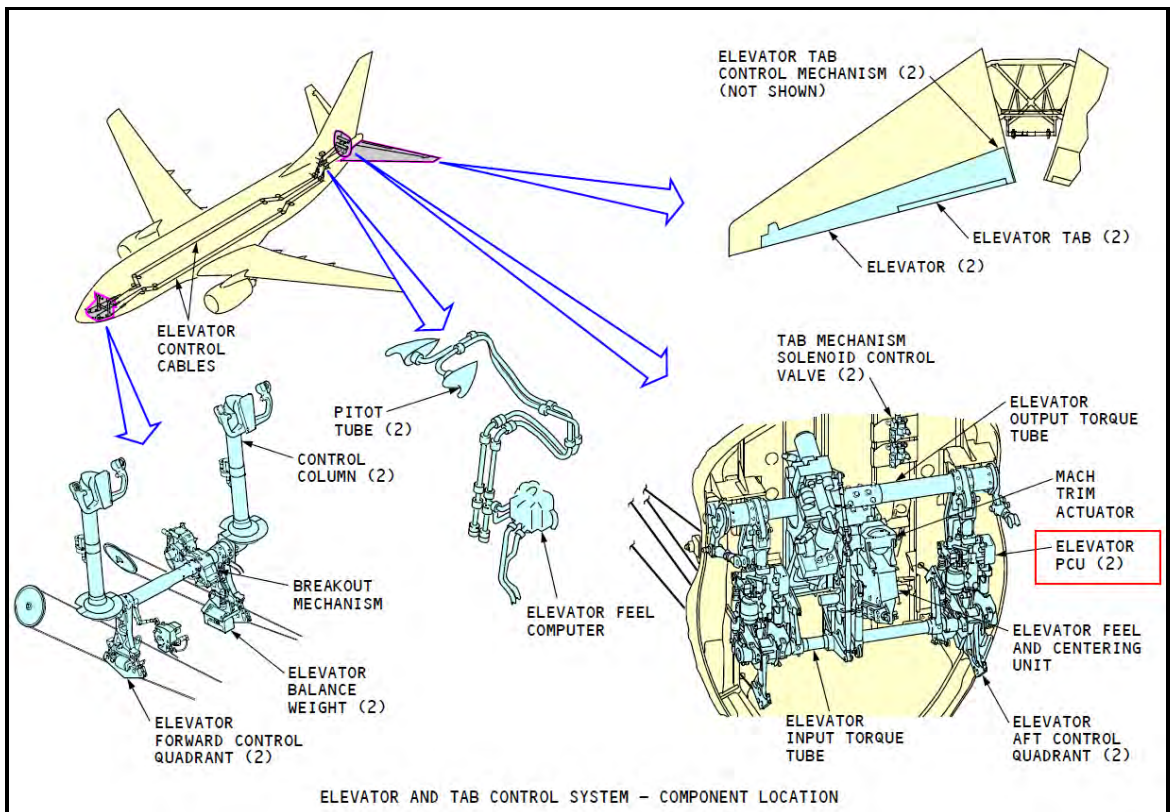
Figure 4: Illustration drawing of the elevator system and component location. Source: - Boeing Proprietary Information. Copyright © Boeing. Reprinted with permission of the Boeing Company

- 1.6.3.2 The elevator system is located in the Tail Cone Compartment. There is a mechanical cable transfer from the control columns at the flight deck and back to the Tail Cone Compartment (see Figure 4). The cables are connected to transfer arms that twist the lower “Elevator Input Torque Tube”. From there, force is transferred via two compressible rods “Input Pogo’s” to the four Input cranks on the aircraft's two PCUs (see Figure 4 and Figure 6).

- 1.6.3.7 The aircraft type's two elevator PCUs are identical. Viewed from the direction of travel, the Primary Input crank on the left PCU and Secondary Input crank on the right PCU are located on the outside toward the fuselage (see Figure 4). The minimum distance from the fuselage opening to the outer Input crank on a PCU is approximately 18 cm (7.9 inches) and the equivalent distance to the inner Input crank is approximately 21 cm (8.3 inches).
- 1.6.3.8 As is evident from Figure 8, the Secondary Input cranks on the PCUs have a cover that partially enclosed the Input cranks, while the Primary Input cranks have no protective cover. The cover encloses the Input crank toward the back, but has an opening in the aircraft's direction of travel.

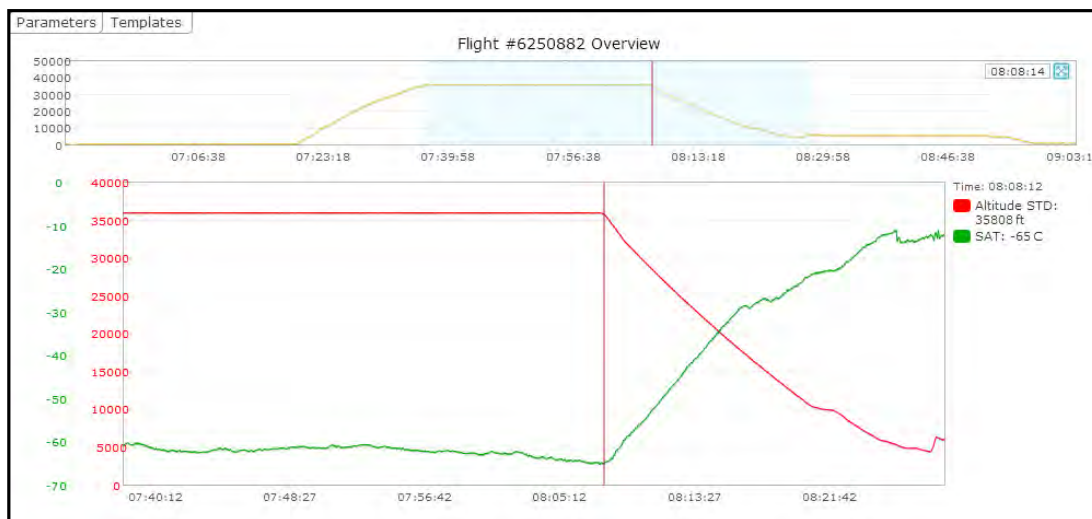
Figure 9: Shows outside temperature (SAT) from when the aircraft was established at cruising altitude until just after the incident in Kittilä. Source: AIBN (data acquired from the aircraft's flight recorder)

- 1.7.1 Wind directions varied during the period 23-26 December 2012, while LN-DYM was parked outdoors at Helsinki airport Vantaa, mainly from the east and wind speeds were up to 15 kt. Temperatures varied between -7 °C and -19 °C, and there were snow showers.
- 1.7.2 METAR for Helsinki airport Vantaa on 26 December:
- During de-icing: EFHK 0650Z 28007KT CAVOK M17/M19 Q0998 NOSIG
 During departure: EFHK 0720Z 28003KT CAVOK M17/M20 Q0998 NOSIG
- 1.7.3 NAX5630 flew Helsinki – Kittilä at flight level FL360, equivalent to approximately 36 000 ft. The aircraft's flight recorder registered an outside temperature of between -60 and -65 °C at cruising altitude (see Figure 9).

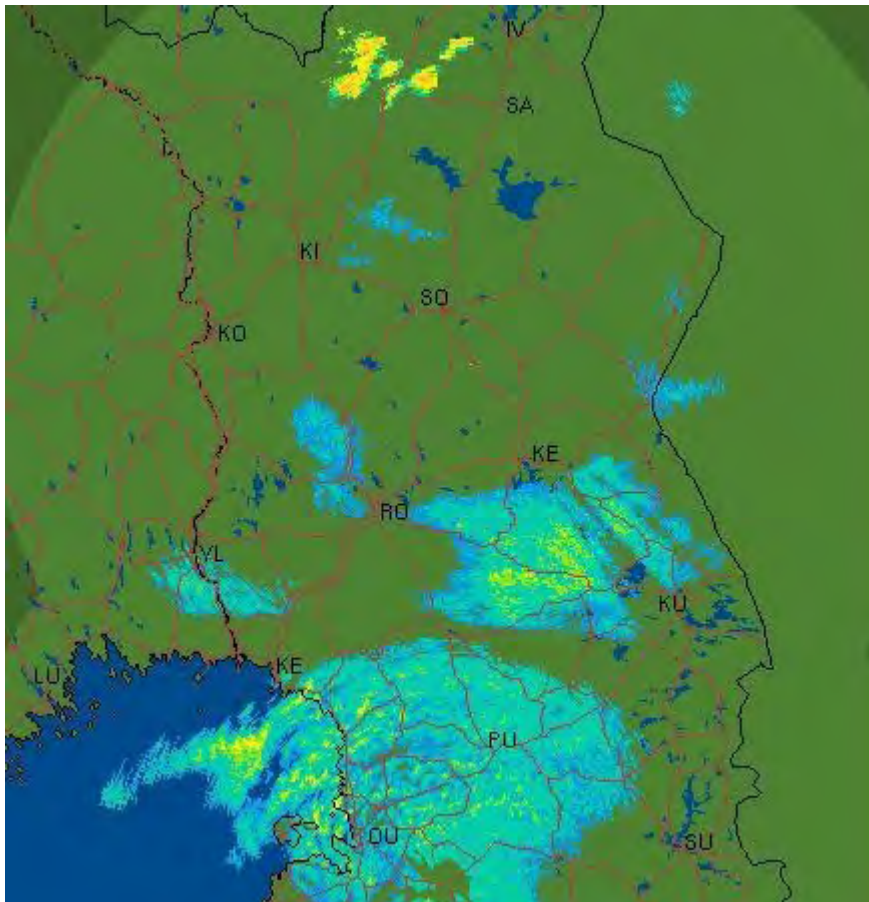
Picture 2. Radar picture 26.12.2012 at 08.30UTC.

Based on metar's and radar it was dry weather in Kittilä. Picture 2 shows radar picture at time 08.30 UTC. It seems some light snowfall towards northeast from Kittilä (KI) and also towards south near Ro that is city of Rovaniemi.

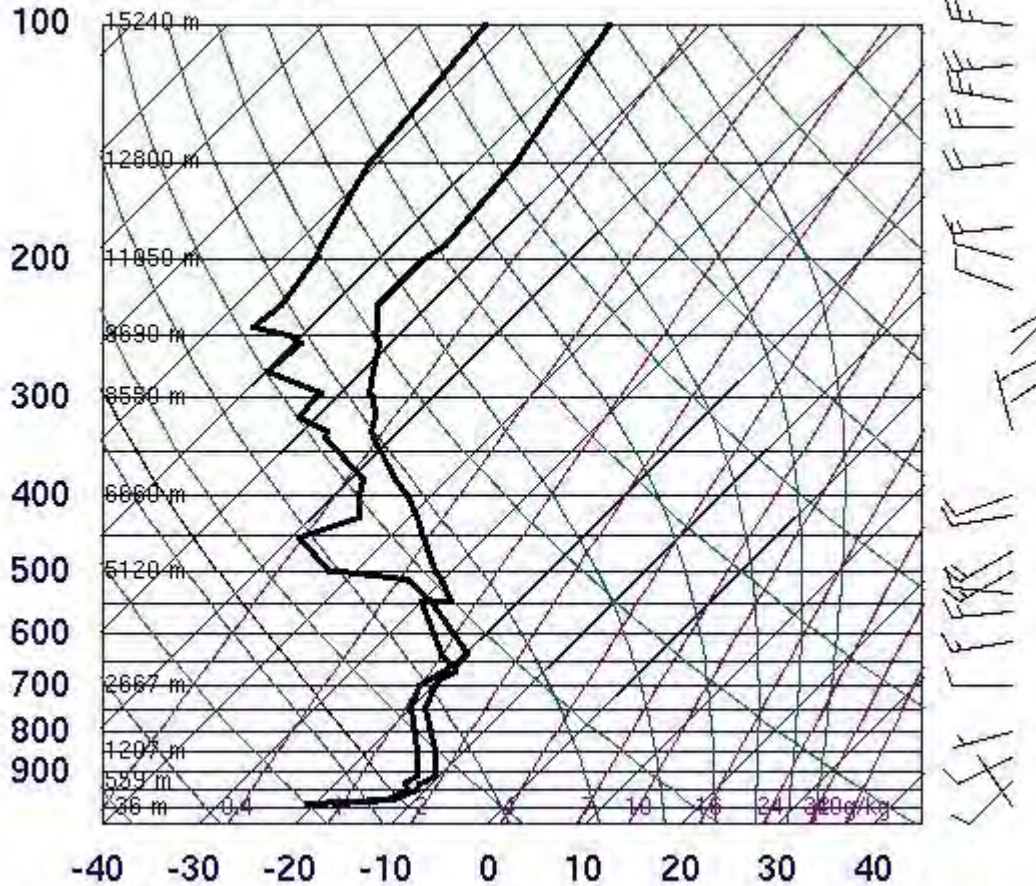
Picture 3. Lulea sounding at 00UTC 26.12.2012 is taken from website:
<http://weather.uwyo.edu/upperair/sounding.html>

Temperature on the ground was about minus 20 degrees and there were a strong inversion near the ground which can be seen from Laps, picture 4. Also sounding from Lulea 00 UTC picture 3 indicates strong inversion in Northern Scandinavia. In Finland we have Sodankylä sounding at 12 UTC, picture 5. There can still be seen inversion level below one kilometer. An another inversion level is around 5000ft in Sodankylä 12 UTC it's anymore about 5 degrees, but earlier pilot report (Boeing 737) has noticed there 11 degrees inversion at 0911UTC.
