SL 2016/02

REPORT ON SERIOUS INCIDENT NEAR KLANTEN AIRFIELD, NORWAY ON 26 MAY 2015 WITH ALEXANDER SCHLEICHER GMBH & CO SEGELFLUGZEUGBAU ASK 21 MI, LN-GMI

Date of submission: 23.02.2016
SL Report: 2016/02

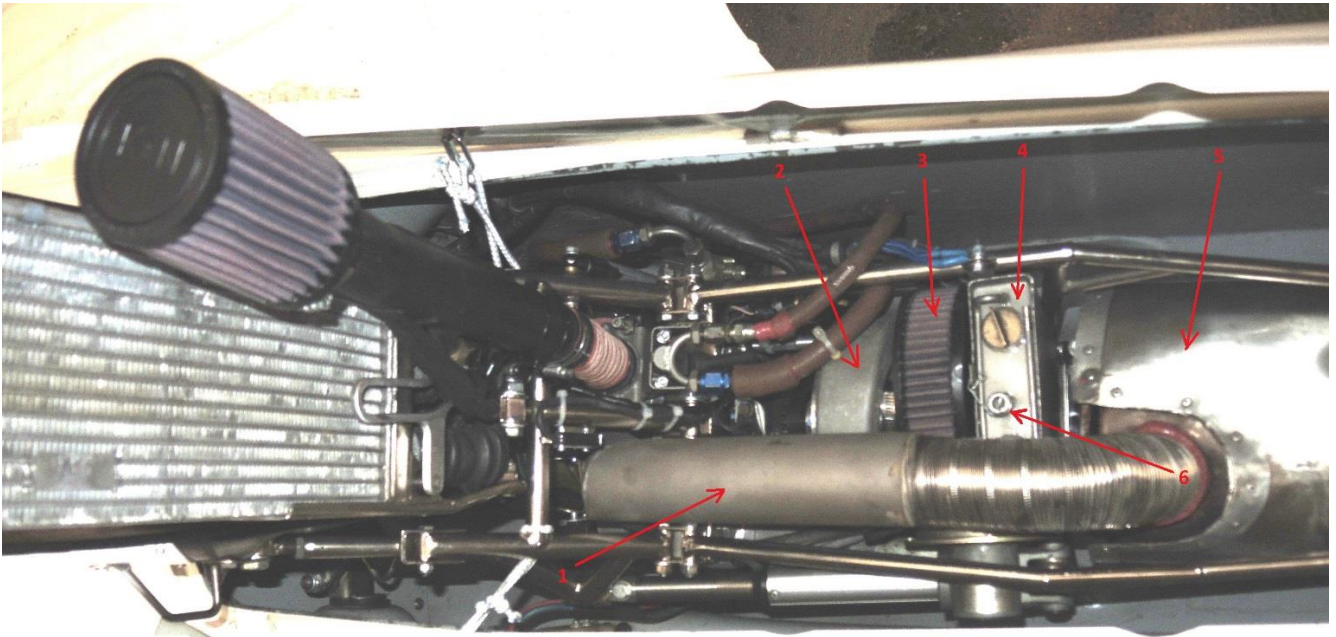
The engine is attached to the fuselage by two mounts in the rear and one in front. The rear mount includes a bolt going through the oil tank and down into the fuselage under the oil tank (see Figure 3, Part 6, and Figure 6).

Figure 3: The engine installation seen from above. 1 Exhaust pipe, 2 Cooling fan, 3 Air filter, 4 Oil tank, 5 Exhaust silencer, 6 Rear engine mount bolt. Photo: AIBN
