REPORT

SL 2016/11

REPORT ON SERIOUS AVIATION INCIDENT AT SVOLVÆR AIRPORT HELLE ON 2 DECEMBER 2010 INVOLVING BOMBARDIER DHC-8-103, LN-WIU, OPERATED BY WIDERØE'S FLYVESELSKAP AS

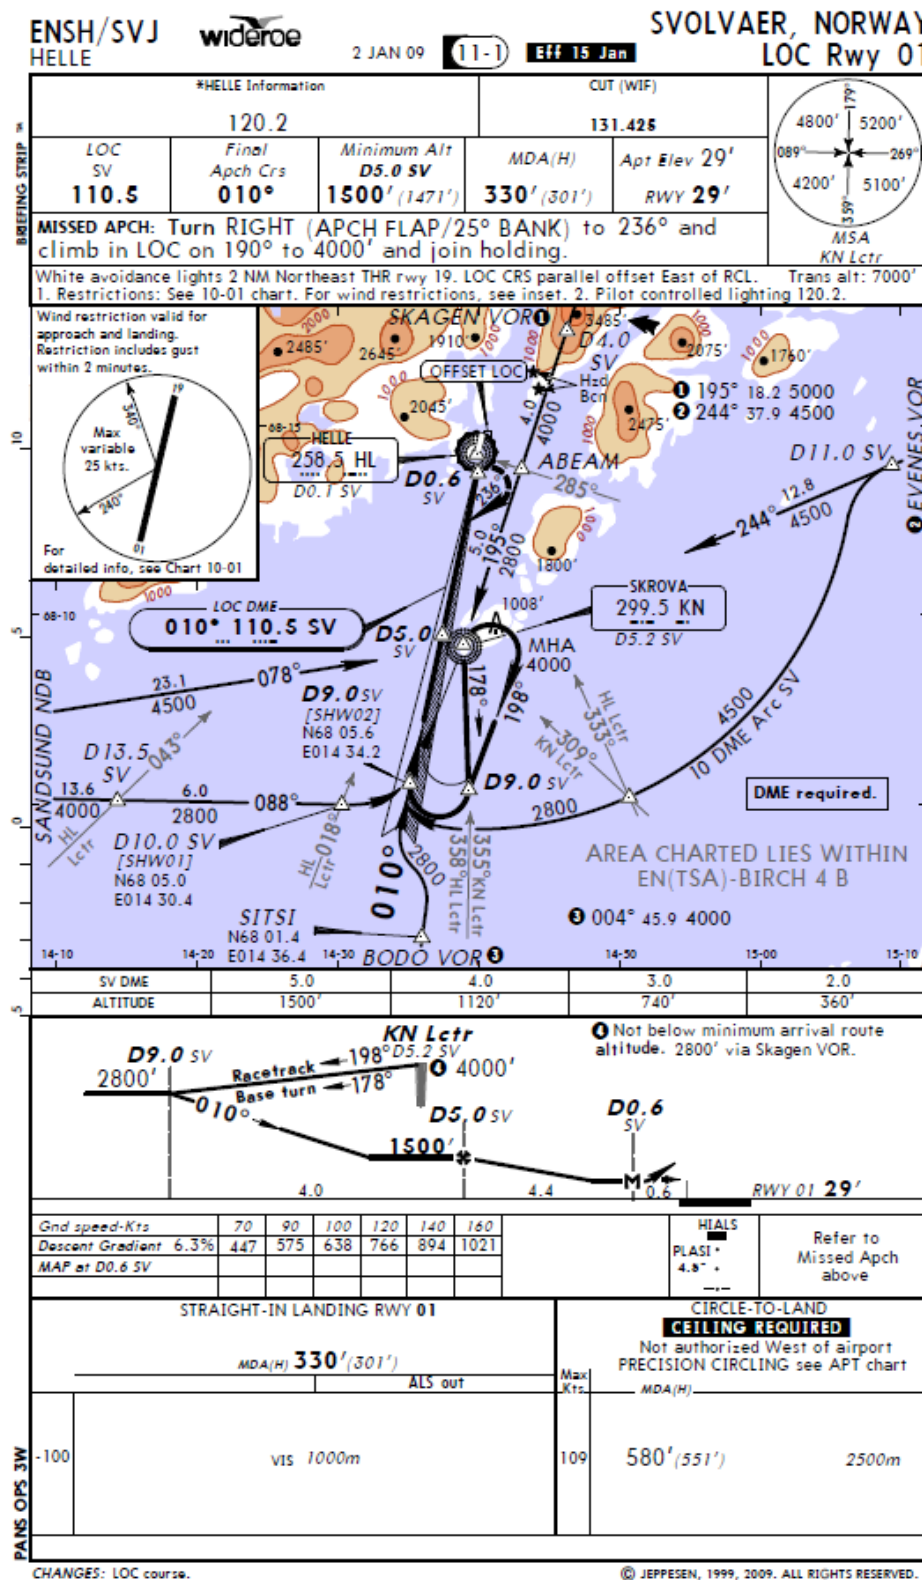
Figure 1: Widerøe's applicable approach map for ENSH at the time of the incident. For landing towards the south the "Circle-to-land" procedure is followed. See also Figure 2. Source: Widerøe

2.9.3.1 The Accident Investigation Board also considered whether there were elements of the company's circling procedures or the concept of "Precision circling" that it would be relevant to point out in this case (cf. Chap. 1.17.3). Without making terminology a main issue, AIBN would like to point out that the term "precision" may be perceived as misleading here, as the position support in the circling pattern in Svolvær is not very precise. The fact that the circling pattern has been designed based on a maximum speed of 109 KIAS, illustrates the obstacle situation and considerations that have been made (cf. Figure 1). The margins are small. Consequently, the precision requirements for execution will be high.

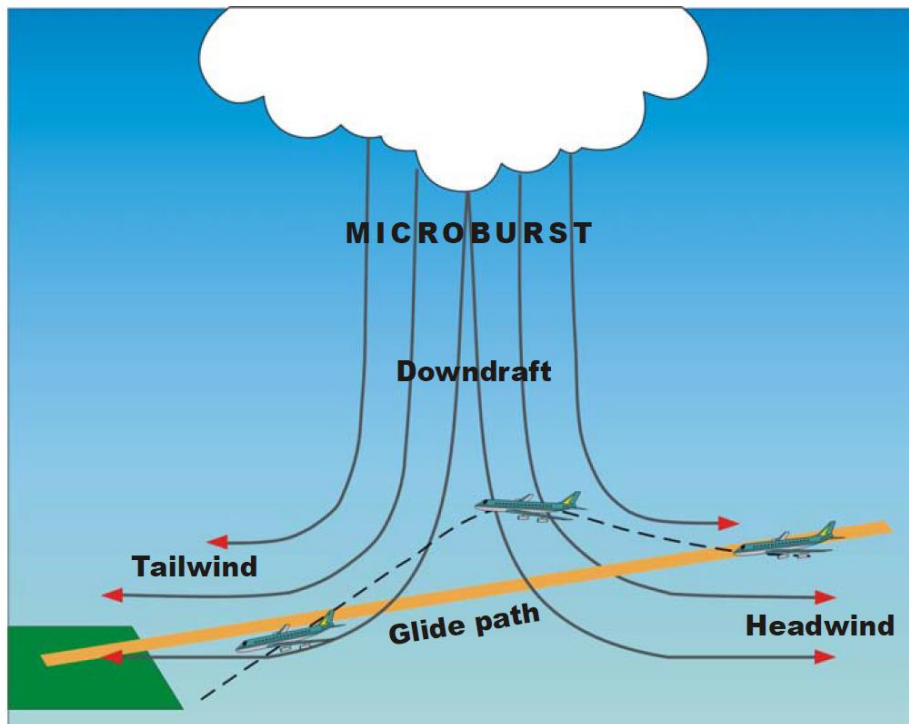
- 1.7.5.1 In this connection, wind shear means a sudden change in wind direction and/or strength, of such nature, scope and duration that an aircraft may experience major problems in maintaining its planned speed and trajectory. It is a well-known fact that wind shear at low altitude constitutes a serious threat. At worst, it can cause an airplane to stall and fall without control, or have such a significant deviation from the planned profile that it flies into the ground, even with fast and correct reactions on the part of the crew.
- 1.7.5.2 Strong local wind shear, often of short duration, can occur when vertical wash out below a cumulonimbus veers off and spreads horizontally as the air hits the ground (so-called microburst, see Figure 5).

Figure 5: Wind shear caused by microburst. Source: ICAO Manual on Low-level Wind Shear

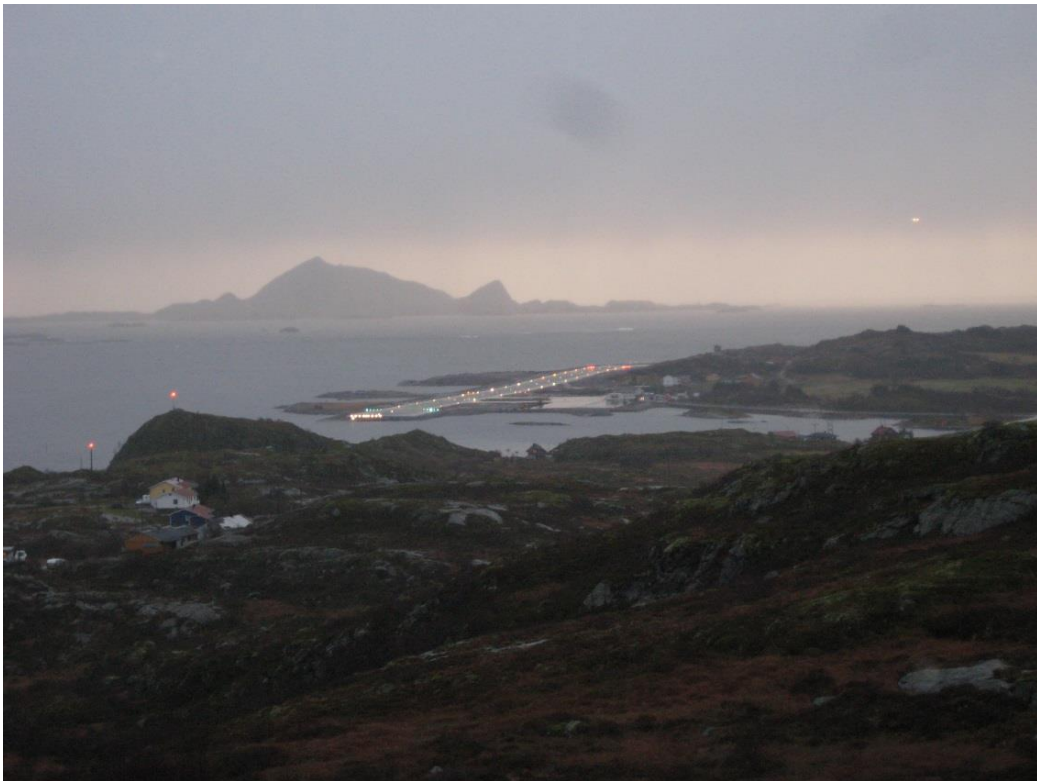
Figure 6: Illustration photo ENSH, seen from the northwest (runway 19). Note red obstruction lights north of the airport. Photo: Avinor

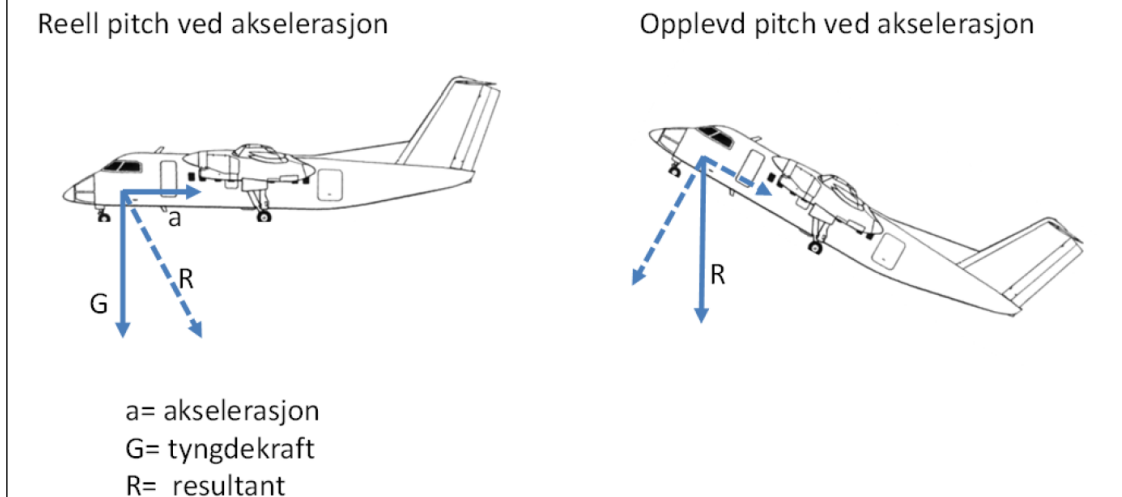
Figure 11: Resultant force and perceived pitch (nose position) in a somatogravisk illusjon.
Source: FMI

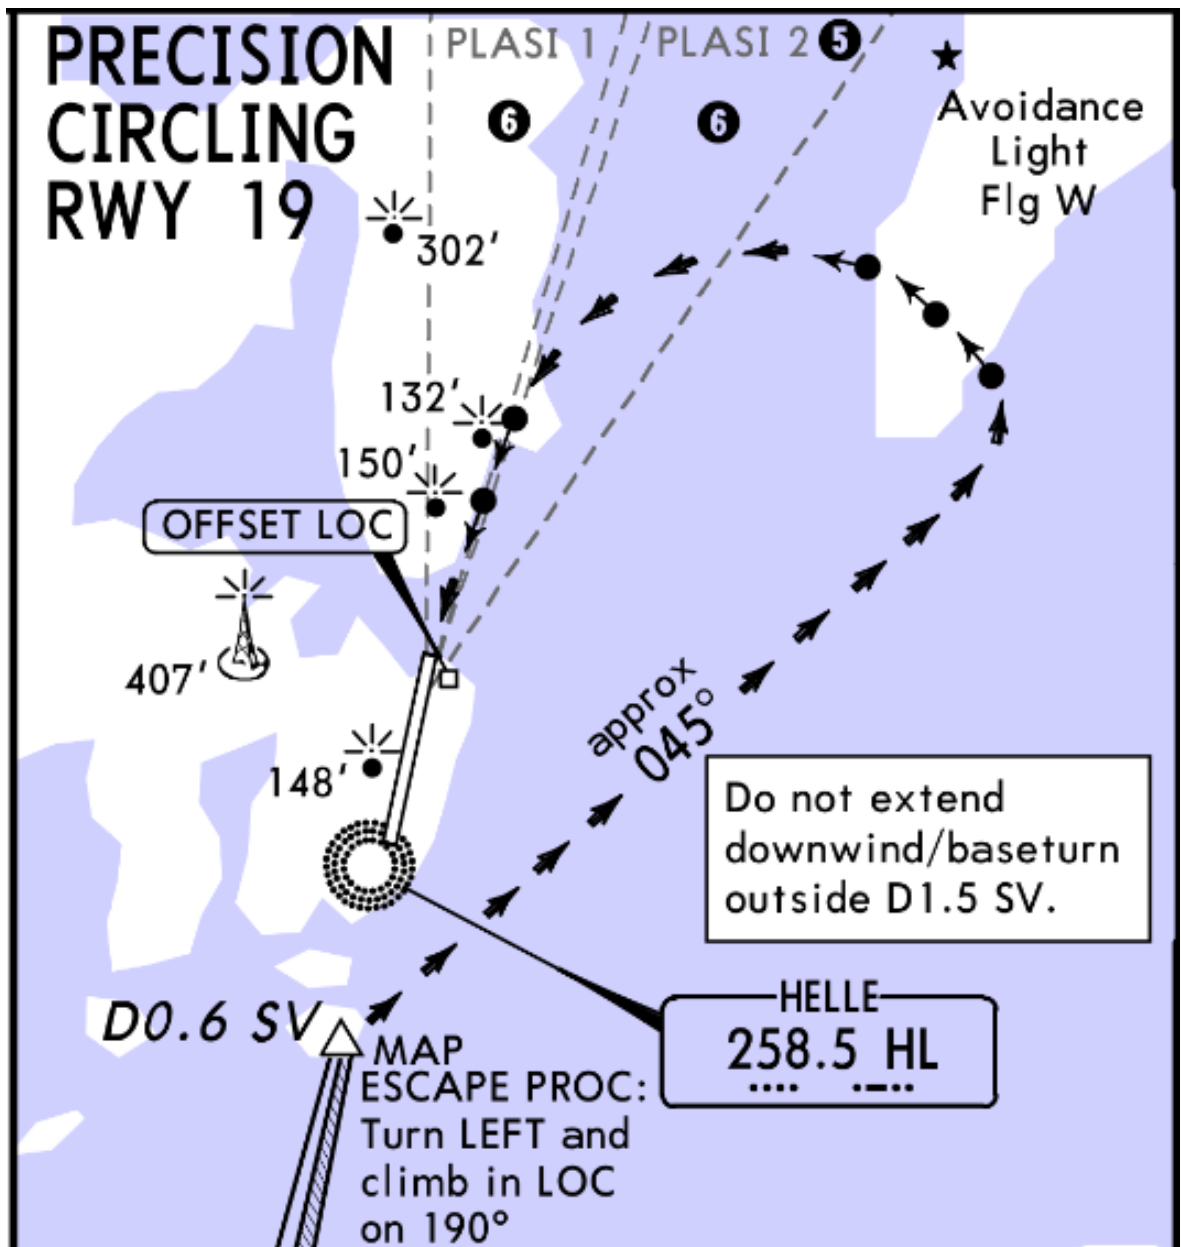
Figure 15: Widerøe's circling pattern in Svolvær dated 20 February 2015. Note circling lights onshore to the northeast and double PLASI. Source: Widerøe

- 2011: New lights installed.
 - 20 September 2013: New expanded circling pattern and approach lights in place after extensive consideration in the local and central safe aviation practice committee (cf. Figure 15).
