UPDATE TO PRELIMINARY REPORT ON ACCIDENT AT TURØY, NEAR BERGEN, NORWAY ON 29 APRIL 2016, INVOLVING AIRBUS HELICOPTERS H225, LN-OJF OPERATED BY CHC HELIKOPTER SERVICE AS

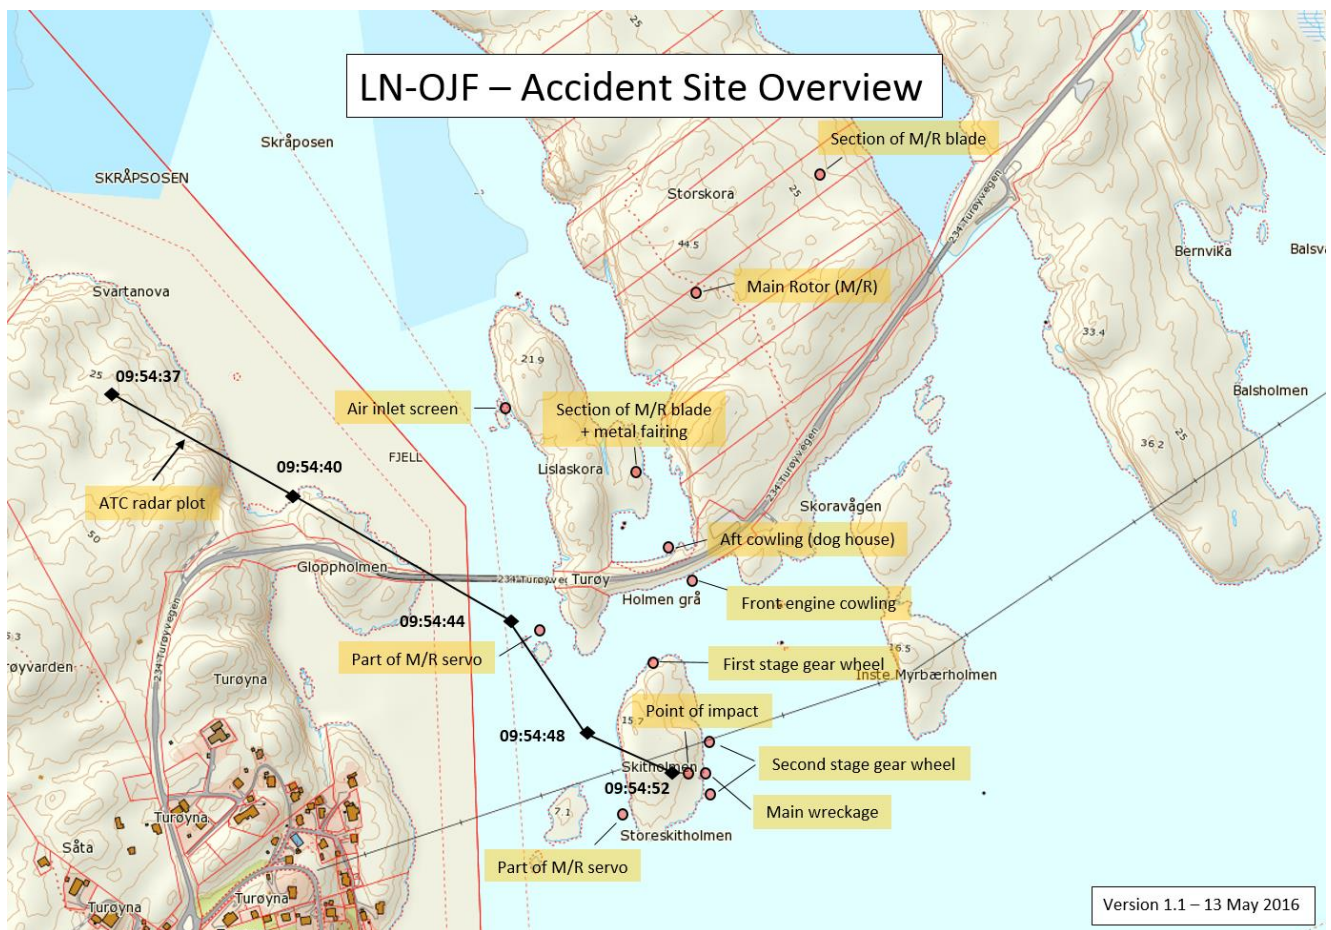
Figure 1: The Accident Site. (Time on ATC Radar Plot is UTC.) Map: © The Norwegian Mapping Authority. Illustration: AIBN

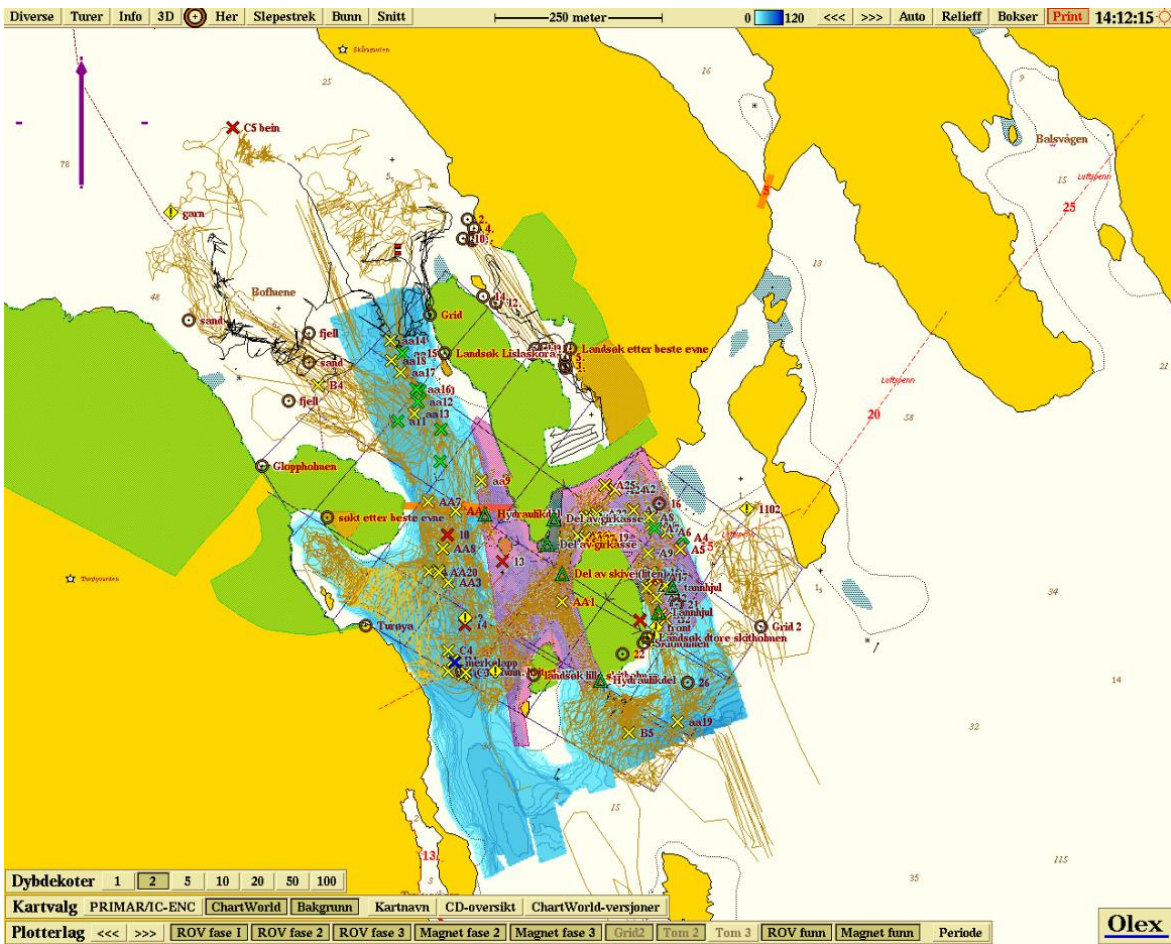
Whilst several parts vital for the investigation have been recovered the four weeks since the accident, some key components are still missing. These components are in particular the epicyclical second stage planet gear carrier and parts of the forward suspension bar. A comprehensive search involving both civil and military resources was organised by AIBN until Friday 20 May. Before the next search phase is launched, the intention is to study in detail all information from the searches so far. A refined flight path and mapping of where the different components have been found will be carried out in order to possibly fine-tune a new search for these key components. Please refer to the AIBN web page for additional information on missing components and instructions on how to behave if 3rd parties discover parts from the helicopter.

Figure 2: Illustration of underwater search grid.
