**PRELIMINARY REPORT ON THE AIR ACCIDENT NEAR TURØY, ØYGARDEN  
MUNICIPALITY, HORDALAND COUNTY, NORWAY 29 APRIL 2016 WITH AIRBUS  
HELICOPTERS EC 225 LP, LN-OJF, OPERATED BY CHC HELIKOPTER SERVICE AS**

28 April 2017

## AIR ACCIDENT PRELIMINARY REPORT

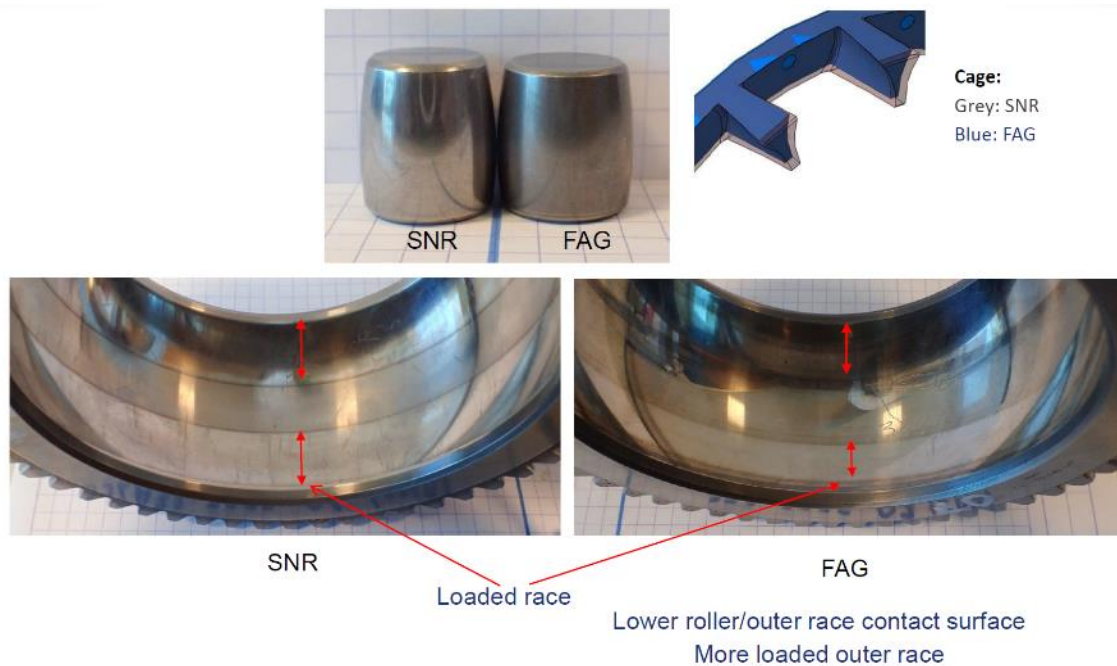
Figure 9 shows the differences between a FAG and a SNR bearing and their contact pattern on outer race. Table 5 shows the contact pressure for FAG and SNR second stage planet gear bearings, with FAG having a significantly higher contact pressure on the outer race (OR). In addition, the differences in the finishing process performed by the suppliers can affect the outer race surface residual stress, with FAG having a significantly higher compressive stress at the race surface.

Contact pressure at take-off-power transient	FAG	SNR	Key difference
IR max contact pressure [MPa]	1,811	1,862	FAG IR contact pressure = 0.97 x SNR
OR max contact pressure [MPa]	1,800	1,550	FAG OR contact pressure = 1.16 x SNR

Figure 9: Differences between SNR and FAG bearings and contact pattern on outer race. Source: Airbus Helicopters

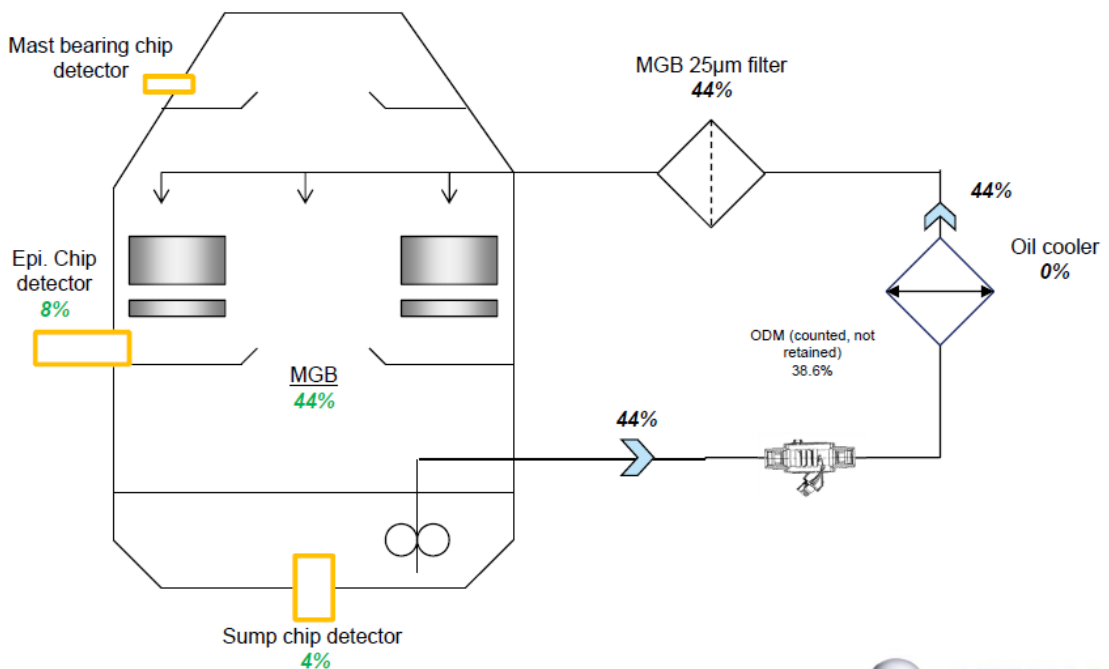
Airbus Helicopters launched a MGB spalling test program following the G-REDL accident (see chapter 1.18.3). The single test, presented to the AIBN, has shown that the total detection rate (% of all free magnetic particles expected to be collected on the plugs) is 12 %, while 44 % of the particles were said to end up in the oil filter. However, due to the recent finding of several particles recovered from inside the oil cooler of LN-OJF (see chapter 1.16.8.3), Figure 12 is no longer representative. 44 % of the particles do not reach the MGB oil filter like the figure shows, but particles are actually also collected by the oil cooler.

Figure 12: The test set-up and the detection rate of chip detectors (%: Particle quantity) presented following the G-REDL MGB spalling test program. Source: Airbus Helicopters

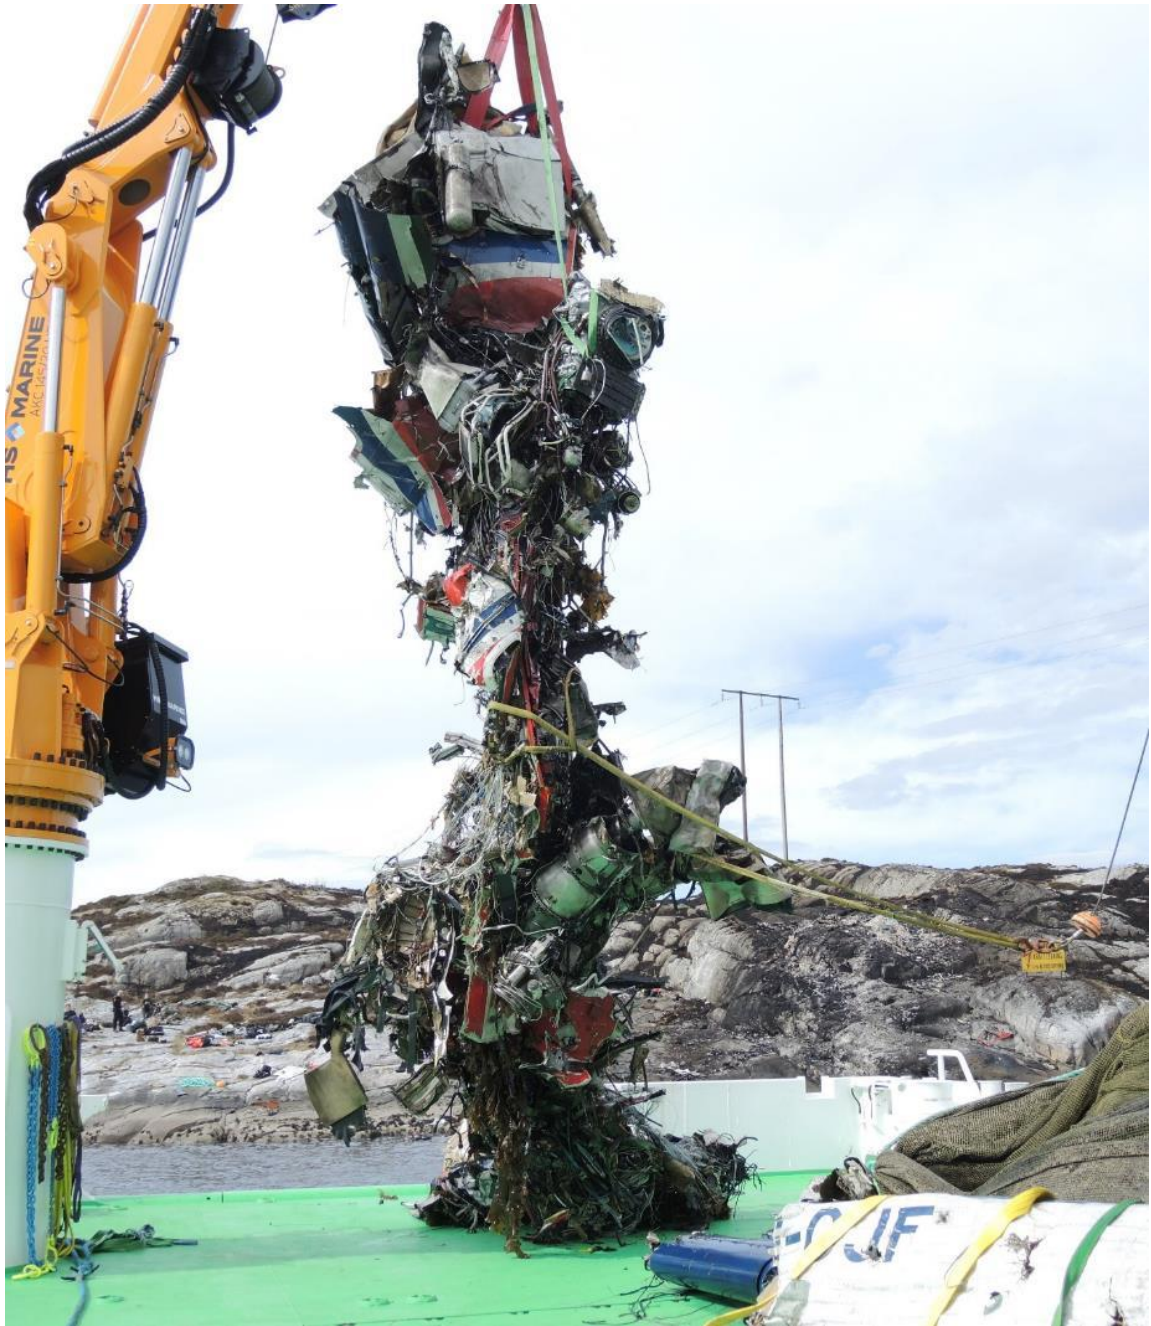
The main parts of the helicopter cabin, including the cockpit, were recovered as one piece, held together by bars, wires, tubes and pipes, but otherwise structurally damaged. They were damaged to such extent that it was almost impossible to conduct any meaningful investigations of the wreckage components (see Figure 22).

Figure 22: The main wreckage during recovery. The tail boom seen at the lower right had already been recovered. Photo: AIBN

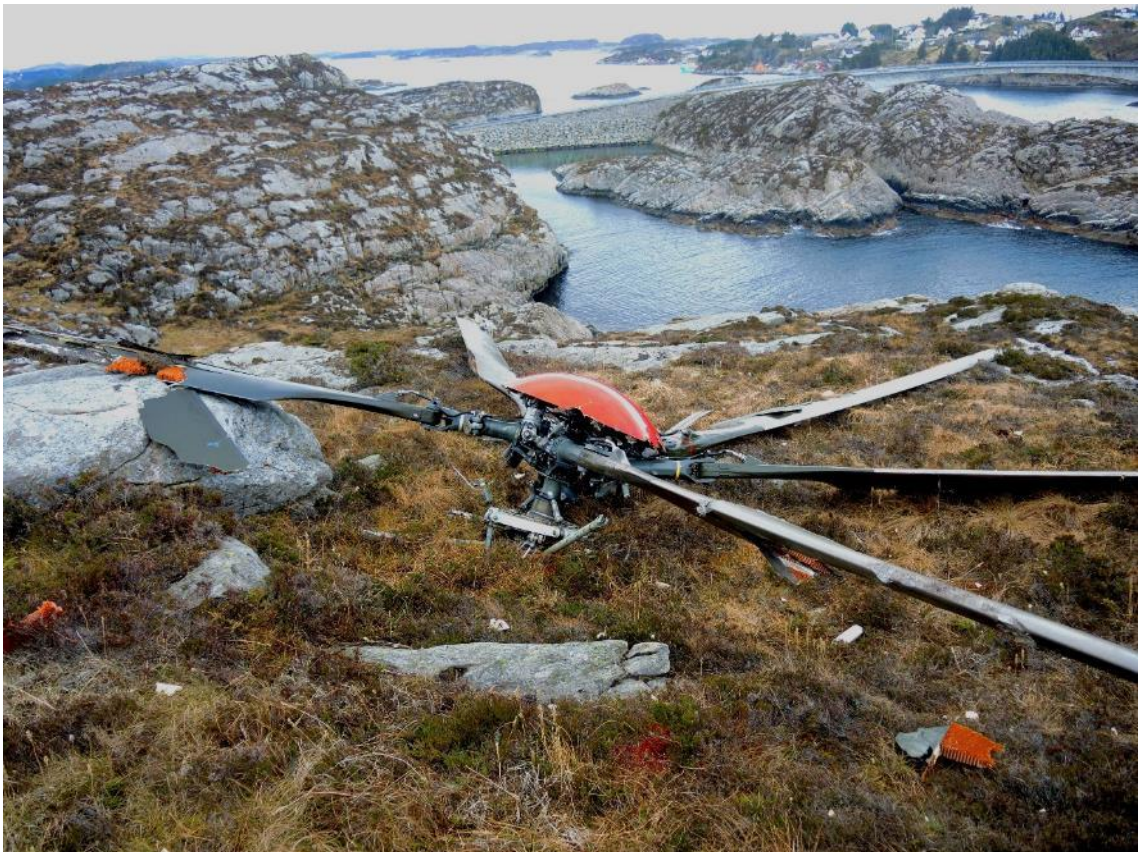
The main rotor including the main rotor mast, parts of the conical housing including the lift bearing and two suspension bars were discovered on Storskora Island (see Figure 24).

Figure 24: The main rotor and rear suspension bars as found at the island Storskora.  
Photo: AIBN

The two aft suspension bars were still attached to the lift housing when the main rotor was found (see Figure 24). Both lower fuselage fittings had been torn out of the fuselage and were found with the main rotor. These parts were shipped, together with the rotor mast and rotor head, to Airbus Helicopters for examination, see Figure 29 and Figure 54.

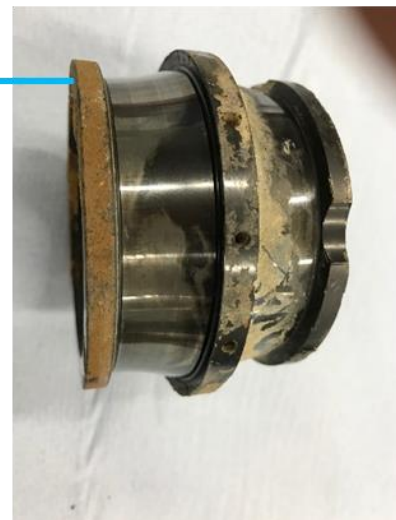
During a diving exercise in February 2017 the second stage planet carrier was found (see Figure 49). On the planet carrier the inner race of the fractured planet gear was still on the carrier but pulled off 20.4 mm. The lower rotor mast bearing was installed on the carrier. After cleaning, the inner race surface (see Figure 50) appears to be in good condition for further examination at QinetiQ together with the carrier and the bearing. The rotor mast splines have been visually inspected and no geometrical deviations were observed. Further investigation of the carrier is in progress.

Figure 50: The inner race of the fractured planet gear after cleaning of the upper race (left in photo). Position on the carrier is given by the arrow. Photo: AIBN/QinetiQ

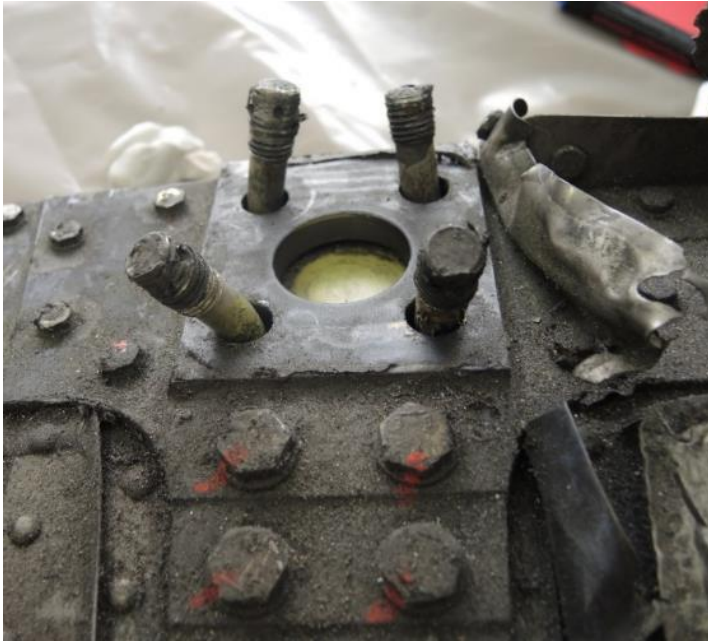
Inspection of available suspension bar airframe fittings, the mating airframe shim and plate, showed no major fretting, see Figure 58.

*Figure 58: The four bolts from the lower forward fuselage fitting protruding from the support plate.  
Photo: AIBN*
