SL 2018/10

REPORT ON AIR ACCIDENT AT HØYLAND, HÅ MUNICIPALITY IN ROGALAND 30 APRIL 2016 INVOLVING AIRBUS HELICOPTERS AS 350 B3, LN-OSG

Date of submission: 13.11.2018
SL Report: 2018/10

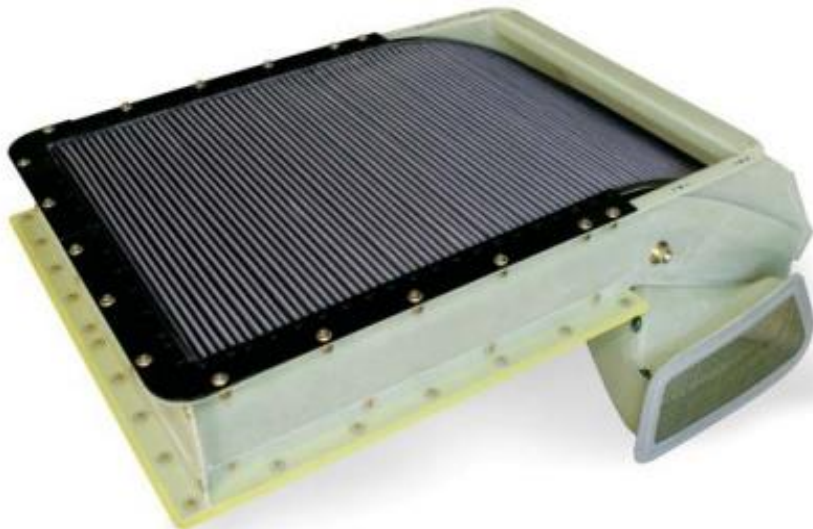
Figure 6: Air intake filter Source: FDC/aerofilter

The fire that broke out in the engine compartment involved the engine's air intake, which was equipped with an air filter (see Figure 6). The filter material was by design impregnated with oil, and was intended to prevent small particles from accompanying the air stream into the engine. The air intake filter was completely burnt (see Figure 7). The engine itself and its accessories had only minor thermal damage.

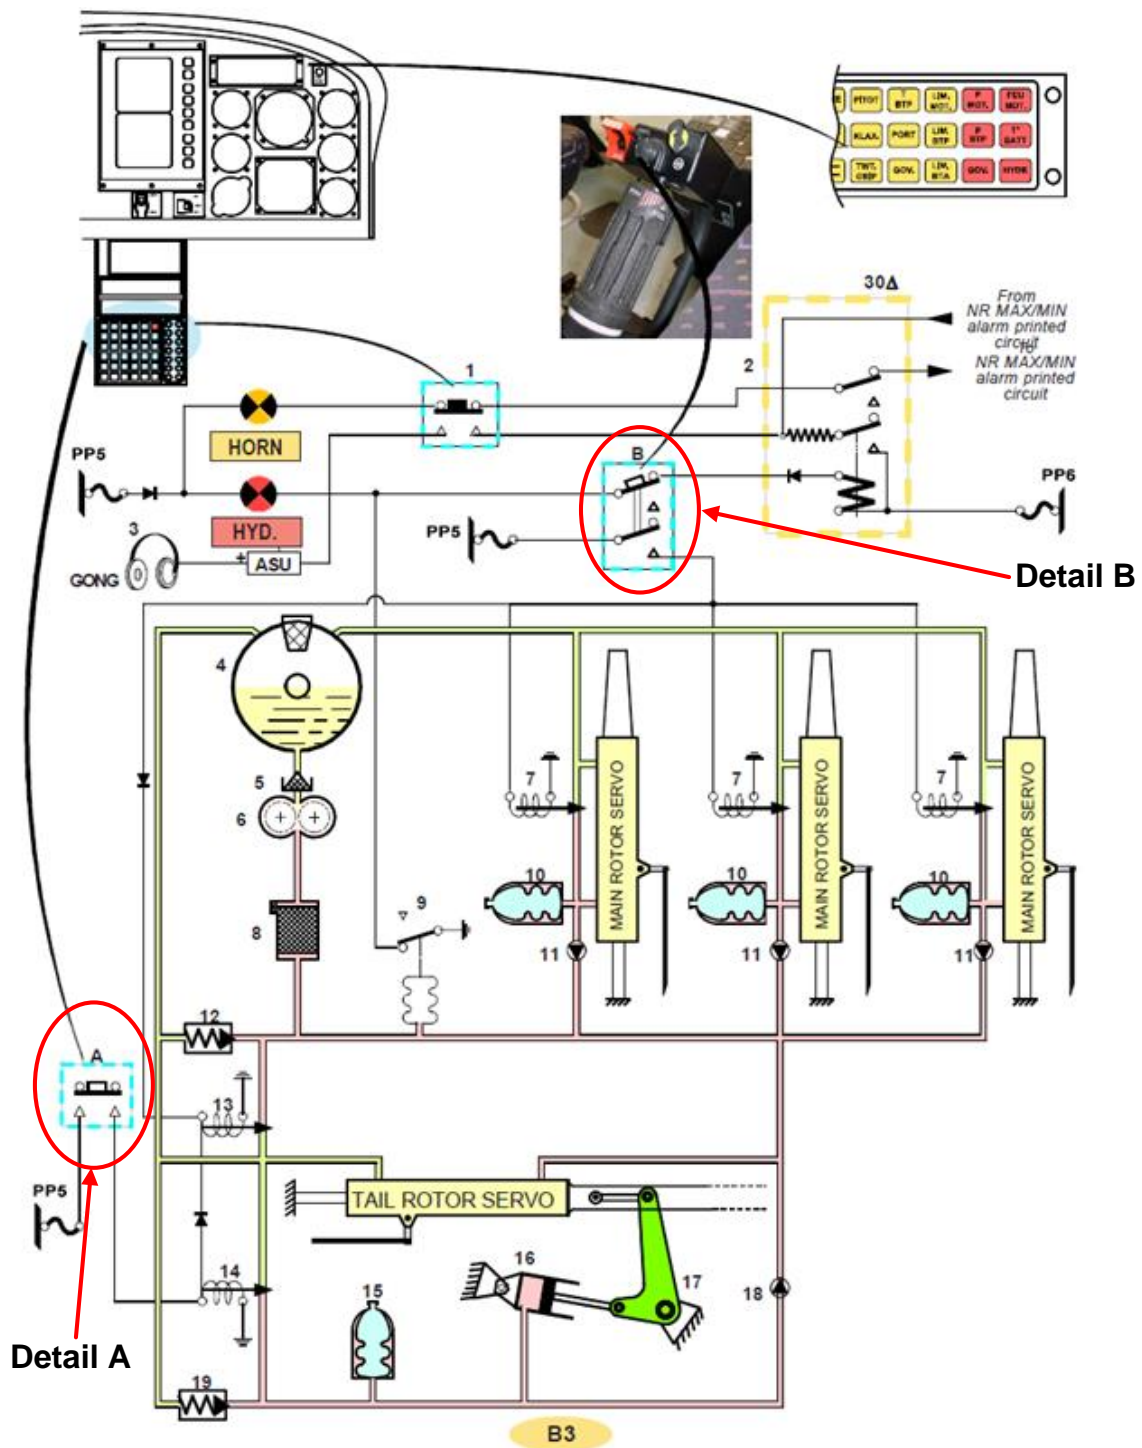
Figure 9: Hydraulic system AS 350 B3. Source: Airbus Helicopters

- Activation of the "HYD TEST" pushbutton (see Figure 8 and detail "A" in Figure 9) entails that the hydraulic oil from the pump is returned to the tank, while the accumulators on the main rotor's servo actuators maintain the accumulated pressure. Hydraulic pressure is lost in both the load compensator, which is part of the tail rotor control system, and the servo actuator for tail rotor control. Removing the pressure from the load compensator means that the pedals can be centred before start-up. While flying, the pedals are "harder" when this switch is activated. The objective of this switch is primarily to check that the flight controls are servo-assisted using accumulator pressure after start-up. This is part of the normal check list for starting up the helicopter. Secondly, the switch is used during training to simulate loss of pressure from the hydraulic pump.

- There is a control switch (see Figure 8 and detail "B" in Figure 9) on the collective lever for the pilot sitting in the primary position (right side) which, when activated, depressurises the hydraulic system, and opens the return to tank from the servo actuators' accumulators. The pressure in the load compensator in the tail rotor control system is maintained. This means that only manual forces on cyclic and collective control the main rotor. The objective of this switch is to check that the hydraulic system is operational after start-up, and also to be able to switch off the system if there is a hydraulic failure. A hydraulic failure in one of the actuators for controlling the main rotor may result in asymmetric forces on cyclic with subsequent control difficulties.
