SL 2019/04

REPORT ON AVIATION ACCIDENT AT ÅNGARDSVATNET IN OPPDAL MUNICIPALITY 26 FEBRUARY 2017 INVOLVING DYN AERO MCR 4S, LN-DLH

Date filed: 22.03.2019
SL Report: 2019/04

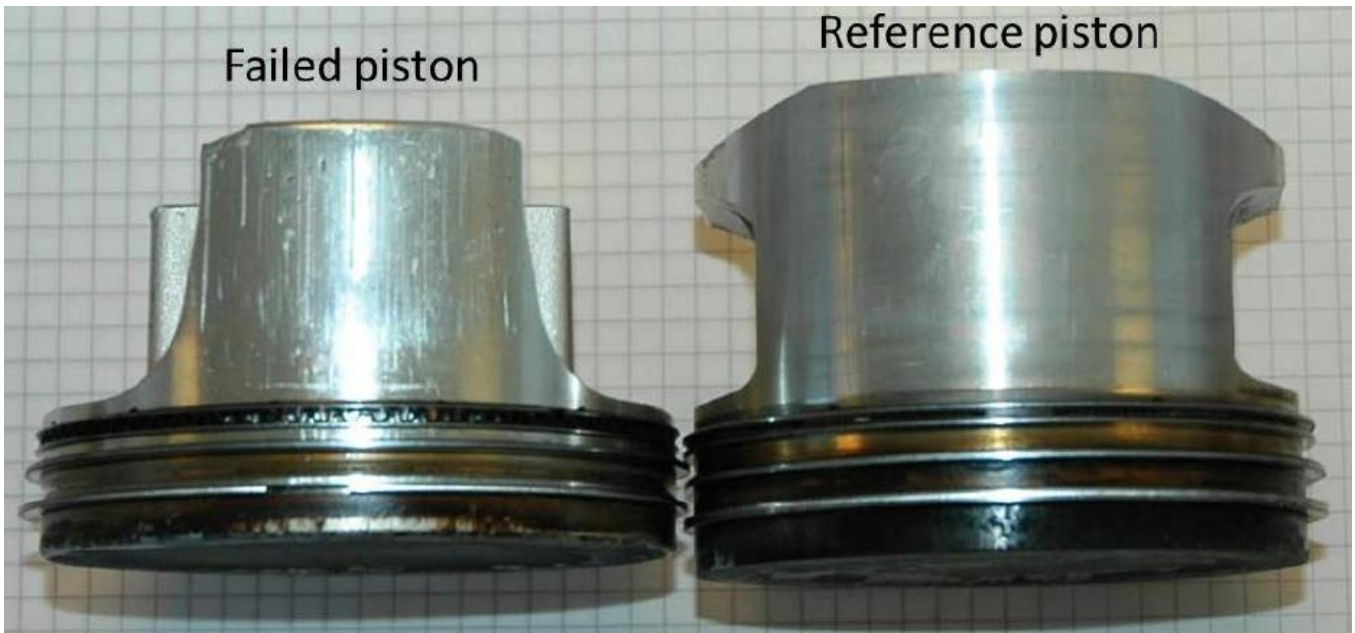
The purpose of this modification was to increase the engine's power output and make it possible to use 95 octane Mogas. This is done by increasing the engine's displacement, which is achieved by increasing the cylinder diameter and installing new pistons with a larger diameter, and with a design different to that of the original Rotax pistons. The engine's displacement was increased from 1352 cm³ to 1417 cm³, which, and according to EdgePerformance, gives an increased output of 7 hp together with a lower compression ratio than on the original engine. The pistons that came with the conversion kit didn't have full-circumference piston skirts, which the engine manufacturer's original pistons did (see Figure 4). The modification also meant that the engine manufacturer's original cylinders were bored up to a larger inside diameter. Larger cylinder diameter gives less material thickness in the cylinder walls. This modification was intended for engines equipped with turbochargers. LN-DLH was not equipped with turbocharger.

Figure 4: Comparison. Original piston from Rotax to the right. Photo: AIBN/NDLO

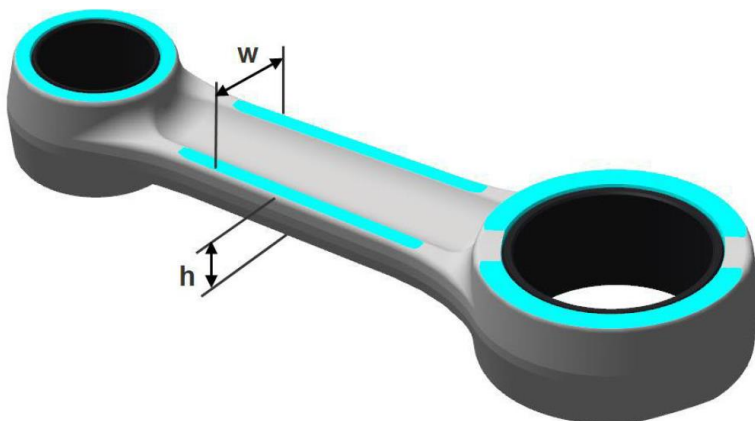
Piston skirts that don't go all the way around the pistons, which was the case in the LN-DLH engine, requires according to Rotax larger dimensions on the connecting rods linking the pistons to the crankshaft. The connecting rods are a part of the sideways steering of the pistons (in the longitudinal direction of the piston pins). These movements occur due to the clearance necessary between the pistons and the cylinder walls. The Rotax pistons have full-circumference piston skirts, which makes it possible to have connecting rods that are 6 mm thick (detail «h» in Figure 14). Rotax would have used connecting rods with a thickness of approximately 13 mm (detail «h» in the illustration) for the connecting rods to be sufficiently stiff to withstand the forces from the pistons' sideways movements in the cylinders if they had used pistons of the same design as those installed in the engine. These concerns were not taken care of when the «Big Bore» pistons were installed in the LN-DLH engine.

Figure 14: Sketch of connecting rod. Illustration: Rotax
