# REPORT

SL 2019/10

## REPORT ON AIR ACCIDENT AT SVOLVÆR AIRPORT HELLE, NORWAY ON 11 FEBRUARY 2018 INVOLVING PIPER PA-28-161, LN-TOS

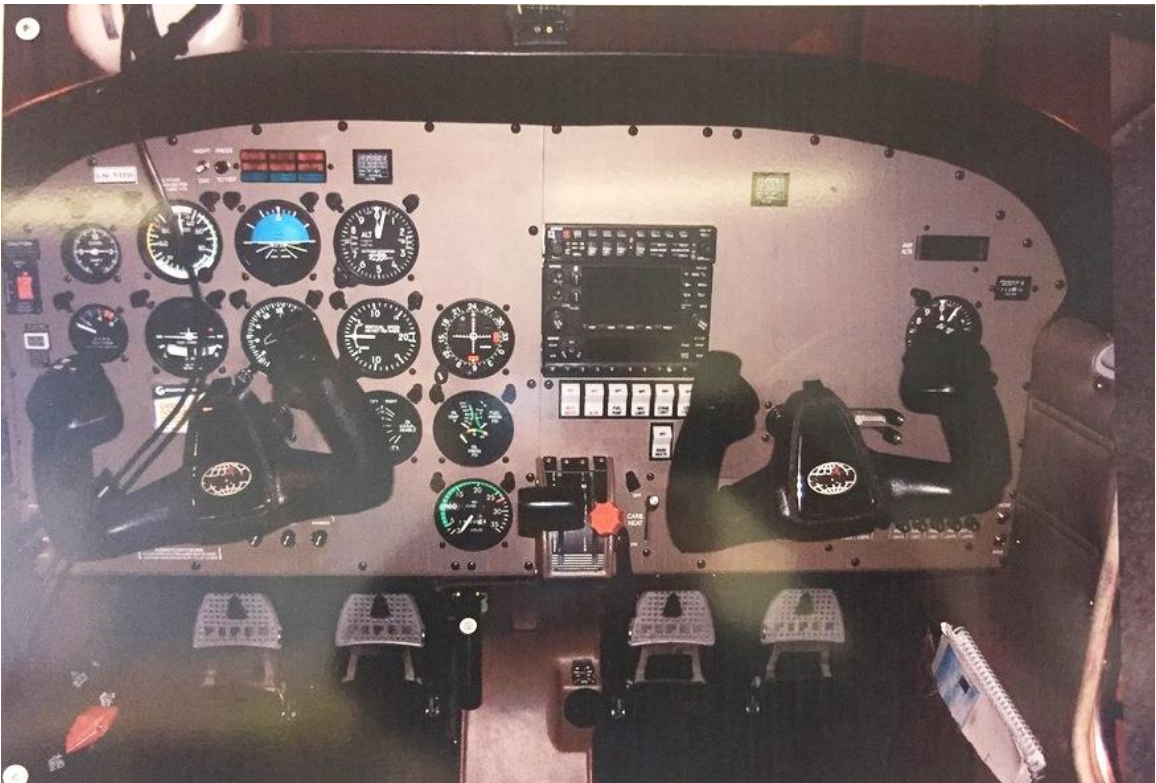
1.6.3.2 LN-TOS was equipped to fly night VFR. It was equipped with a standardised set-up with flight instruments on the left side, but only an altimeter on the right side. The centre of the instrument panel included e.g. a combined communication and navigational system of the type Garmin 430 (see Figure 1).

Figure 1: Instrument panel in LN-TOS. Six of the eight white switches in a row are visible in the centre of the image. Photo: Tromsø Flying Club

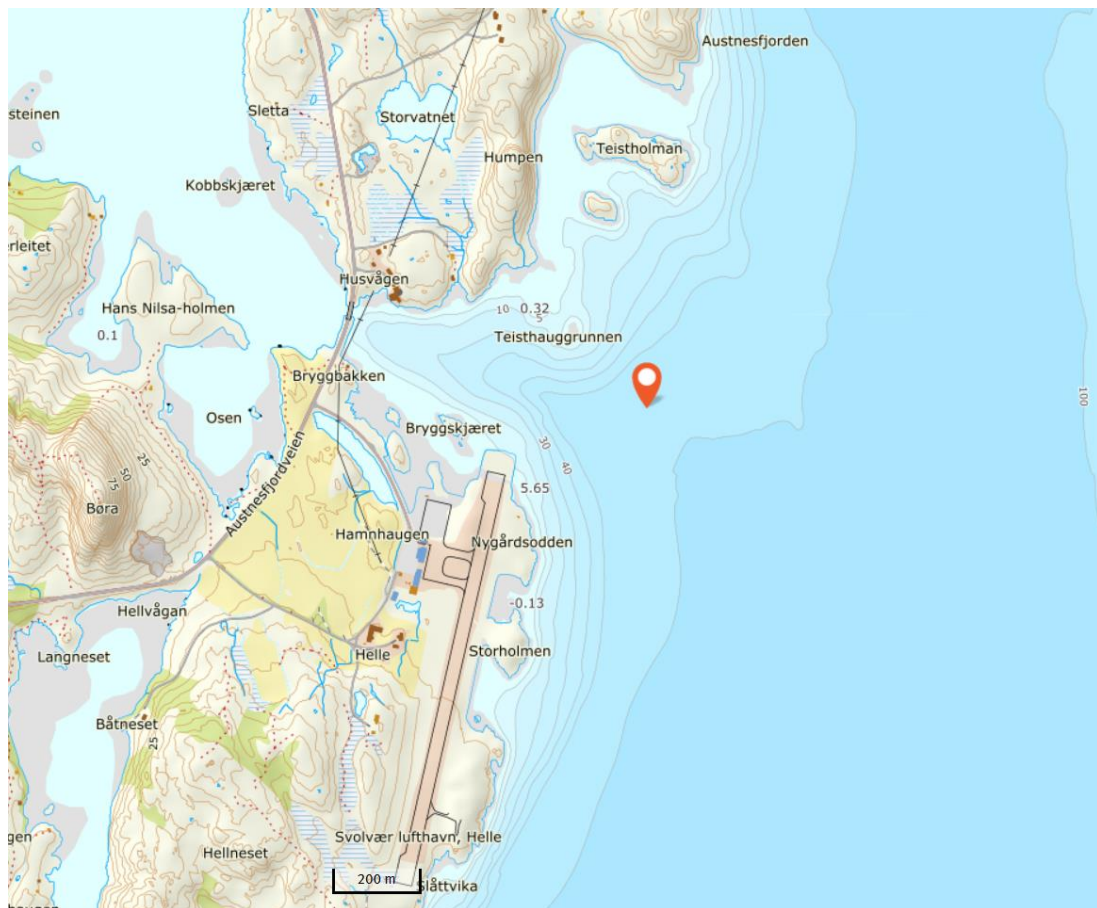
LN-TOS crashed in the sea and came to rest at a depth of 77 metres approx. 360 metres north-east of the end of the runway at Helle, position 68° 14.884 N 014° 40.743 E. The seabed was sloping, rocky and partially covered by fine sand.

Figure 3: Map of the airport and crash site. Map: © Norwegian Mapping Authority

- 2.6.1 The take-off was towards the north. After the end of the runway was passed, there were very few visual references in the area. Some lights from the buildings at Husvågan and red obstruction lights on elevated terrain directly north of the site (see Figure 3) could provide references at the beginning, but during the climb-out it is probable that these lights were blocked by the engine and left wing. Once the aircraft started turning to the right, there were no lights to serve as a reference. Consequently, the two people on board had no natural horizon to use as reference. The AIBN’s investigation shows that the conditions during this take-off were so demanding that they severely challenged the preconditions for being able to fly VFR at night. A precondition must be sufficient visual references.

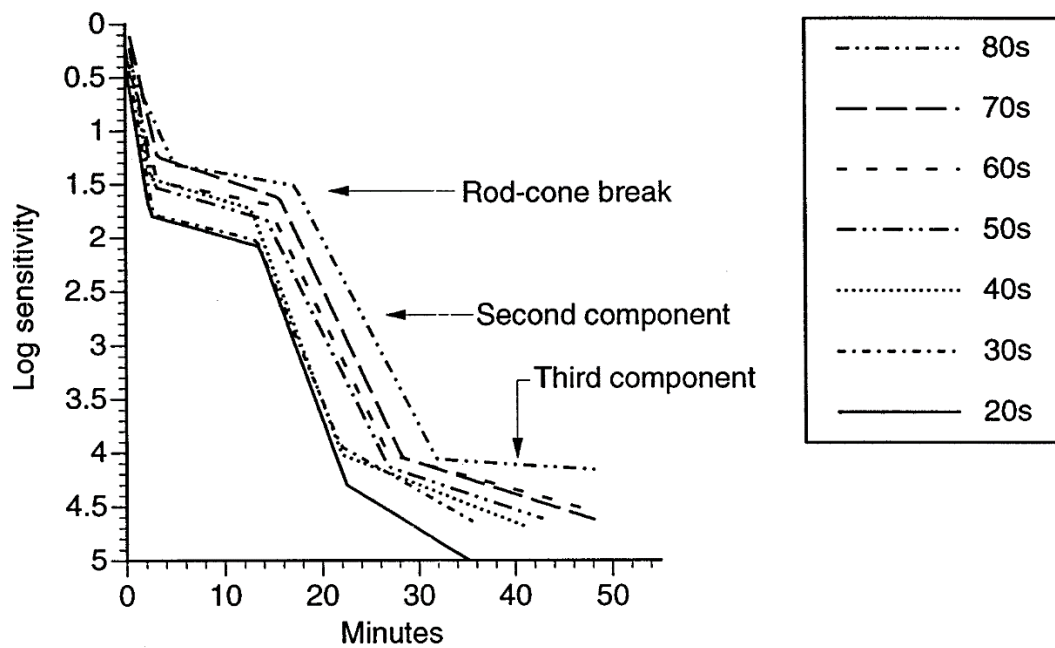
- 1.13.2 The two decedents showed no signs of consumption of alcohol, narcotic substances or medication.
- 1.13.3 A study undertaken by Jackson et al (1999), *Aging and dark adaptation*, shows that the ability to adapt to night vision varies considerably, but generally declines with age. The result of tests with 94 people aged 20 – 80 can be found in Figure 9. The figure shows that, on average, an 80-year-old person takes 16.69 minutes to achieve "Rod-cone break"<sup>6</sup>. The corresponding figure for a 20-year-old is 13.56 minutes. The figure also shows that older people never achieve the same sensitivity to light as younger people (third component).

Figure 9: The ability to transition to night vision as a function of age. Please note that the scale for photosensitivity is logarithmic. Source: *Vision Research* 39 (1999) 3975-3982
