REPORT

SL 2020/03

REPORT ON AIR ACCIDENT AT OSLO AIRPORT GARDERMOEN ON 11 JANUARY 2017 WITH CESSNA AIRCRAFT COMPANY 560 ENCORE, LN-IDB, OPERATED BY HESNES AIR AS

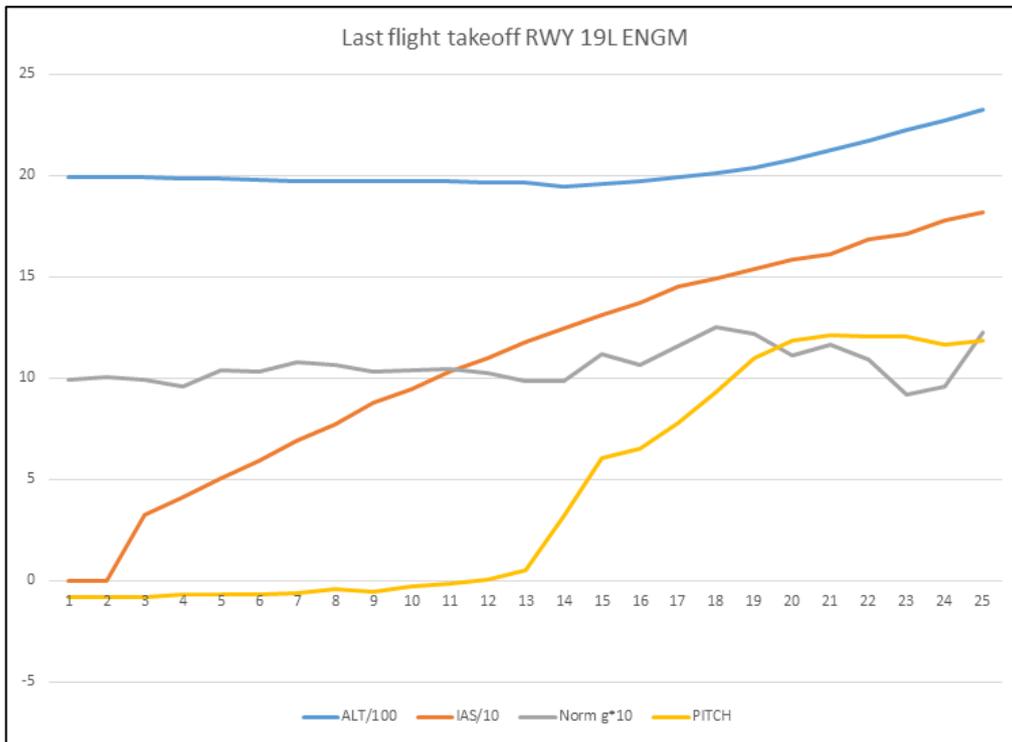
Figure 3: LN-IDB's take-off position and flight path. Source: FDR data

1.6.7.1 Figure 3 shows the aircraft's position during take-off, obtained from FDR data. The yellow line shows that the aircraft's nose position was 5-7° above the horizon before the main wheels left the ground. The figure also shows the aircraft's speed, altitude, nose position and normal G value. The dip in barometric altitude at the aircraft's 7° pitch, shows when the wing develops lift and is an indication that the aircraft experienced ground effect, which resulted in increased pressure under the aircraft, until the pressure declined again when the aircraft climbed further away from the runway. The peak in normal G value shows when the PF pulled the yoke back to raise the nose position to take-off position 5-7°. At this time, the aircraft was pitched up higher, with its tailplane closer to the runway. This meant that there was more airspace between the underside of the wings and the runway, resulting in the tailplane being closer to the runway. The tailplane is therefore presumed to be more exposed to both slush spray from the main gear and the falling snow.

1.6.7.2 Note that altitude as registered by the FDR is based on the standard altimeter setting for Flight Level, which is 1013 hPa. The difference between the altimeter setting for standard altitude and the setting for height above sea level (QNH=965 hPa), was 48 hPa. 1 hPa corresponds to 30 ft at the sea level, which yields an altitude difference of 1,440 ft. This must be added to the elevation of Gardermoen (673 ft), which thus provides the aircraft's altitude during take-off, $673 + 1,440 \text{ ft} = 2,113 \text{ ft}$.

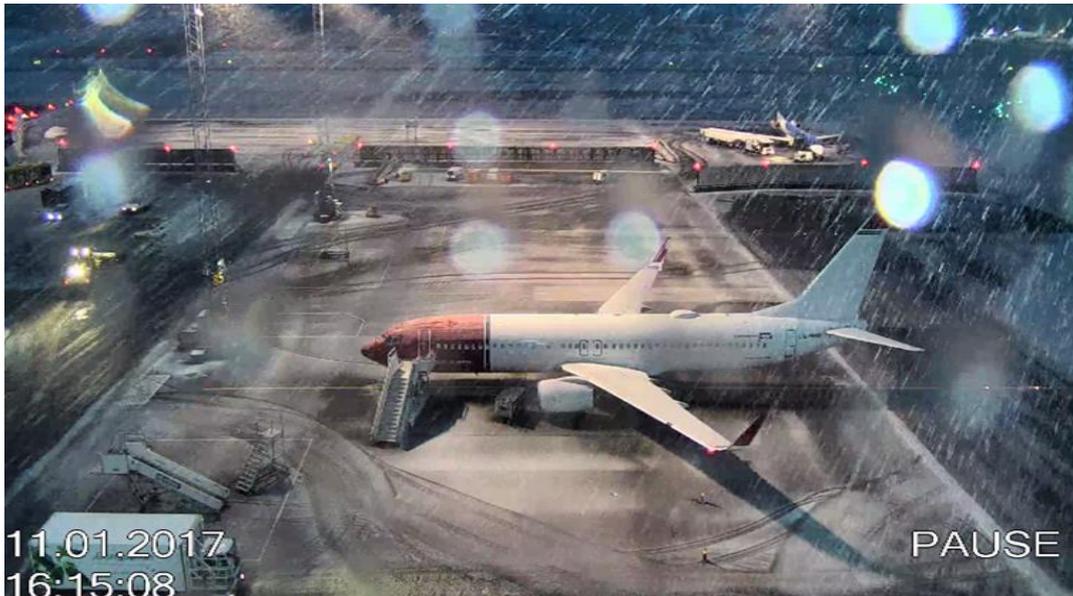
Figure 7: Weather at Gardermoen at 1615 hours, just before LN-IDB's departure. The image shows that there was snowfall. Photo: Avinor

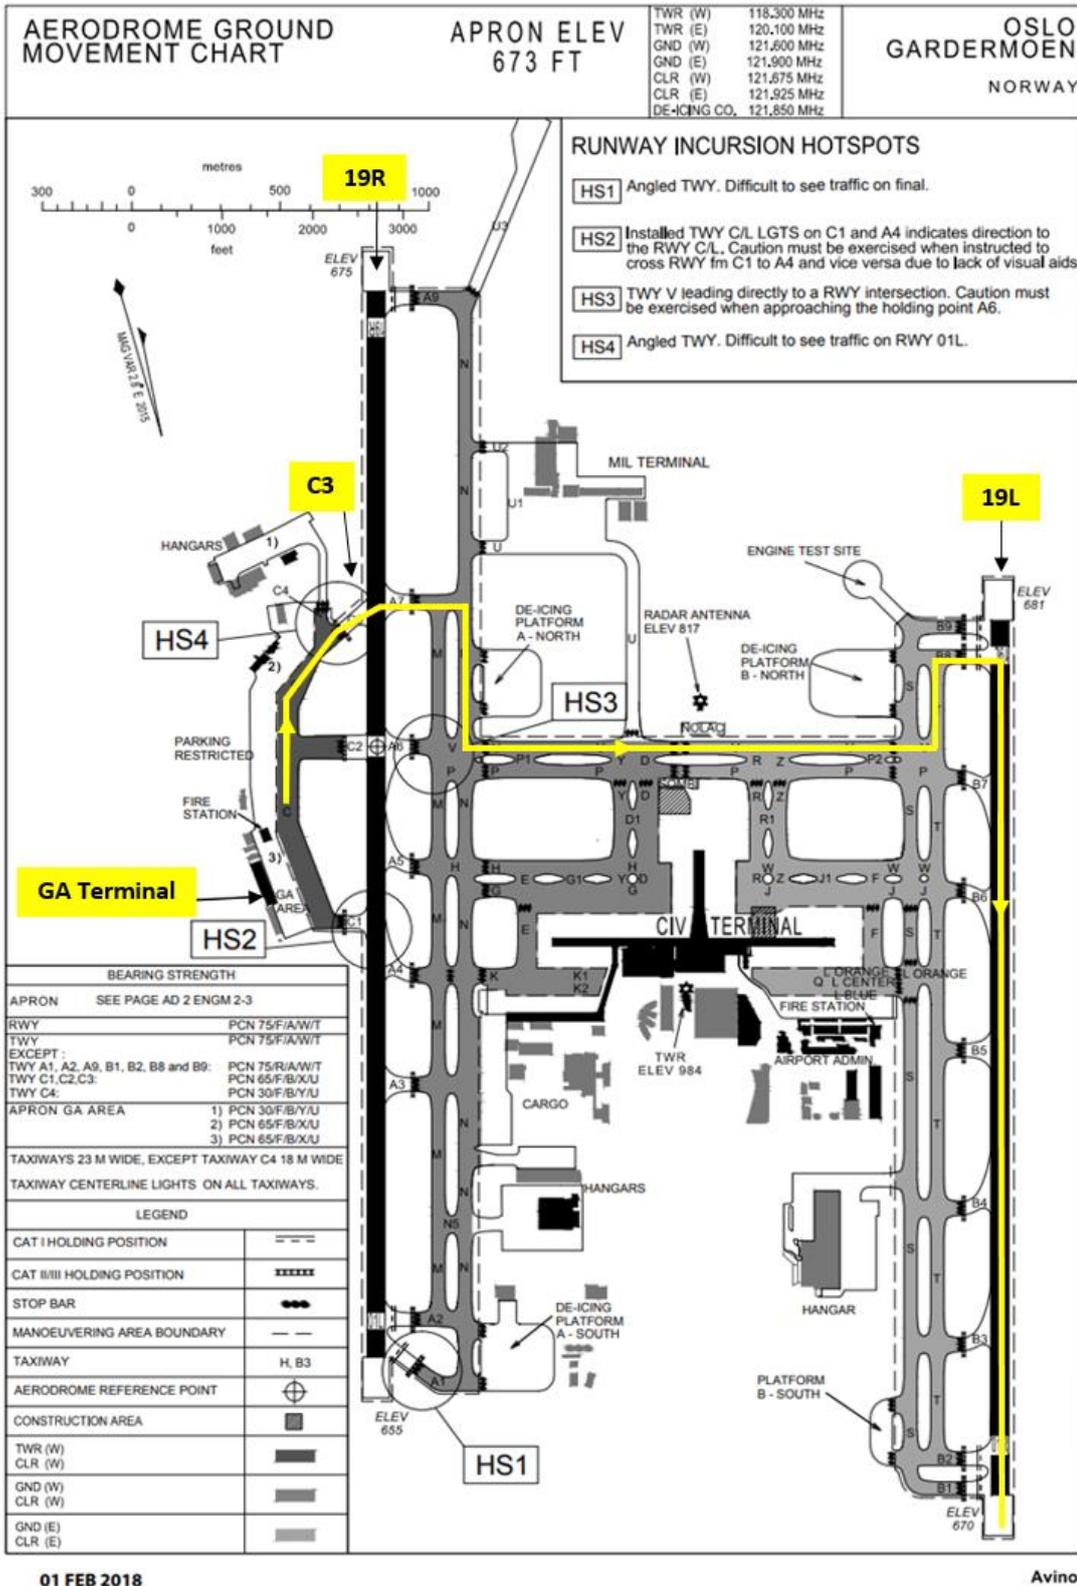
LN-IDB taxied past de-icing platform B-North without de-icing.

Figure 8: Map of Gardermoen Airport with LN-IDB's taxi route from the GA Terminal to take-off on runway 19L. Markers in yellow were added by AIBN. Source: AIP Norway

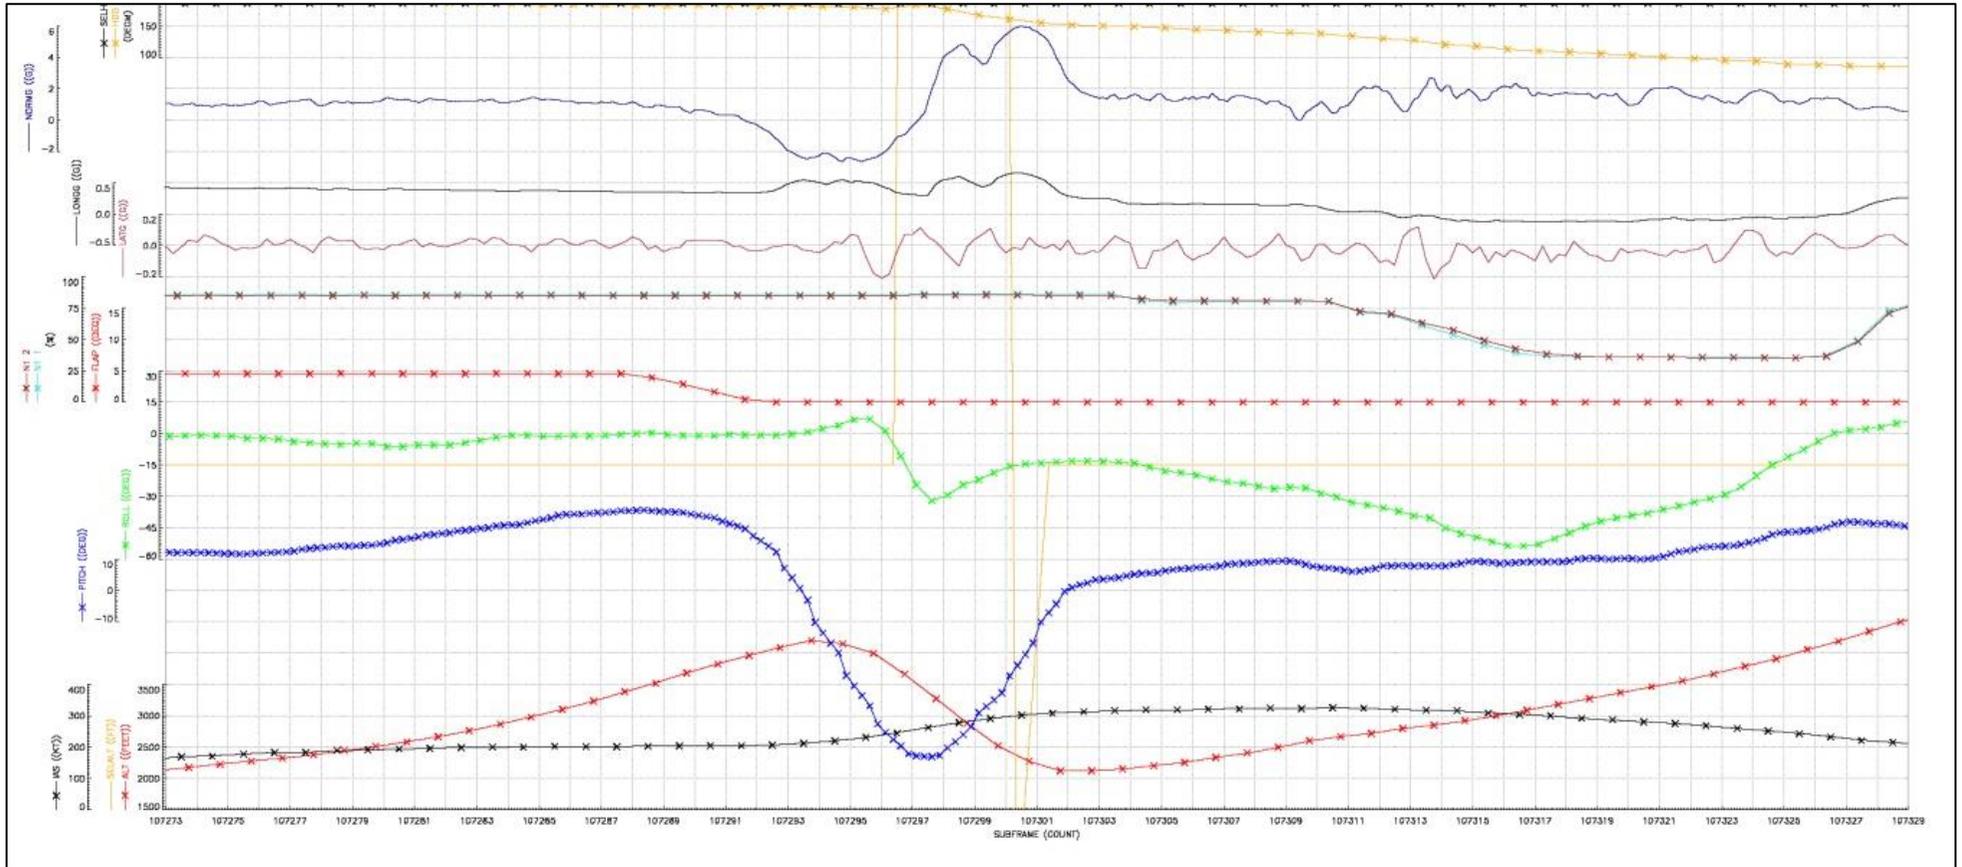
Figure 9: Printout from Flight Data Recorder. Source: FDR data from LN-IDB

Initially, the take-off proceeded as normal. The landing gear was retracted and both pilots observed that the speed was rapidly approaching 200 kt, which is the maximum speed with flaps deployed. As the flaps were retracted, the crew experienced a violent nose-down movement and the pilots were "hanging by their seat belts", while the aircraft started sharply banking to the left. Following the accident, data from the Flight Data Recorder (FDR) showed that the aircraft at this moment experienced negative 2.62 G.

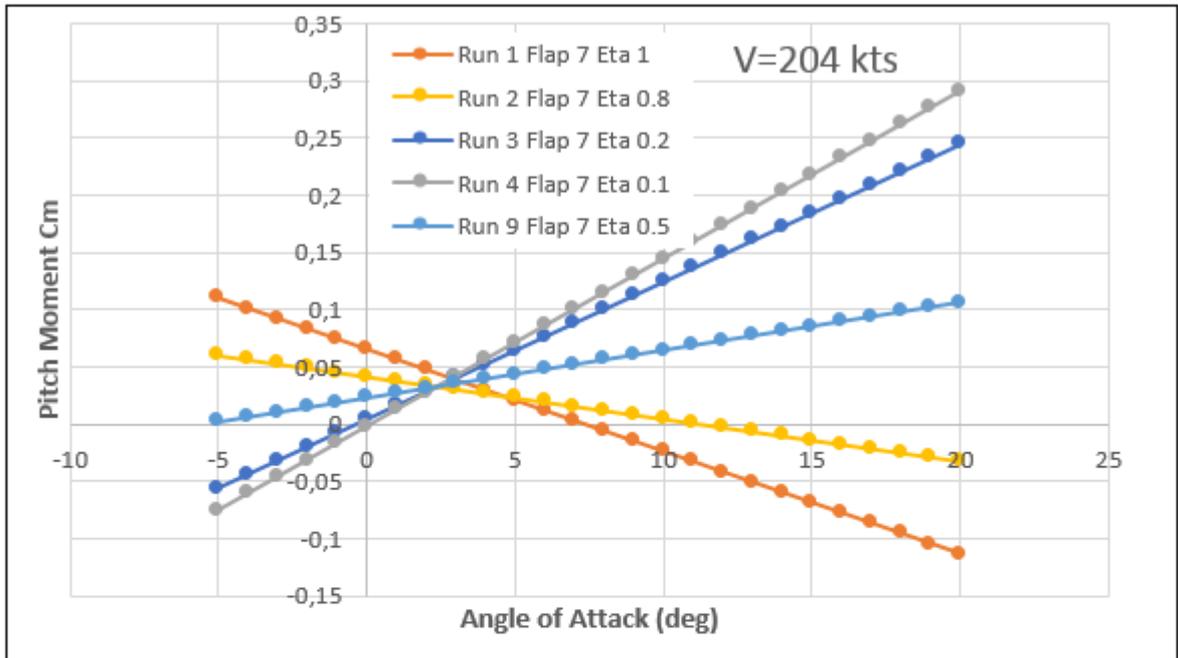
Figure 12: Longitudinal Stability (Cm) vs Angle of Attack (deg). Illustration: Coventry University cf. Appendix E

- 1.16.1.2 Figure 12 shows that the aircraft's longitudinal stability is reduced proportional to lower efficiency in the tailplane, e.g. in connection with contamination in the form of ice, frozen snow or slush. Run 1 shows the aircraft's normal longitudinal stability without a contaminated tailplane. Run 2 shows stability with a contaminated tailplane at 80% efficiency. Runs 9, 3 and 4 respectively show increasing instability in pitch alongside increasing levels of contamination/diminishing tailplane efficiency, such as in connection with stalling due to icing.

Stability decreases as Tailplane Efficiency Factor Decreases

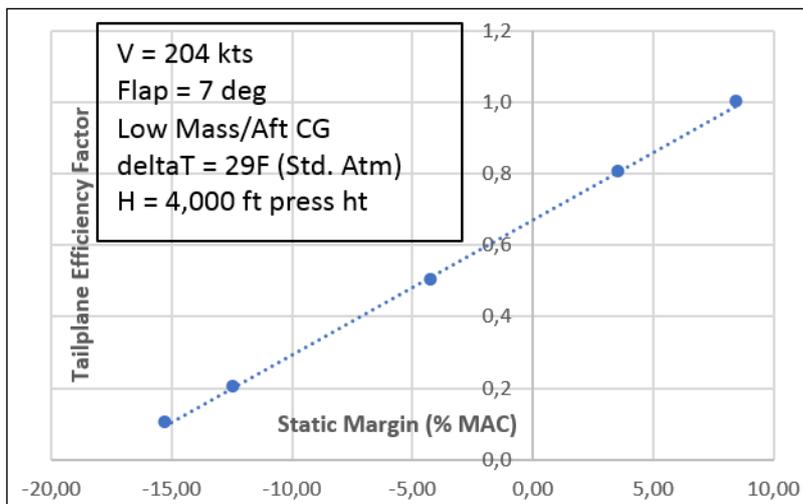
Figure 13: Static Margin (% MAC) vs Tailplane Efficiency Factor (TEF). Illustration: Coventry University cf. Appendix E

1.16.1.3 Figure 13 shows a gradual reduction of the stability indicator Static Margin (% MAC) as a function of Tailplane Efficiency Factor (TEF) (such as contamination in the form of icing). We can see that the aircraft is neutrally stable at approx. 68% TEF, and unstable at 20% TEF.

Neutral stability @ Eta approx. 0.68

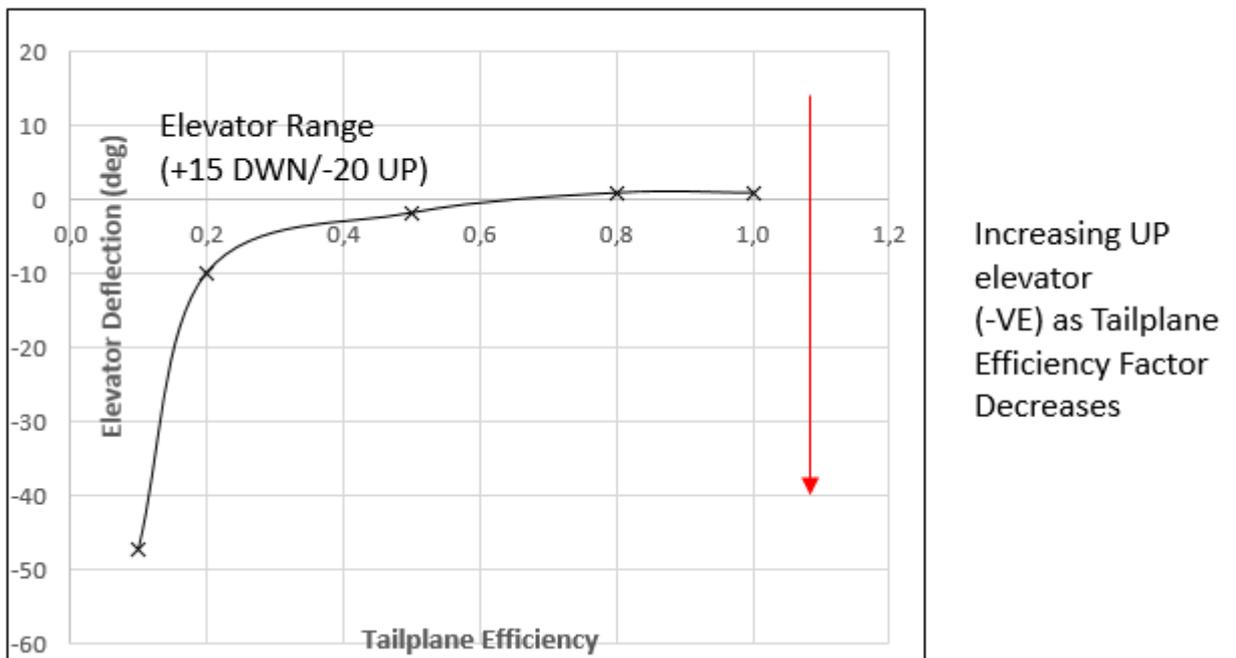
Figure 14: Elevator Deflection (deg) vs Tailplane Efficiency Factor (TEF). Illustration: Coventry University cf. Appendix E

1.16.1.4 Figure 14 shows compensating elevator deflection to counteract reduced tailplane efficiency.

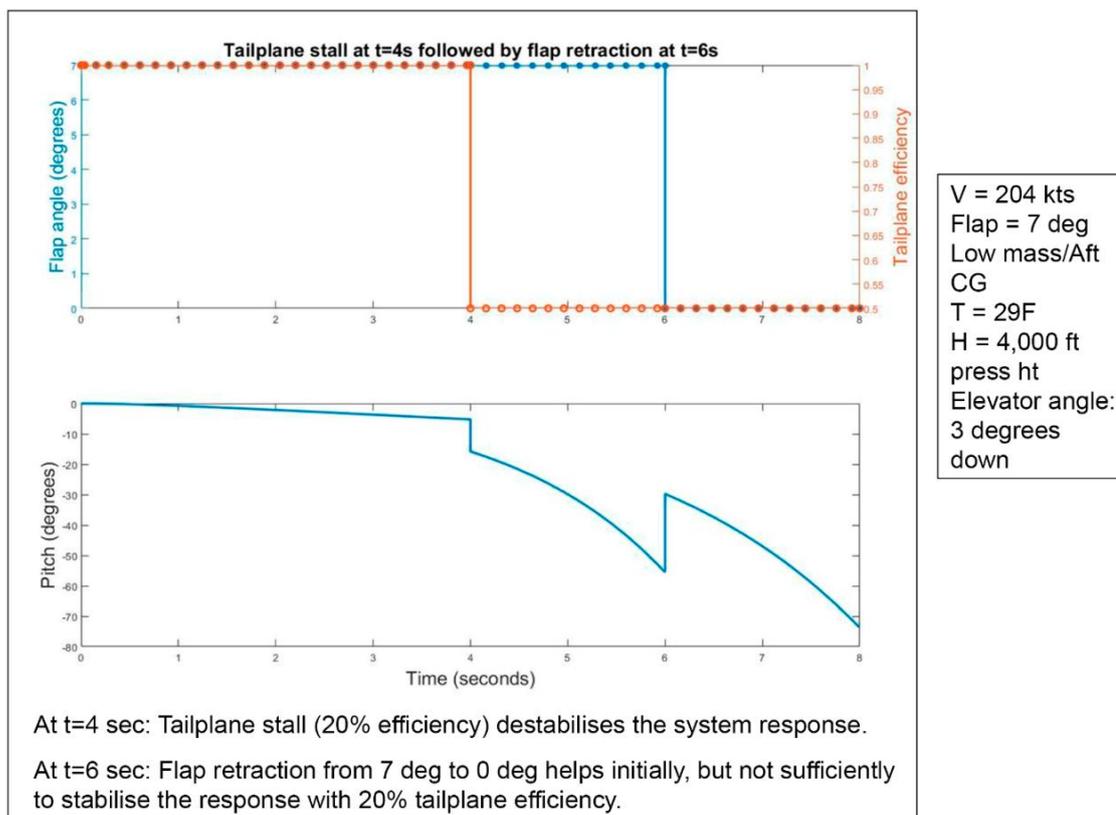
Figure 15: Tailplane stall followed by flap retraction. Illustration: Coventry University cf. Appendix E

1.16.1.5 Figure 15 shows the effect of retracting flaps when stalling the tailplane. Retracting flaps will reduce the aircraft's pitch down (nose down) movement.

2.2.8.2 Figure 15 from Coventry University's model simulation shows that extending flaps reduces the aircraft's longitudinal stability, and that retracting flaps increases stability. This is in line with general flight mechanics principle and AIBN's hypothesis that retracting the flaps did not trigger the aircraft's pitch down (bunt) (cf. Appendix E).

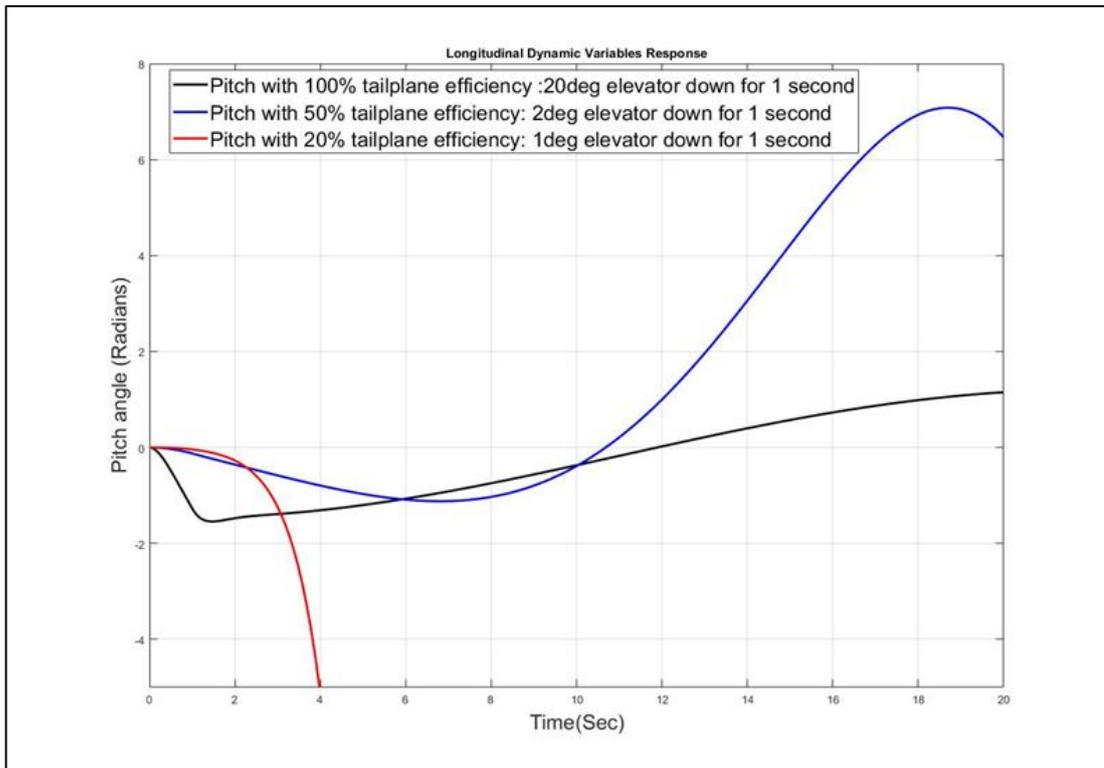
Figure 16: Longitudinal Dynamic Pitch Responses at 100%, 50% and 20% Tailplane Efficiency Factor. Illustration: Coventry University cf. Appendix E

1.16.1.6 The red line in Figure 16 shows that the aircraft is unstable at 20% tailplane effect (tailplane stall).

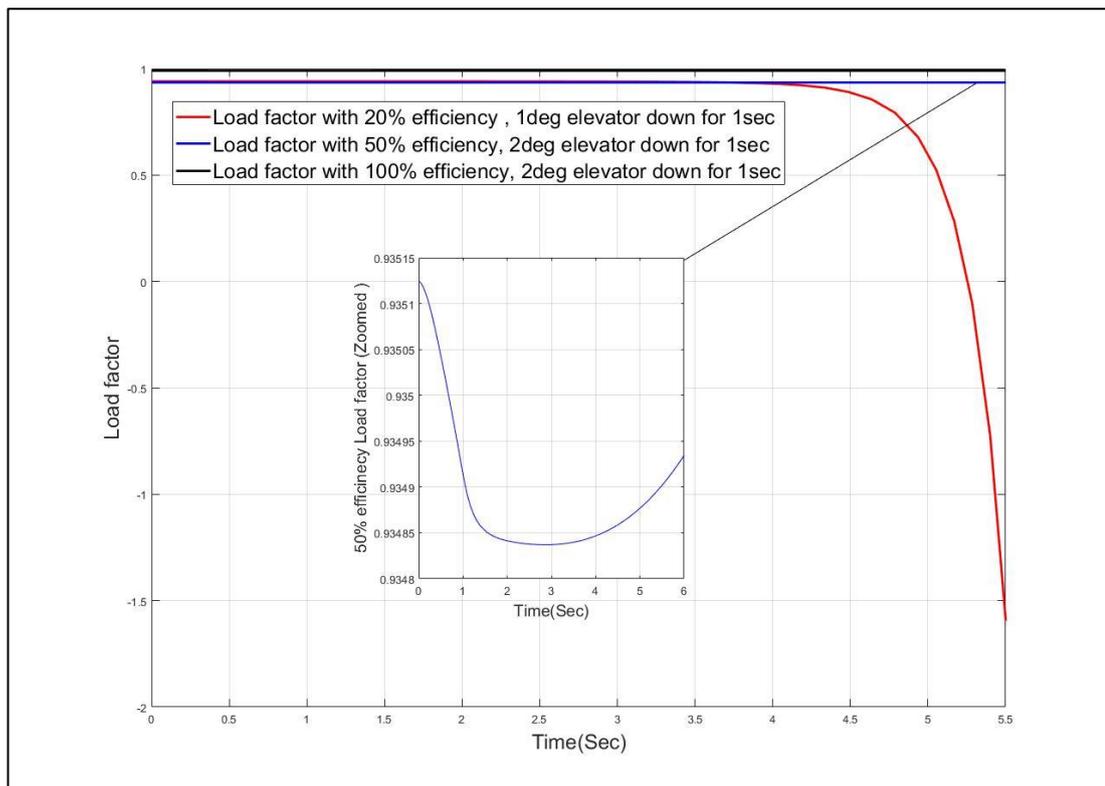
Figure 17: Load Factor as a result of elevator inputs that 100%, 50% and 20% Tailplane Efficiency Factor. Illustration: Coventry University cf. Appendix E

1.16.1.7 The three lines in Figure 17 indicate that a potential contamination of the tailplane will result in a TEF reduced to below 50%, in addition to making the aircraft unstable (divergent) at 20% tailplane effect (tailplane stall). The red line in the figure shows that, over time, the "pitch angle" changes rapidly develop negative values at 20% TEF, which will result in the aircraft being exposed to negative G forces.

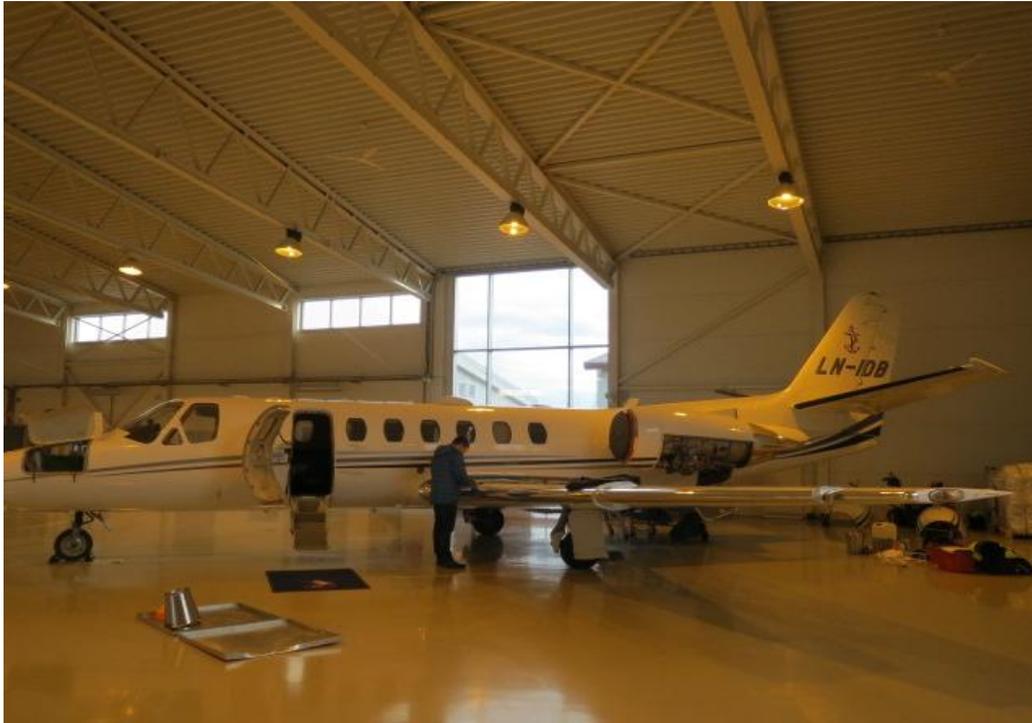
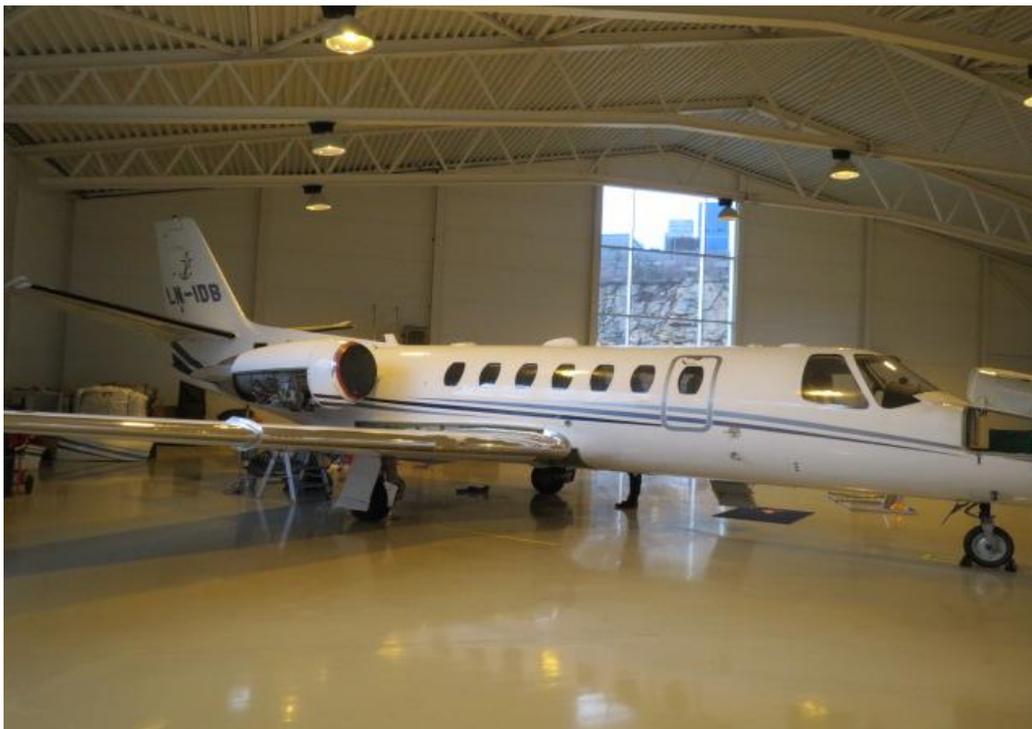
Figure 1.1 View of aircraft after being recovered

1.6.6.1 LN-IDB experienced loads of -2.62 and +5.99 G. The Limit Load Factor (LLF) for 560 flaps up is -1.44 to + 3.6 G and the Ultimate Load Factor (ULF = LLF x 1.5) is -2.16 to +5.40 G. The aircraft was overstressed well above ULF and considered not to be economically viable to repair.

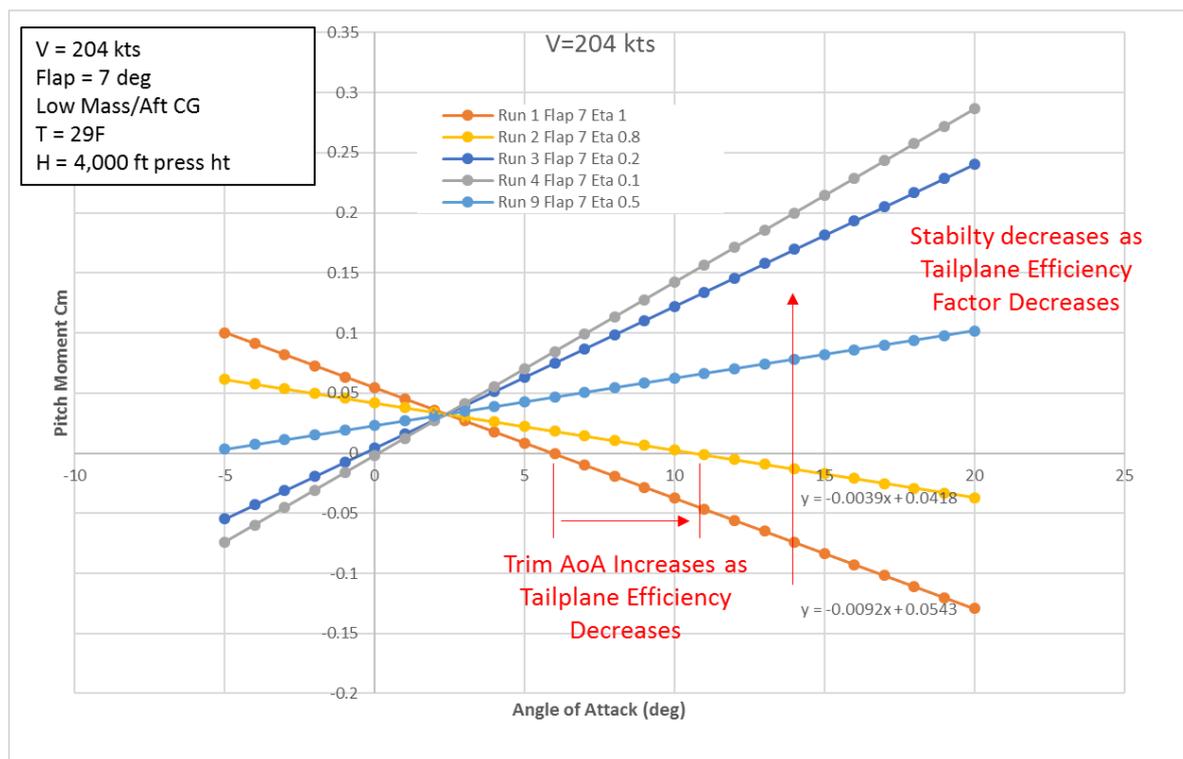
Figure 7, Pitching Moment vs AoA with Varying Tailplane Efficiency Factor

For the ‘generic business jet’, using the given flight condition of $V= 204$ KTAS, $H = 4,000$ ft pressure height, $T = 29$ F, aft CG/low MTOM with flap = 7 degrees, the variation of pitching moment with angle of attack was obtained for a range of horizontal tailplane efficiency (η_{HT}) from 1 (100% efficient) to 0.1 (10% efficient) to simulate the effects of icing on the aircraft tailplane (Figure 7). The results show that the gradient ($\frac{dC_m}{dC_\alpha}$) decreases as the horizontal tailplane efficiency decreases, hence aircraft static stability also decreases as horizontal tailplane efficiency decreases.

The results also show that the angle of attack for trimmed flight conditions increases as tailplane efficiency decreases. A cross-plot of horizontal tailplane efficiency versus stick-fixed static margin (Figure 8) suggests that static margin decreases as the horizontal tailplane efficiency decreases and that the aircraft is neutrally (statically) stable when the

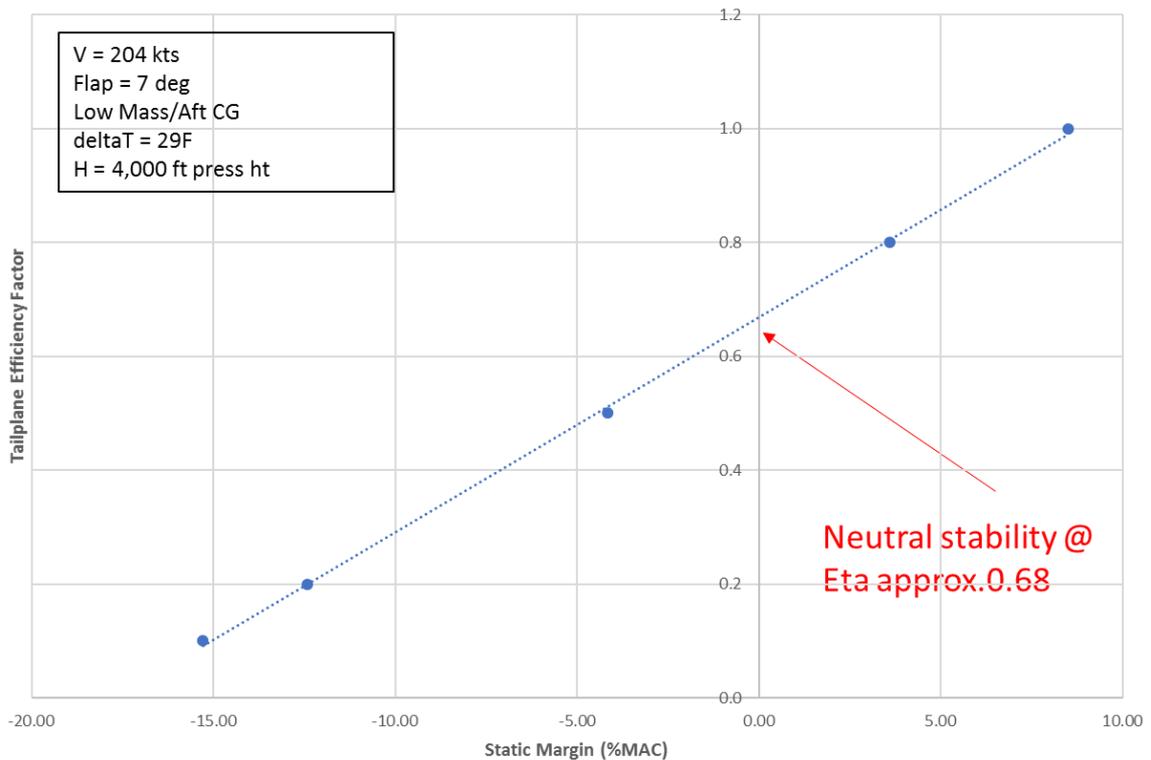
Figure 8, Tailplane Efficiency Factor vs Static Margin

horizontal tailplane efficiency is approximately 0.68 for the 'generic business jet' model in given flight conditions.

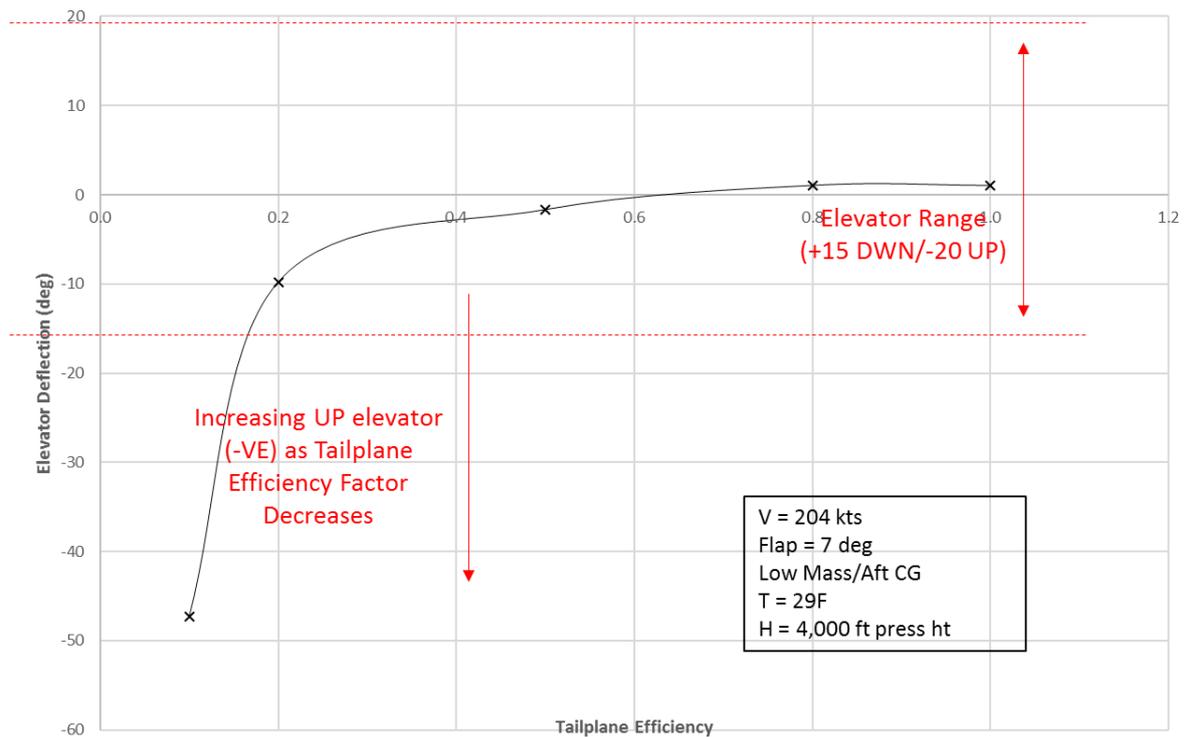
Figure 9, Elevator Deflection vs Tailplane Efficiency

A further plot of elevator deflection versus horizontal tailplane efficiency (Figure 9) suggests that increasing UP elevator (-ve deflection) is required to maintain trimmed flight as the horizontal tailplane efficiency decreases. The range of elevator deflection for the 'generic business jet' model was 20 degrees UP and 15 degrees DOWN. The results suggest that as horizontal tailplane efficiency decreases below approximately 0.2 (20%), there is insufficient UP elevator to maintain trimmed flight.

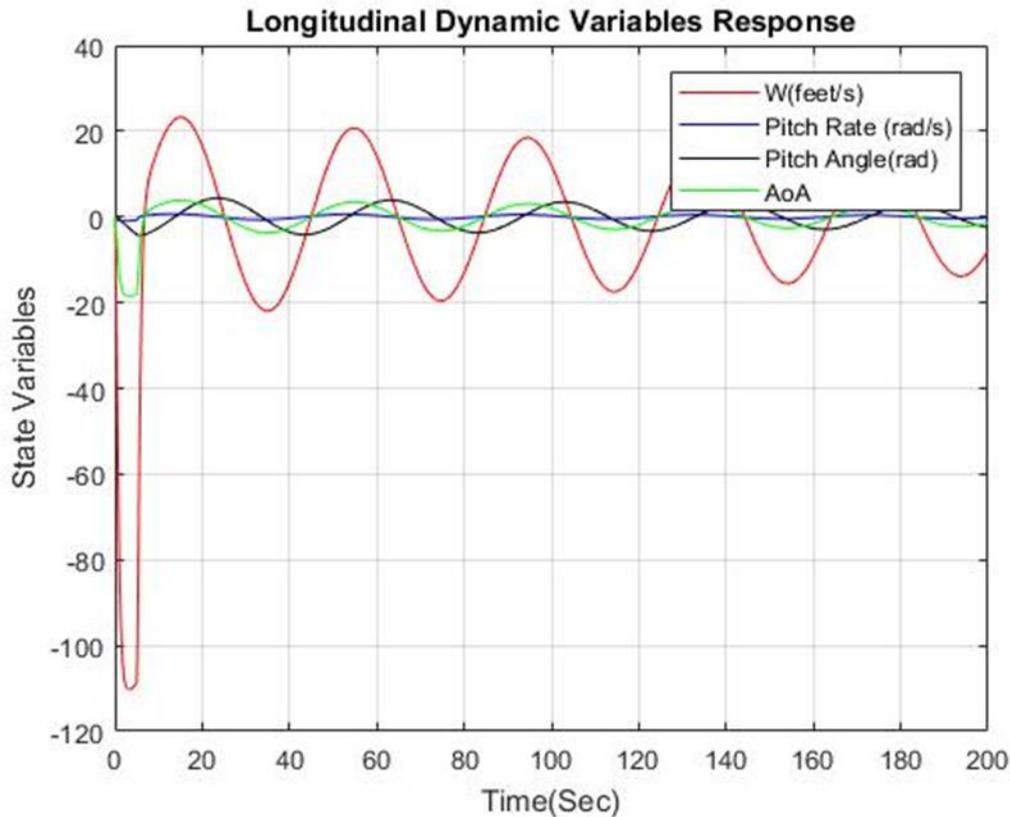
Figure 13, Long Period Oscillation (LPO) with 80% Horizontal Tailplane Efficiency

When the efficiency is reduced to 80%, the response for the LPO is also stable although with less damping of oscillations than the 100% efficiency case (Figure 13). The results of the dynamic stability are in agreement with those of the static stability analysis.

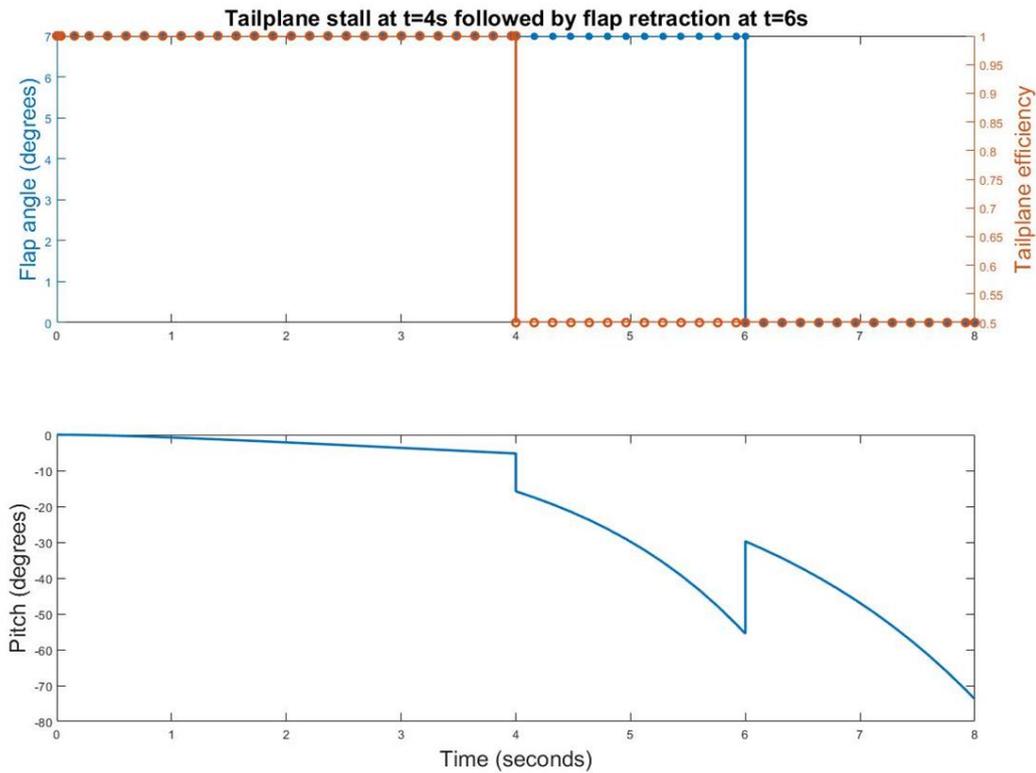
Figure 15, Pitch Response with Tailplane Stall then Flap Retraction

Figure 15 shows the results of a flap retraction following a tailplane stall. Initially, the tailplane efficiency is 100% and the flap angle is 7 degrees. At $t=4$ seconds, a tailplane stall is applied by a step reduction of 50% to horizontal tailplane efficiency, which destabilises the system response. The aircraft pitches down (-30 degrees) within 2 seconds. At $t=6$ seconds, the retraction of flaps from 7 degrees to 0 degrees helps initially, but not sufficiently to stabilise the response with only 50% tailplane efficiency.

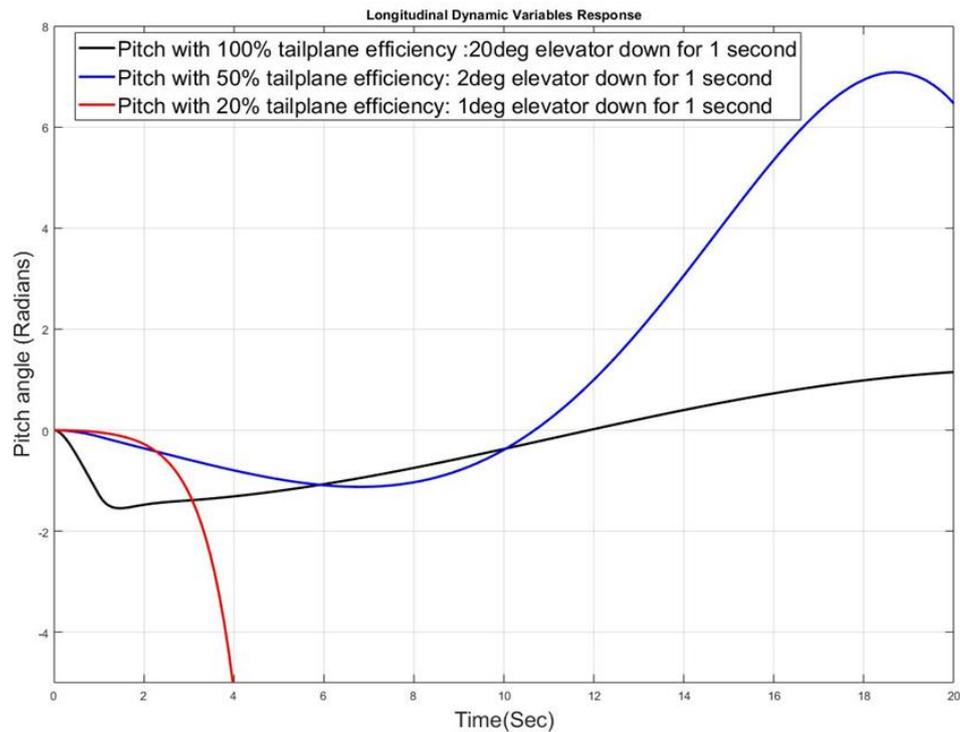
Figure 16, Pitch Response with Varying Tailplane Efficiency and Elevator Inputs

The effect of tailplane efficiency on the initial response to a 1 second elevator impulse is shown in figure 16. At 100% horizontal tailplane efficiency, a large 20deg elevator down during 1 second is needed to initiate a large magnitude but stable phugoid response, which is shown during the first 20 seconds for comparison purposes (Figure 16). At 50% efficiency, a 1 second 2-degree elevator down input destabilises the system with oscillations and at 20% efficiency, 1-degree elevator down is sufficient to produce very fast divergence without oscillations.

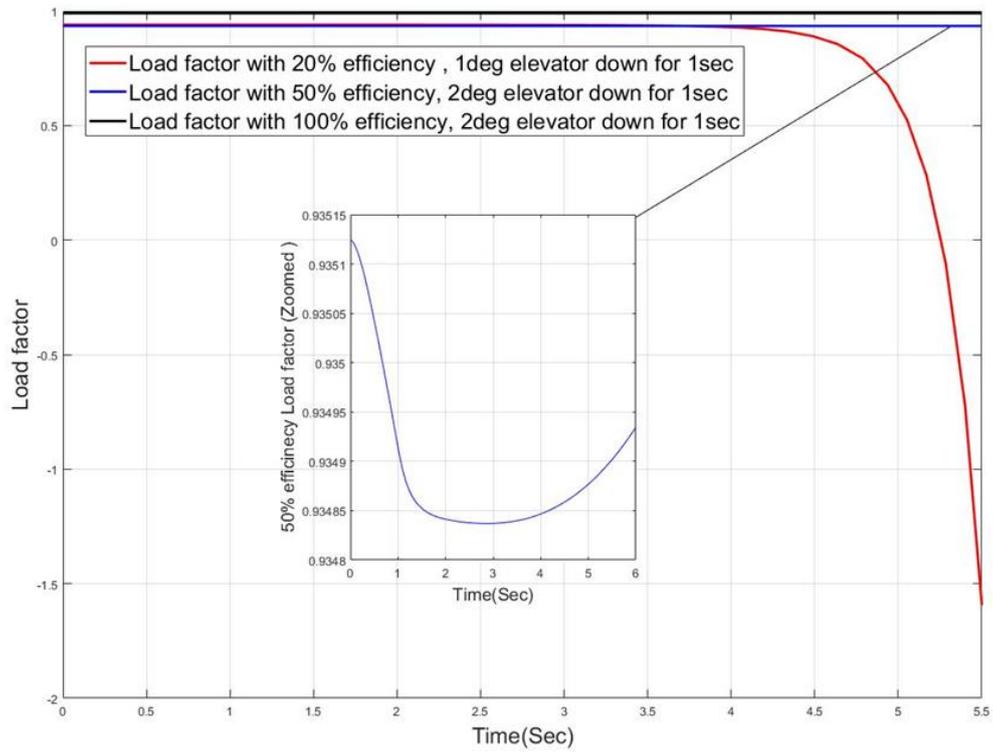
Figure 17, Load Factor with Varying Tailplane Efficiency and Elevator Inputs

Load factor changes with 1 second elevator down commands for varying horizontal tailplane efficiencies were also presented (Figure 17). With 100% efficiency, load factor remains very close to 1 with a small elevator command, as expected. With 50% tailplane efficiency, load factor is reduced but changes are small. Major changes to load factor are however obtained with 20% tailplane efficiency and **negative G** is quickly reached in this case. This is believed to be closer to the conditions during the flight incident.

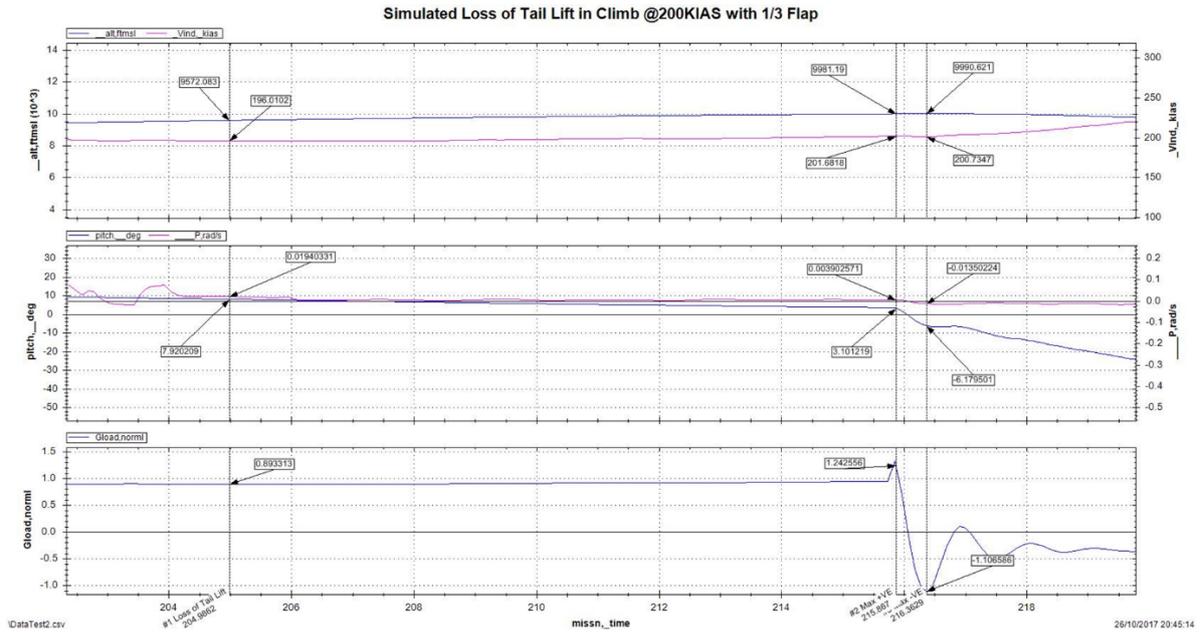
Figure B3, Normal 'G' before/after Tailplane Loss Max 1.24G/ Min -1.11G (Indicative only)

For preliminary insight into the loss of tailplane effectiveness a commercial flight simulation package and generic business jet flight model was used (Figures B1 & B2). A (negative) nose down pitching moment was observed with negative 'G' as a result of simulated total loss of the tailplane (Figure B3).
