REPORT

SL 2020/04

REPORT ON AVIATION ACCIDENT IN ISFJORDEN ON SVALBARD, NEAR BARENTSBURG, 26 OKTOBER 2017, WITH Mil Mi 8AMT, RA-22312 OPERATED BY CONVERS AVIA AIRLINES JSC

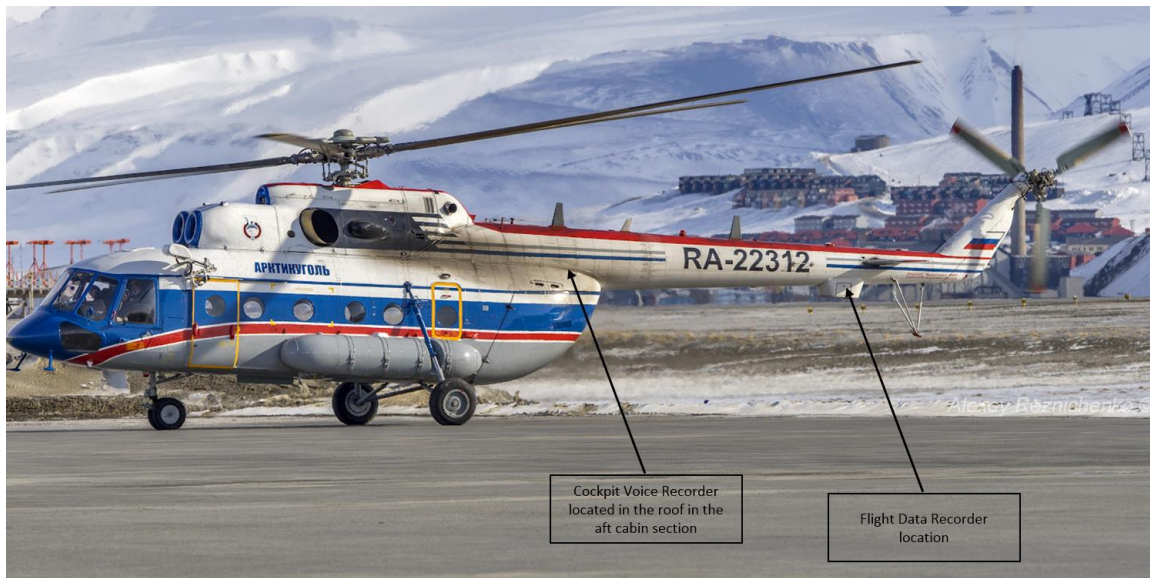
- 1.11.2.1 The helicopter was equipped with a Flight Data Recorder (FDR), model BUR-3-2 with memory module ZBN-1-3. The FDR was mounted in a separate container fixed underneath the helicopter tail boom (see Figure 5). The unit was not equipped with an acoustic transmitter (Underwater Locator Beacon – ULB), which could have enabled a search for the unit using a hydrophone.

Figure 5: Location of CVR and FDR. Photo: Alexey Reznichenko. Illustration: AIBN

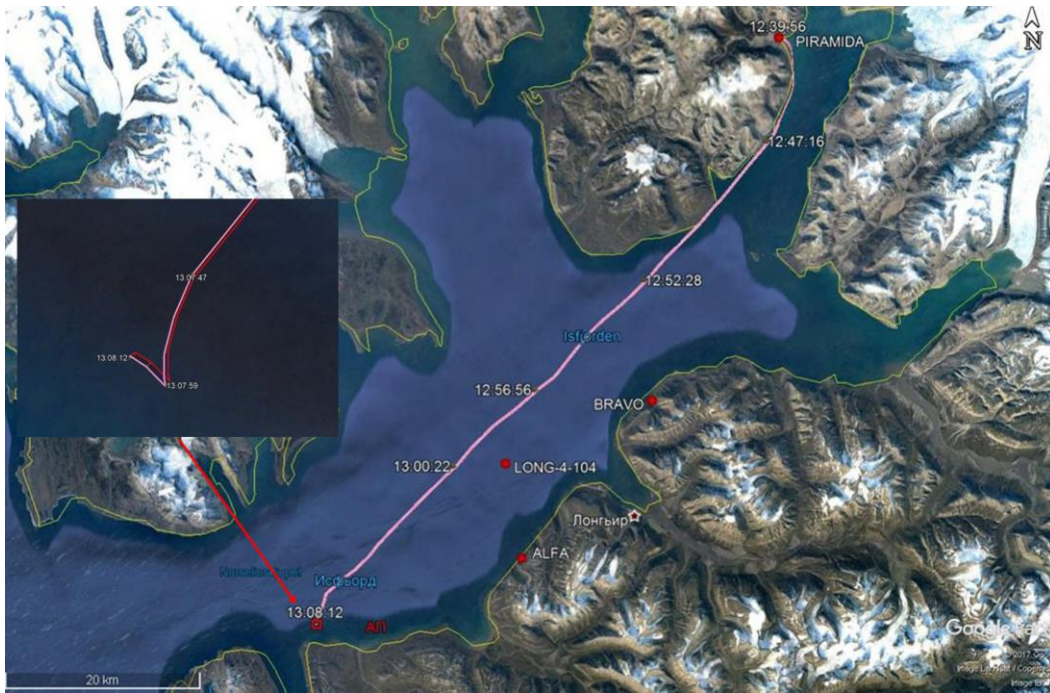
- 1.11.3.1 The helicopter was equipped with two portable GPS units: A Garmin 695C unit and a Garmin 276C unit. Both units were put in containers with distilled water and transported to IAC/MAK in Moscow for downloading of data. A representative from AIBN was present when the units were downloaded. It proved that the Garmin 276C unit did not contain data for the last flight.
- 1.11.3.2 The Garmin 695 unit contained data for the flight from Pyramiden to Heerodden. In Figure 8, the flight track from Pyramiden towards the Heerodden is plotted in Google Earth.

Figure 8: Plotted track from Pyramiden to Heerodden. Source: IAC/MAK

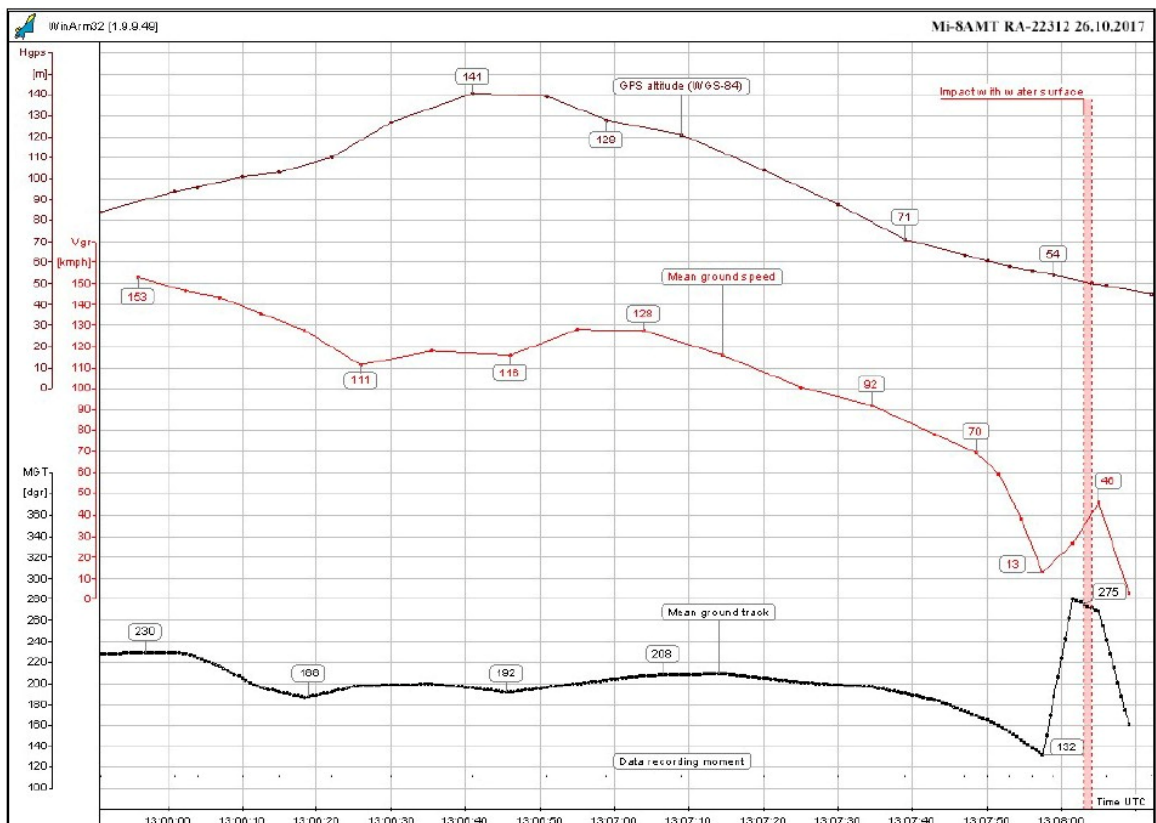
Figure 9: Plotted calculated parameters for the accident flight. The vertical, red line indicates the time of impact with the water. Source: IAC/MAK

- 1.11.3.3 During the last minutes of the approach towards Heerodden, the speed was reduced from approximately 200 km/h down towards 13 km/h. During this phase of the flight, the helicopter turned towards a more south/southeasterly heading relative to the normal heading of approximately 200 degrees, which is usual during approach towards Heerodden when arriving from Pyramiden. The helicopter, in the course of the last minute before the accident, turned left to a heading of 135 degrees. The distance from the helicopter base was then approximately 2.5 km. Data from the last seconds of the flight show a quick turn to approximately 275 degrees. The data from the last stage are most likely unreliable since the helicopter's movements and attitude may have had an impact on the GPS antenna's reception conditions.

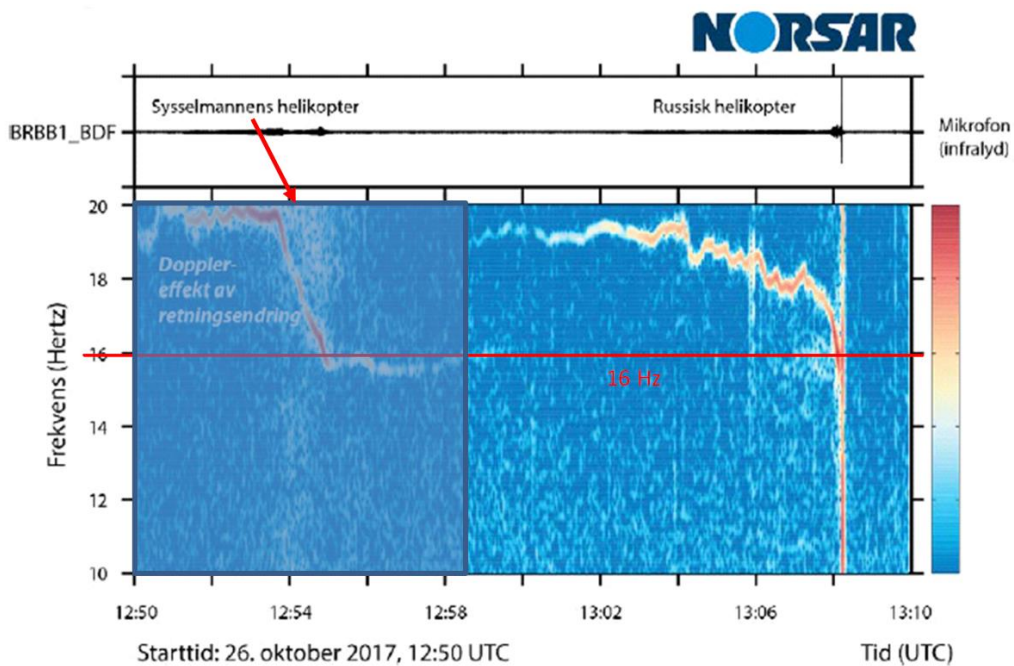
- 1.11.4.2 Based on triangulation of data from these sensors, it has been possible to pinpoint a quite precise location and the correct time when the helicopter impacted the water. Further it has been possible to estimate the helicopter's changes in speed relative to the infrasound microphone's location near Heerodden. The helicopter's main rotor generates a sound frequency of 16 Hz. The Doppler effect would alter this frequency depending on whether the helicopter is approaching or moving away from the sound sensor or alters its speed. In a report from NORSAR on what their sensors captured at the time of the accident, a time/frequency diagram appears, which supports the speed data registered by the Garmin GPS 695 unit, that is: that the helicopter immediately before the impact with the water had a very low speed (see Figure 10).

Figure 10: Time/frequency spectrum of infrasound signals from the accident helicopter. Source: NORSTAR

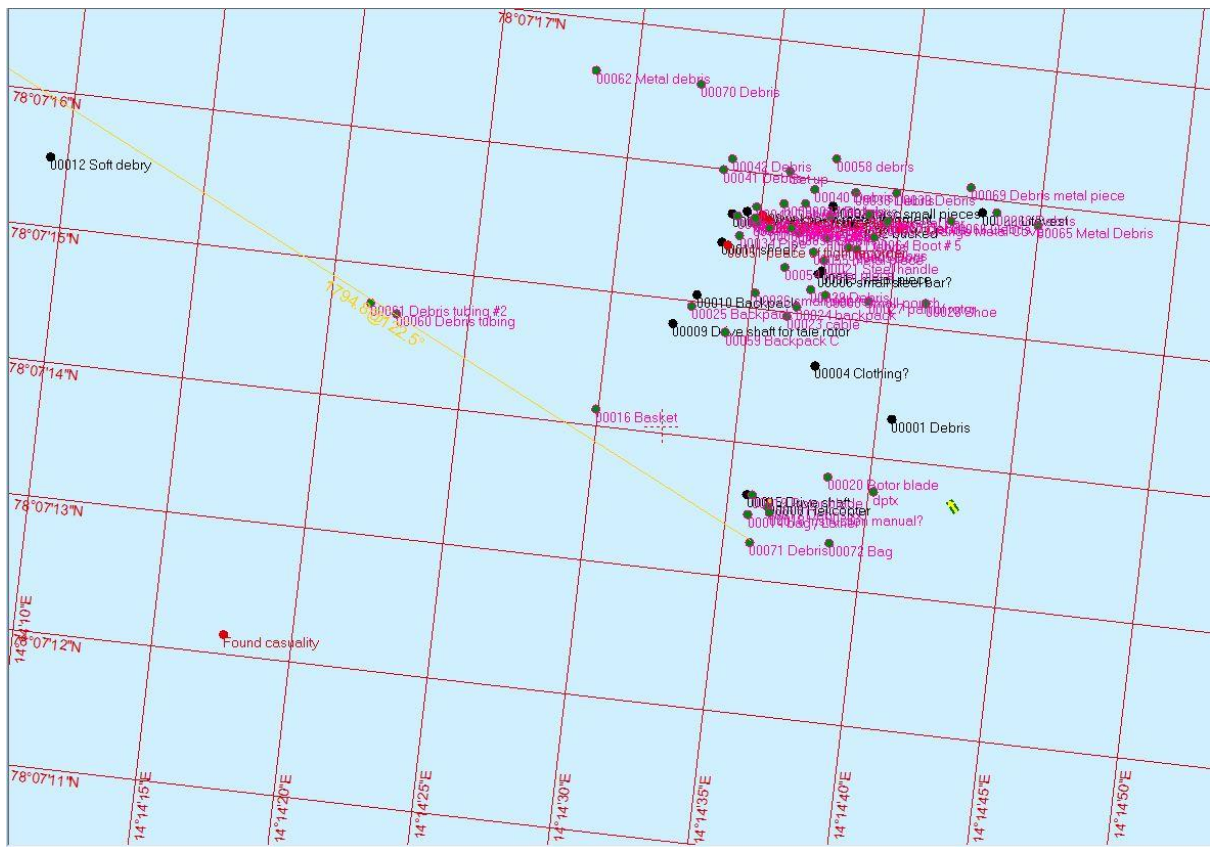
- 1.12.1.1 The accident site in Isfjorden, northeast of Heerodden is calculated to be in position $78^{\circ}07'16.24''N$ $14^{\circ}14'32.77''E$. The helicopter wreck was found on flat, sandy bottom at a depth of 209 meters at $78^{\circ}07'13.59''N$ $14^{\circ}14'36.48''E$. Parts and loose equipment were found near where the main portion of the helicopter lay on the bottom (see Figure 11).

Figure 11: Mapping of objects found on the seabed. Source: Maersk Forza

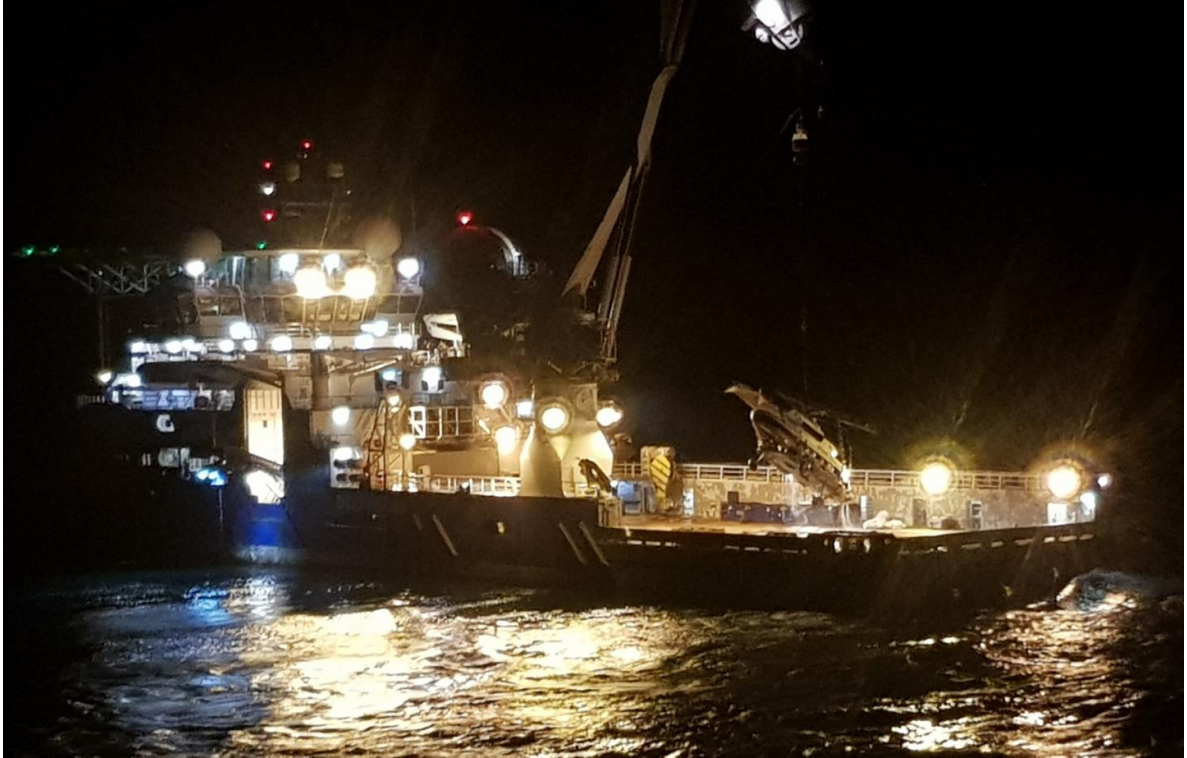
manipulator arms, a chain was threaded in between the main rotor's pitch links²⁰ and around the main rotor shaft. The lifting hook from the ship's main crane was connected to the chain. When the lifting started November 3, the helicopter rolled over and remained hanging by the chain, which was around the main rotor shaft. The helicopter was then lifted up and early the night 4 November it was on board the Maersk Forza (see Figure 14).

Figure 14: The helicopter is lifted on board. Photo: The Governor of Svalbard
