REPORT

SL 2020/07

REPORT ON THE AIR ACCIDENT NEAR ØIAN AIRFIELD IN MERÅKER IN THE COUNTY OF TRØNDELAG, NORWAY ON 7 NOVEMBER 2018 WITH VAN'S AIRCRAFT INC (EX) RV-6, LN-AAL

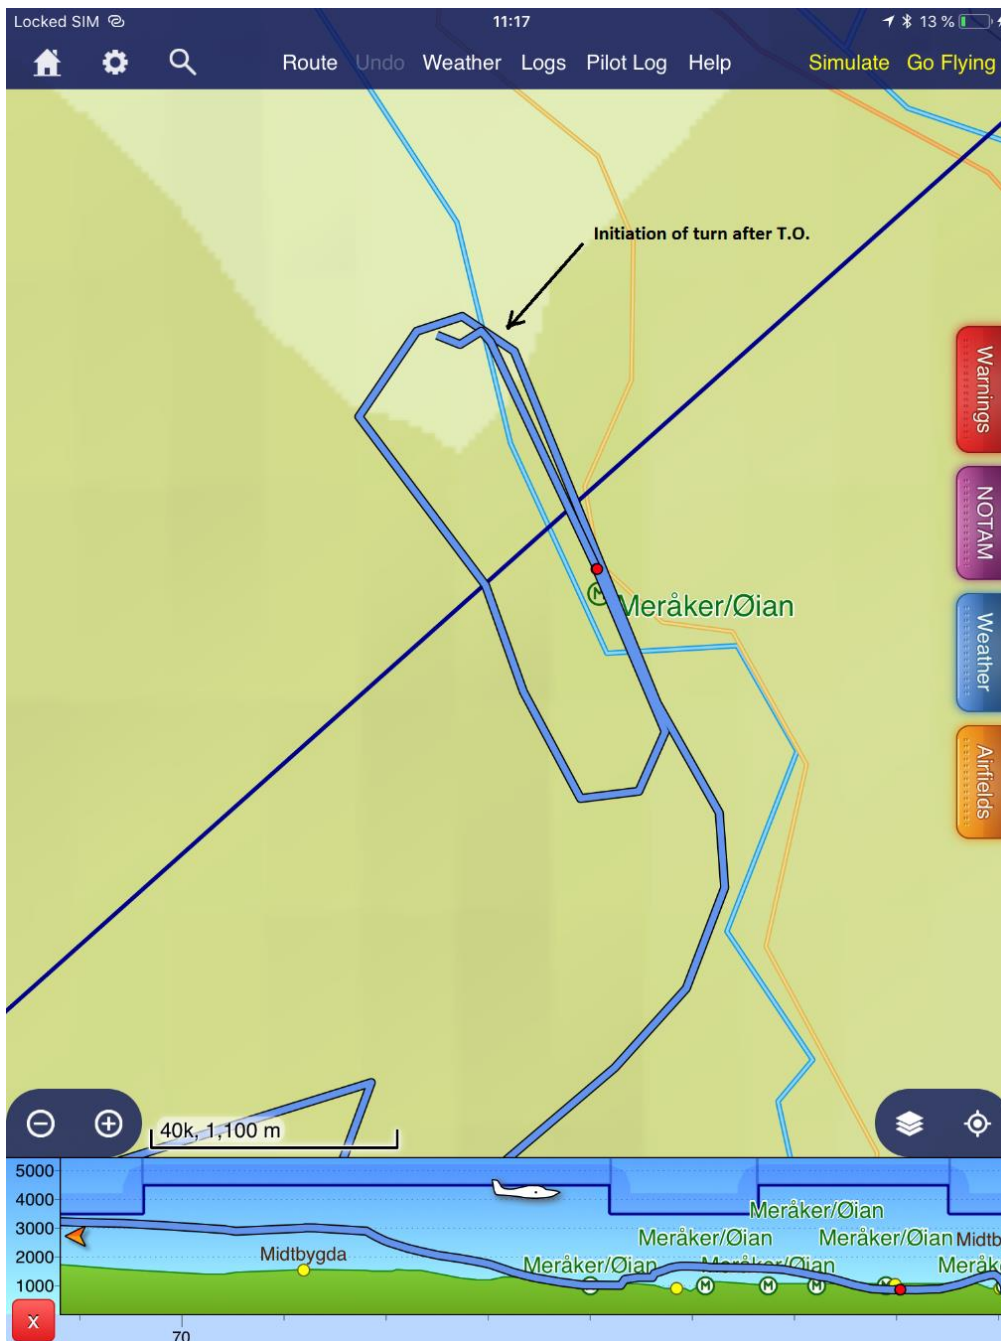
Figure 2: SkyDemon map showing the touch-and-go and the last take-off from Øian Airfield. The red dot indicates that the system briefly lost GPS coverage while the aircraft was on the ground. Source: SkyDemon

- 1.1.14 Figure 2 shows the take-off from Øian Airfield. It shows that a turn had been initiated in roughly the same place as LN-AAL had initiated its cross-wind leg turn during the previous touch-and-go.

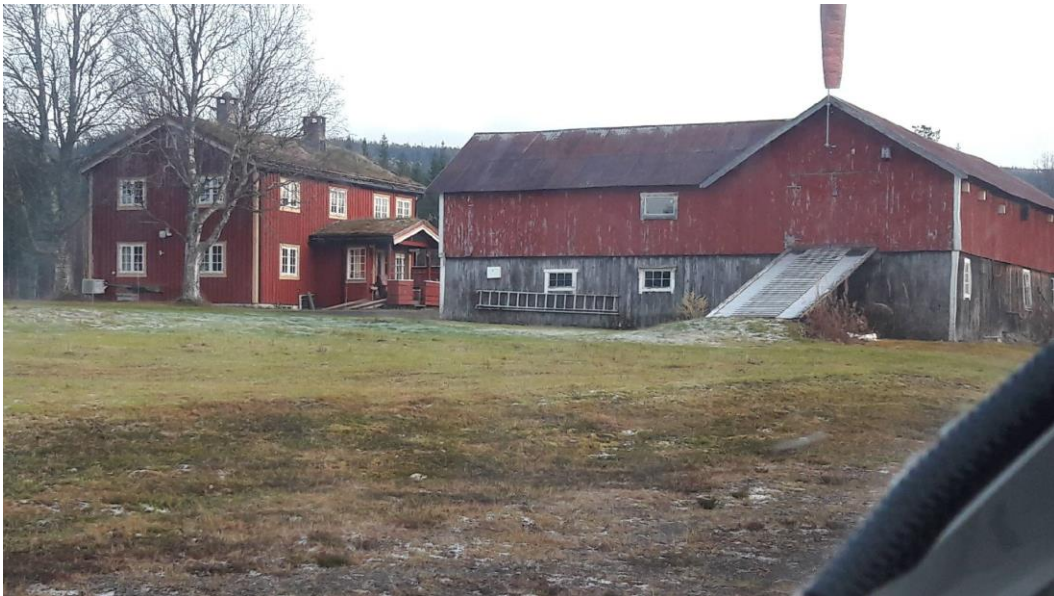
Figure 3: Photo sent from the LN-AAL commander's mobile phone just before take-off. The photo shows the windsock hanging motionless. Photo: LN-AAL commander

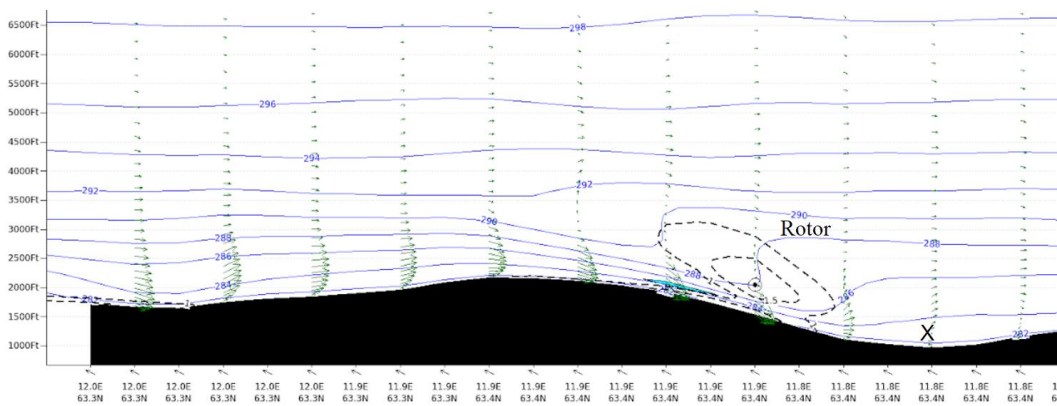
The strong low-level inversion with a certain wind field formed mountain waves, which most likely broke at higher altitudes as the wind decreased and then changed direction (critical level⁴) with increasing altitude. A 500 m resolution model indicates potential downslope winds and rotors in the Øian area (see Figure 6 and Figure 8). The 500 m model also indicates areas with moderate turbulence and moderate downdrafts on the leeward side of the mountains in this area. The exact location of the rotor does not need to be the same as predicted by the model, and such phenomena may fluctuate in time and space.

Figure 8: The figure shows tendencies of a hydraulic jump with a turbulent rotor in the area and wind shear downstream of the mountain south-east of Meråker at 1500 hours on 7 November 2018. The blue lines show the potential temperature in Kelvin. The green arrows show the wind along the section. The X indicates the approximate position of Øyan Airfield. Source: The Norwegian Meteorological Institute

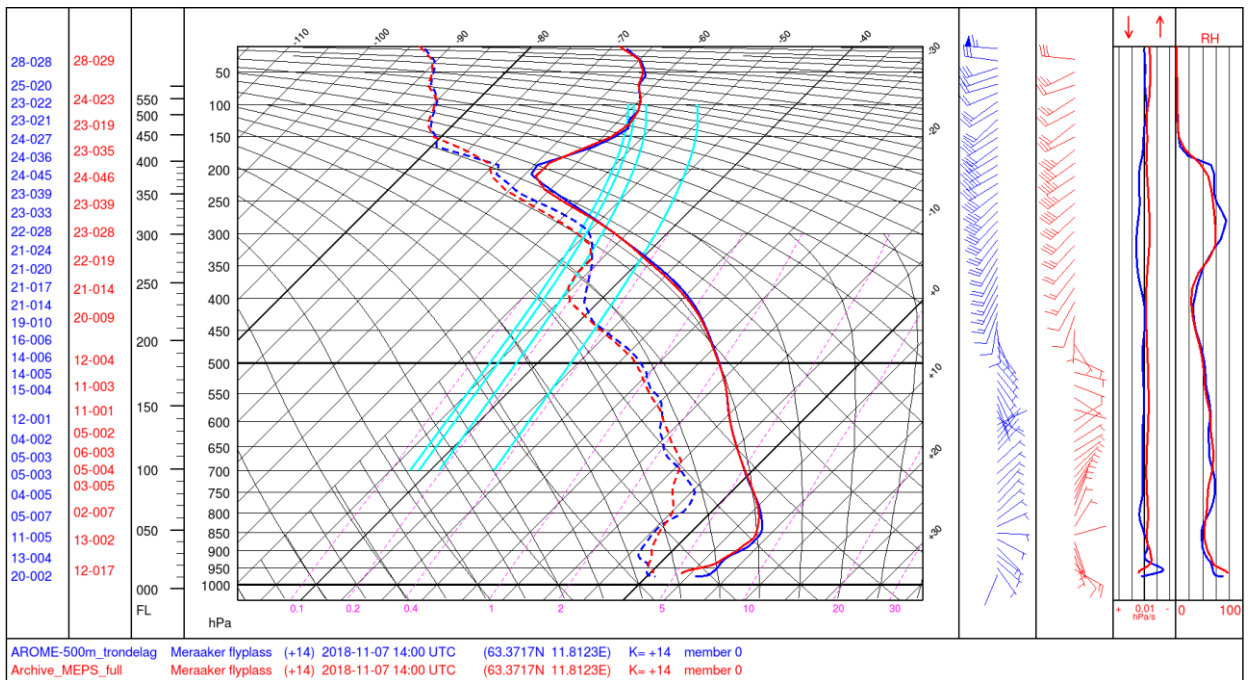
Figure 10: Vertical profile 7 November 2018 at 1500 hours local time (1400 hours UTC) above Meråker Airfield Øian, showing how the temperature (solid line), dew-point temperature (dotted line), horizontal wind (figures and wind arrows), vertical wind (negative values show upwind and positive values downwind) and relative humidity change with the altitude, according to high-resolution model calculations. Source: The Norwegian Meteorological Institute

The spread between temperature and dewpoint above Øian Airfield was approximately 5 °C according to Figure 10. The likelihood of getting carburetor icing was therefore limited. LN-AAL had an Ellison carburetor that has good resistance against carburetor icing. It is therefore unlikely that the loss of engine power was caused by carburetor icing.

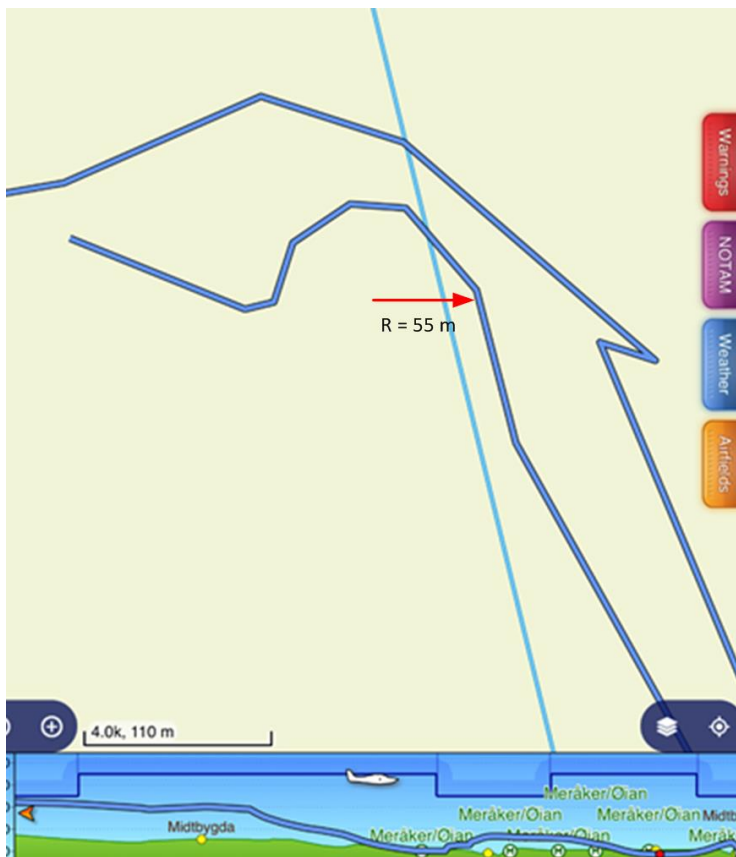
- 2.2.4 The AIBN's calculations of the assumed bank angle and G forces in the turn after take-off from Øian are based on information from the SkyDemon navigation program. (see Figure 22). However, there is some uncertainty related to the accuracy of the SkyDemon information, due to, among other factors, unstable GPS reception in the Meråker area.

Figure 22: Calculation of the turning radius after take-off from Øian Airfield. The outer track is from the touch-and-go, whereas the track nearest the center shows the climb and turn after the last take-off. Source: SkyDemon

without the use of flaps at 56.5 kt. Furthermore, the AIBN believes a turn was initiated as is apparent from the navigation plot in Figure 22.
